ORNL-2833  
UC-25 - Metals, Ceramics, and Materials

CORROSION ASSOCIATED WITH  
HYDROFLUORINATION IN THE  
OAK RIDGE NATIONAL LABORATORY  
FLUORIDE VOLATILITY PROCESS

A. E. Goldman  
A. P. Litman

METALLURGY DIVISION

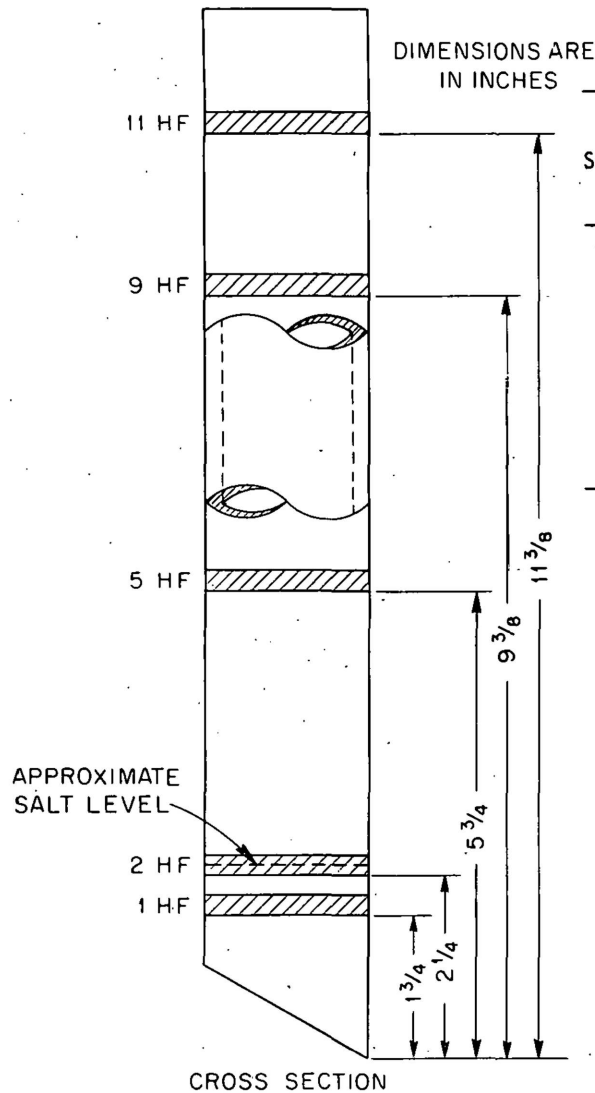
Following decontamination, the vessel was sectioned and five areas removed for metallographic study. Figure 2 illustrates the sections taken and the results of the metallographic examination. Since the corrosion rates attributable to the decontamination solutions were negligible, the corrosion noted was assigned solely to the dissolution studies.

The Inconel Hot-Facility Hydrofluorinator Dissolver demonstrated poor resistance to the Volatility Process dissolution environment. Both the salt bath region and the salt-vapor interface region had corrosion rate losses

Fig. 2. Regional Corrosion Losses and Metallographic Observations for the Inconel Hot-Facility Hydrofluorinator Dissolver.

greater than 30 mils/month. In addition, a portion of the middle vapor region also had losses of the same magnitude. Of particular interest are the metallographic sections removed from these three major loss regions which are pictured in Fig. 3. The salt and salt-vapor interface samples had extremely rough surfaces and showed evidence of pitting attack. However, the sample removed from the middle vapor region had a smooth surface and no indication of preferential corrosion was noted.

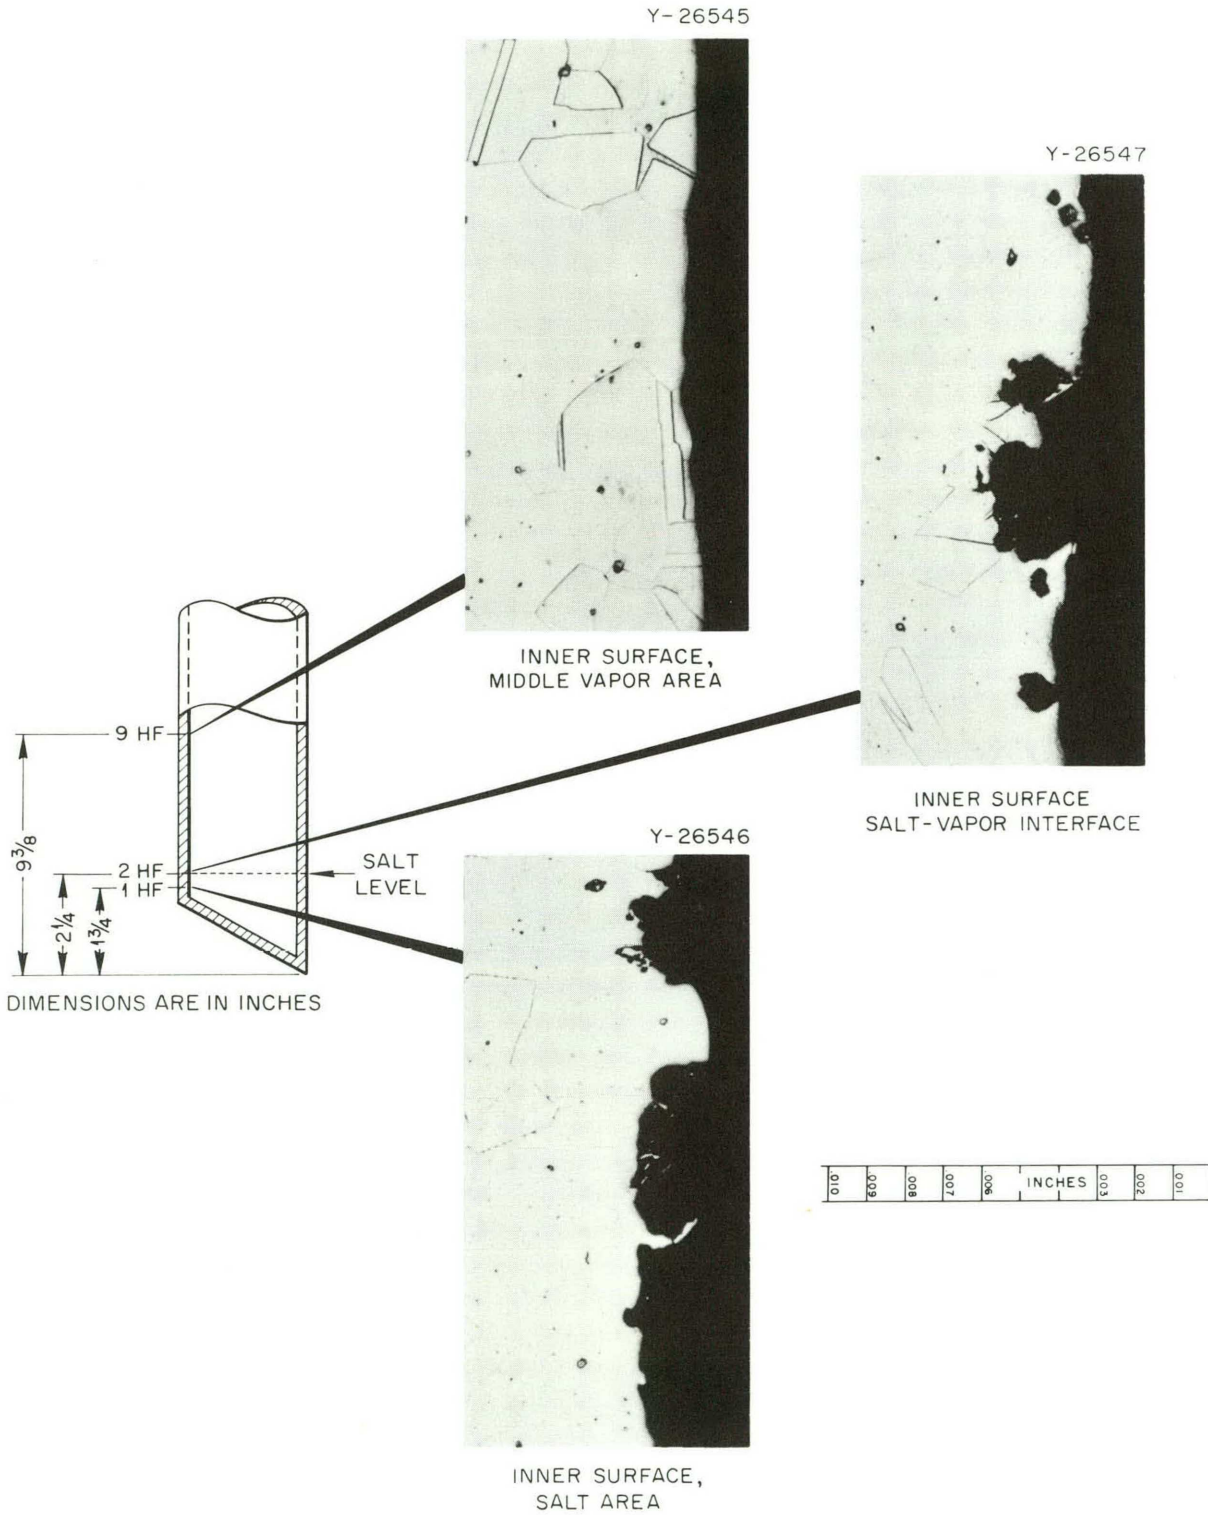
Fig. 3. Chemical Development Section A Inconel Hydrofluorinator.  
Etchant: glyceria regia. Reduced 24%. 250X.

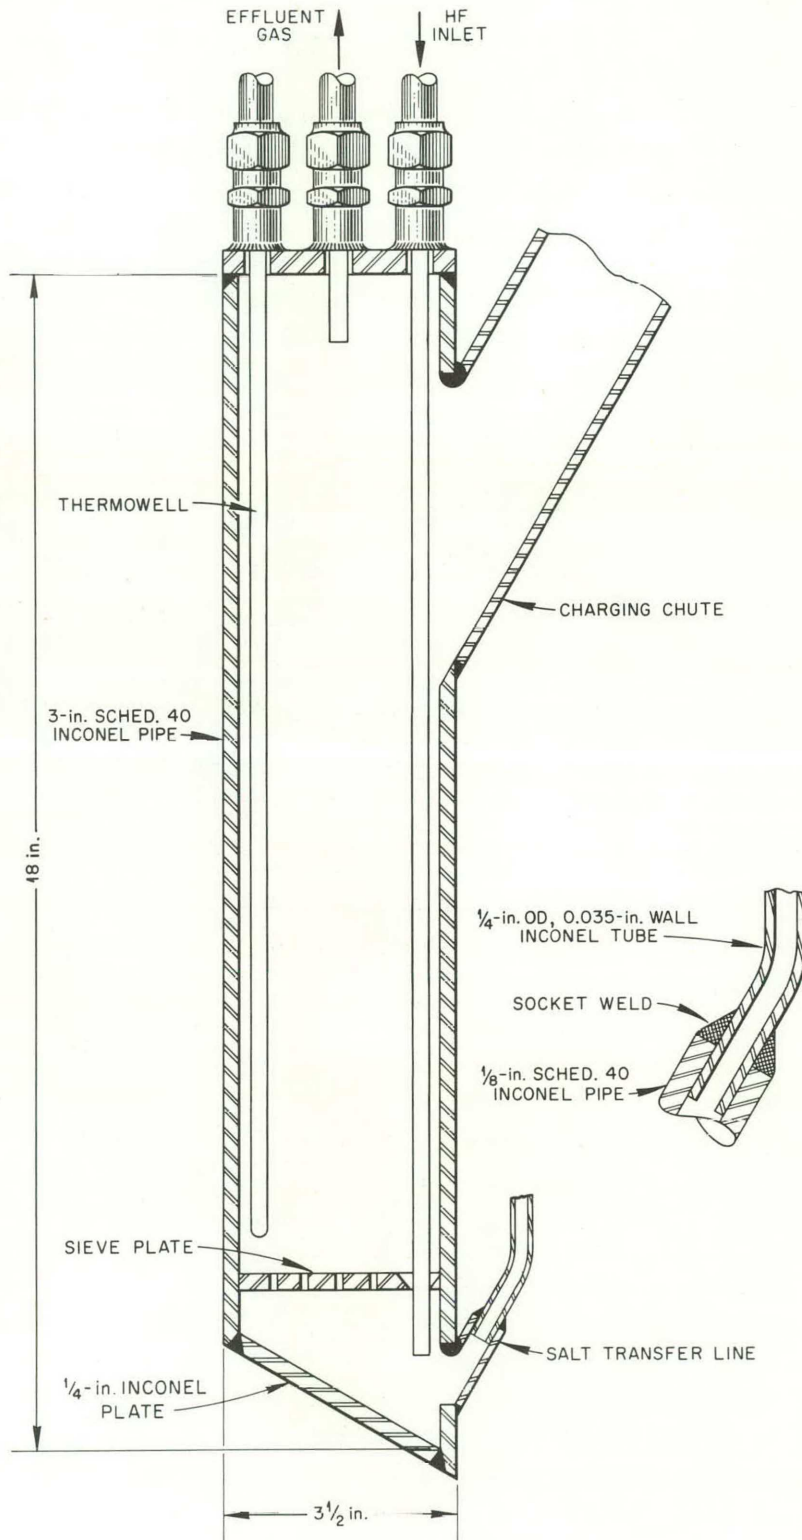
Fig. 4. Cross Section of Inconel Hydrofluorinator Dissolver.

Following the exposure listed above, failure occurred in the salt-transfer line at a point  $1/8$  in. above the tube-to-pipe weld shown in Fig. 4. The failure permitted molten salt to drain out, filling the recess between the vessel and the external furnace wall and reacting vigorously with the vessel's external surfaces. Figure 5 illustrates the point of failure and corroded exterior surfaces.

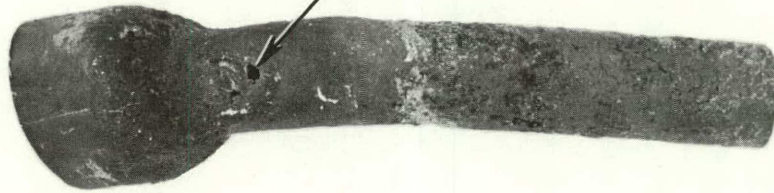
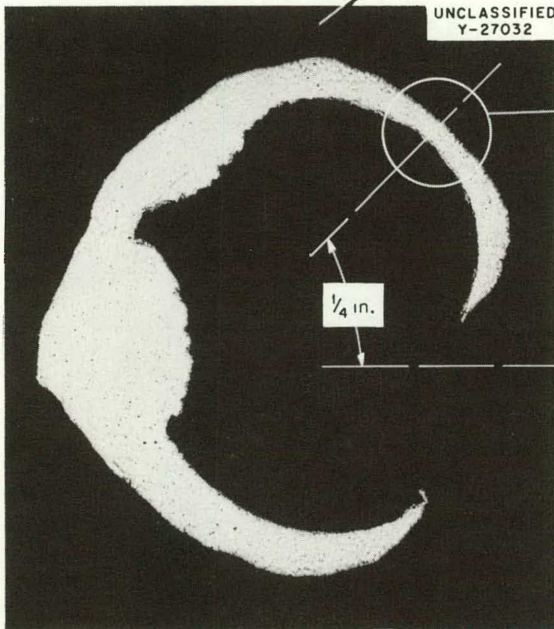
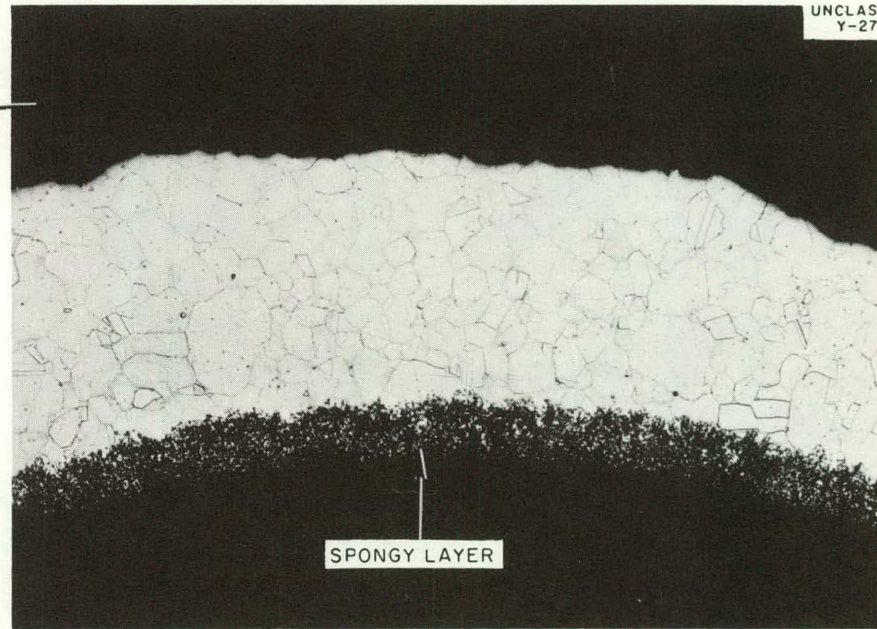
POINT OF FAILURE

Visual and metallographic examination of the failure area revealed that the cross section of the transfer line had been reduced prior to service because of field repairs made on the adjacent socket weld (Fig. 5) and that a porous corrosion product layer was visible on the interior of the pipe close to the point of failure.

The corrosion product layer on the interior wall of the Inconel salt-transfer line was 0.004 in. thick and had the characteristic appearance of Inconel from which chromium has been selectively leached. The corrosion product and the Inconel line in proximity to the failure were highly ferromagnetic. It has been reported previously that hydrogen fluoride, produced from the contact of fluoride with moist air in a fluoride salt system, preferentially removes chromium from Inconel.<sup>4,5</sup> No analysis of the product layer was obtained because of the small amounts available.

The failure described apparently occurred when the previously thinned weld repair area was weakened further by corrosion to the point where it could not withstand the internal salt pressure of a regular salt transfer. The failure allowed molten salt to flow outward, greatly enlarging the original hole. No further study was carried out on the vessel. Presumably, similar corrosive attack had occurred on the parts of the vessel in contact with salt and hydrogen fluoride.

(NOTE SPONGY LAYER ON INTERIOR OF TUBE CLOSE TO POINT OF FAILURE)

Fig. 5. Salt-Transfer Line Failure from Inconel Hydrofluorinator Dissolver.

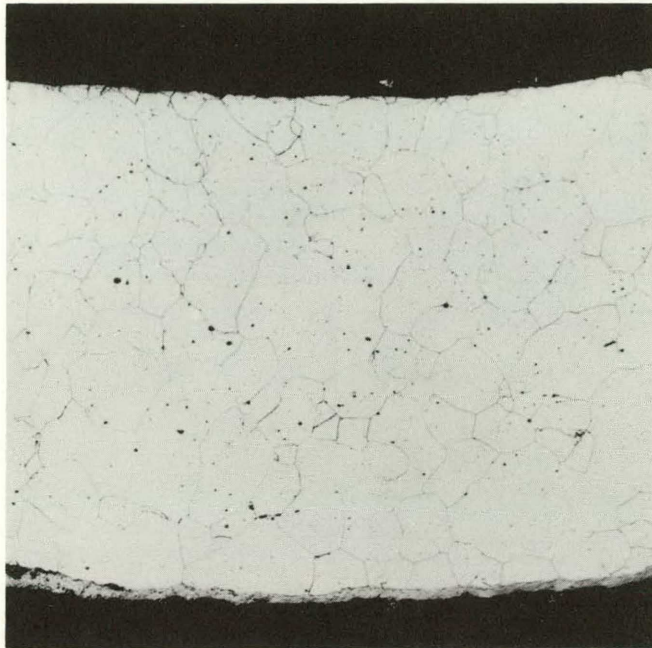
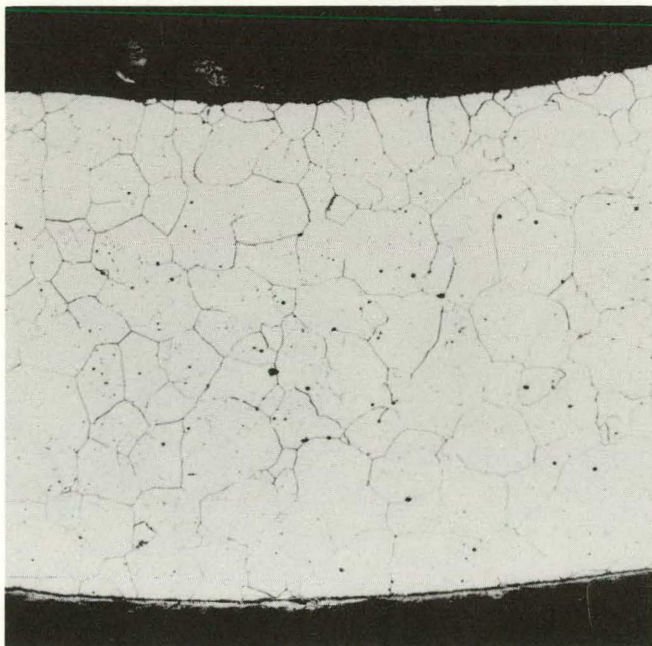
Maximum corrosive attack occurred on the hydrogen fluoride entry tube in the region of the vapor-salt interface. If the assumption is made that all corrosion occurred during the hydrogen fluoride sparge, the rate loss for this area would be 6.5 mils/month for the combined inside and outside-diameter losses or 3 mils/month for the outside diameter in contact with the hydrofluorination environment. These rates were unusually low and lent impetus toward building a semiworks-size INOR-8 hydrofluorinator dissolver discussed below.

VAPOR-SALT INTERFACE SAMPLE

SALT PHASE SAMPLE

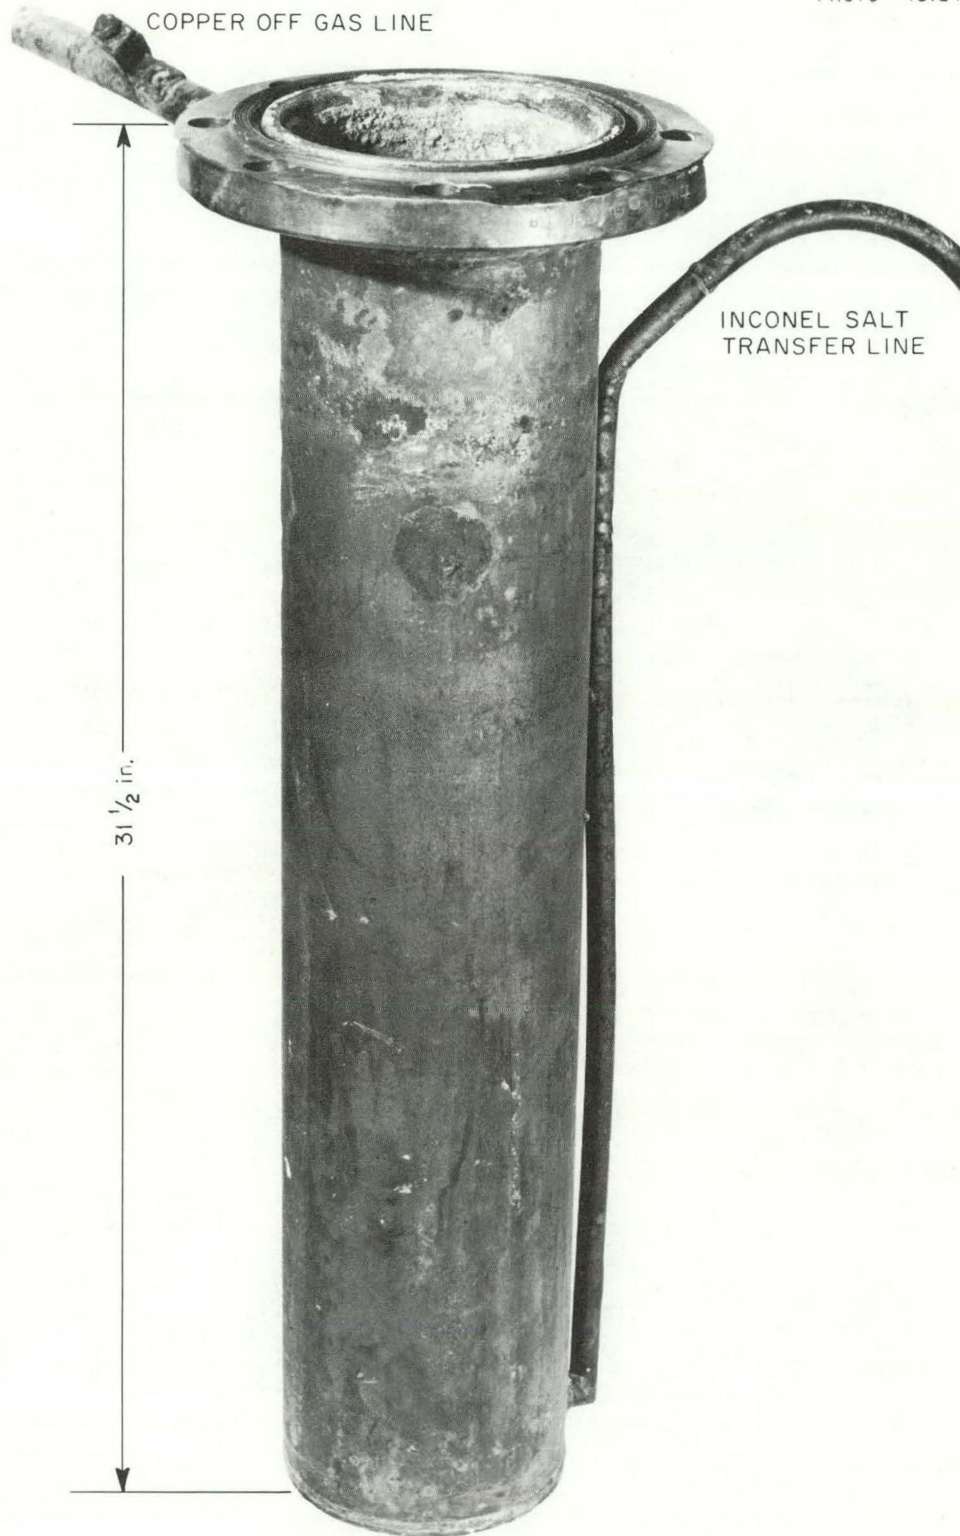
Fig. 11. Mark I Copper-Lined Hydrofluorinator Dissolver after 24 Dissolution Runs.

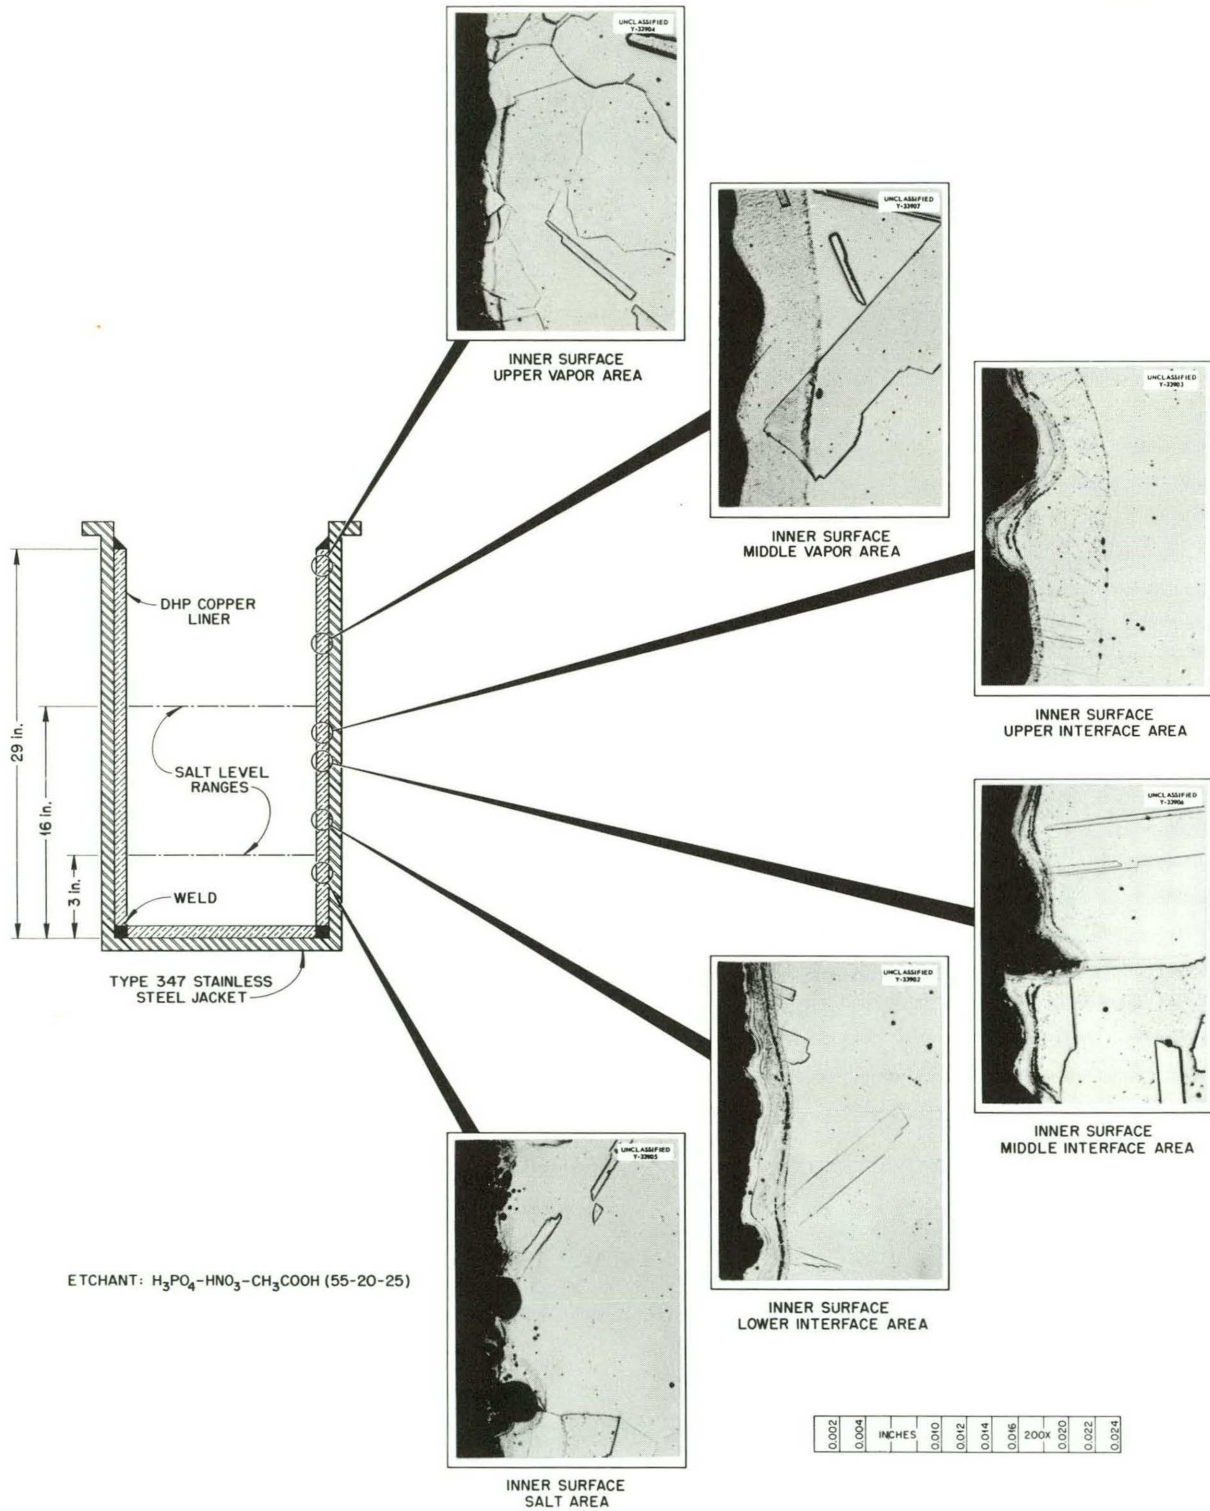
Fig. 12. Typical Microstructures of Samples from the Copper Liner of the Mark I Hydrofluorinator Dissolver. Etchant: Phosphoric-acetic-nitric acid. Reduced 62%. 200X.

specimens showed duplex layers and at various distances below the surface the layers appeared to be separated by alignment of voids. Of particular interest were the particles in the subscale of the upper interface specimen in that they seemed to be deposited in subgrain boundaries.

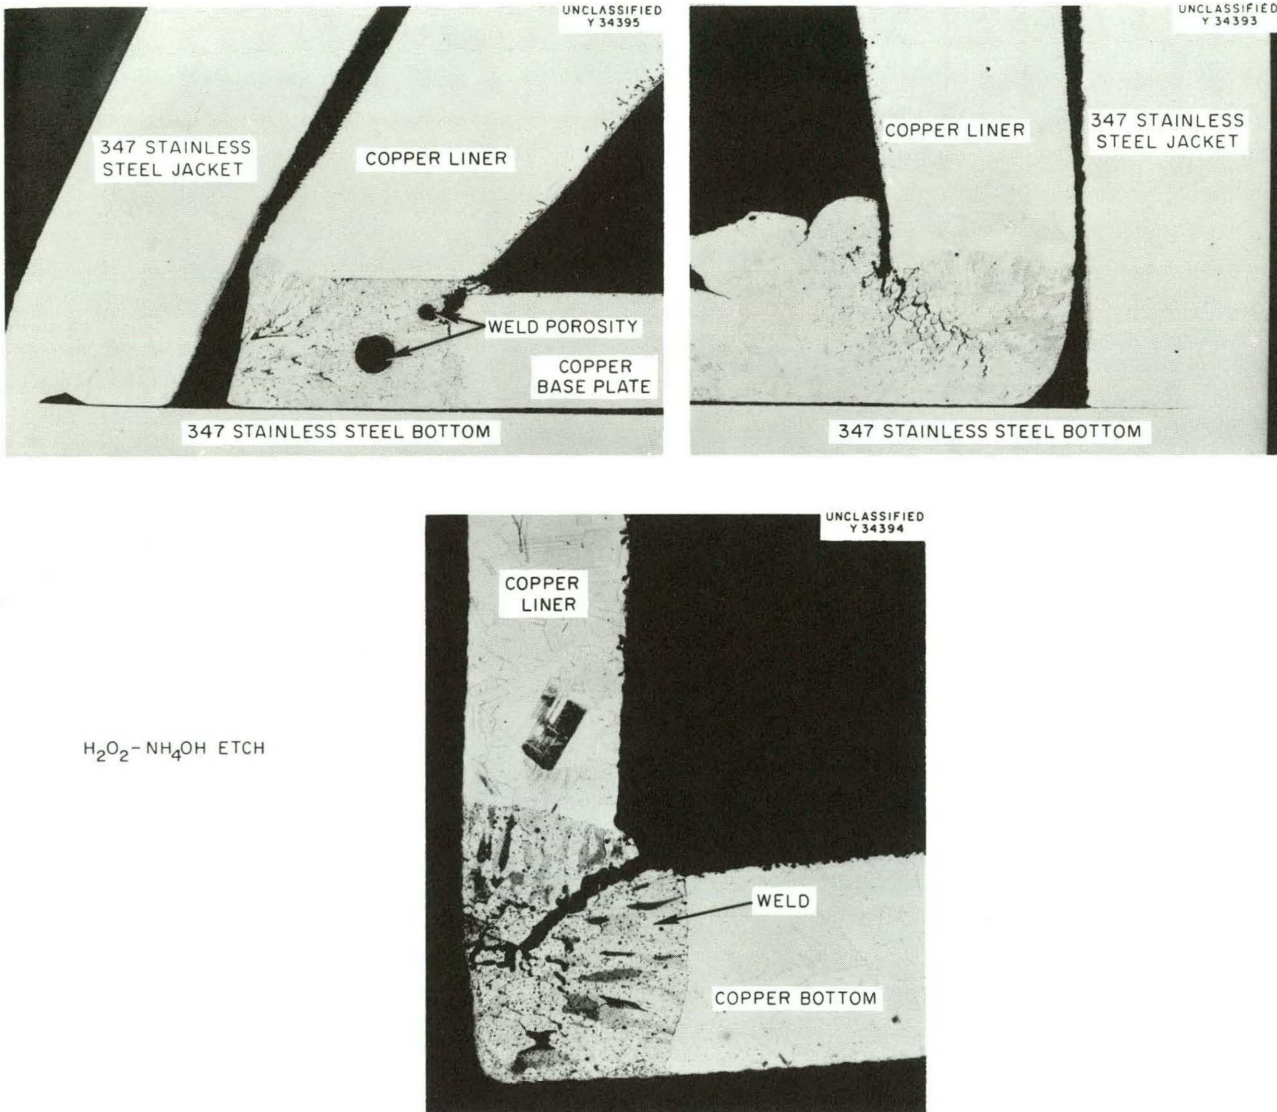
Fig. 13. Typical Microstructures of Copper Liner-to-Bottom Head Weld from the Mark I Hydrofluorinator Dissolver. Etchant: Hydrogen peroxide-ammonium hydroxide. 5X.

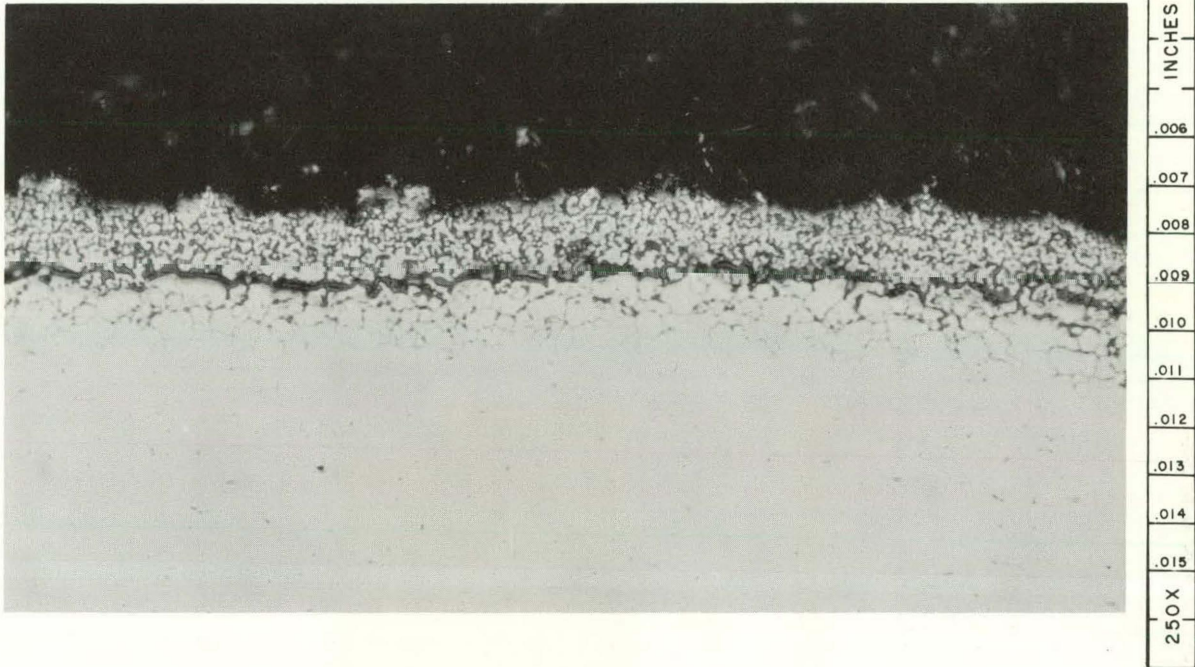
Fig. 14. Photomicrograph of Type 347 Stainless Steel Jacket from Copper-Lined Hydrofluorinator Dissolver. (Note spongy surface layer and intergranular modifications on side unintentionally exposed to the hydrofluorination environment.) As polished. 250X.

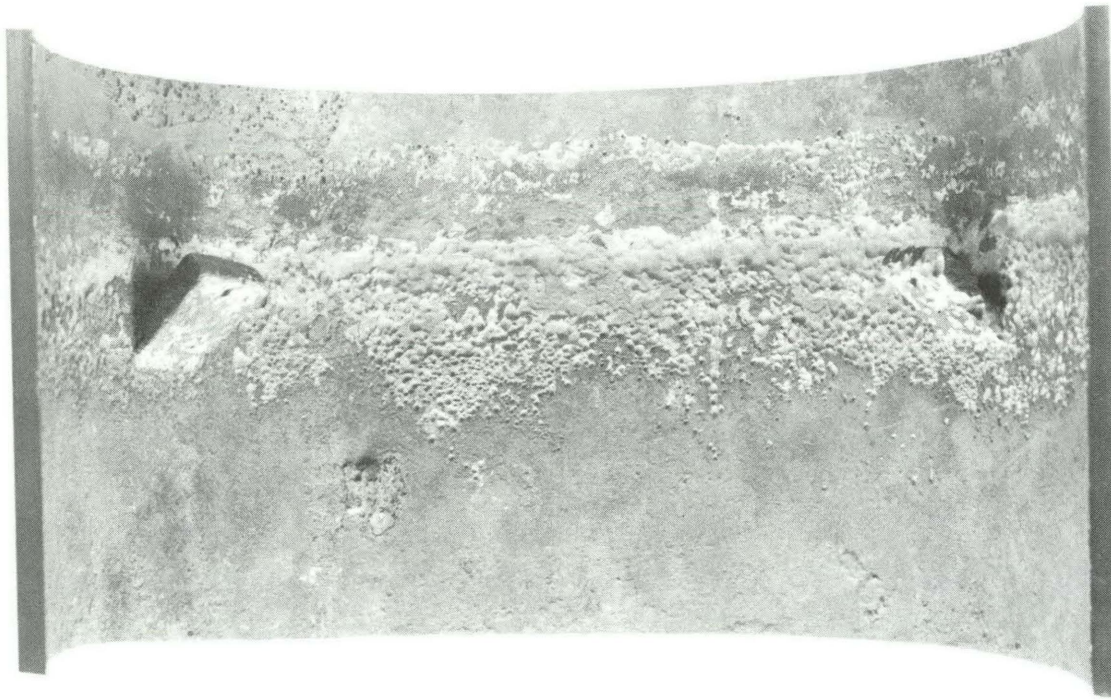
Fig. 18. Appearance of the INOR-8 Hydrofluorinator Dissolver Vapor-Salt Interface Region after Ten Experimental Runs. (Most of the corrosive attack shown occurred during run No. 10 during which time zirconium metal was not dissolving.)

After the ten runs described, BMI personnel conducted a survey of the pitting attack and bulk-metal losses on the Mark I INOR-8 vessel. A summary of these data, shown in Table XII, indicates that the most severe attack occurred at the vapor-salt interface region. Pit depths up to 72 mils were noted in the interface region.

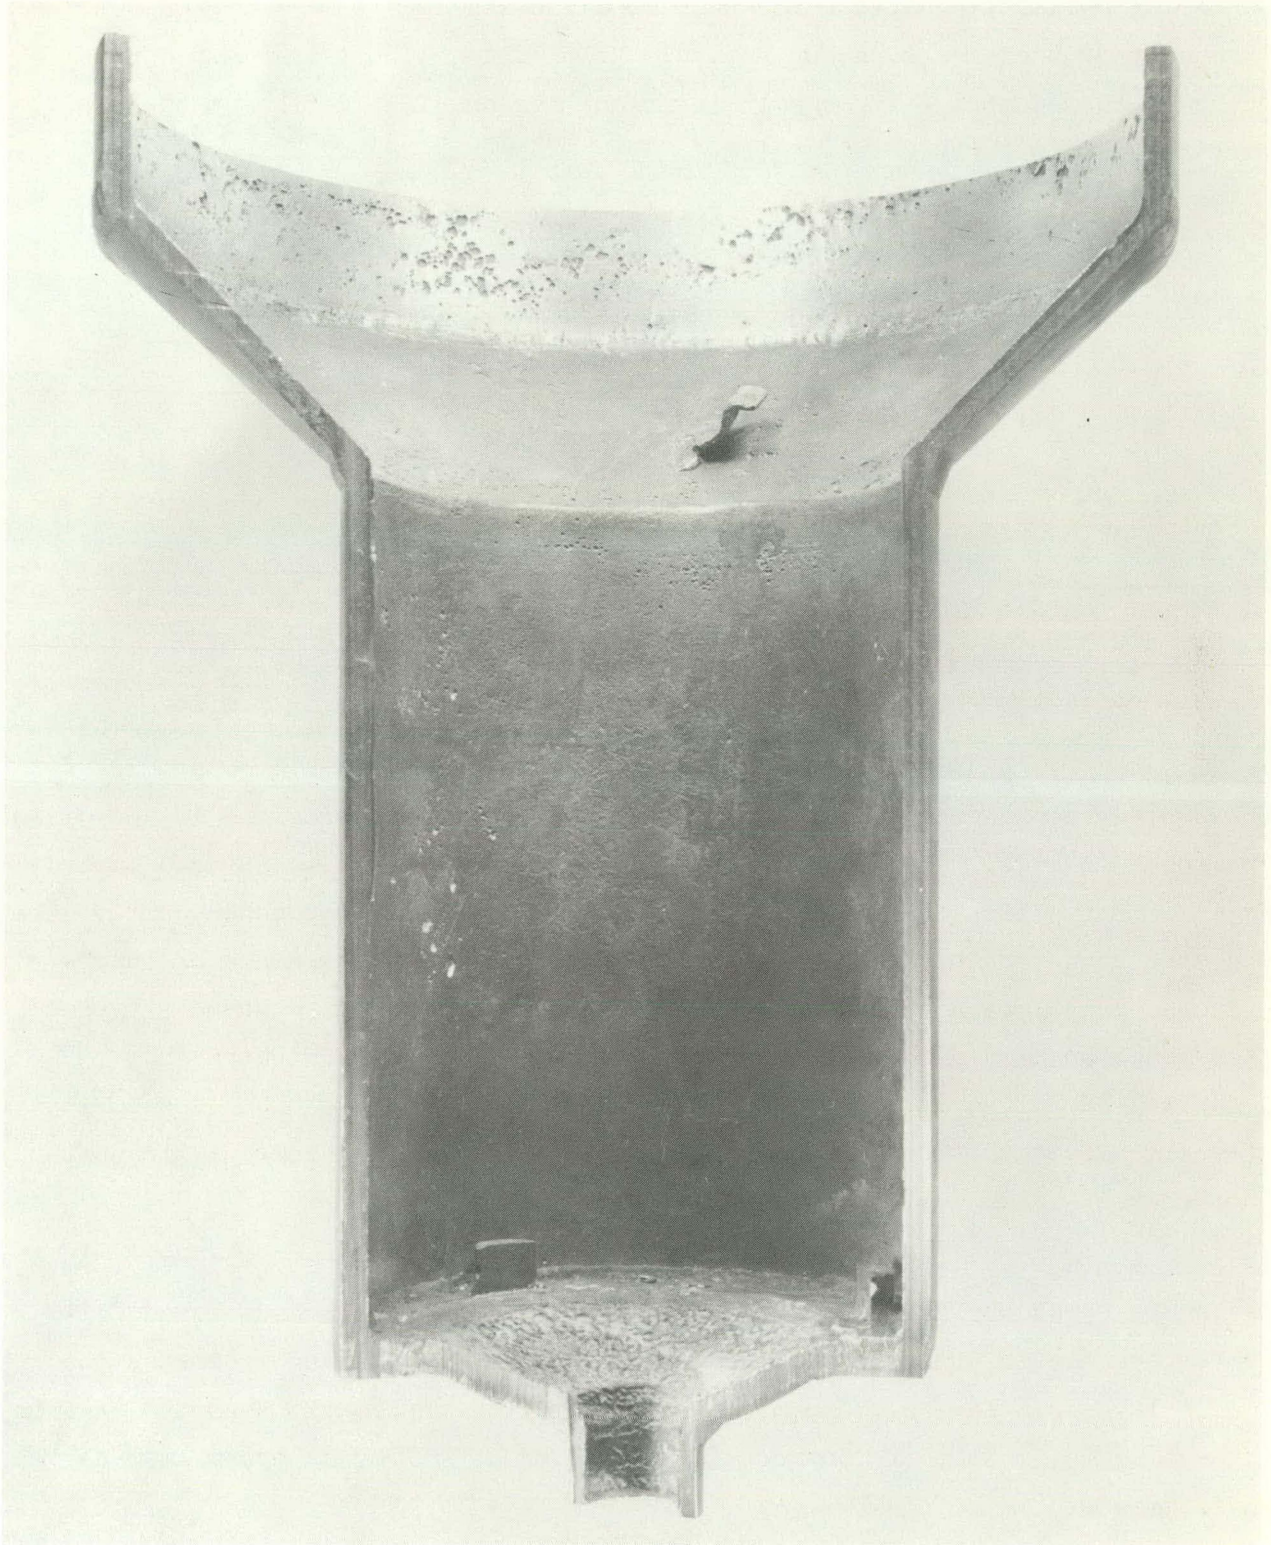
Fig. 19. Appearance of the INOR-8 Hydrofluorinator Dissolver Salt Region after Ten Experimental Runs. (Most of the pitting attack occurred during the last run when bulk zirconium was not present.)

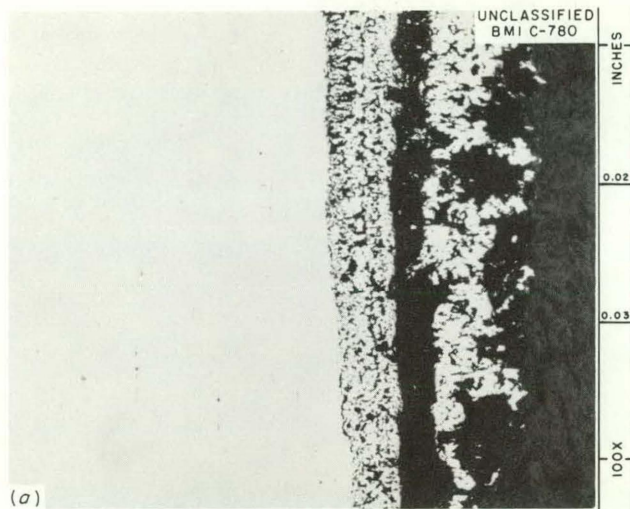
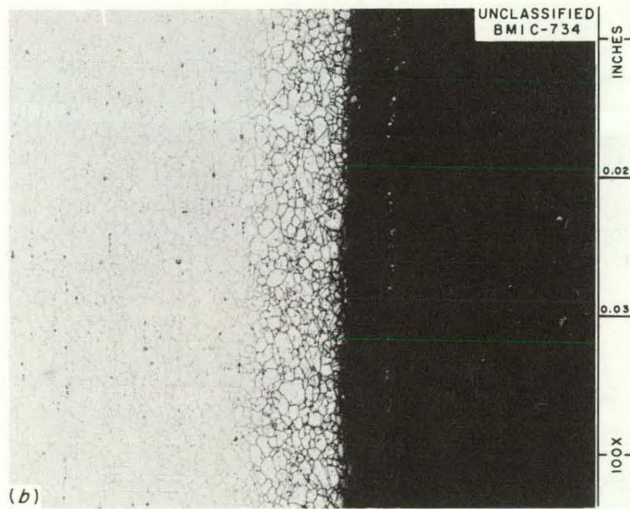
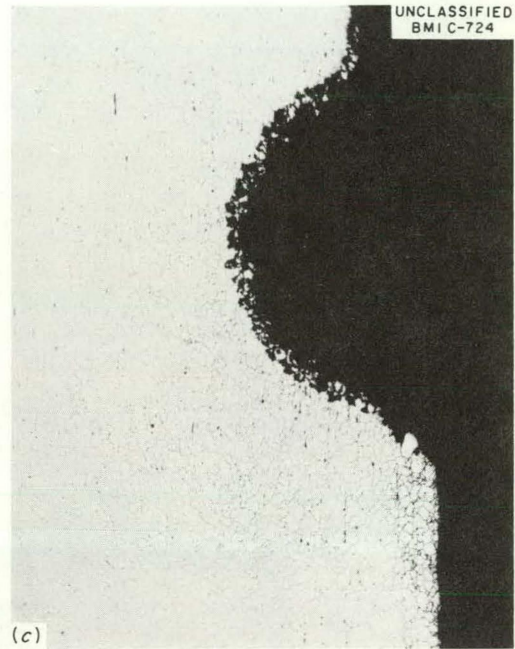
(4) Chemical Analyses. The surface layer shown in Fig. 21(a) was analyzed at BMI by spectrographic and wet analysis methods. Table XIII summarizes the information obtained on the major elements and indicates the porous layer was severely depleted in chromium and moderately depleted in iron content as the result of contact with the Volatility Process hydrofluorination environment.

(a)  
100X UNETCHED  
CROSS SECTION OF WALL SHOWING POROUS SURFACE LAYER

(b)  
100X ETCH  $H_2CrO_4$ -HCl  
CROSS SECTION OF WALL SHOWING SAME REGION AS ABOVE IN ETCHED CONDITION AND ILLUSTRATING INTERGRANULAR ATTACK

(c)  
70X ETCH  $H_2CrO_4$ -HCl  
CROSS SECTION OF TYPICAL PIT SHOWING SLOUGHING OF GRAINS AS THE RESULT OF INTERGRANULAR ATTACK

Fig. 20. Microstructures from the Mark I INOR-8 Hydrofluorinator Dissolver Vapor-Salt Interface Region Showing Typical (a) Corrosion Product, (b) Intergranular Attack, and (c) Pit Cross Section.

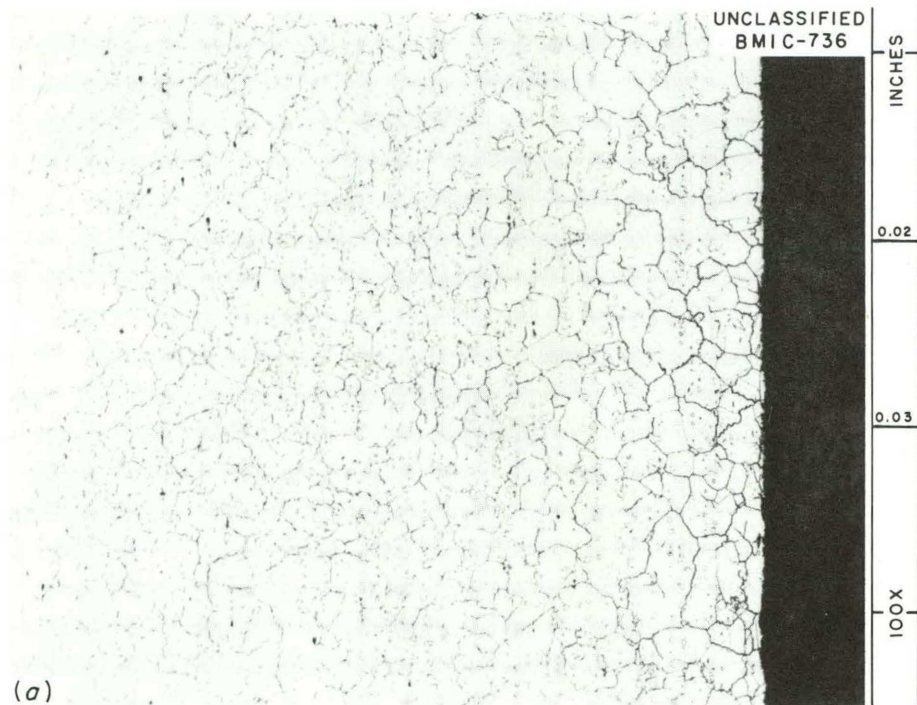
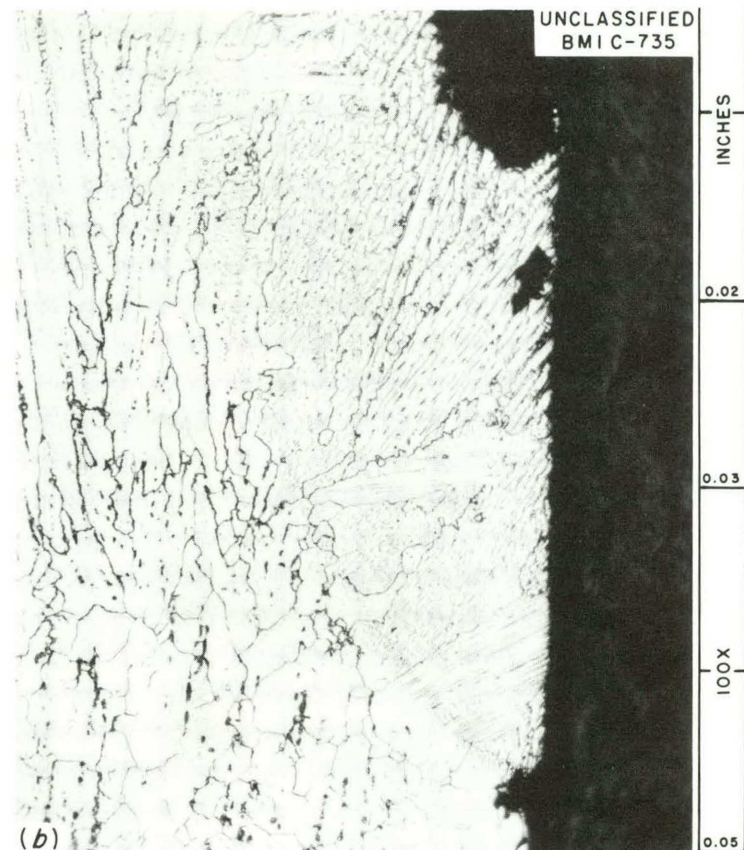
CROSS SECTION OF WALL FROM LOWER PORTION OF SALT  
REGION IN PROXIMITY TO DRAFT TUBE

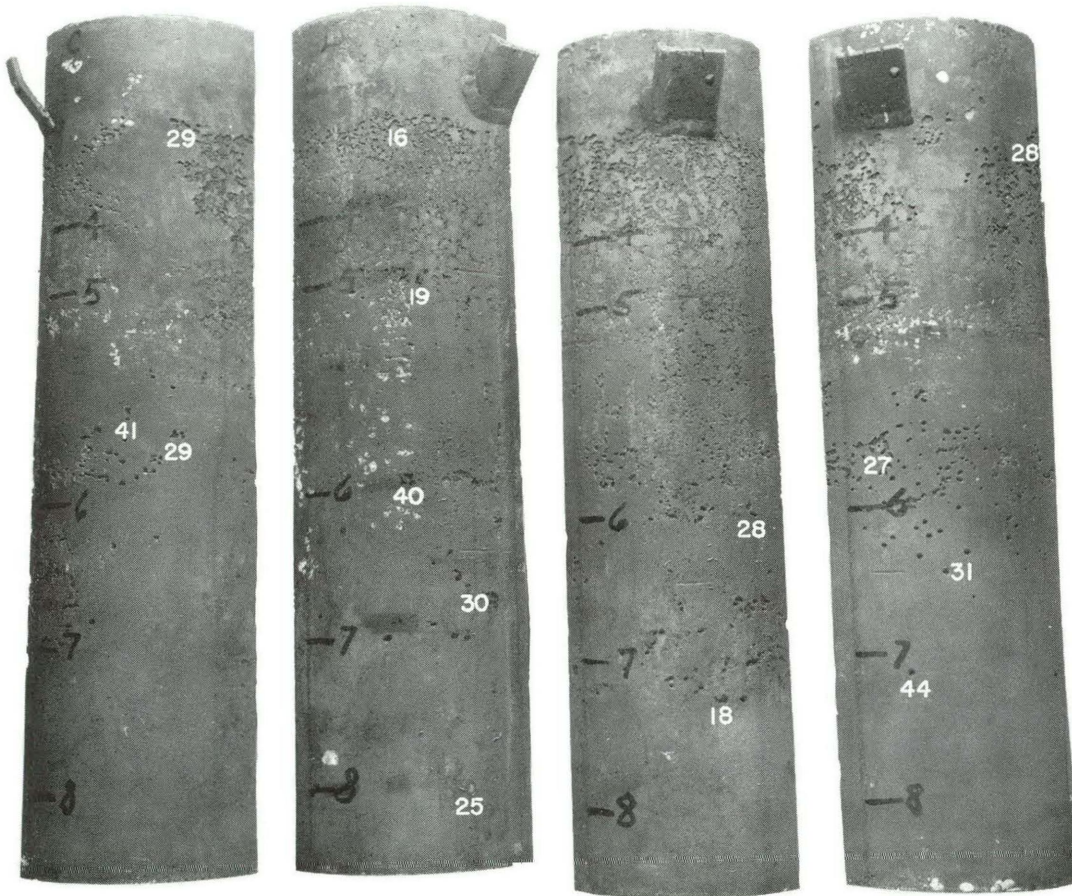
Fig. 22. Several Views of INOR-8 Draft Tube used in Mark I INOR-8 Hydro-fluorinator Dissolver. White numbers indicate pit depth in mils. Approximately one fourth actual size.

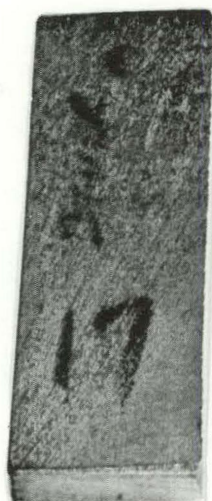
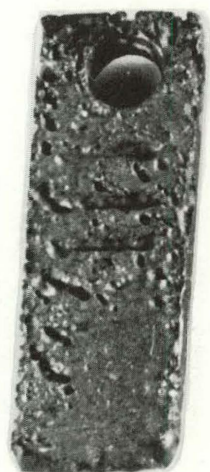
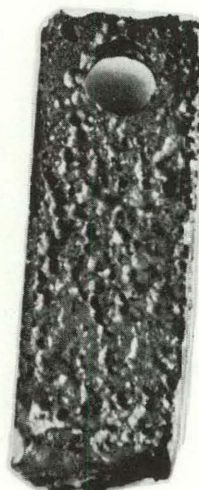
Fig. 25. Vapor-Salt Interface Corrosion Specimens Exposed during Runs No. 9 and 10 in the Mark I INOR-8 Dissolver. (Weight-loss data indicated all corrosion occurred during run No. 10.)

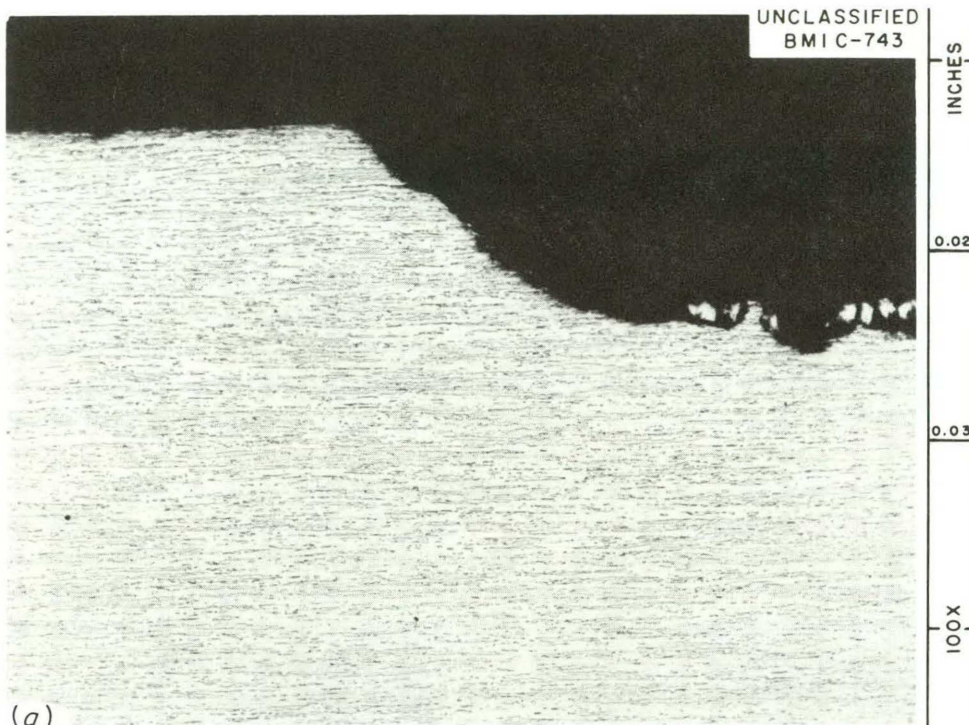
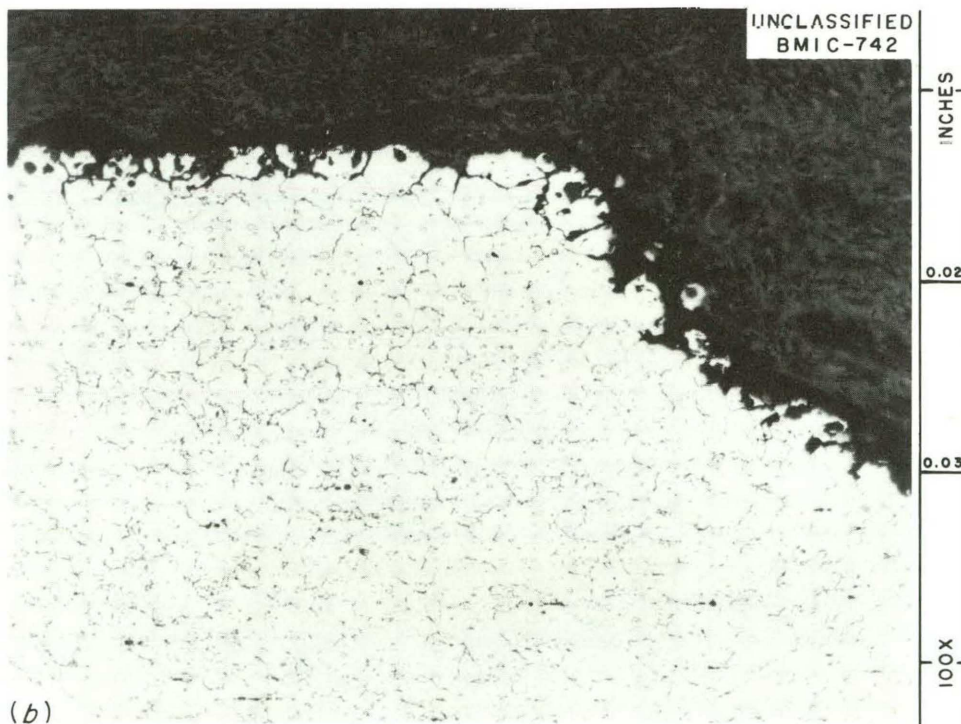
Fig. 26. Typical Microstructures of (a) Molybdenum, and (b) INOR-8 Corrosion Specimens Exposed in the Mark I INOR-8 Hydrofluorinator Dissolver. 100X.

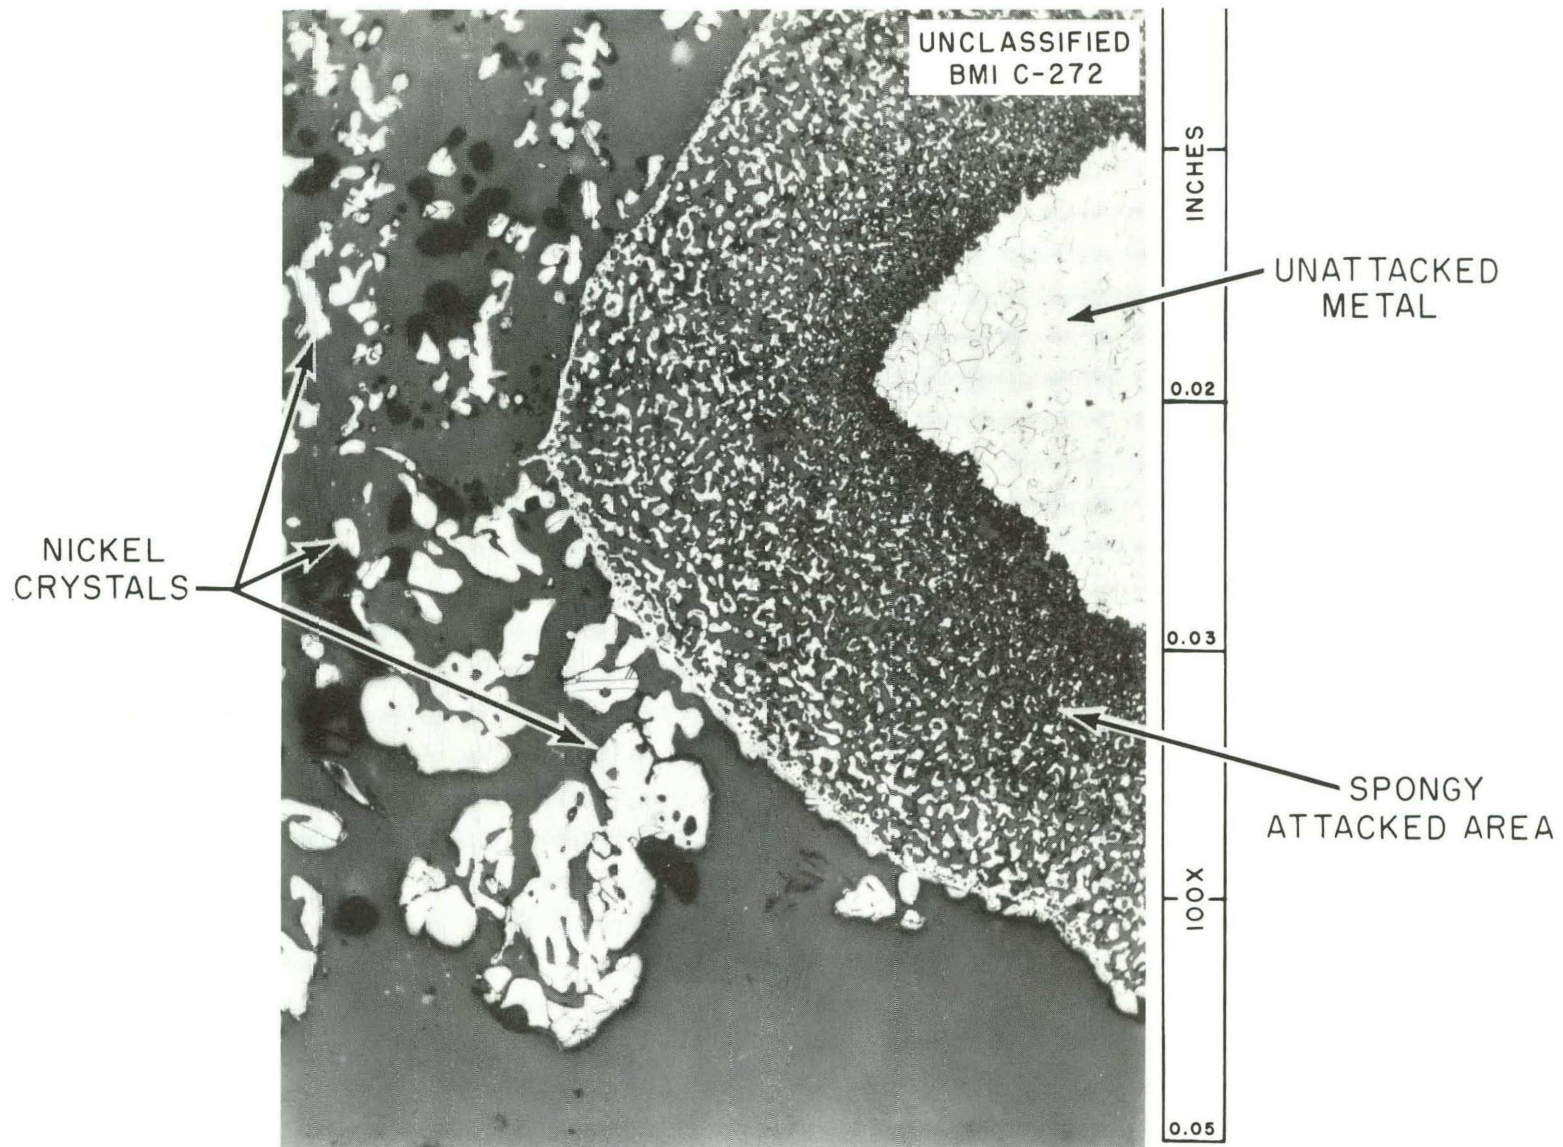
Fig. 29. Photomicrograph of Inconel Sparge Tube which Failed during Early BMI Tests.  
Etchant: Nitric-hydrochloric acid. 100X.

sparge tube indicating the spongy areas where leaching of chromium occurred and where the metal crystals were deposited. Similar results were found during operations of a semiworks-scale vessel at ORNL when an Inconel salt line and hydrogen fluoride carrier line failed in service (see Section I of this report).
