ORNL-3253
UC-25 - Metals, Ceramics, and Materials

CORROSION OF VOLATILITY PILOT PLANT
MARK I INOR-8 HYDROFLUORINATOR
AND MARK III L NICKEL FLUORINATOR
AFTER FOURTEEN DISSOLUTION RUNS

OAK RIDGE NATIONAL LABORATORY
operated by
UNION CARBIDE CORPORATION
for the
U.S. ATOMIC ENERGY COMMISSION

FEB - 9 1962

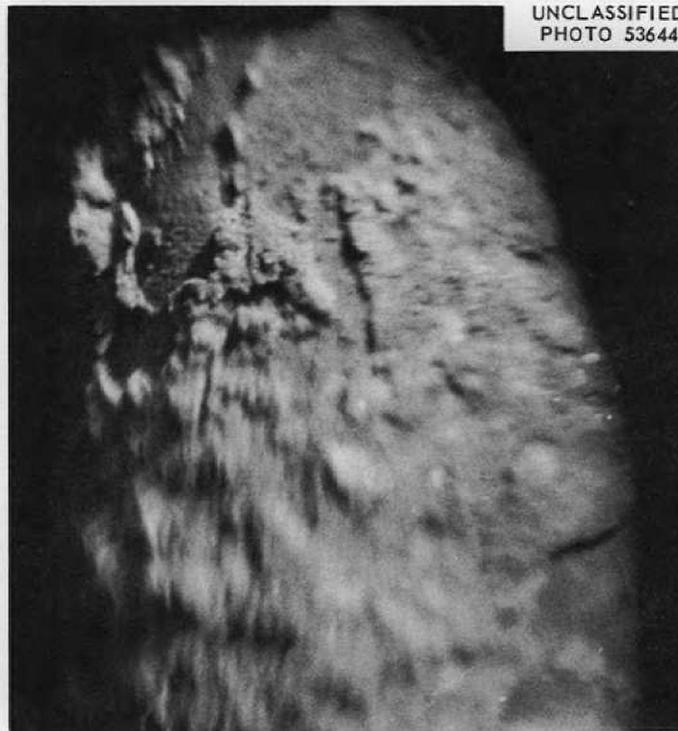
The regions of the hydrofluorinator that had been in contact with process vapors were covered with a beige-colored deposit, while the salt-containing area appeared to be black with tints of green and brown. Dark-colored coarse flakes of material were noted on top of the hydrogen fluoride distributor plate (Fig. 2). The flakes had the appearance of dried salts discolored by corrosion-dissolution products. (The LiF-NaF-ZrF₄ salts used during dissolution are white in color and develop a greenish cast as UF₄ is added to the mixture.) The deposits on the distributor plate also appeared to contain metallic particles. Some of the deposits adhering to the vertical walls and interior piping in the salt region were of appreciable thickness and were loosely adherent. Typical of these regions is the deposit noted on the thermocouple well and shown in Fig. 3.

Fig. 3. Portion of the Thermocouple Well in the Lower Salt Region of the VPP Mark I INOR-8 Hydrofluorinator After Run TU-7 Showing Typical Loosely Adherent Deposits. Photograph taken through the Omniscope optical system. Approx 4X.

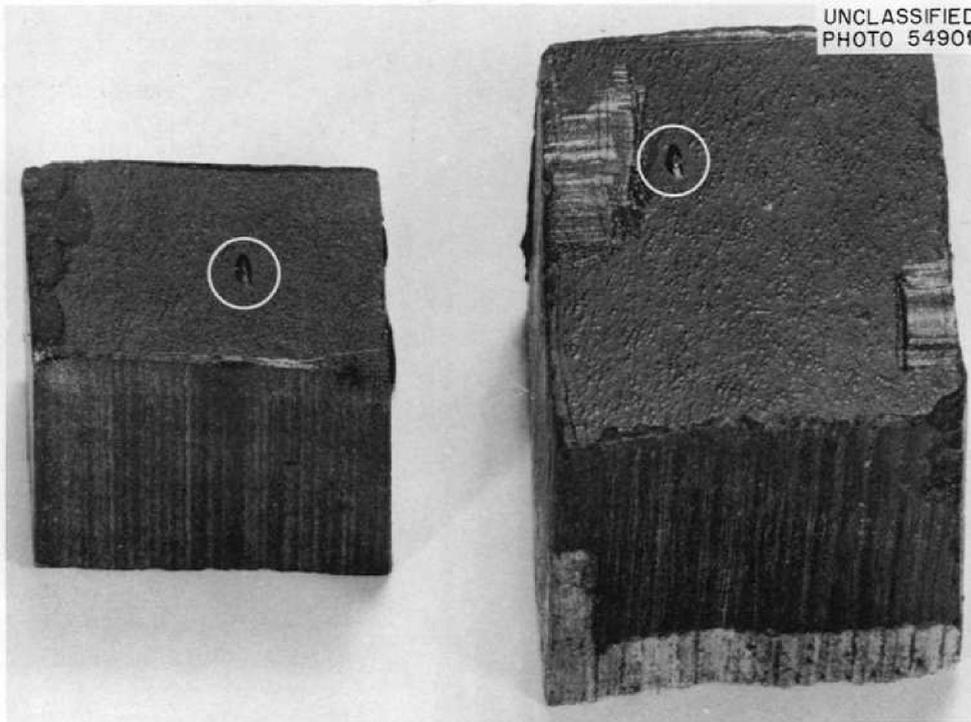
Initial replication confirmed the pitting attack in the vapor-phase region observed on the radiographic film. Duplicate impressions, at different times, disclosed that the maximum pitting depth here was 8 mils. Figure 6 shows portions of the replications illustrating the configuration of the pit. The height of the replication was measured by a toolmaker's microscope and was cross-checked by an optical comparator and a dial gage with a long lever arm.

Fig. 6. Duplicate Wax Replications of an 8-mil Pit (Encircled) Found in the VPP Hydrofluorinator North Quadrant, About 36 in. Down from the Top of the Upper Cylinder.

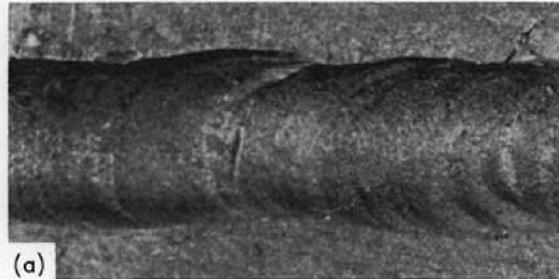
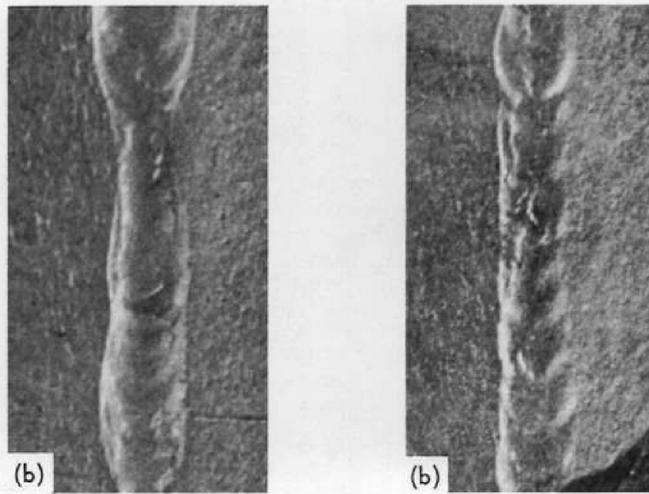
Replications were also made of portions of circumferential and longitudinal welds in the hydrofluorinator; portions of the replications are shown in Fig. 7. The impressions indicated the welds to be in good condition with little, if any, evidence of corrosive attack.

Fig. 7. Portions of Wax Replications of Welds in the VPP Hydrofluorinator. (a) Circumferential weld, southwest quadrant, 48 in. down from top of vessel; (b) longitudinal weld, southeast quadrant, 21 in. down from top of vessel. Approx 4X.

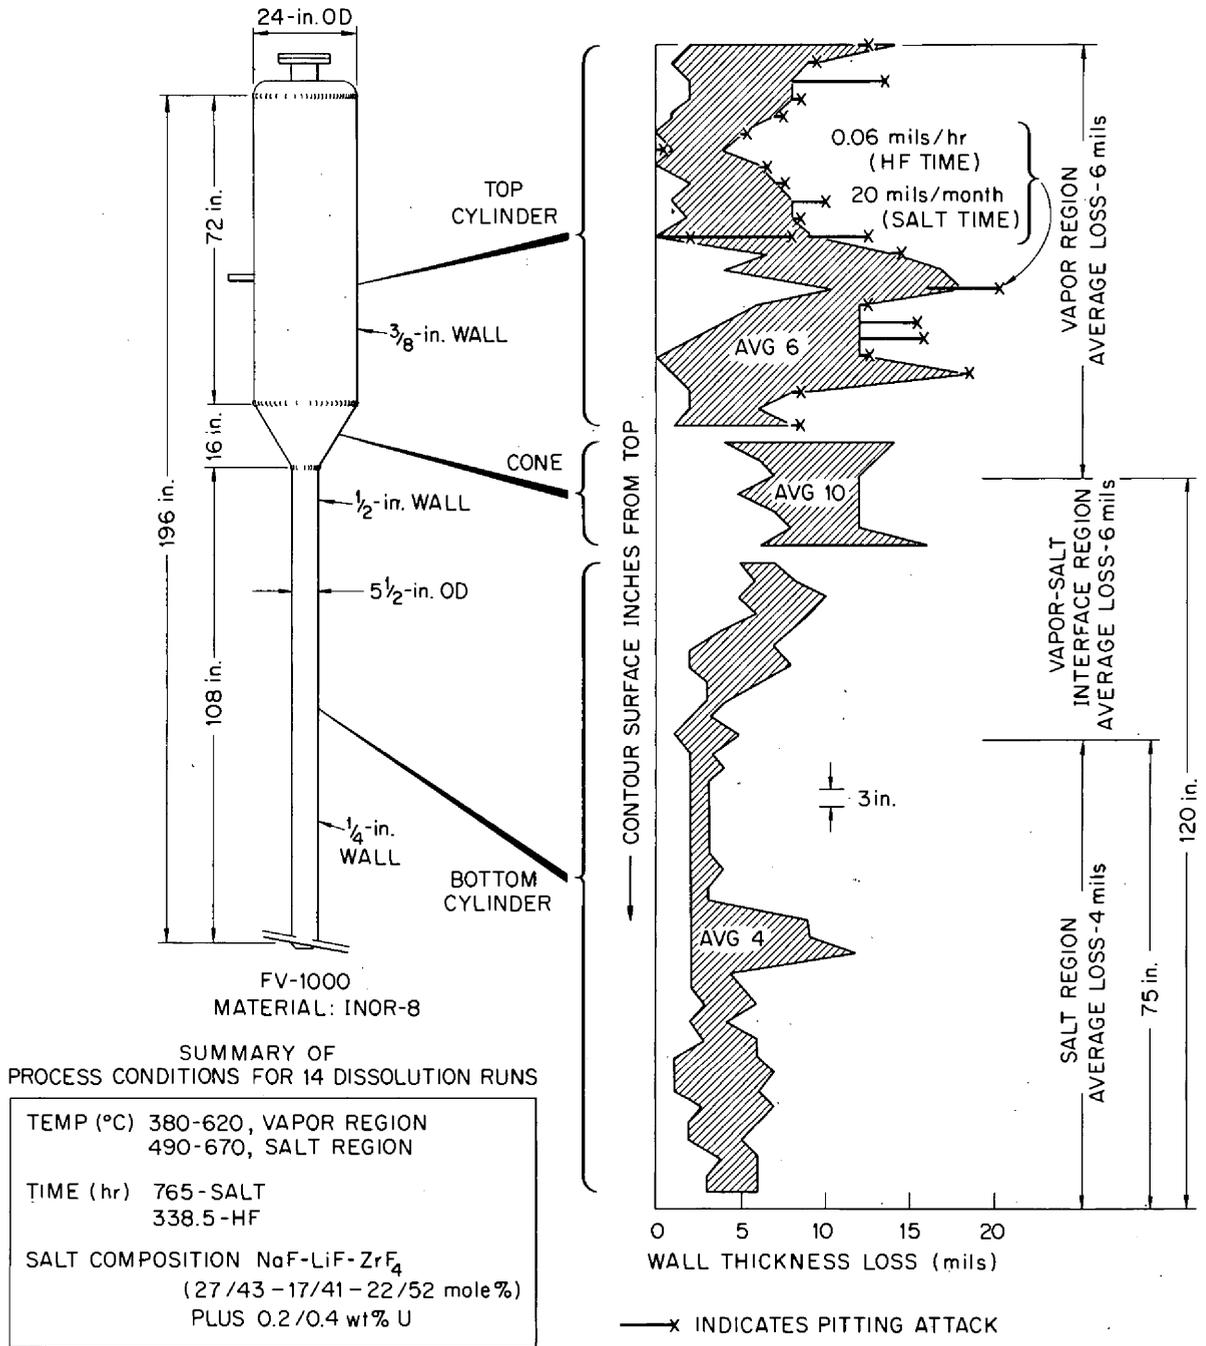
Fig. 8. Wall-Thickness Losses and a Portion of the Pitting Attack on the VPP Mark I INOR-8 Hydrofluorinator.

The depths of the pits in the upper portion of the hydrofluorinator, as determined by wax replication, are shown in Fig. 8 as extensions of the appropriate wall-thickness loss points, depending on the particular quadrants where each form of corrosion was found.

The maximum attack to date occurred in the middle vapor region at a calculated corrosion rate of 20 mils/month, based on 765 hr of molten fluoride salt residence time, and 0.06 mil/hr, based on 338.5 hr of HF exposure time.

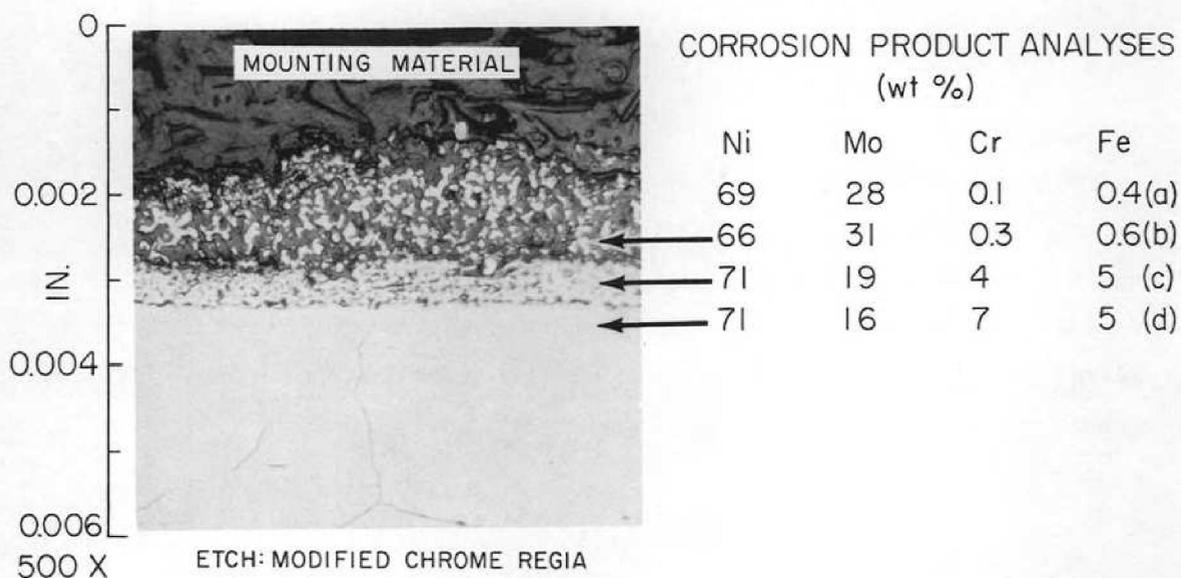
UNCLASSIFIED
ORNL-LR-DWG 61655R2

A black, semiadherent scale was present on the clip and was found to be depleted in chromium and iron when compared with the base metal (Fig. 9). The nickel content of the scale was comparable with the nominal INOR-8 analysis, but the molybdenum content was considerably higher. Scale x-ray diffraction patterns could not be matched with known compounds. Since the metallic content of the scale was less than 50% of the total weight, a good possibility exists that the scale is an Ni-Mo-F complex.

Fig. 9. Corrosion Product Layers on INOR-8 as the Result of Hydrofluorination Service Showing Composition of (a) Surface Scale (Not Shown in Photomicrograph), (b) Spongy-Surface Layer, (c) Subsurface Layer, and (d) Substrate Base Metal.

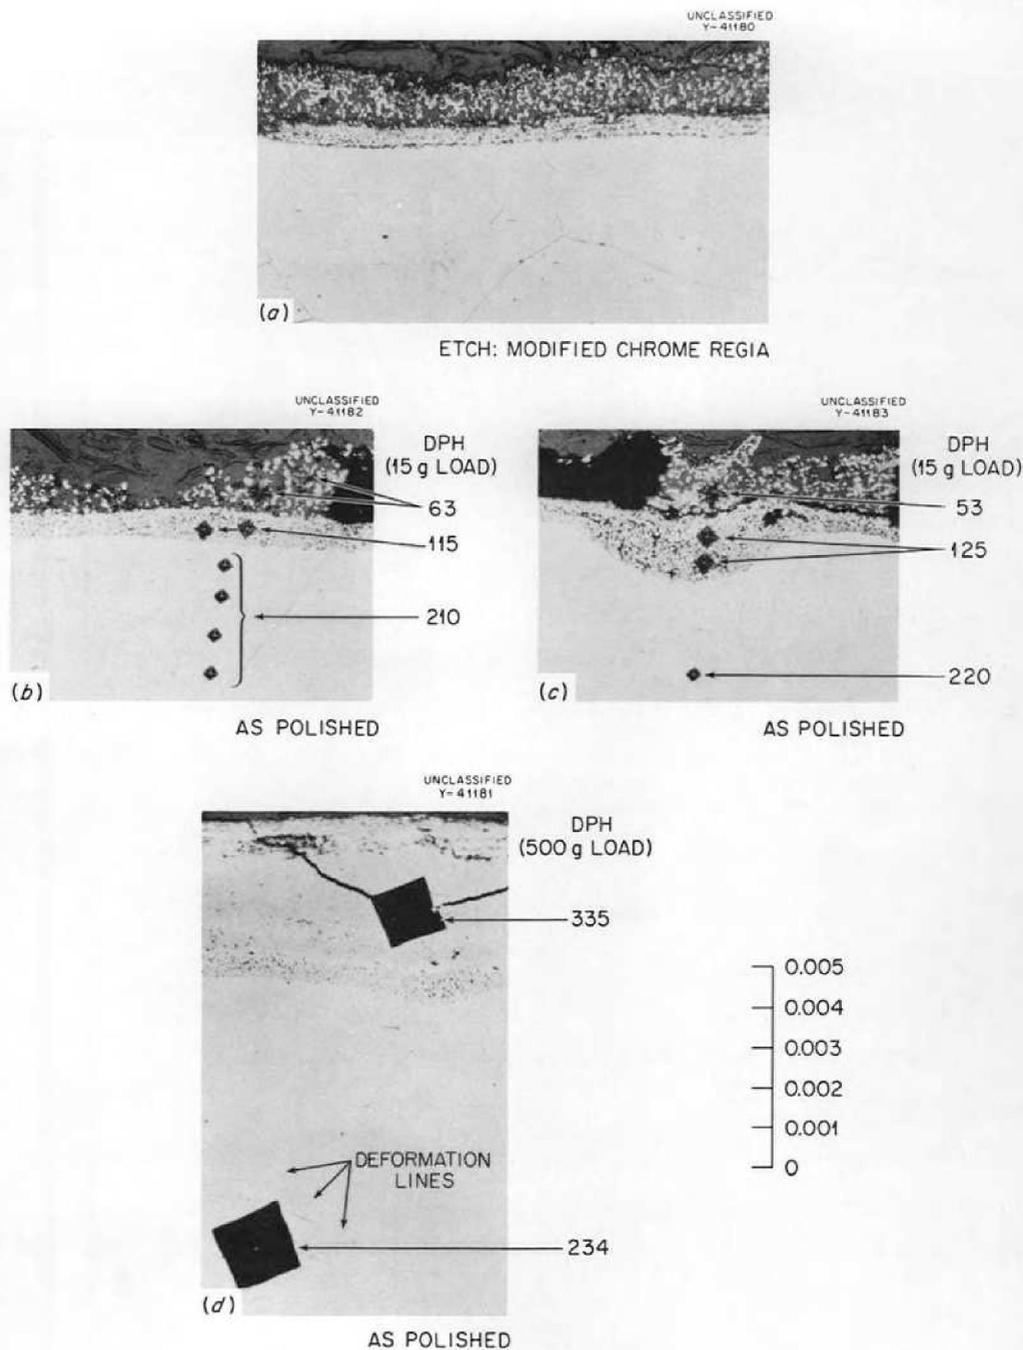
Metallographic examination of the clip disclosed a soft (53-63 diamond-point hardness) spongy-surface layer and a subsurface layer of variable hardness (115-335 DPH) as compared with a base INOR-8 value of 210 to 234 DPH (Fig. 10). Millings from the two layers were subjected to spectrochemical analyses, with the results shown in Fig. 9. The spongy-surface layer had approximately the same metallic composition as the scale previously described. The subsurface layer was deficient in chromium, had a slightly higher molybdenum content, and had the same iron content when compared with the base metal.

Fig. 10. Corrosion Product Layers on INOR-8 After Exposure to Anhydrous HF and Fused LiF-NaF-ZrF₄ at 500-650°C. Typical areas showing (a) uniform duplex surface layers, (b) uniform intermediate layer, discontinuous surface layer, and hardness impressions, (c) variable thickness intermediate layer, discontinuous surface layer, and tendency for separation of the product layers, (d) an unusually thick intermediate layer showing brittle nature of layer compared with base metal.

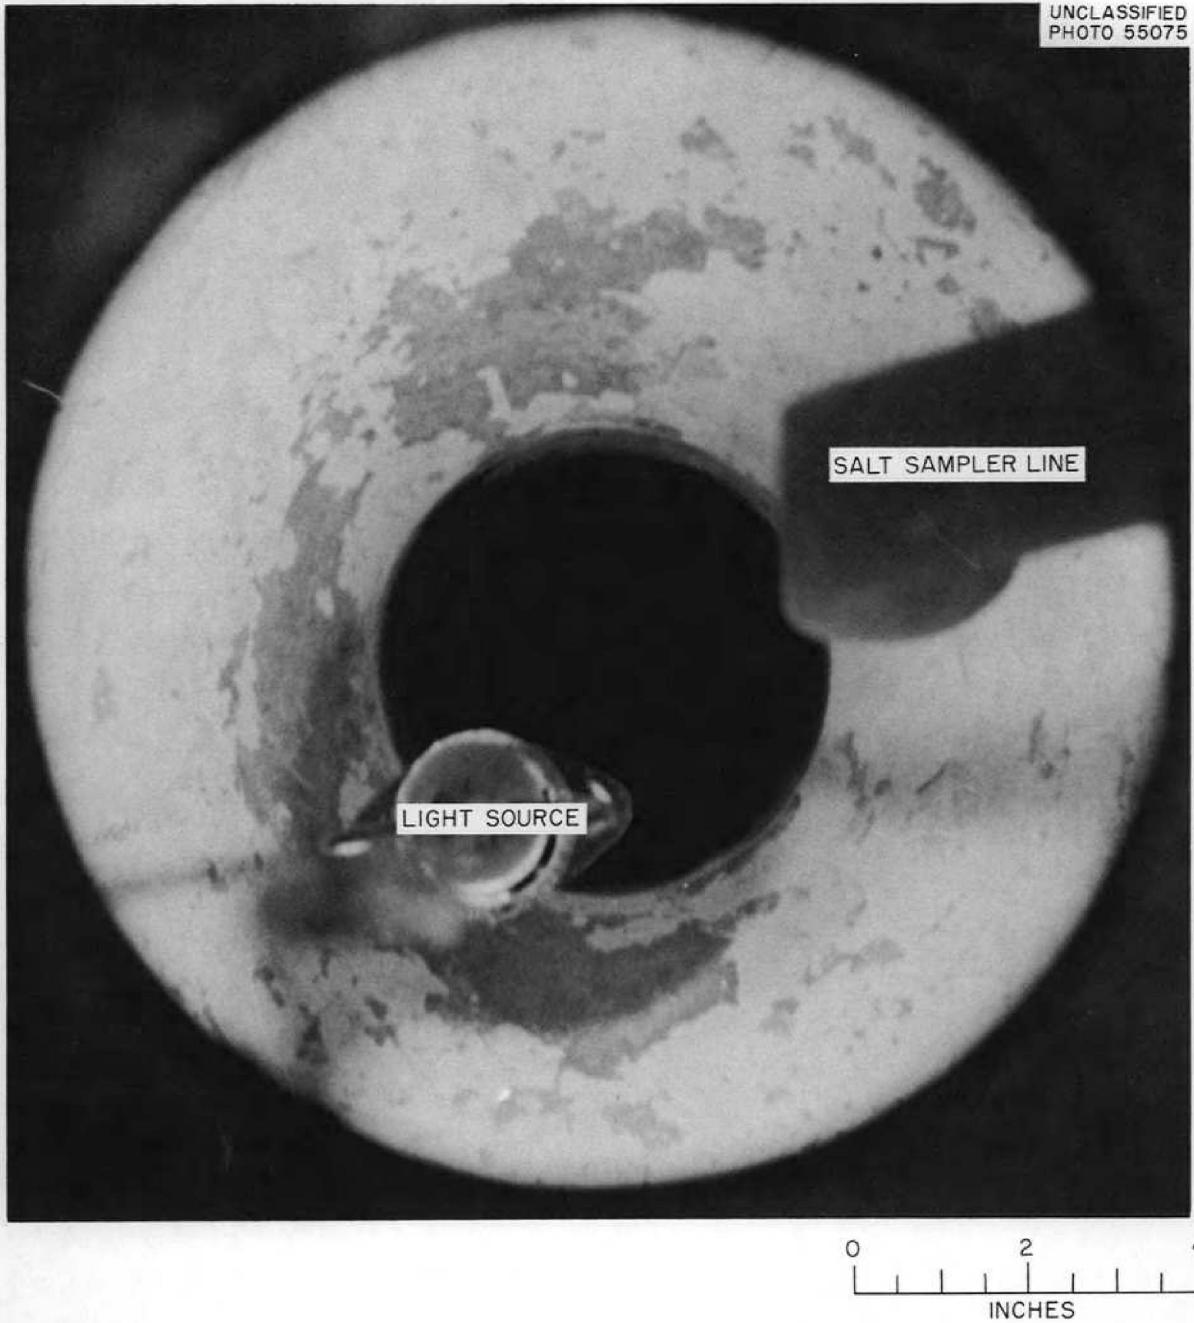
process vapors were covered with relatively thick, light-green deposits. The process vapors were usually F_2 and UF_6 plus volatile molybdenum and chromium fluoride corrosion products, probably as MoF_6 and CrF_5 . The middle-neck region of the vessel, which joins the top and bottom right cylinders, showed the heaviest deposits. Most of the deposits seemed to be loosely adherent, and where the deposits had flaked off, the substrate metal had a dark, dull appearance. Figure 11 illustrates these findings in the upper conical section of the fluorinator. At higher magnification evidence of pitting corrosion was found, especially in the top cylinder of the vessel.

Fig. 11. Interior of the VPP Mark III L Nickel Fluorinator After Run TU-7 Showing Upper Conical Section. Loosely adherent NiF_2 deposits have flaked off in several regions, revealing darker colored substrate metal. Approx 1/2 size.

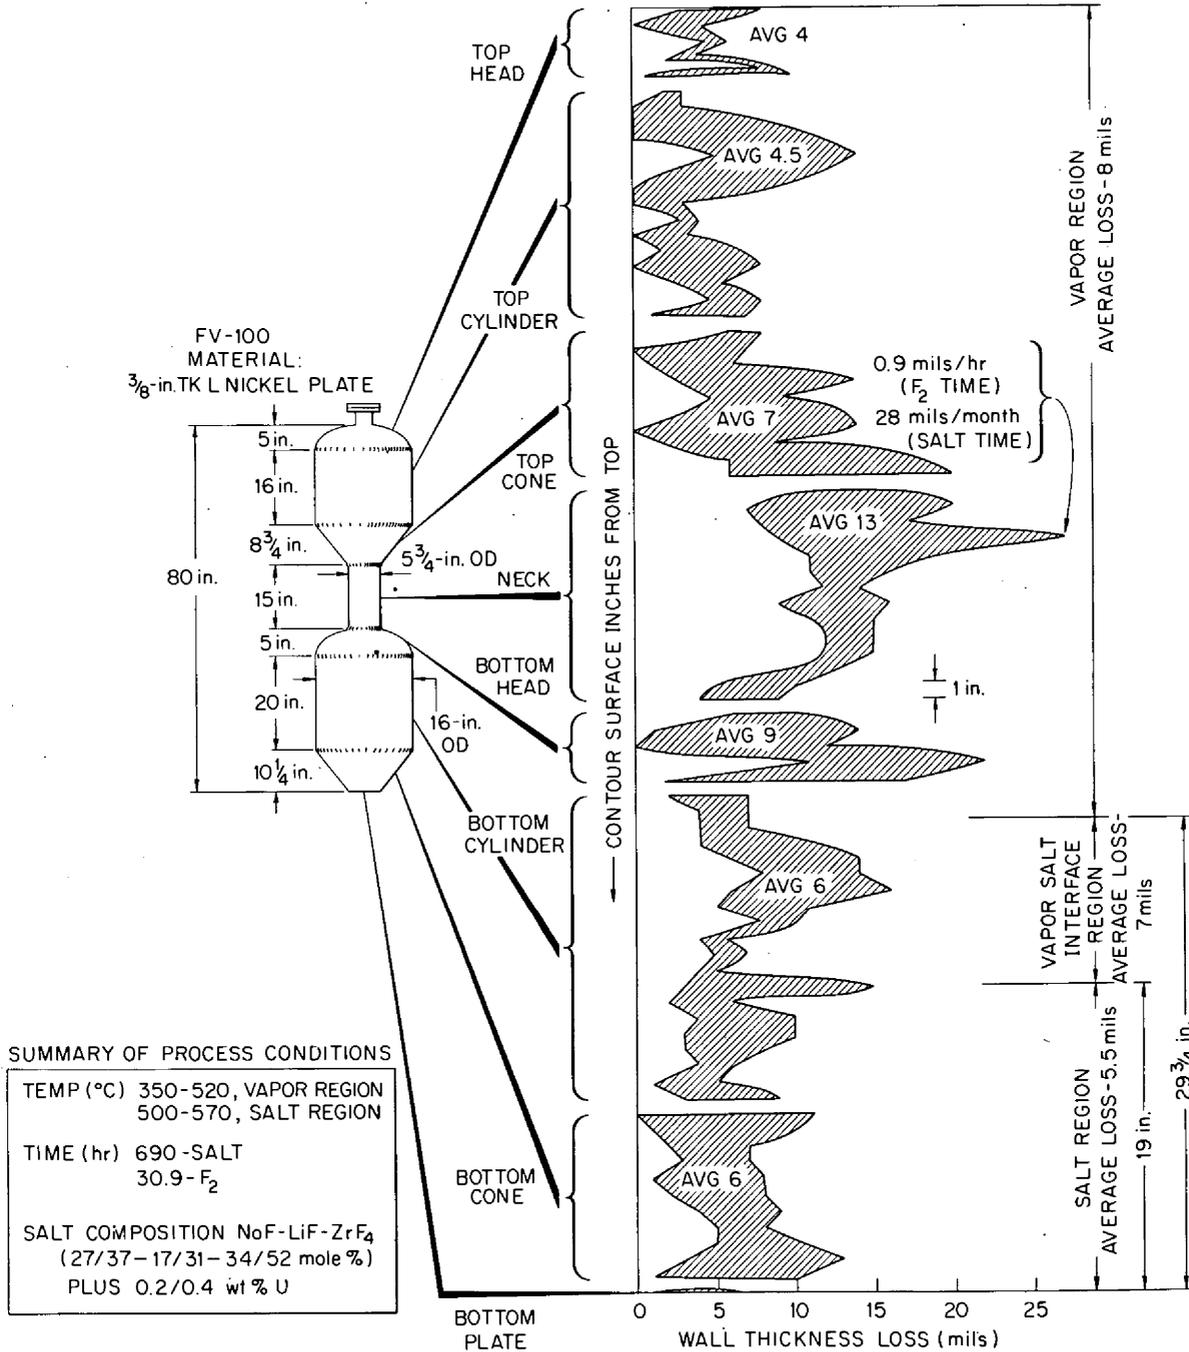
Wall thinning on the VPP fluorinator was determined by Vidigage measurements taken every contour surface inch in each quadrant, and the results were compared with base-line data. Figure 12 shows the bulk metal losses found. Quadrant geometry did not appear to be significant in analyzing the data, and so all data are presented at each elevation and the loss ranges outlined.

Fig. 12. Wall-Thickness Losses on VPP Mark III L Nickel Fluorinator.
