2362
ORNL-4829

INTERGRANULAR CRACKING OF INOR-8 IN THE MSRE

H. E. McCoy
B. McNabb

NOVEMBER 1972

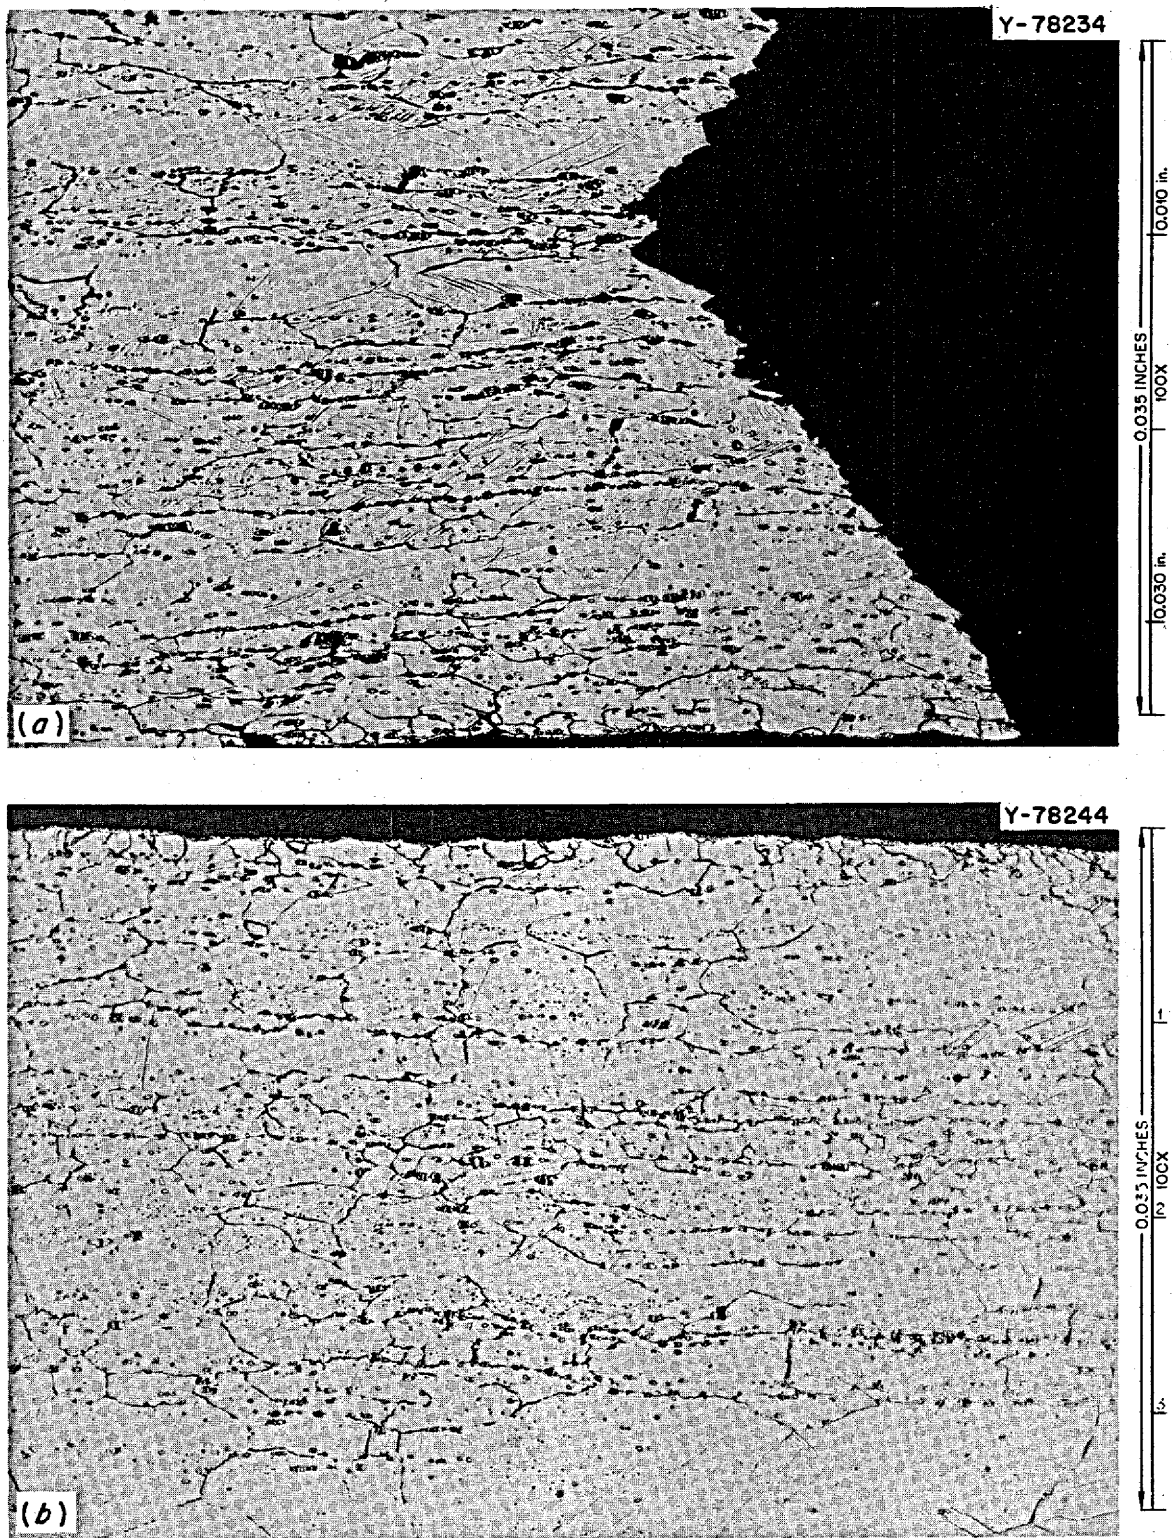
Fig. 8. Photomicrographs of Control Specimen AC-8 from Heat 5081 Tested at 25°C and at a Strain Rate of 0.05/min. (a) Fracture. (b) Edge of specimen about 1/4 in. from fracture. Etchant: glyceria regia.

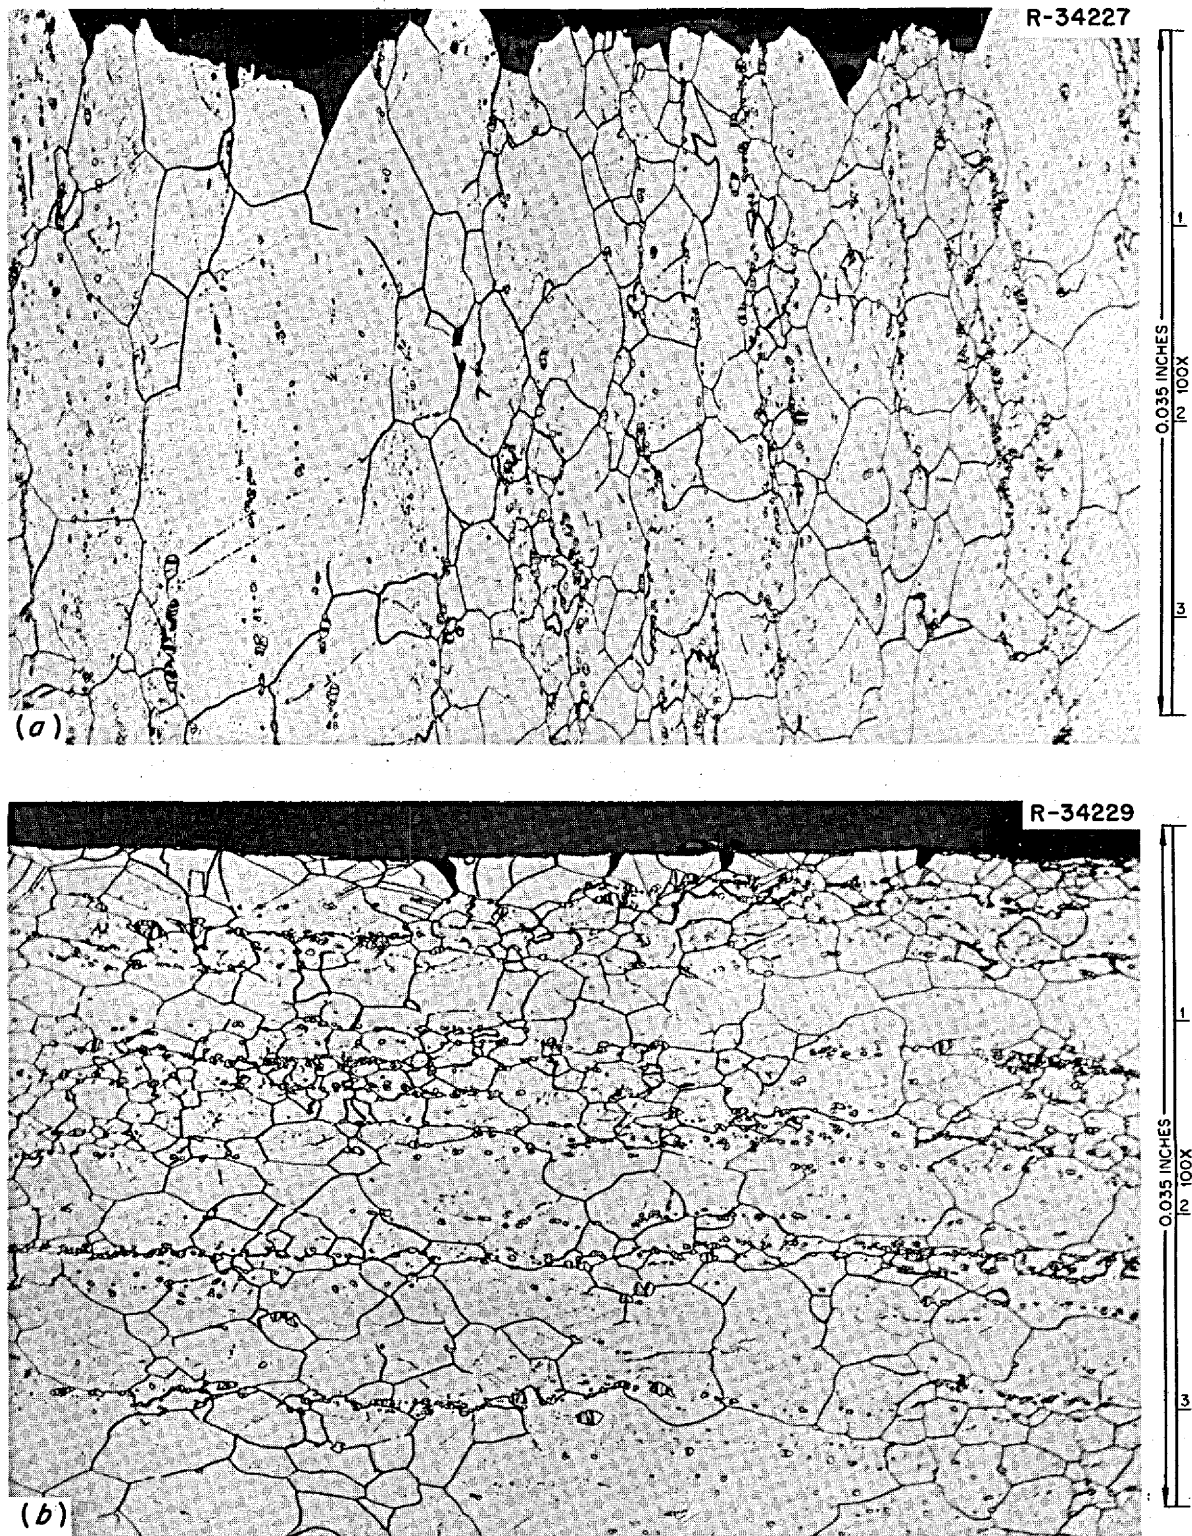
Fig. 9. Photomicrographs of Surveillance Specimen D-16 from Heat 5081 Tested at 25°C and at a Strain Rate of 0.05/min. (a) Fracture. (b) Edge of specimen about 1/4 in. from fracture. Etchant: glyceria regia.

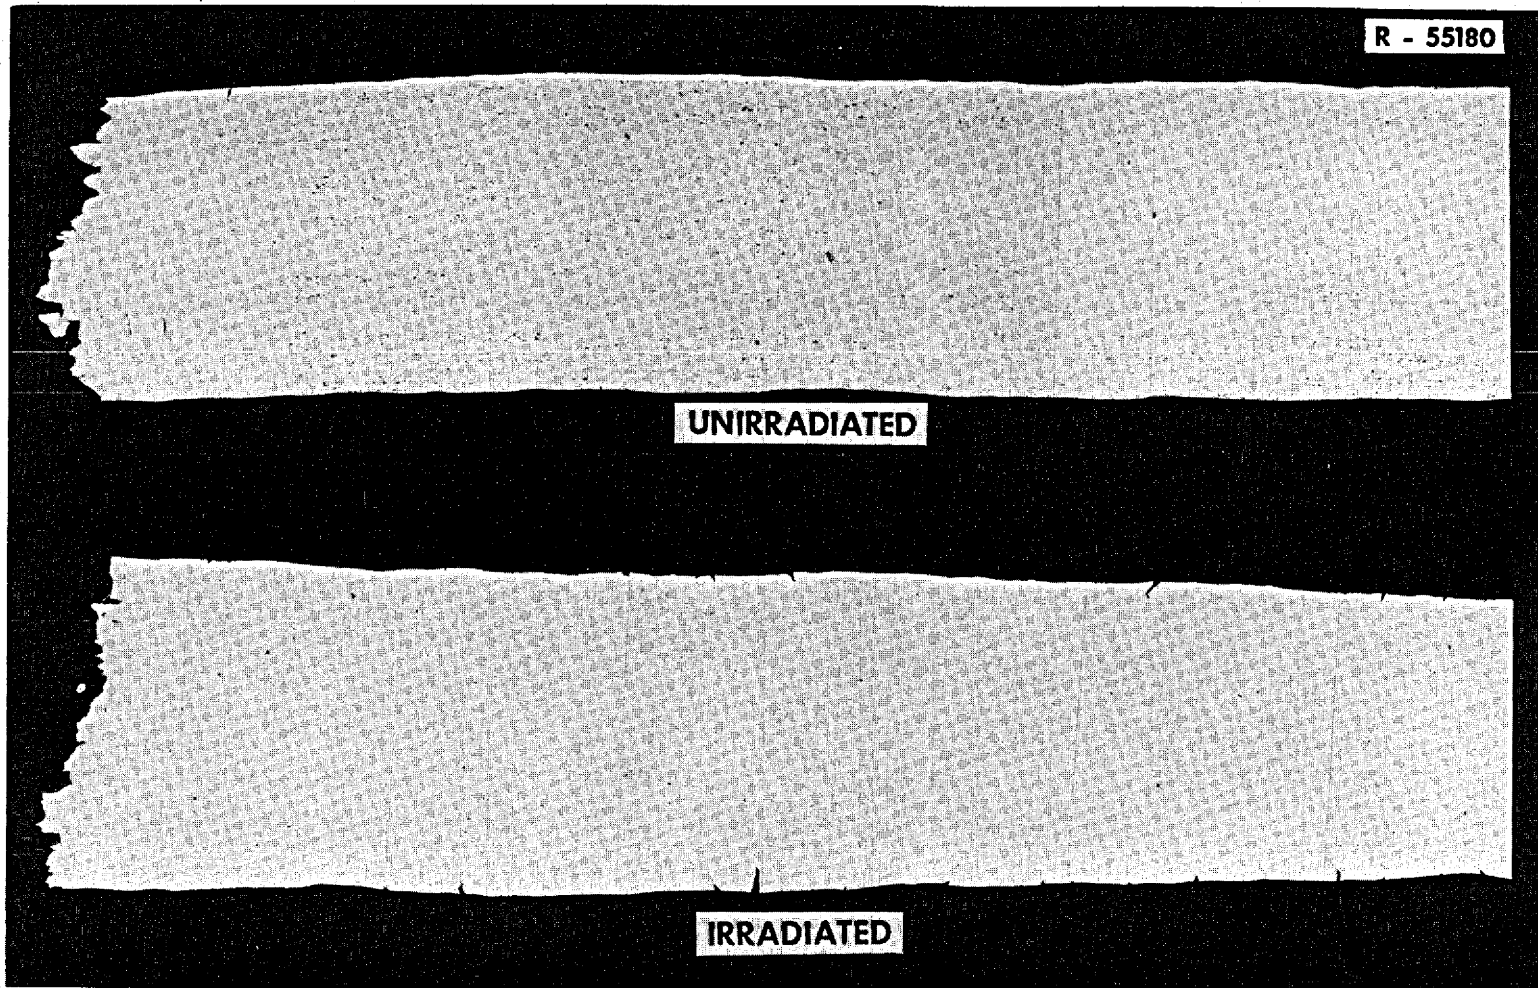
Fig. 12. Photomicrographs of Heat 5085 strained at 25°C After 5550 hr Above 500°C. The top specimen was in static fuel salt containing depleted uranium, and the lower specimen was in the MSRE core. The true specimen diameters are 0.070 and 0.090 in., respectively.

frequency and depth of cracks. In the section of the control specimen, only one surface crack was found (a frequency of about 1 per inch). Its depth was 5.7 mils. The section of the core specimen showed 19 cracks per inch with an average depth of 2.5 mils and a maximum depth of 8.8 mils. The core specimen has more surface cracks than the control specimen (and the pre-power core specimen).

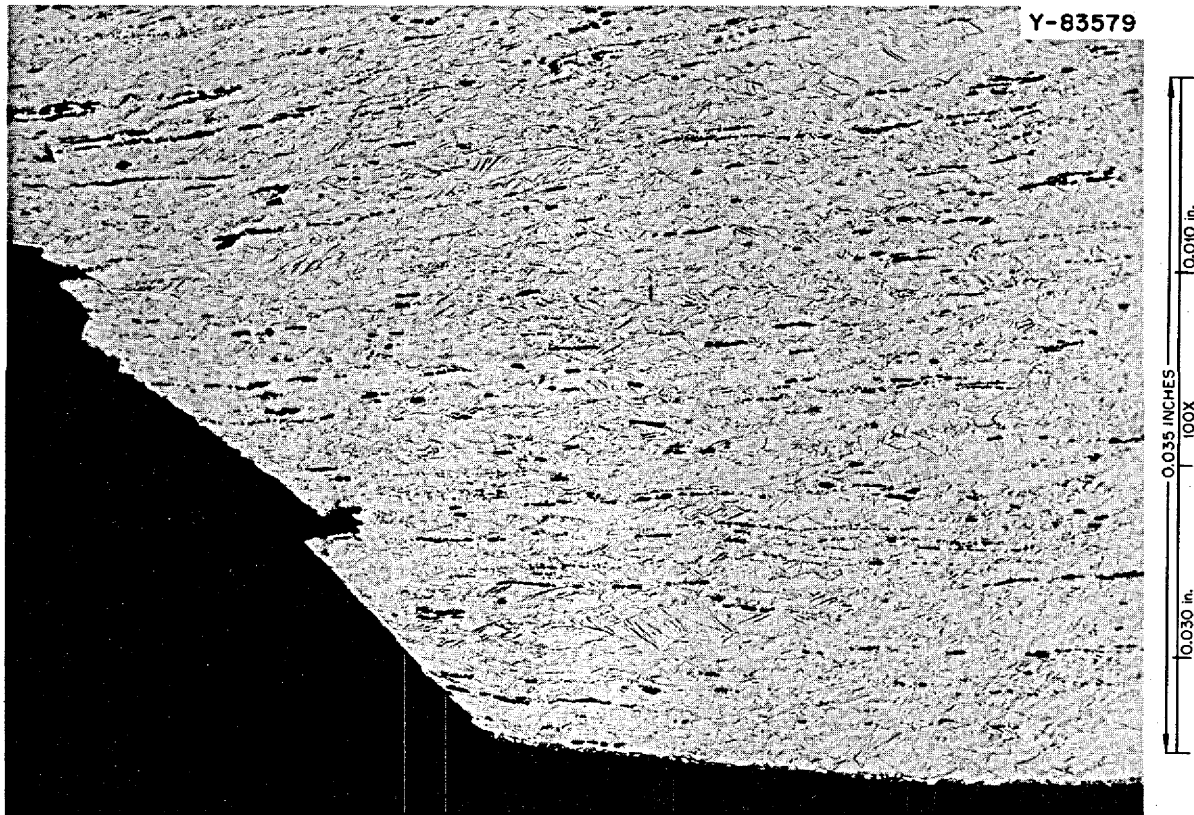
Fig. 15. Photomicrograph of the Fracture of a Zirconium-Modified INOR-8 Sample (Heat 21554) Tested at 25°C at a Strain Rate of 0.05/min. Exposed to a static fluoride salt for 5554 hr above 500°C before testing. Note the shear fracture and the absence of edge cracking. 100x. Etchant. glyceria regia.

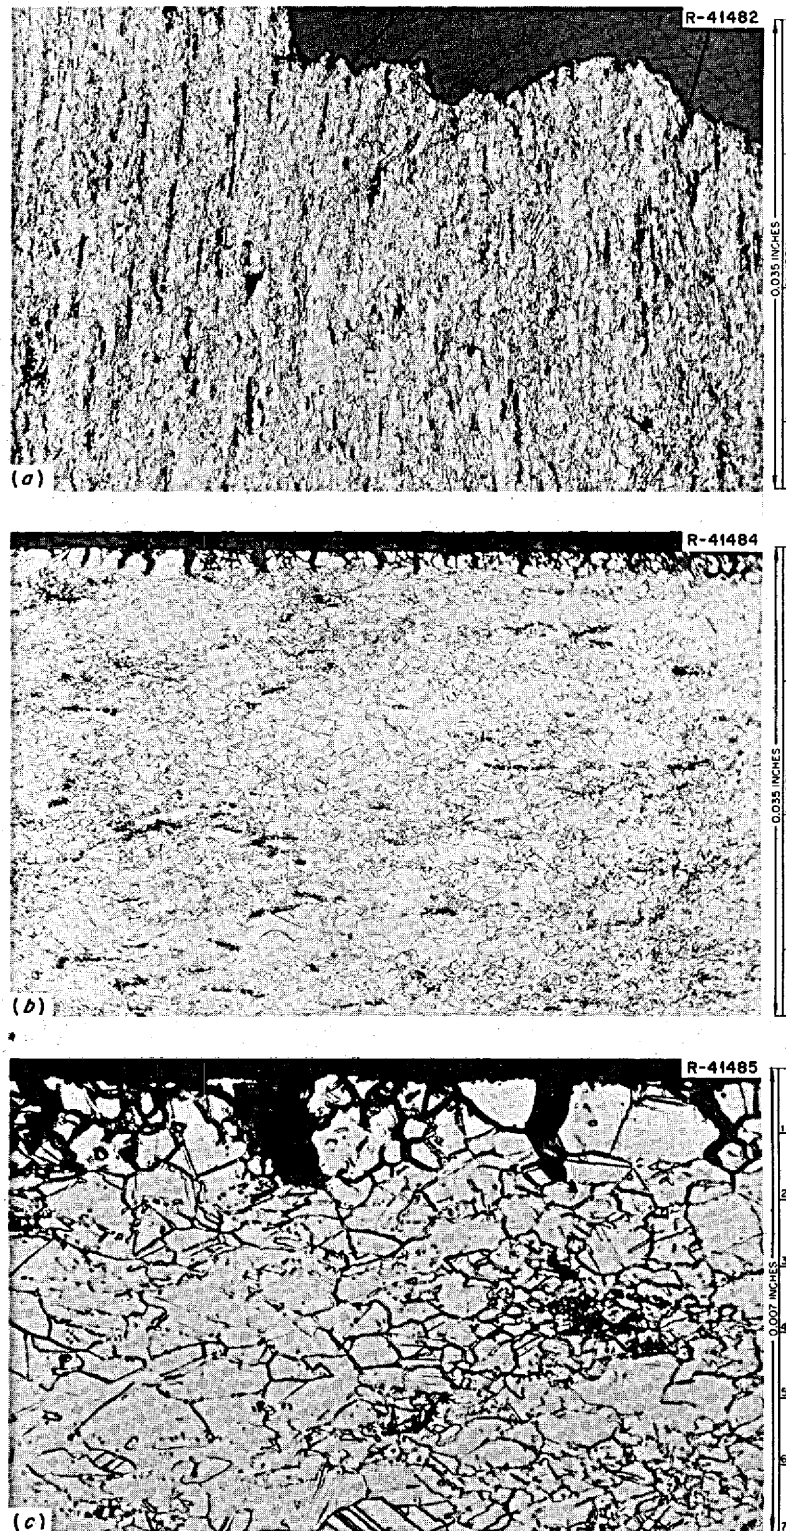
Core specimens of both heats tested to failure in tension developed numerous intergranular cracks along the surfaces, while control specimens tested similarly showed few or no surface cracks. The difference is illustrated in Figs. 15-18. Figure 15 and 16 are control and core specimens respectively of heat 21554. In the core specimen surfaces nearly every grain boundary is cracked to a consistent depth of about 2 mils. In the control specimen there is no evidence of intergranular edge cracking. Figures 17 and 18 show the same thing for heat 21545.

Fig. 16. Photomicrographs of a Zirconium-Modified INOR-8 Surveillance Sample (Heat 21554) Tested at 25°C at a Strain Rate of 0.05/min. Exposed in the MSRE core for 5554 hr above 500°C to a thermal fluence of 4.1×10^{20} neutrons/cm². Etchant: aqua regia. (a) Fracture. 100x. (b) Edge of sample about 1/2 in. from fracture. 100x. (c) Edge of sample showing edge cracking. 500x. Reduced 31.5%.

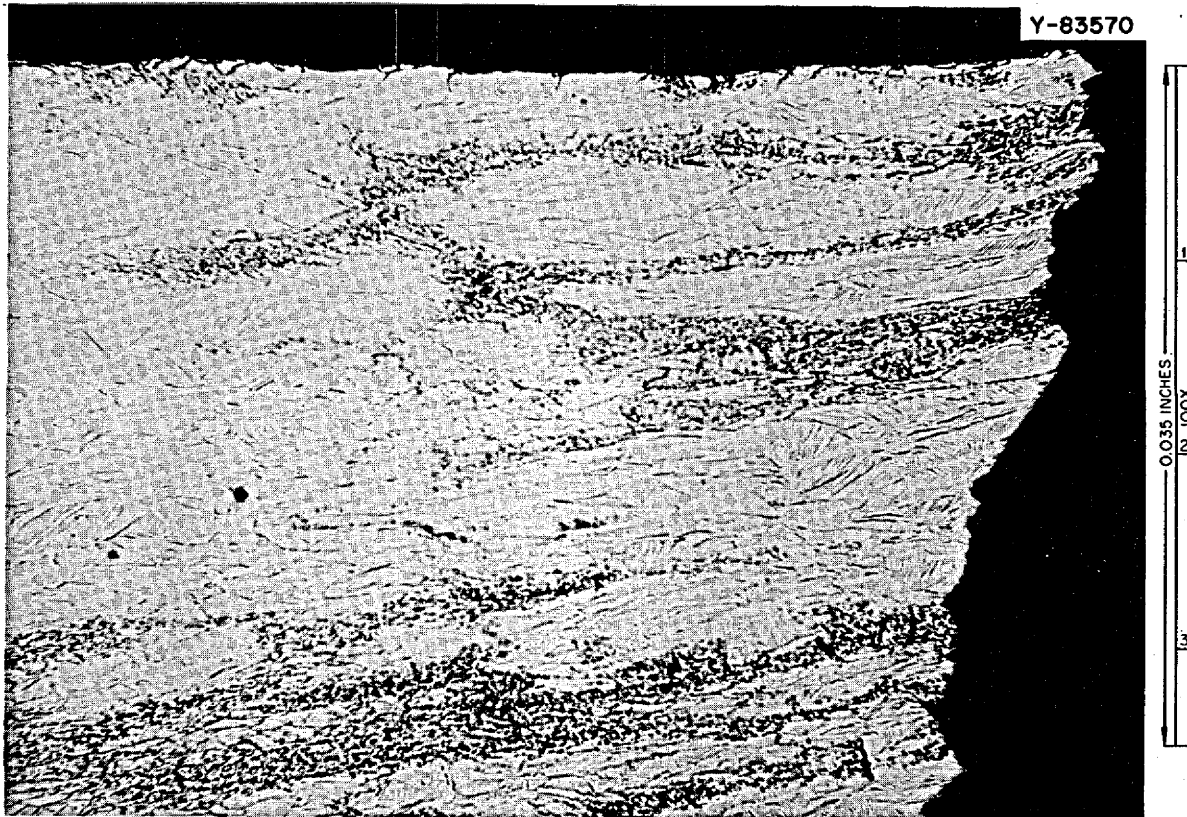
Fig. 17. Photomicrograph of the Fracture of a Titanium-Modified INOR-8 Surveillance Sample (Heat 21545) Tested at 25°C at a Strain Rate of 0.05/min. Exposed to a static fluoride salt for 5554 hr above 500°C before testing. Note the shear fracture and the absence of edge cracking. 100x. Etchant: glyceria regia.

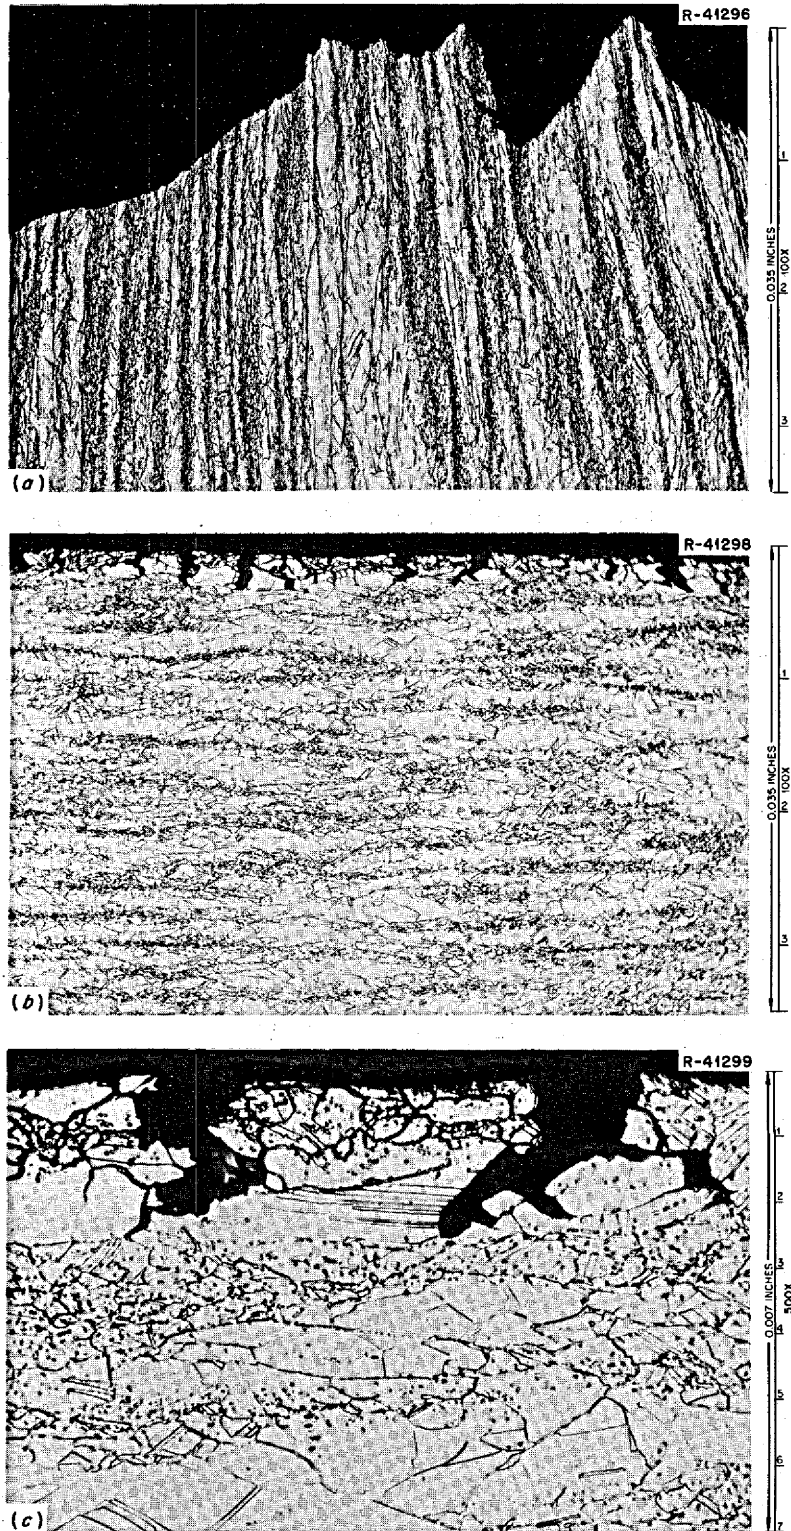
Fig. 18. Photomicrographs of a Titanium-Modified INOR-8 Surveillance Sample (Heat 21545) Tested at 25°C at a Strain Rate of 0.05/min. Exposed in the MSRE core for 5554 hr above 500°C to a thermal fluence of 4.1×10^{20} neutrons/cm². Etchant: aqua regia. (a) Fracture. 100×. (b) Edge of sample about 1/2 in. from fracture. 100×. (c) Edge of sample showing edge cracking. 500×. Reduced 32%.

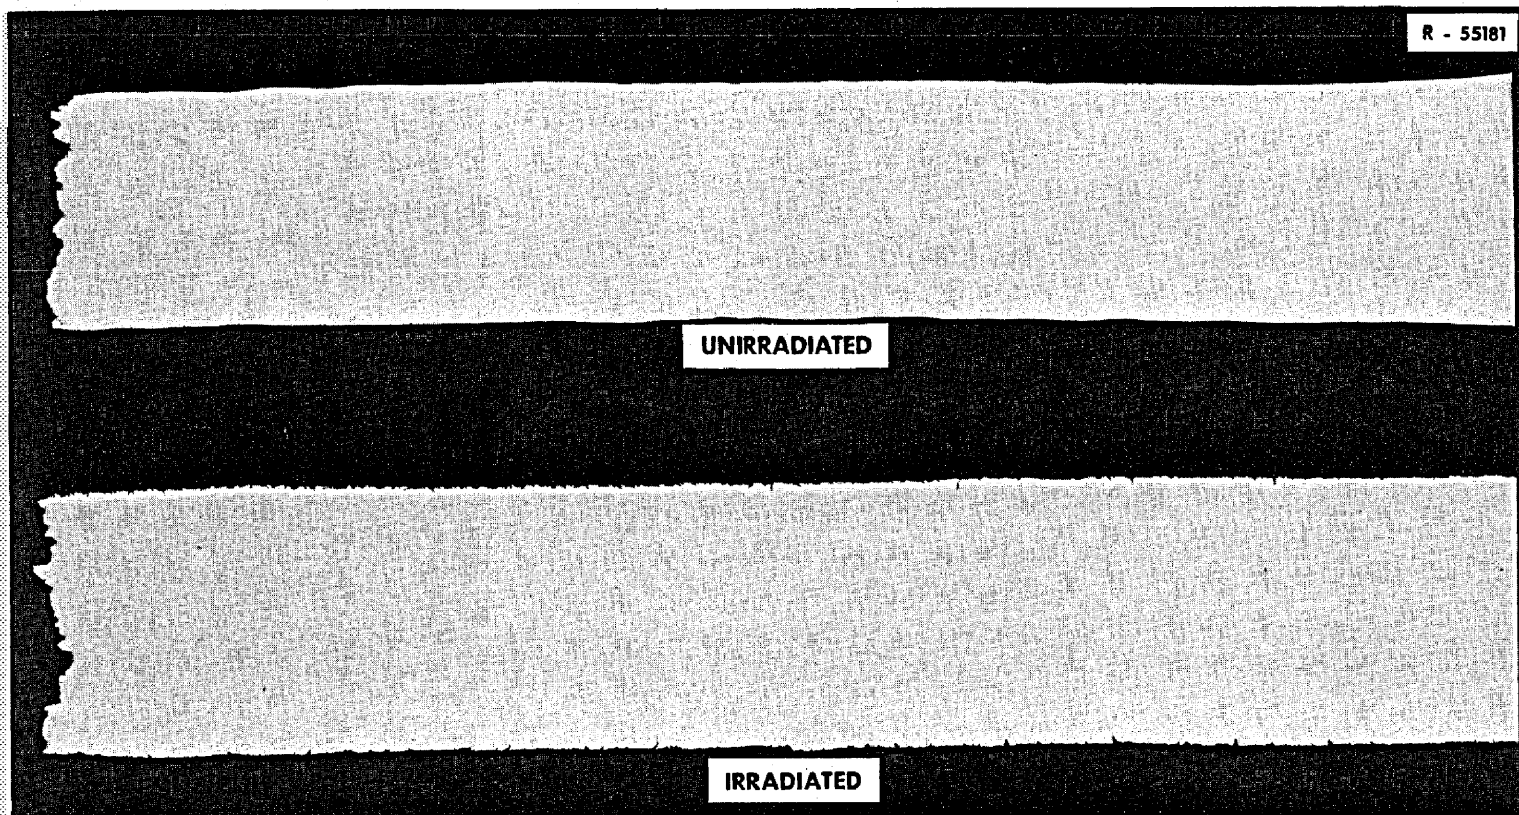
Fig. 28. Photomicrographs of INOR-8 Specimens Strained to Fracture After 11,933 hr above 500°C. The upper sample was in the control facility and the lower sample was in the MSRE core. The sample diameter is about 0.1 in.

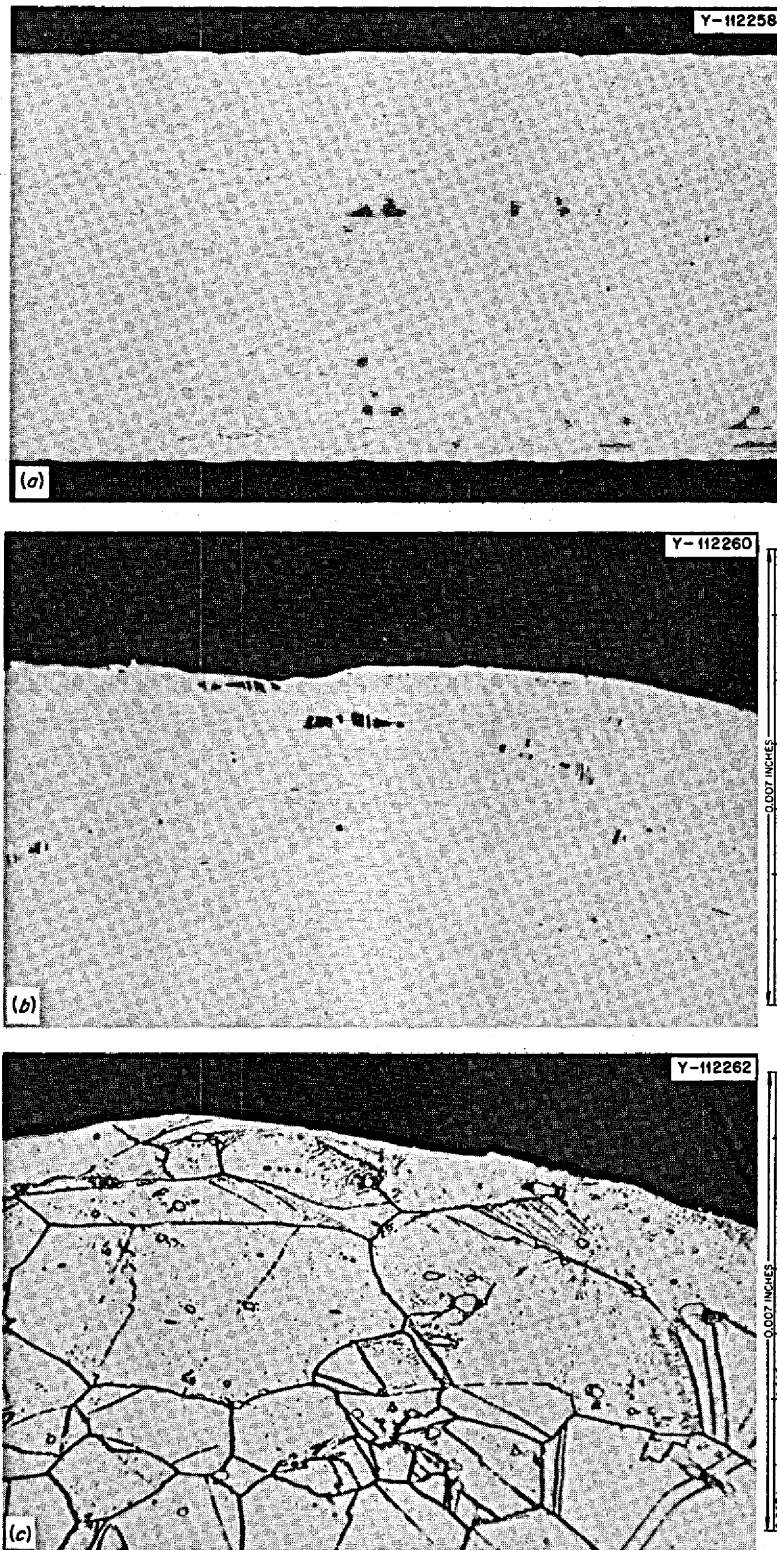
Fig. 40. Photomicrographs of INOR-8 (Heat 5055) Straps Exposed to Static Unenriched Fuel Salt 7203 hr Above 500°C. (a) As-Polished 33x, (b) As Polished, 500x, cracked regions are carbide that fractured during initial forming, (c) Etched with glyceria regia, 500x. Reduced 33%.

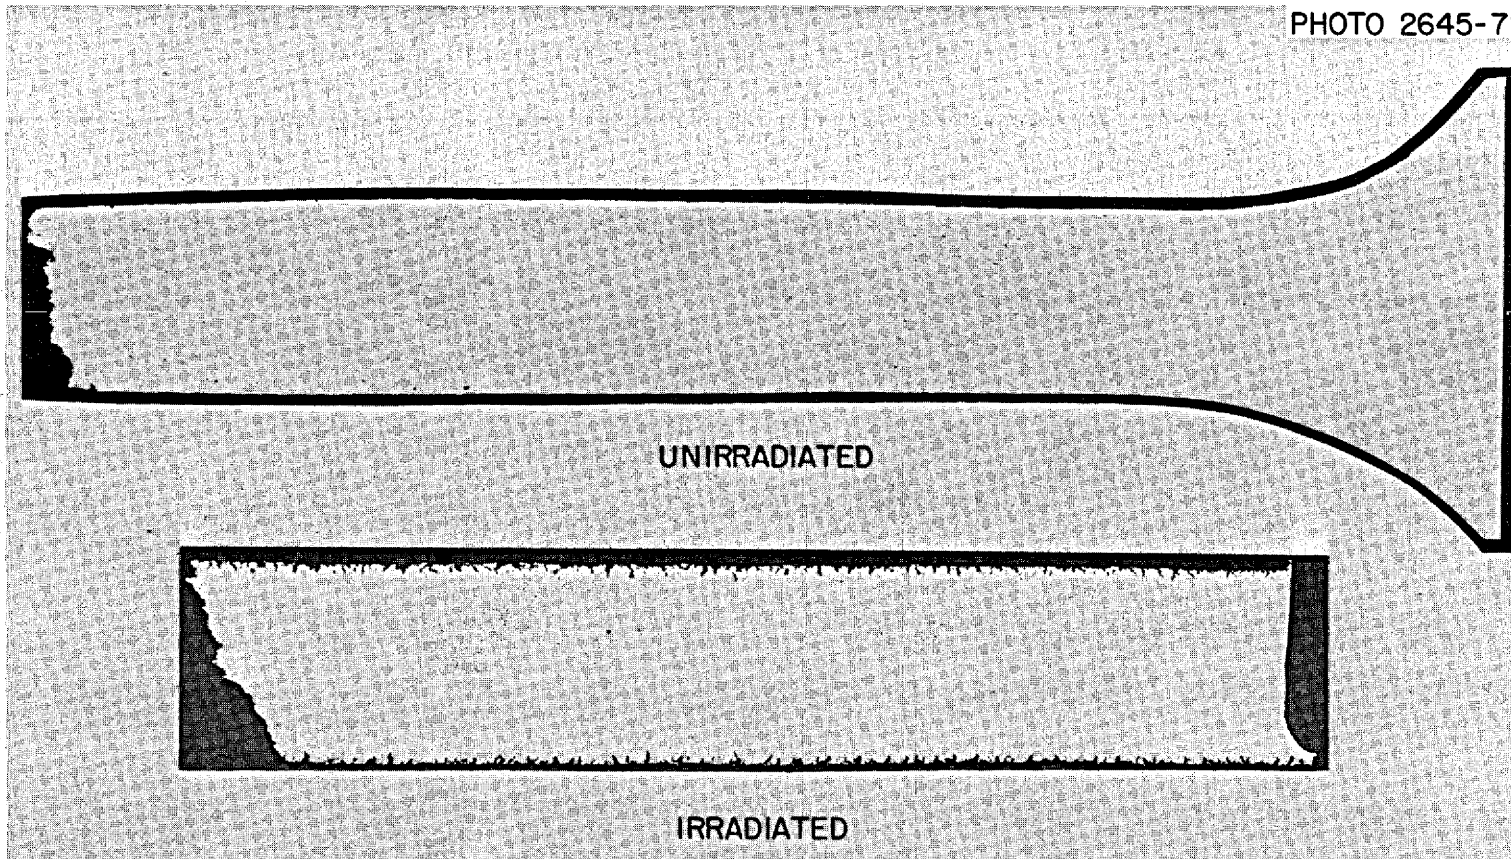
Fig. 47. Photomicrographs of INOR-8 (Heat 5065) Strained to Fracture at 25°C. Top specimen was exposed to static unenriched fuel salt for 19,136 hr above 500°C and the lower specimen was exposed to the MSRE core for the same time. The diameters are about 0.1 in.

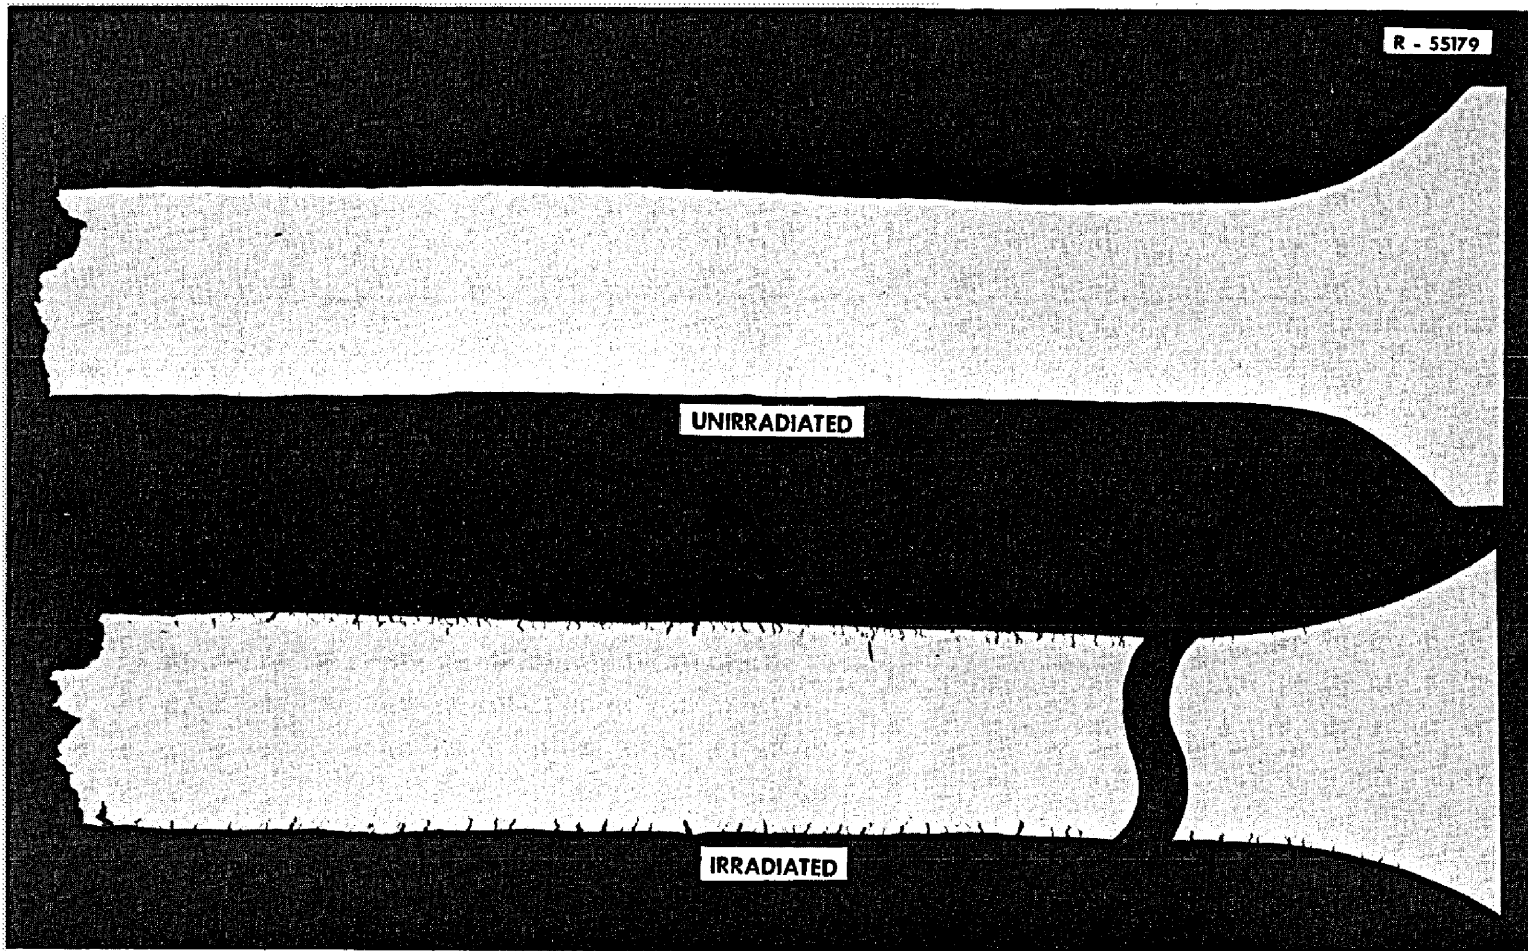
Fig. 48. Photomicrographs of INOR-8 (Heat 5085) Strained to Fracture at 25°C. The top specimen was exposed to static unenriched fuel salt for 19,136 hr above 500°C and the lower specimen was exposed to the MSRE core for the same time. The diameters are about 0.1 in.

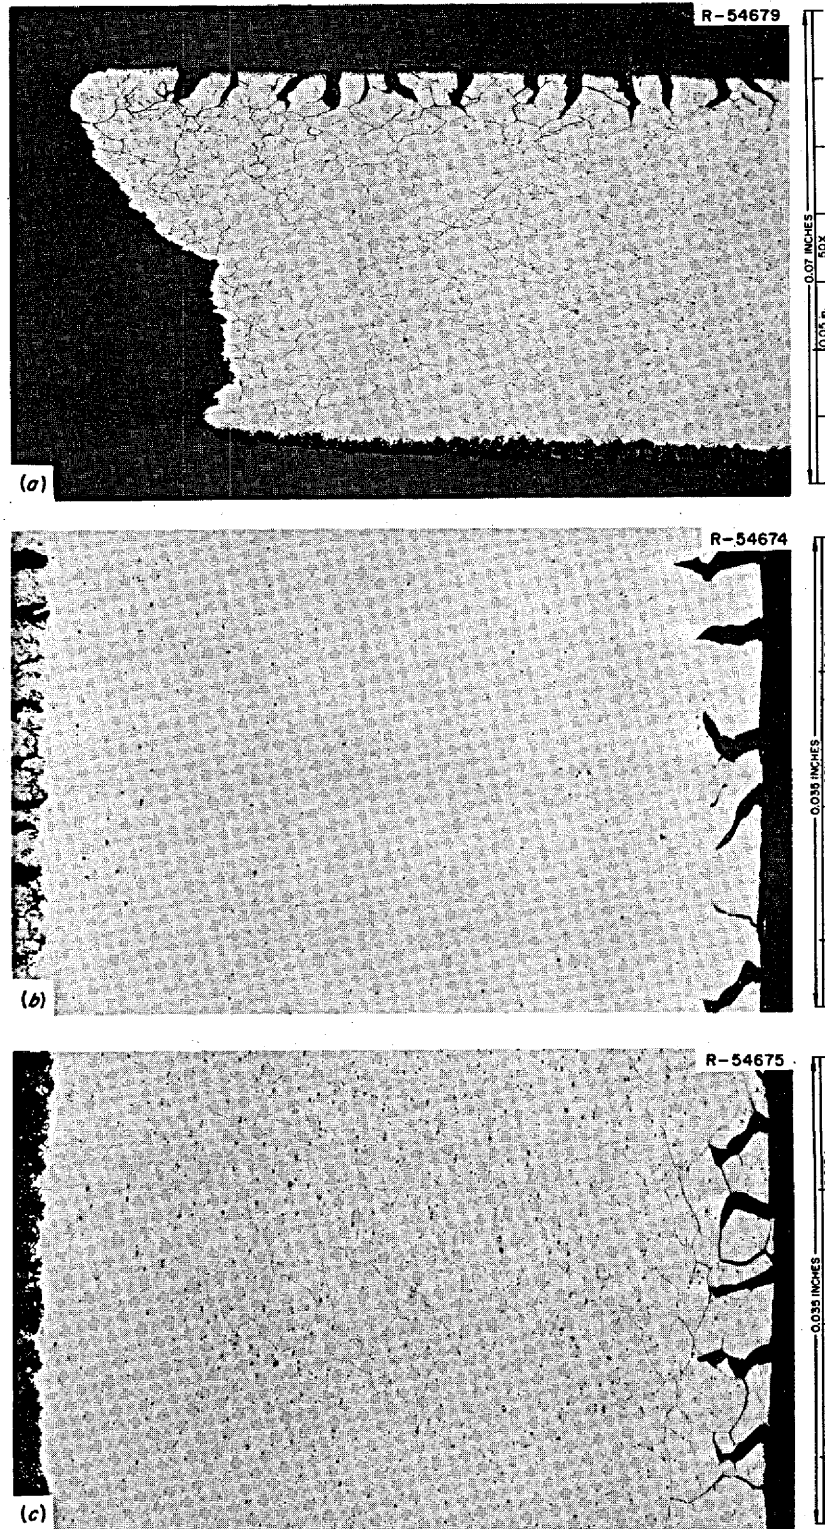
Fig. 68. Photomicrographs of Control Rod Thimble Specimen Exposed to Flowing Salt and Tested at 25°C. (a) Fracture - dark edge is oxide on inner surface of tube, and cracks formed on the outer surface; etched. (b) Cracks in outer surface of tubing as polished. (c) Cracks in outer surface of tubing etched. Etchant: Aqua regia. Reduced 30.5%.

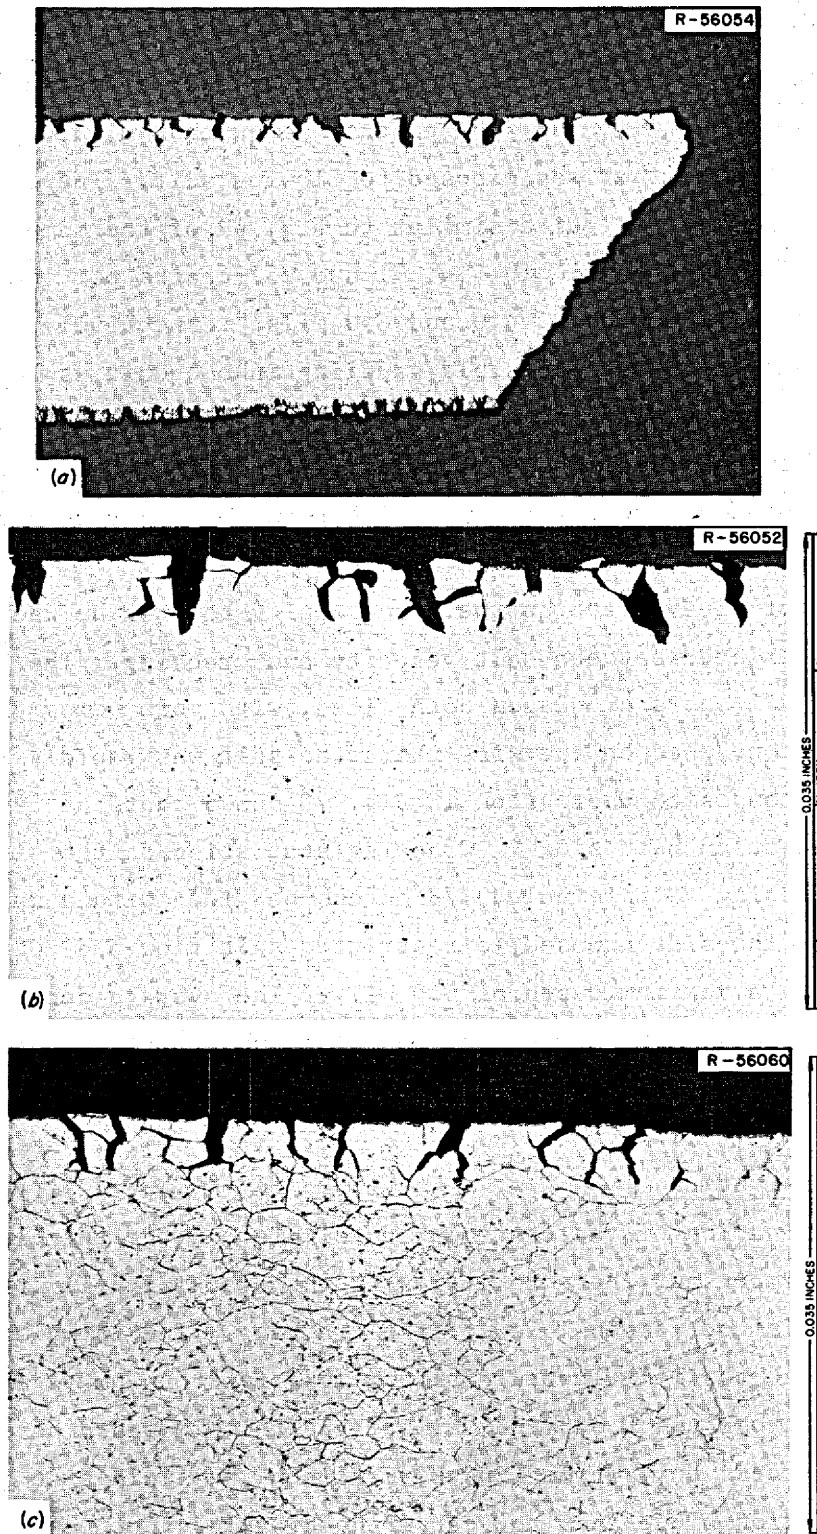
Fig. 70. Photomicrographs of Control Rod Thimble Exposed to Fuel Salt Under a Spacer Sleeve and Tested at 25°C. (a) As-polished view of fracture. 40x. (b) As-polished view of cracks. (c) Etched view of cracks. Etchant: Aqua regia. Reduced 30.5%

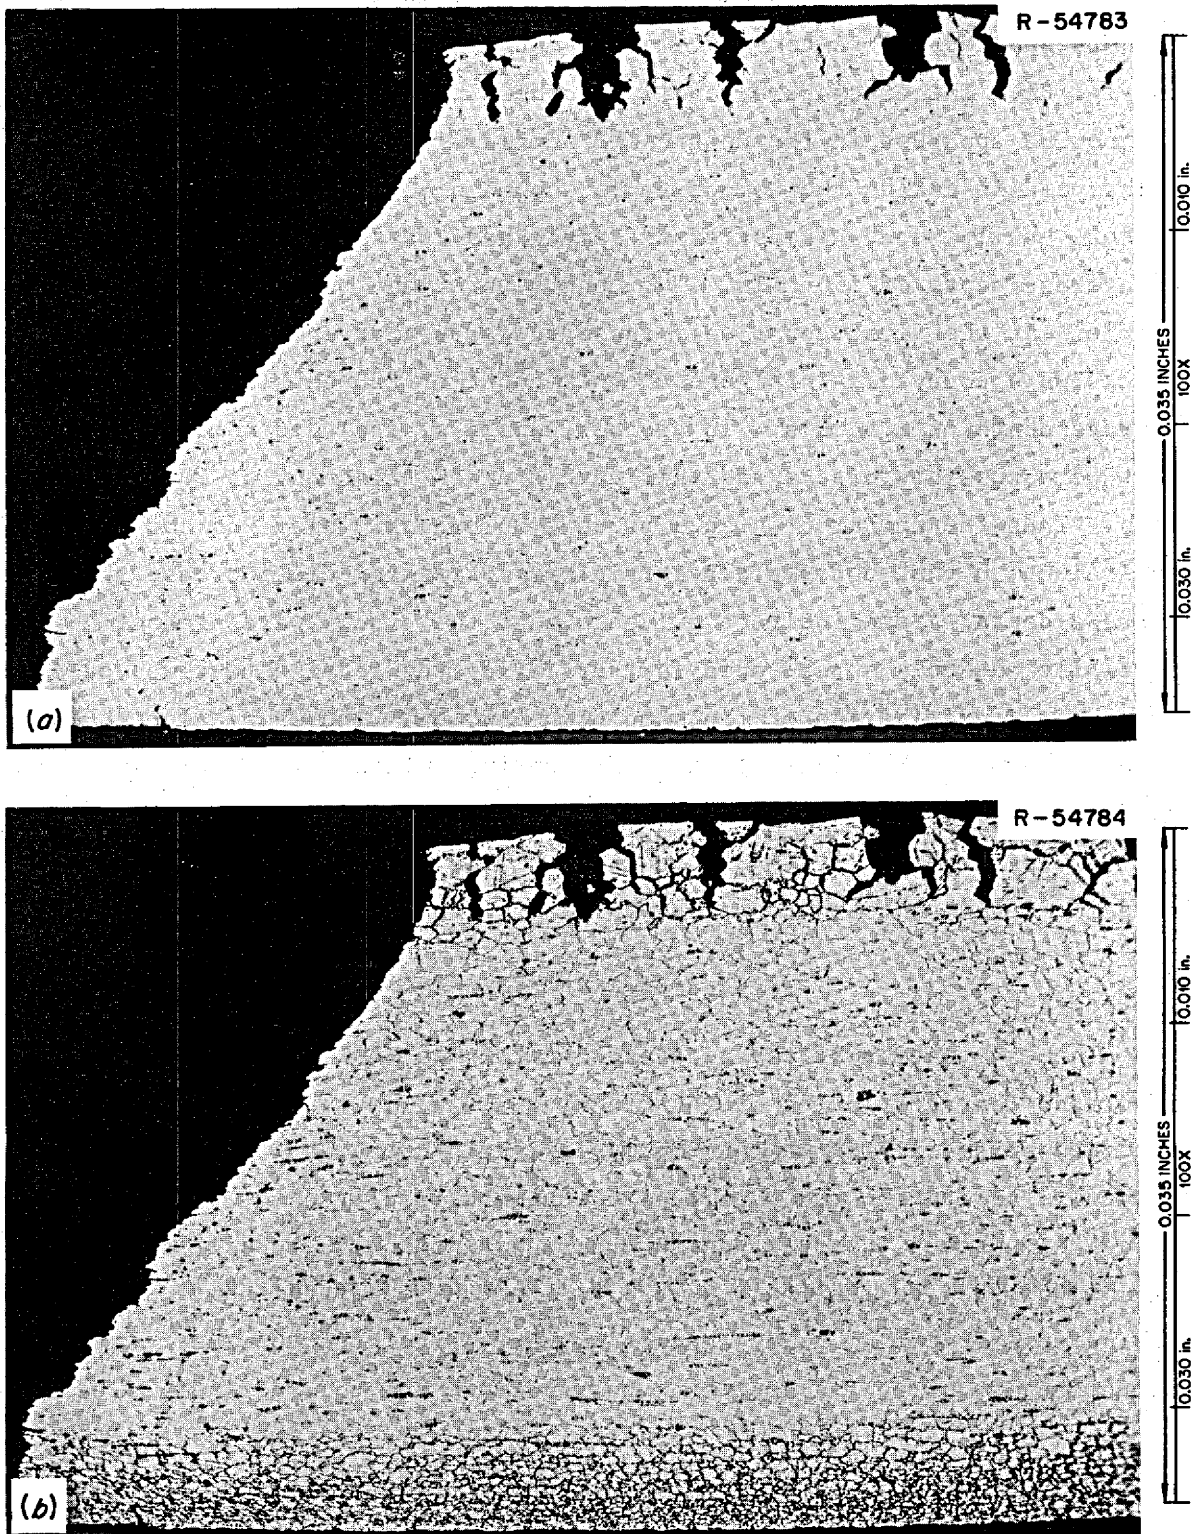
Fig. 80. Photomicrographs of a Heat Exchanger Tube Deformed to Fracture at 25°C. (a) As polished. (b) Etched with aqua regia.

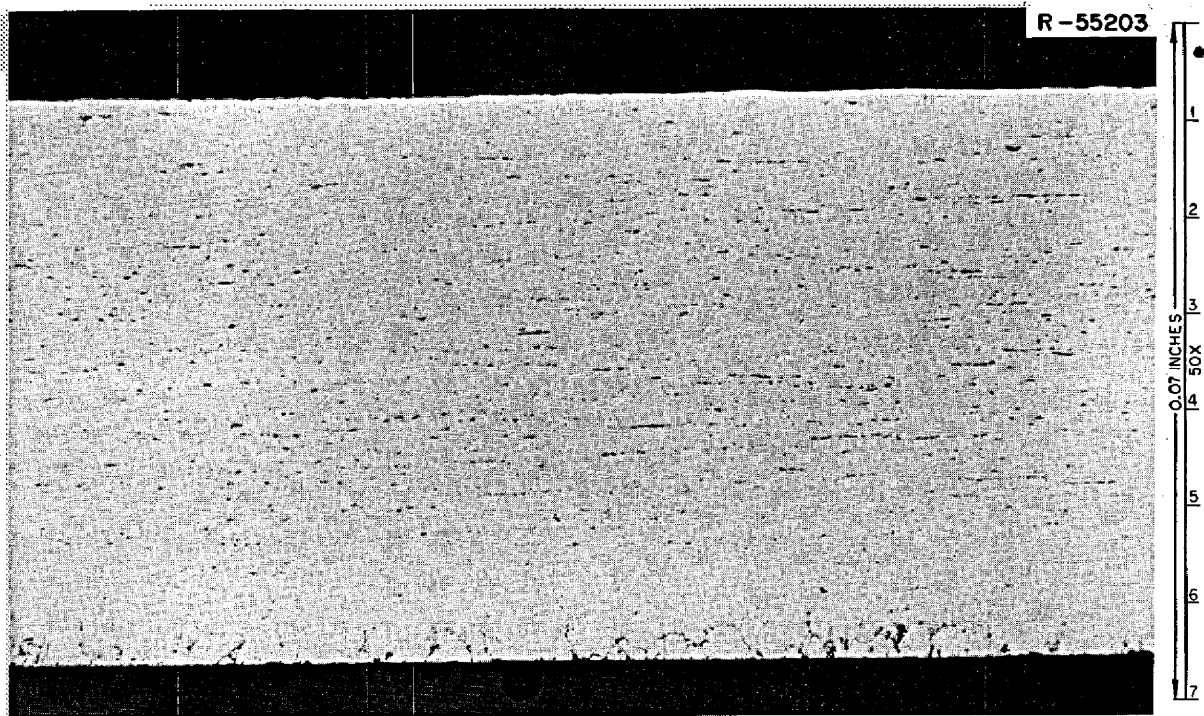
Fig. 82. Photomicrograph of Heat Exchanger Tubing in the Unstressed Condition. The side with the small cracks was exposed to fuel salt and the other was exposed to coolant salt.

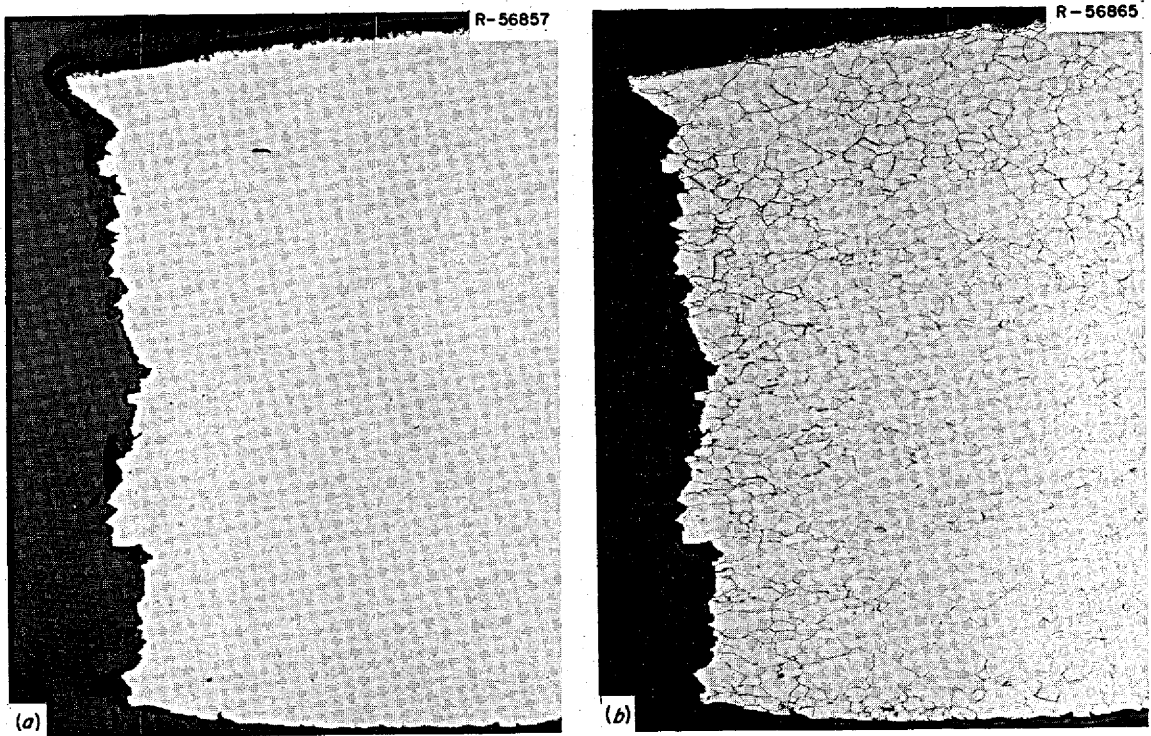
Fig. 103. Photomicrographs of the Fracture of a Ring Specimen from Freeze Valve 105 that was Deformed at 25°C. (a) As polished. (b) Etchant: Lactic acid, HNO₃, HCl. 40×. Reduced 29.5%.
