ORNL-TM-3039

MSRE SYSTEMS AND COMPONENTS PERFORMANCE

Molten-Salt Reactor Experiment Staff

JUNE 1973

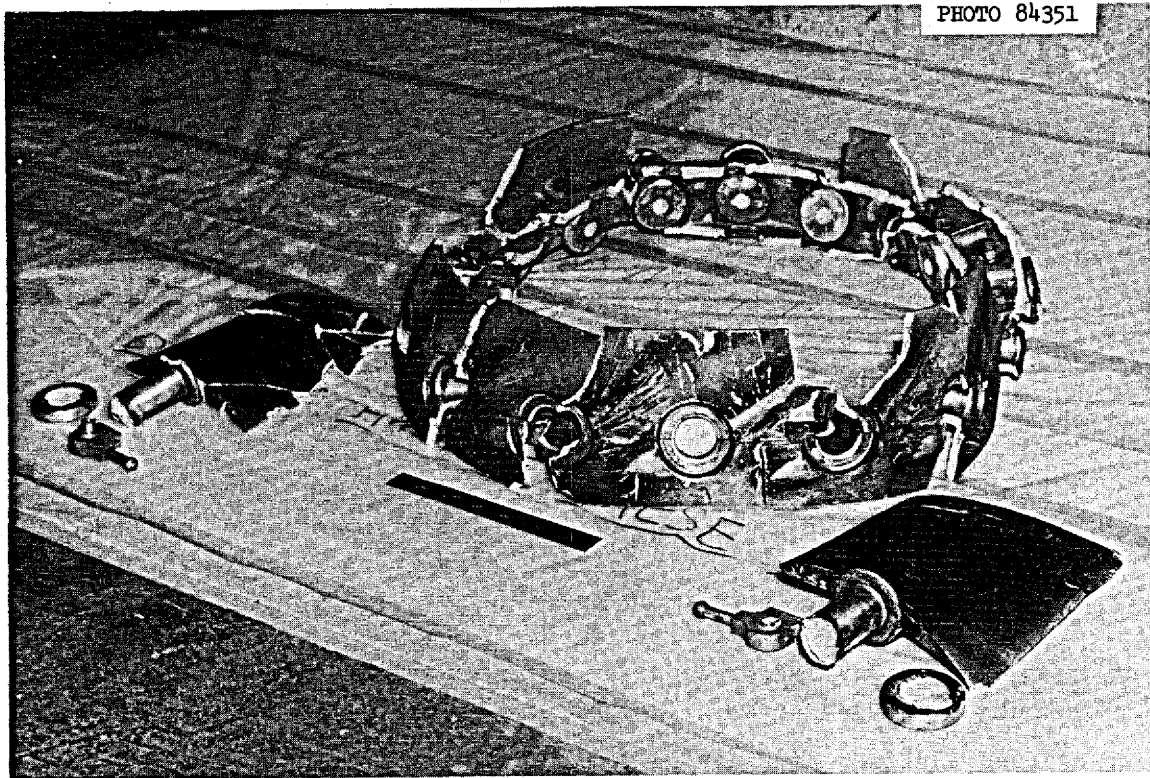
An inspection of the broken pieces of MB-1 revealed numerous "old" cracks in the blades and in the hub as evidenced by darkened or dirty areas on the fractured surfaces. One blade in particular had failed along a

Fig. 6.3 Outer Periphery of Failed MB-1 Hub and Typical Blade Fractures

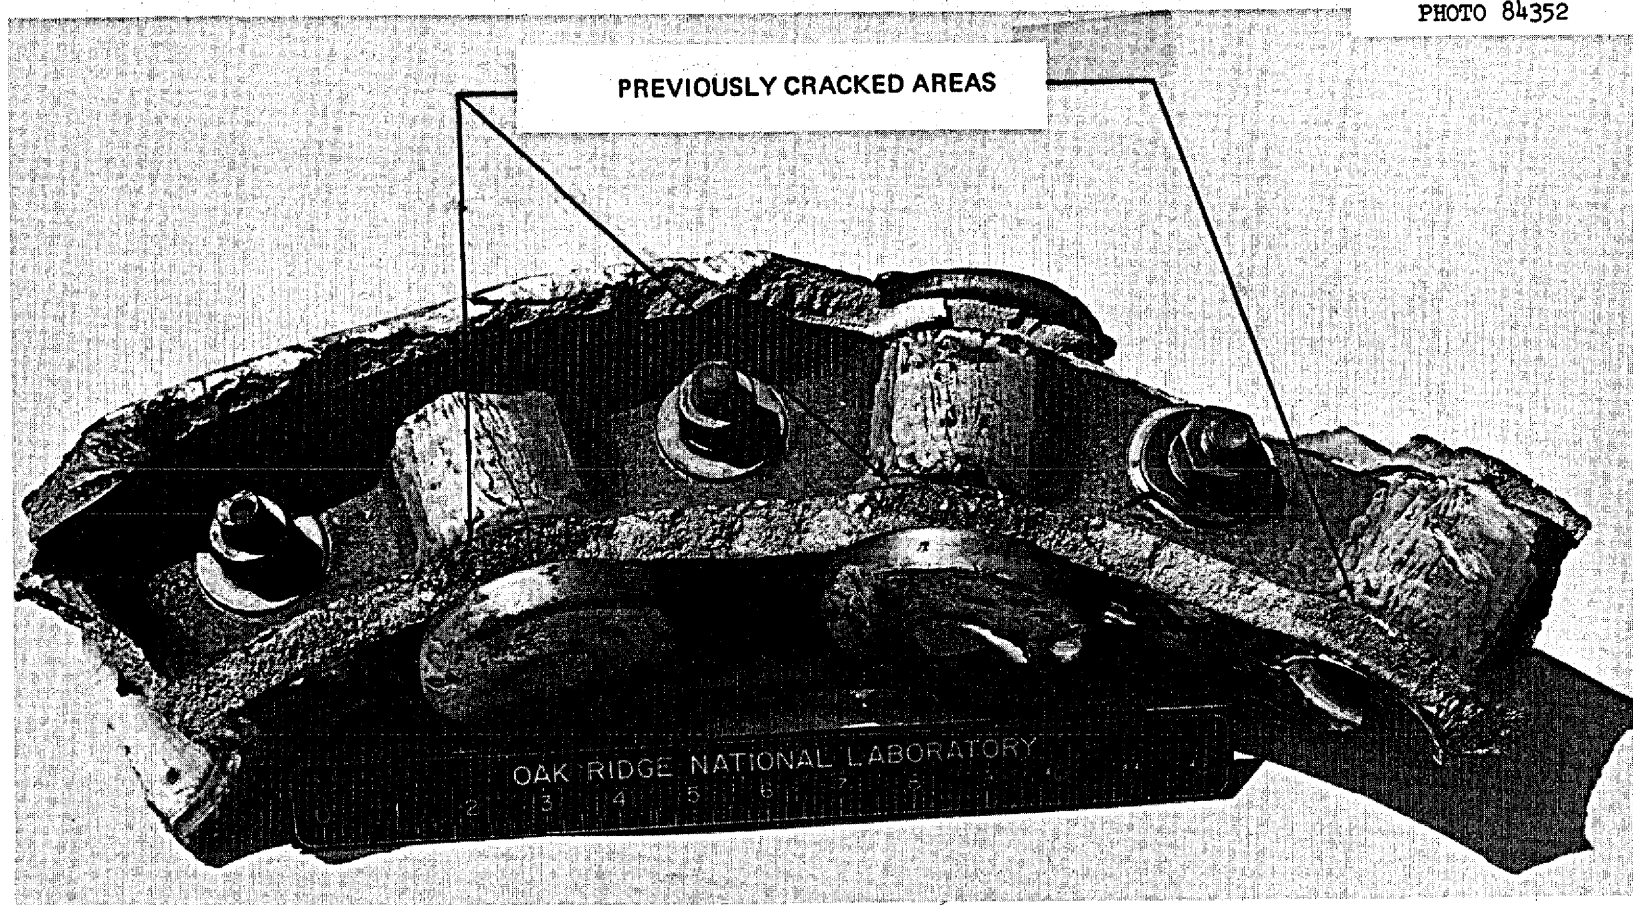
Fig. 6.4 Fragment of MB-1 Hub Showing Areas of Previous Cracking

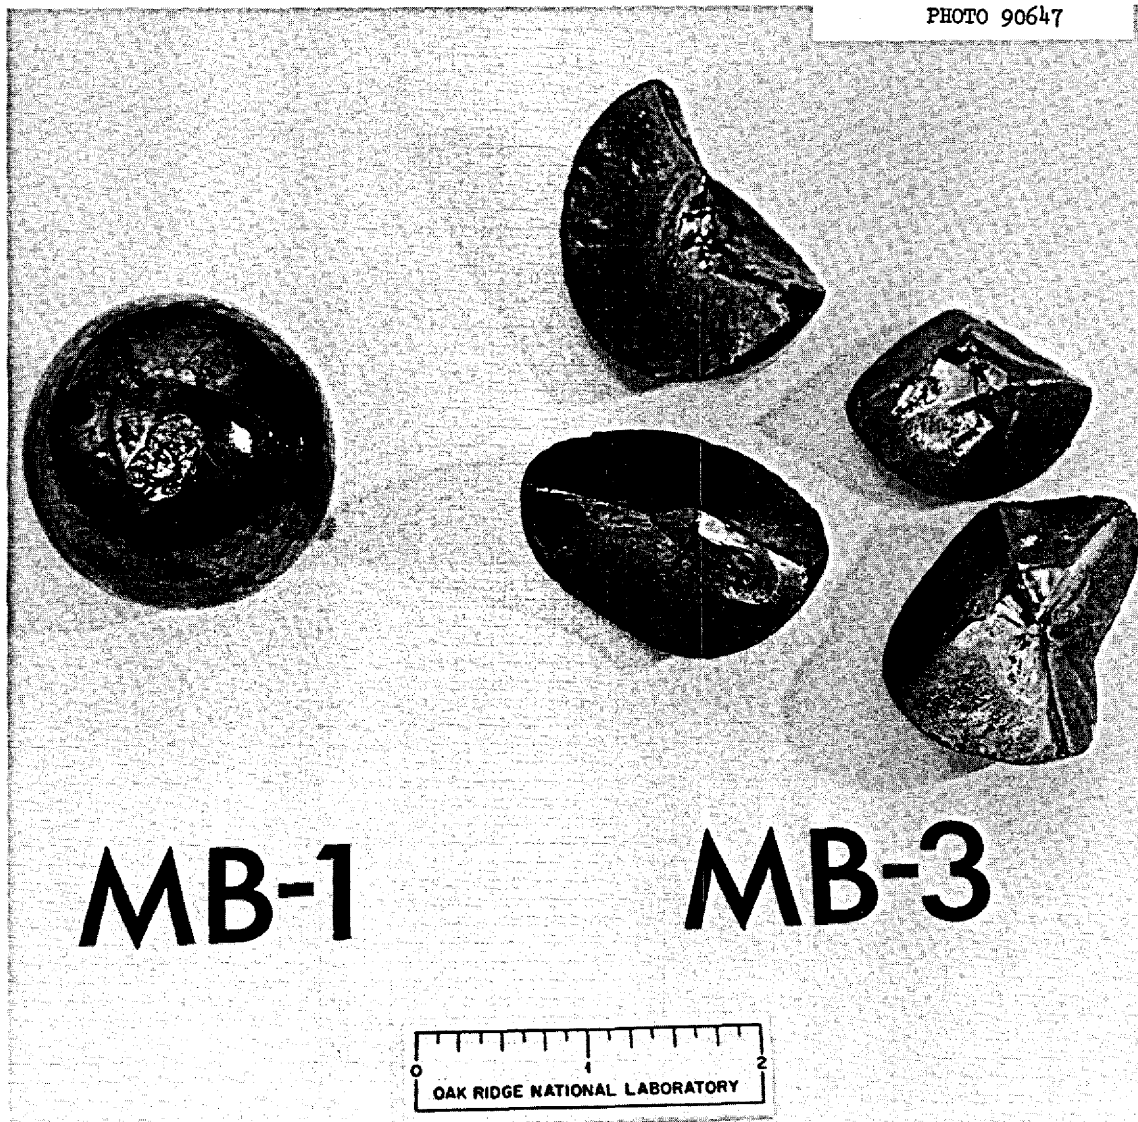
Fig. 6.5 Ball Bearing Failures Taken from MSRE Main Blowers MB-1 and MB-3 in January 1968

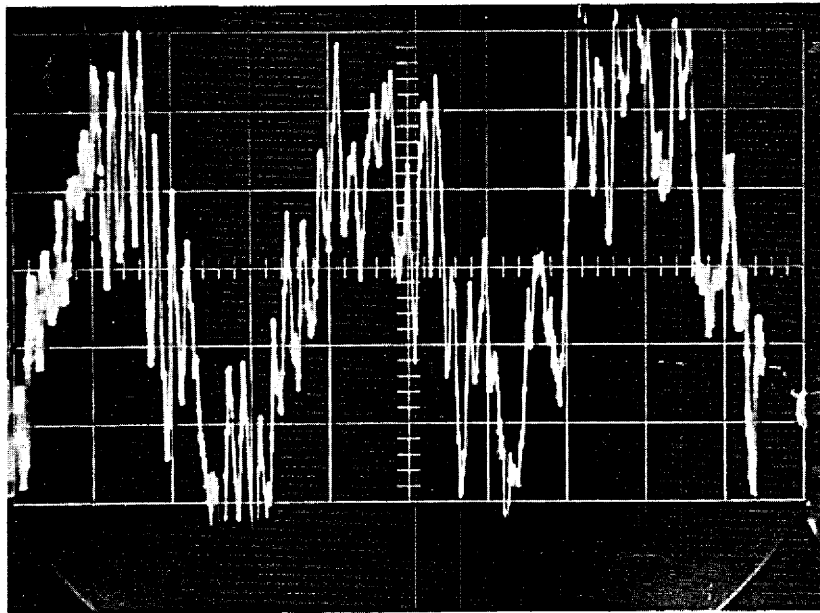
Trace with Fractured Ball - Taken 1/16/68

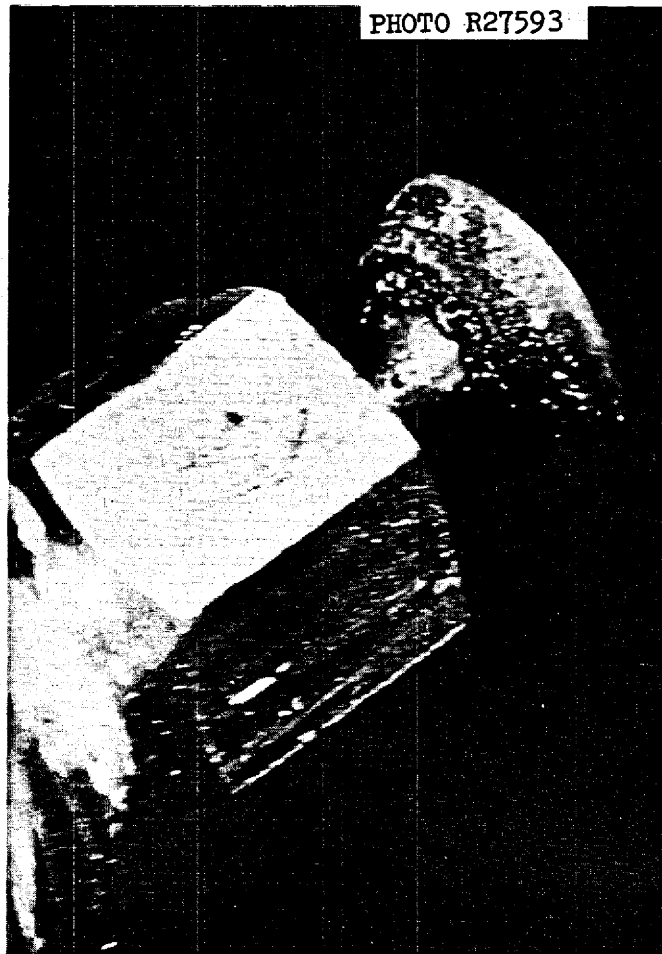
In April 1966, difficulty in venting through the auxiliary charcoal bed was found to be due to a check valve poppet which had become lodged in the inlet line to the bed. Apparently the poppet had vibrated loose from

Fig. 8.4 Check Valve CV-533

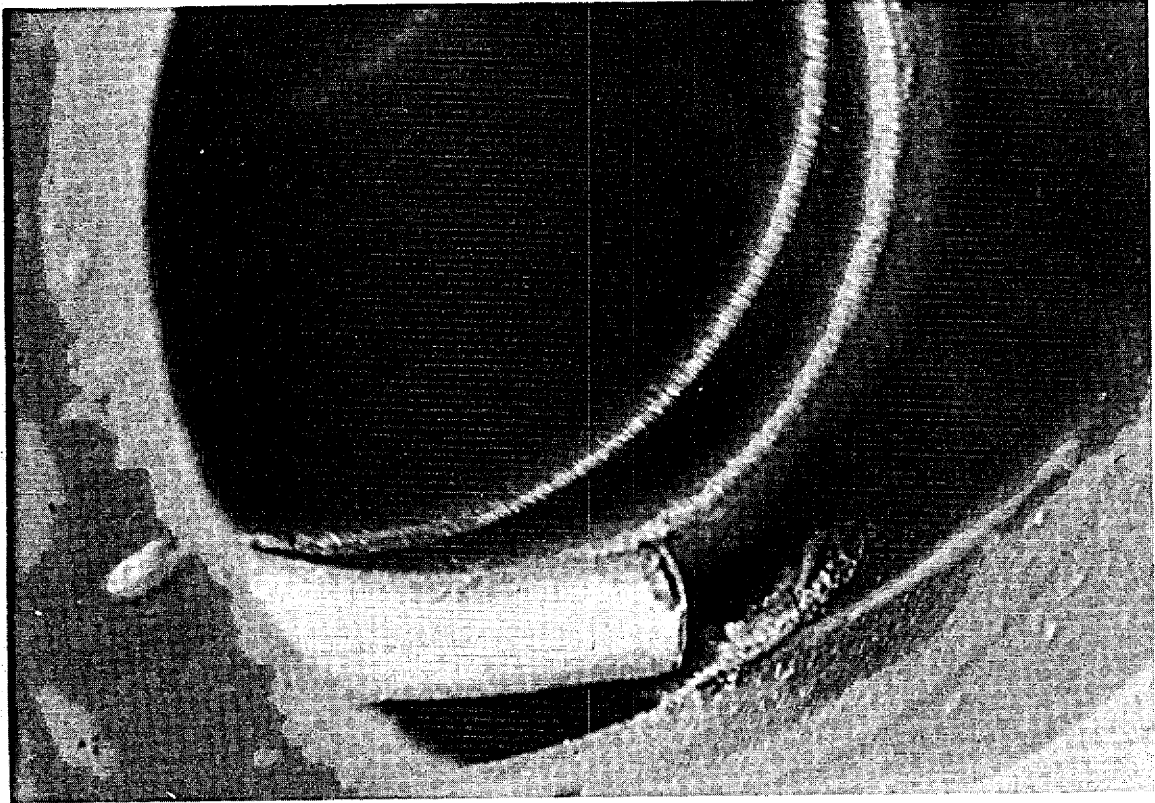
Fig. 8.5 Deposit in Flow Restrictor FE-521.

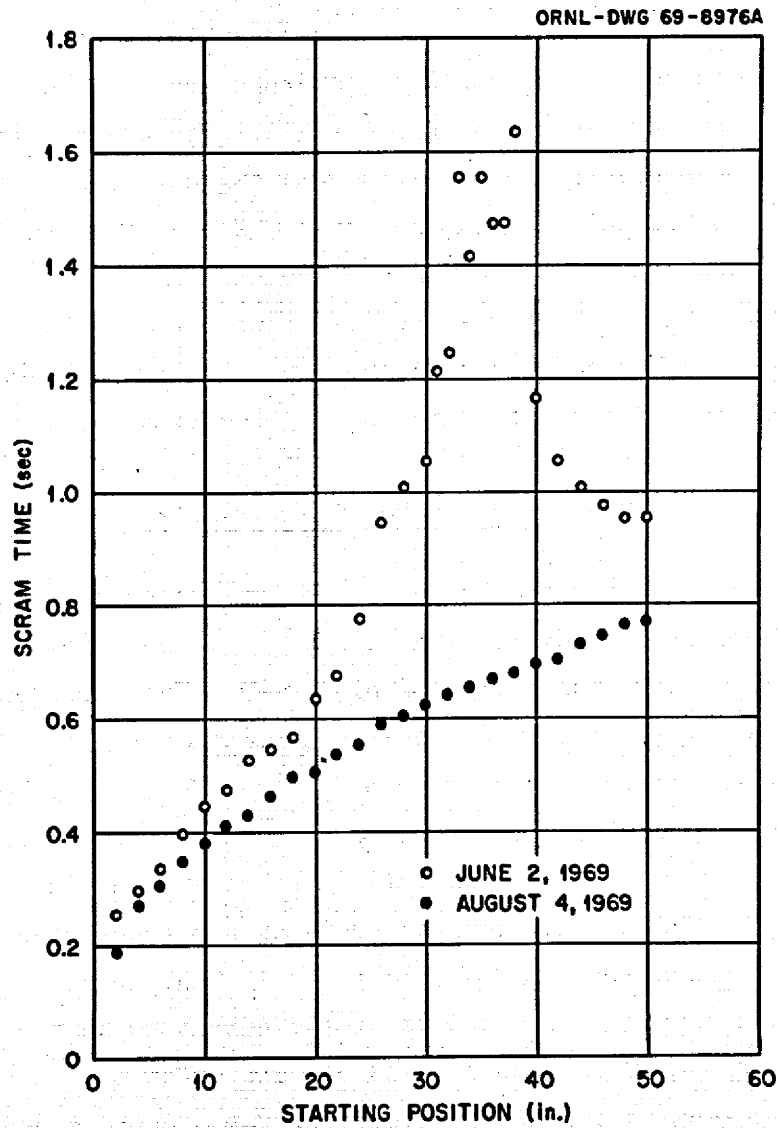
The reactor was shut down in June 1969 by manually scrambling all the control rods. The assembly in thimble T-3 (R-4 and V-1) was at 35.0 in. and did not scram.⁵⁹ The rod was inserted 0.2 in. and scrambled again, this time the rod dropped freely. Repeated attempts to make the rod stick followed this incident but were unsuccessful. Fig. 19.4 shows the results of scram tests at 2-in. increments taken on June 2 before the rod was examined and clearly shows the area of high drag.

Fig. 19.4 Incremental Rod Drop Times

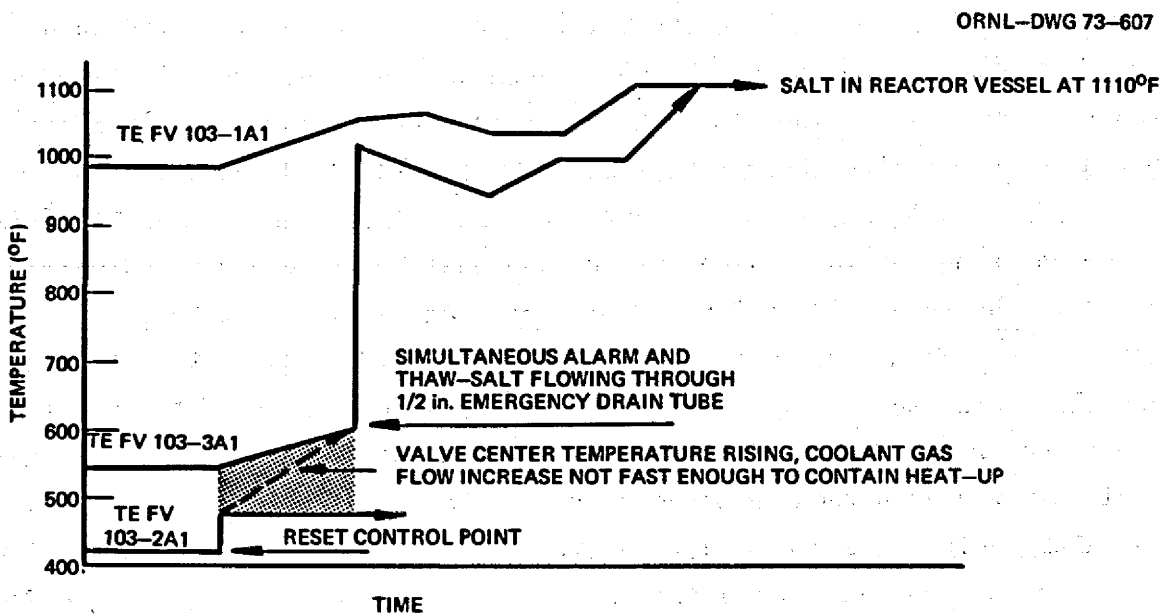
Fig. 20.4 Temperatures During Unplanned Thaw of FV-103
