ORNL-TM- 3524

**OPERATION OF THE SAMPLER-ENRICHER
IN THE
MOLTEN SALT REACTOR EXPERIMENT**

R. B. Gallaher

OCTOBER 1971

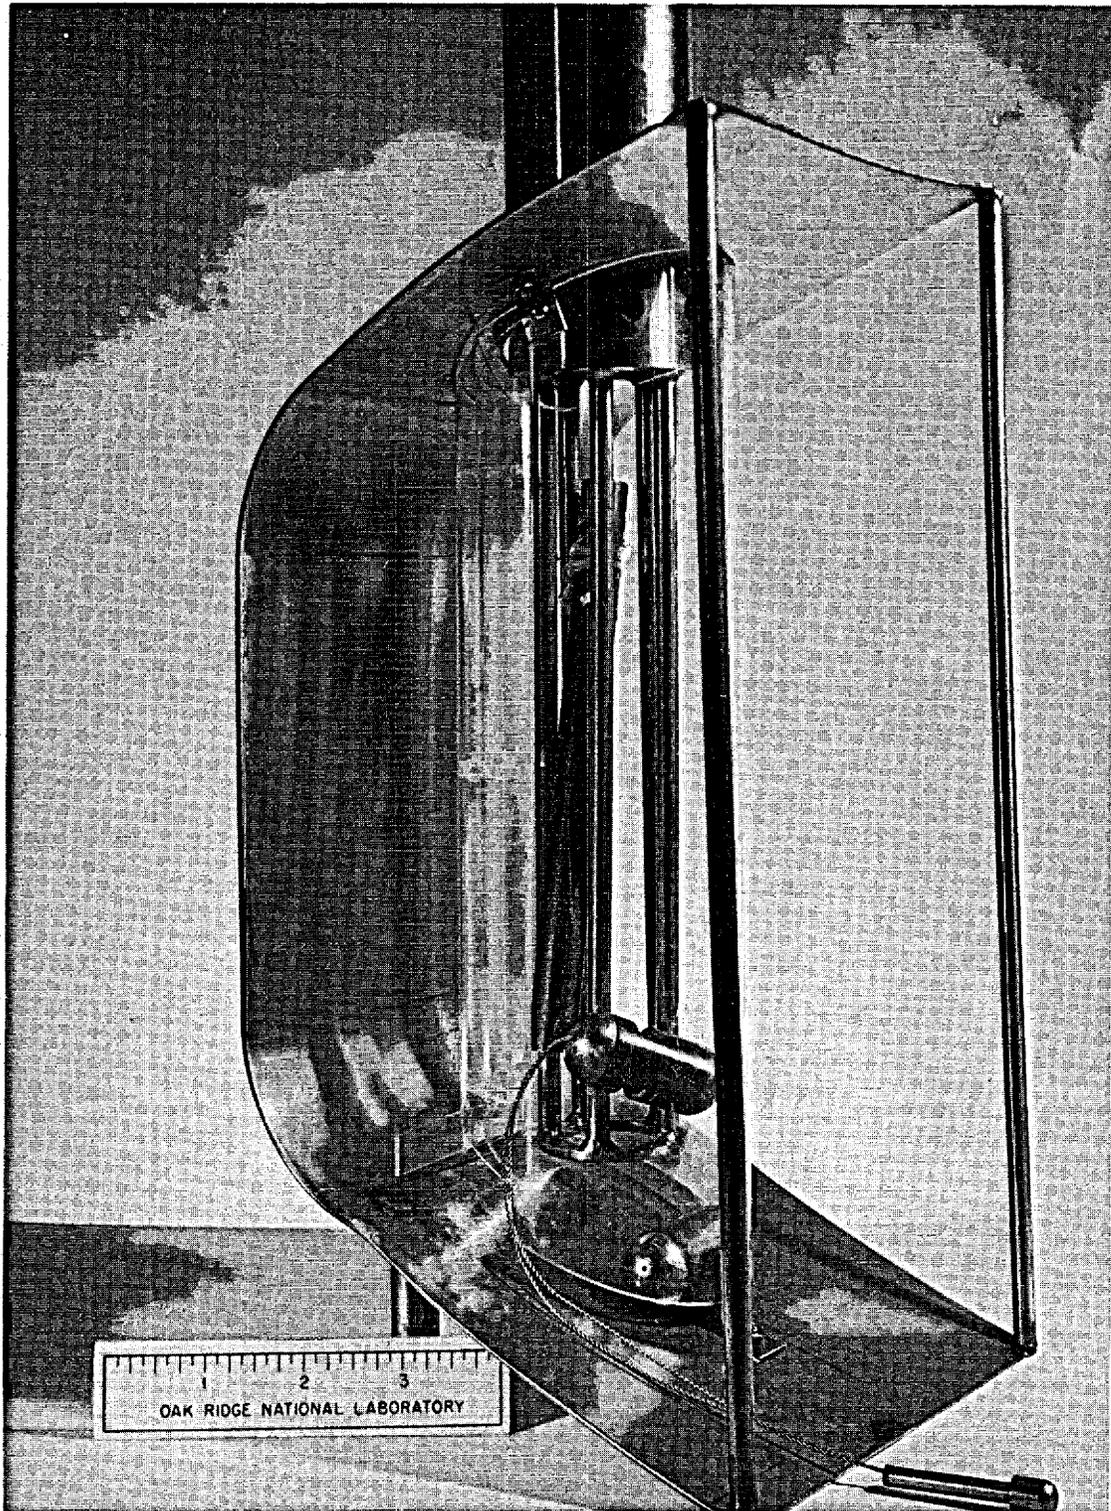
Capsules were actually dropped a few times⁸ and recovered with the magnet. While the capsule was being attached to the latch, the operational valve was closed so a dropped capsule fell only about 15 inches below the access port opening to the gate of the valve. On two occasions, noted later in the report, a capsule was dropped into the pump bowl during periods of abnormal operation when the operational and maintenance valves

Fig. 4. Mock-up Fuel Pump Bowl Section Showing Dropped Capsules and Magnet.

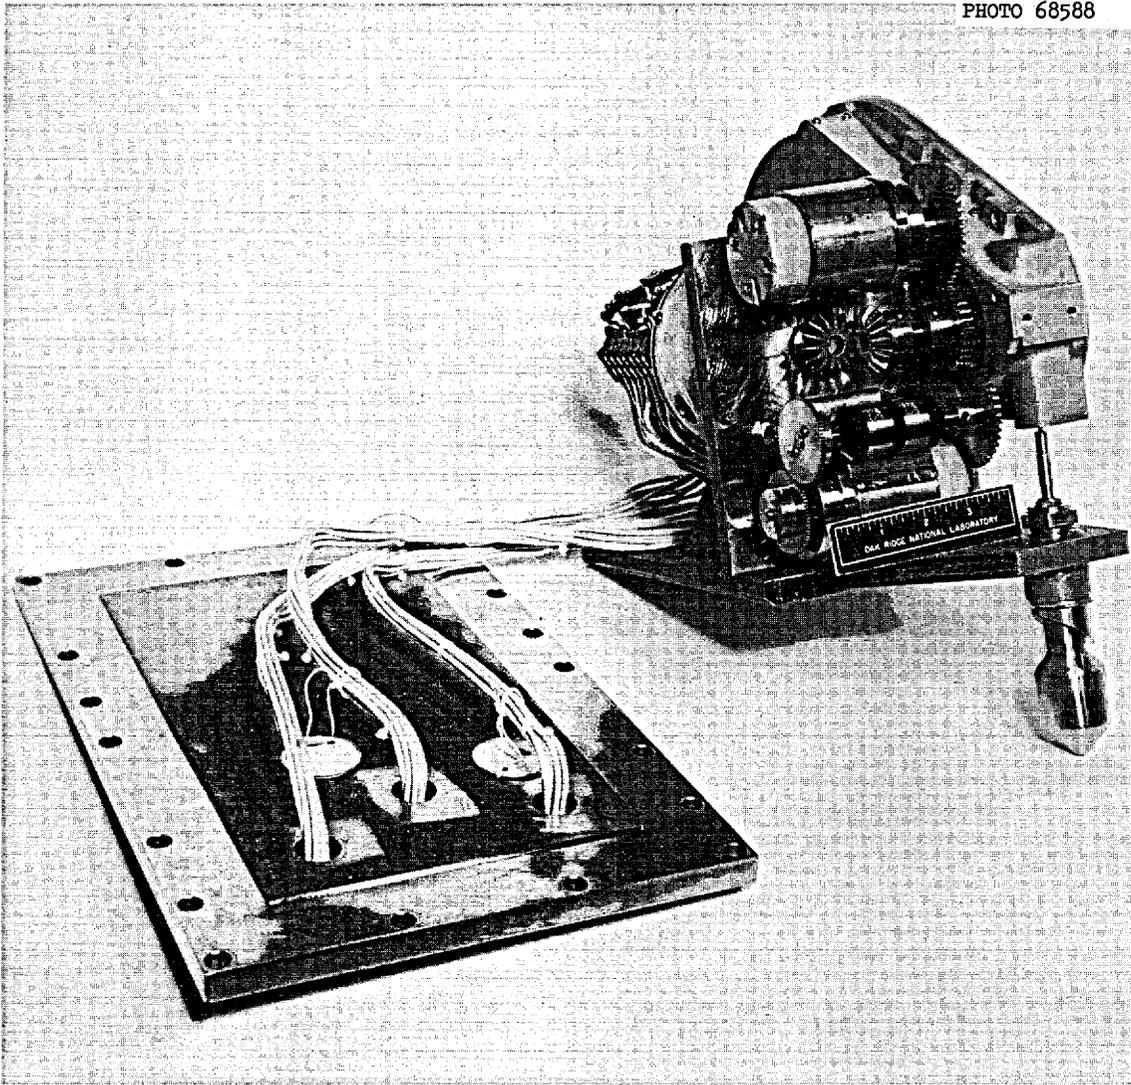
The latch attached to the end of the drive unit cable operated satisfactorily for about a year. It then started binding in the lower bend of the transfer tube. A new latch with a smaller diameter was installed. Later this latch was replaced with another one of similar dimensions, which was fabricated of 430 stainless steel instead of 304 stainless steel so that it was magnetic. The drive unit assembly is shown in Fig. 5.

One of the bevel gears connecting the cable drive unit to its motor started slipping on its shaft in December 1968 after 15 months of use. The gear was secured to the shaft by two set screws, but the repeated stress placed on the unit while attaching the capsule and checking it probably loosened the screws and caused the gear to slip on the shaft. Also, just prior to this difficulty, a key had jammed in the latch. Extra strain was applied to the drive unit while trying to remove the key from the latch with the manipulator. Slipping was first noticed while attempting to free the key.

Fig. 5. Drive Unit Assembly.

To repair the gearing, the LC assembly was lifted above the top of 3A. This required draining the reactor and removing two top shielding

blocks to reach the bolts of the flange located at the lower end of 1C. Next, a 3-in.-diam hole was drilled through the 1/2-in.-thick wall of the drive unit box at a point adjacent to the gears. When the motor was operated, the gear on the drive unit was observed to slip on its shaft. Using a long-handled wrench, both set screws were tightened, but the gear still slipped. It was then welded to the shaft. Both set screws on the mating gear on the motor shaft were tightened and locking screws were installed to hold them in place. A plug was then welded over the hole in the containment box. At the start of this repair operation the radiation level at the gears was 45 R/hr. At the outside of the containment box where the hole was drilled it was 27 R/hr.

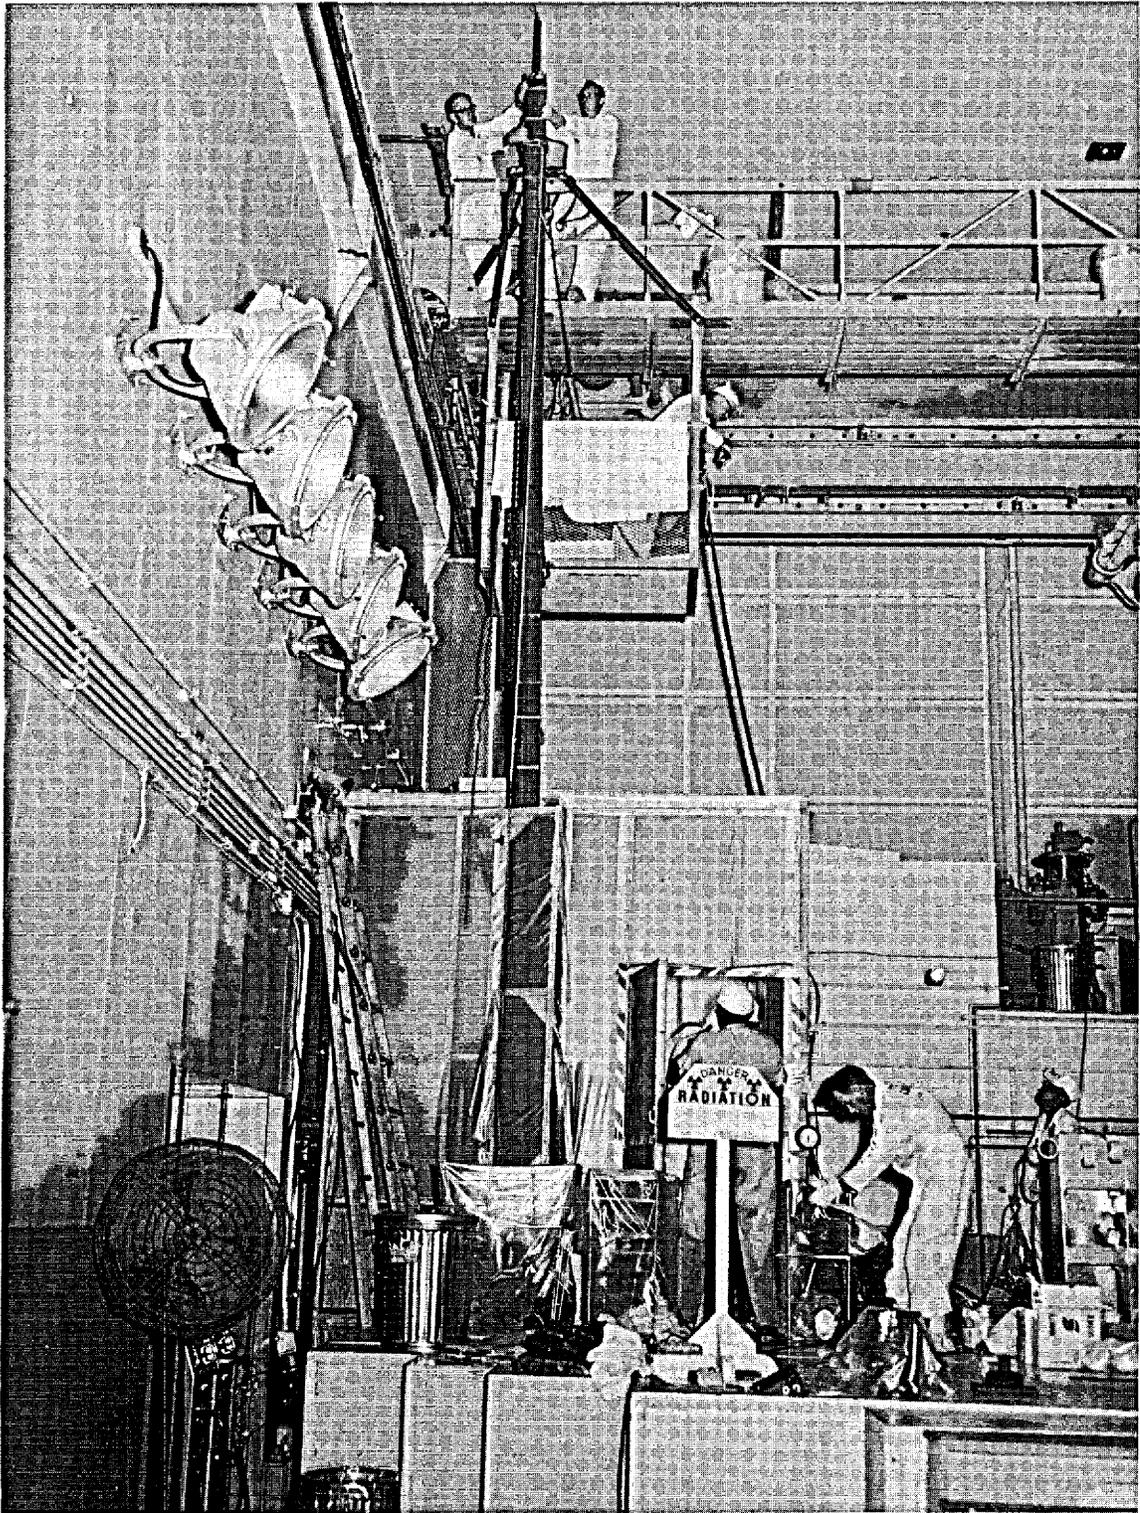
The fifth time the drive unit malfunctioned no attempt was made to close the operational valve as we did not want to chance cutting the cable again. The reactor was drained so that the access port could be

Fig. 6. Tools and Tent Used During Recovery of Lost Latch.

opened to observe the condition of the cable. This was the first opportunity for a visual inspection of this type of trouble. The capsule was seen lying on its side on the lower ledge of the access port opening. The latch was above and behind it. The cable formed many coils. The normal position of the capsule when attached to the latch was about four inches below the place where it was observed. No explanation was found for its observed location. While attempting to grasp the capsule with the manipulator, the operator brushed against one of the coils of cable shifting the position of all parts. The latch fell on its side allowing the key to slip out of it and the capsule to drop into the pump bowl.¹² The capsule recovery attempt with magnets was described in a prior section.

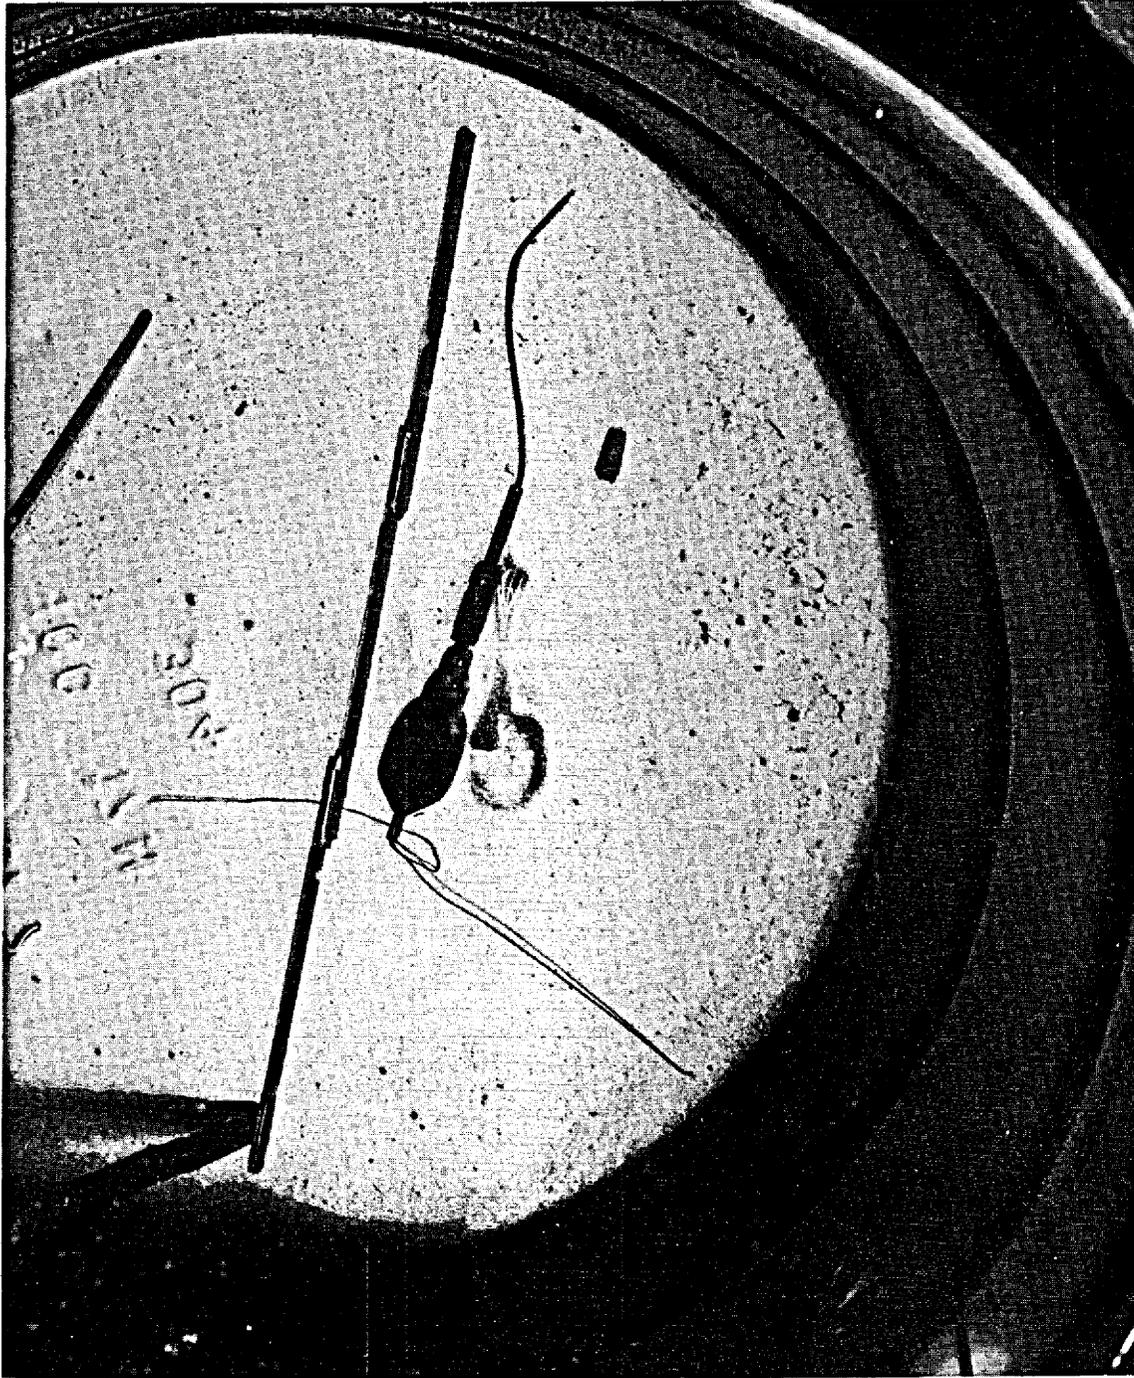
Fig. 7. Latch and Key After Removal from Transfer Line.

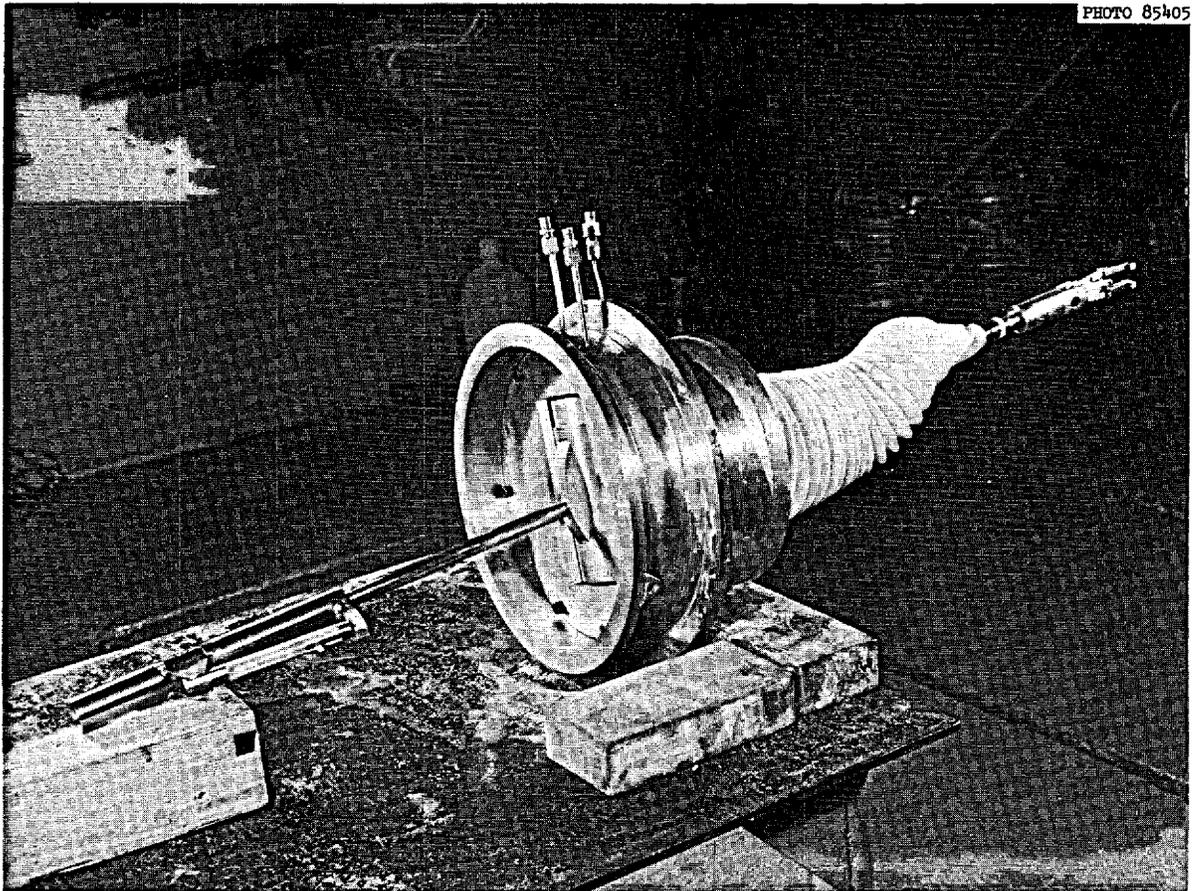
The manipulator (Fig. 9) required more maintenance than any other component of the sampler-enricher. The two-ply polyurethane boots which sealed the arm to the wall of 3A had to be replaced 17 times or an average of 3-1/2 times a year. After standard maintenance procedures were established, the estimated cost per change was \$1,800.¹³

Fig. 9. Manipulator Assembly Without Cover.

When the differential pressure was in the opposite direction, two problems arose from the ballooning of the boots. Some of the steel rings in the inner boot slipped out of the convolutions. The displaced rings pinched holes in the boot after a period of use. During early sampling cycles prior to operating the reactor at power, the pressure differential blew the boots off their flange on 3A. Improved clamping arrangements prevented this from recurring. Also, a differential pressure switch was installed to protect against excessive pressure differentials in the direction that caused ballooning.

Three other types of failure occurred. After installation of the rings, the rough surfaces on the rings punctured the boot when excessive pressure occurred in area 3A. After this, weld joints were filed smooth. Once the outer boot was snagged on the lower part of the transport container, tearing the boot. The third type of failure resulted from airborne particles that were embedded in the plastic during fabrication at the manipulator shop. These particles loosened with continued use leaving pin-holes through the wall. Visual examination of each new boot prior to installation reduced this type of failure.

Improvements in boot design were made throughout the operating period. The first major modification was the addition of steel rings to the convolutions of the inner boot. This prevented the boot from collapsing against the arm when there was a pressure differential across the boot with the higher pressure in 3A. When the boot collapsed, movement of the arm abraded and pinched the plastic. Also, friction made the in-and-out movement of the manipulator difficult.

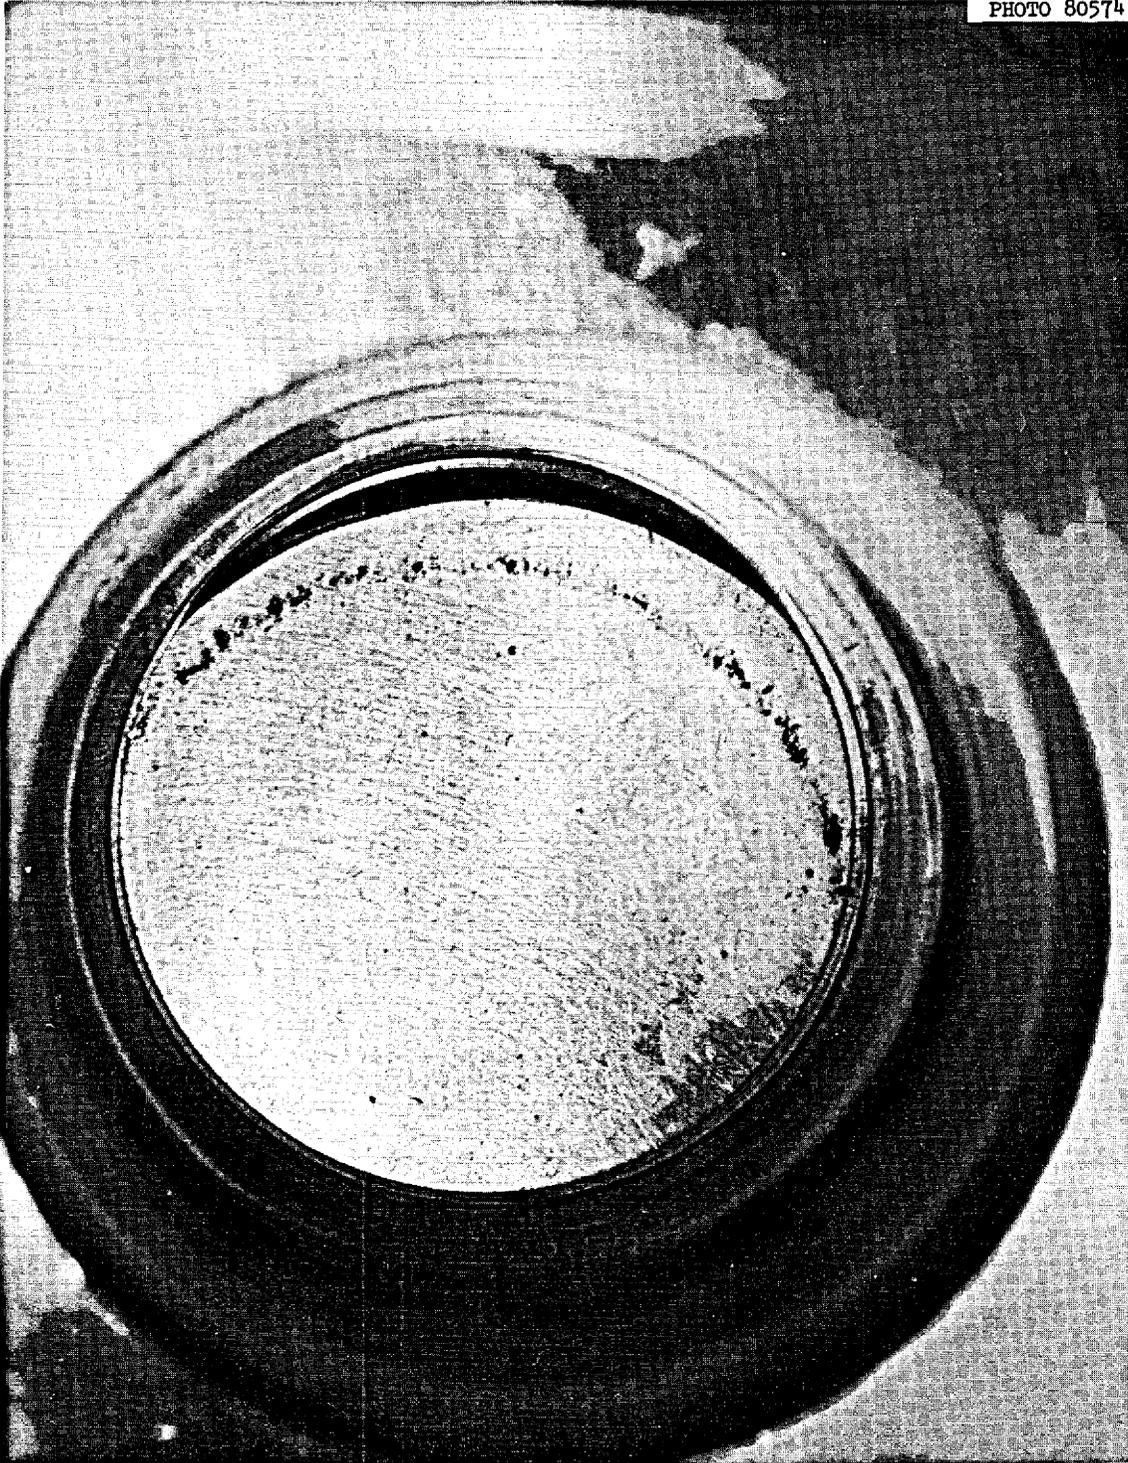
Fig. 10. Dirt on Gate of the Operational Valve.

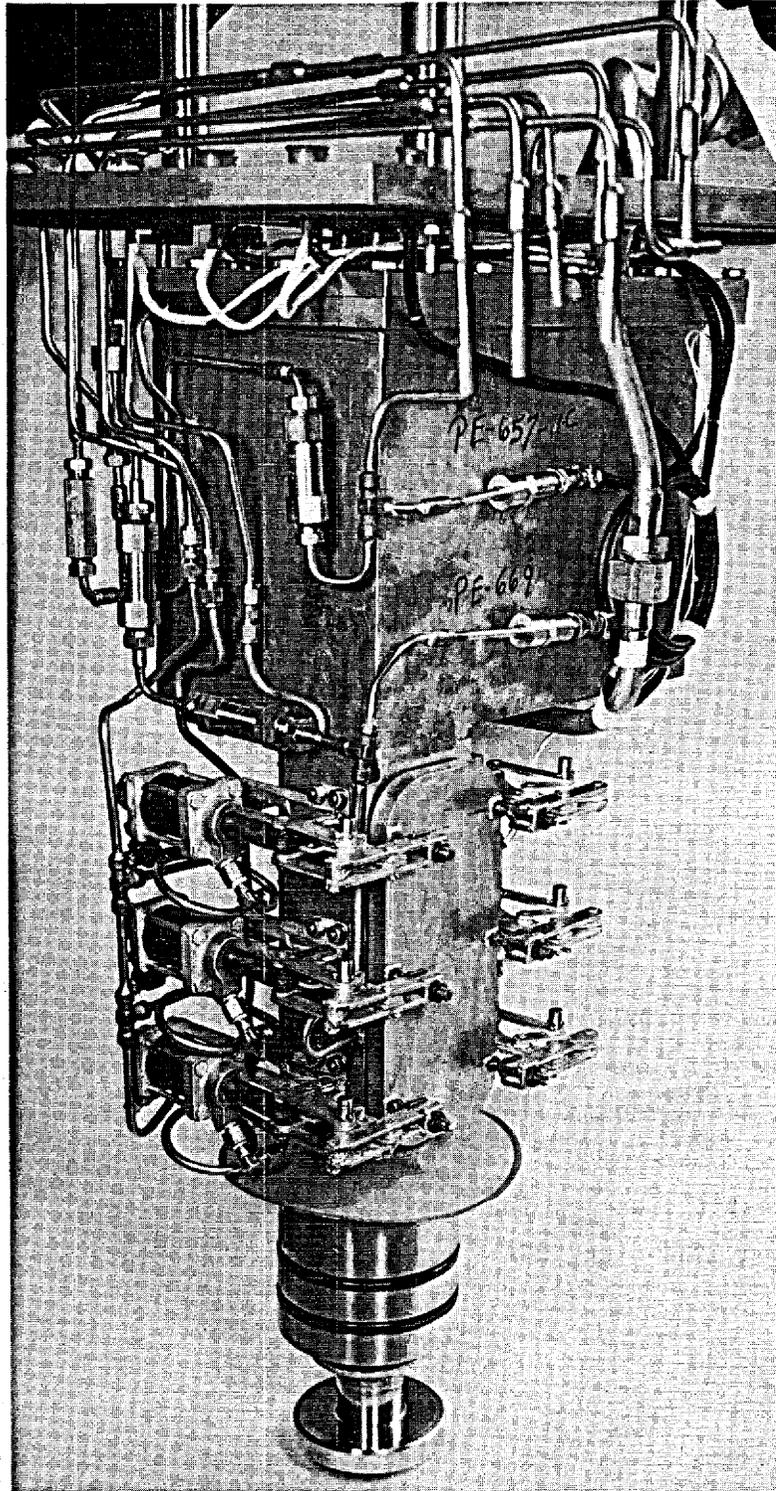
When 1C was pressure checked at 48 psig after installation, the load on each clamp was about 270 pounds. For the configuration used, the clamps were rated for a load of about 300 pounds. The loading that occurred during pressure testing loosened the link pins slightly and reduced the pressure exerted on the gasket, thus increasing the leak rate through the seals. Prior to installation of the 1C assembly, the access port leak rate was less than 1 cc/min at 40 psi differential. After use, it increased by more than a factor of ten.

Fig. 12. 1C Assembly with Access Port Closed.

On the second area 1C assembly, the Knu-Vise clamps were modified so that they could be semi-remotely adjusted to increase the pressure on the gasket while installed. However, the radiation level in 3A was so high (more than 100 R/hr at the manipulator port) that very little adjusting was done.

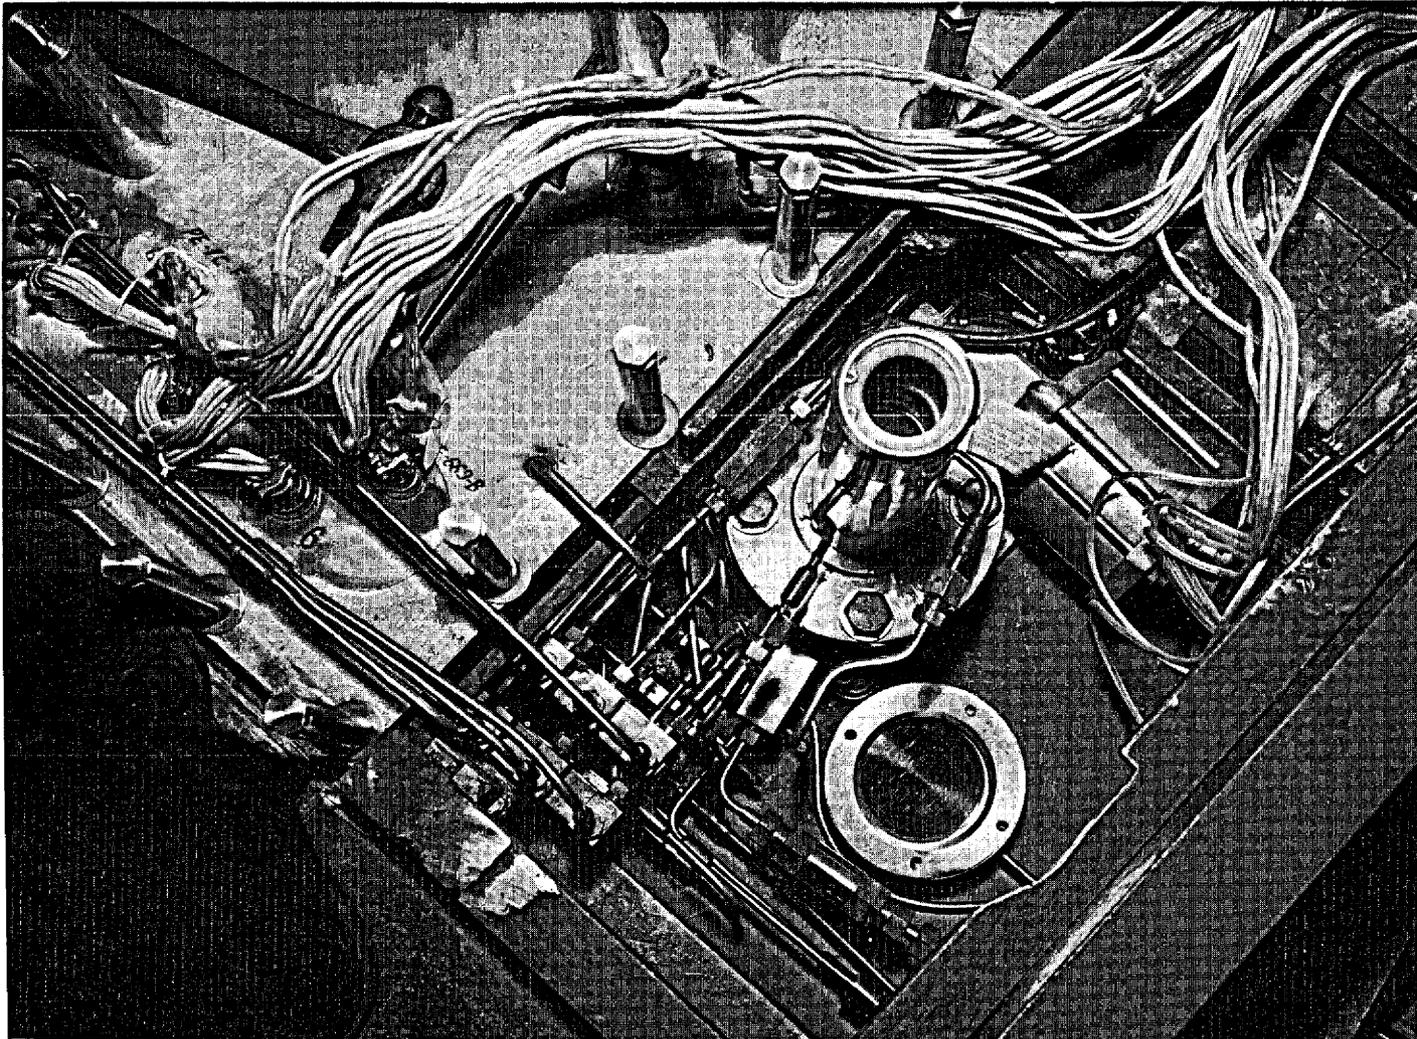
The mounting bracket for the air cylinder operator was not sturdy enough to prevent movement of the cylinder on the valve body which limited the maximum torque that could be applied to the ball by the cylinder. However, the crowded conditions in this region prevented tightening the bracket bolts without removing several components. A top view of this area is shown in Fig. 13.

Fig. 13. Top View Showing Removal Valve Area.

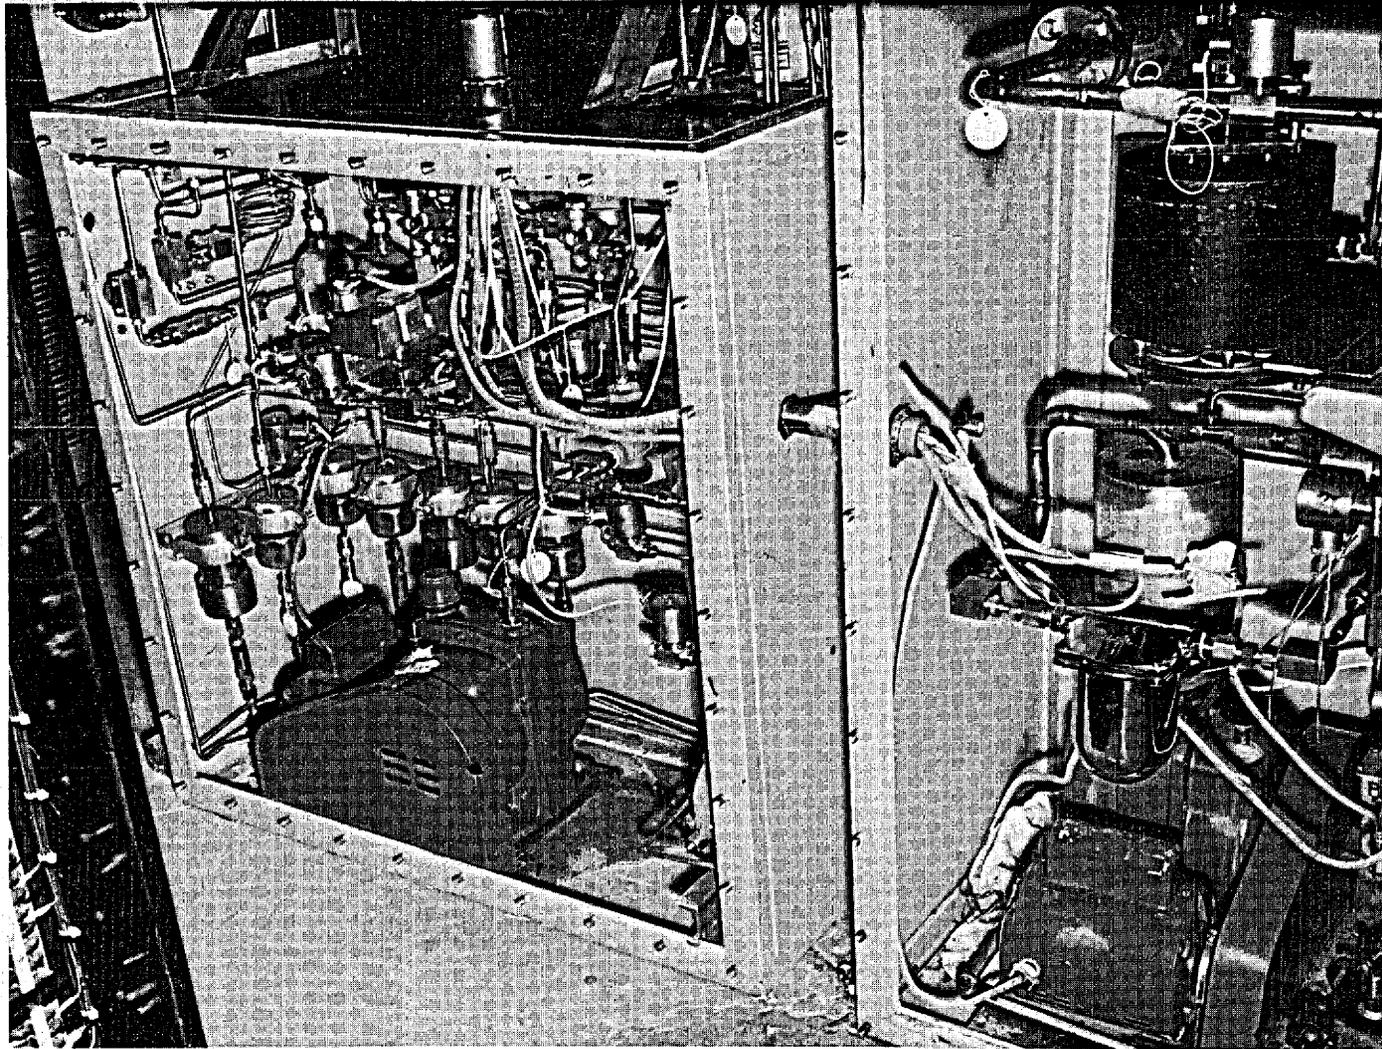
Two vacuum pumps (Cono Hyvac) were used in the off-gas system. The discharge of one pump which was exposed to helium containing gaseous fission products was connected to the auxiliary charcoal bed. The shaft seal in this pump was improperly installed as received and had to be replaced after a few months of operation. The belt was also replaced once. Just a few months prior to shutdown, the unit was replaced rather than repaired because of the radiation level and contamination associated with it. No radiation damage was apparent to the oil. Because of space limitation the oil level in the pump was hard to determine. Once the pump failed to operate properly because the oil level was too low. Oil was added several times. Figure 14 shows the two pumps. The one on the right was the one exposed to contamination.

Fig. 14. Hot Vacuum Pump (Right) Cold Vacuum Pump (Left).
