ORNL-TM-4174

# POSTIRRADIATION EXAMINATION OF MATERIALS FROM THE MSRE

**POSTIRRADIATION EXAMINATION OF MATERIALS FROM THE MSRE**

**DECEMBER 1972**

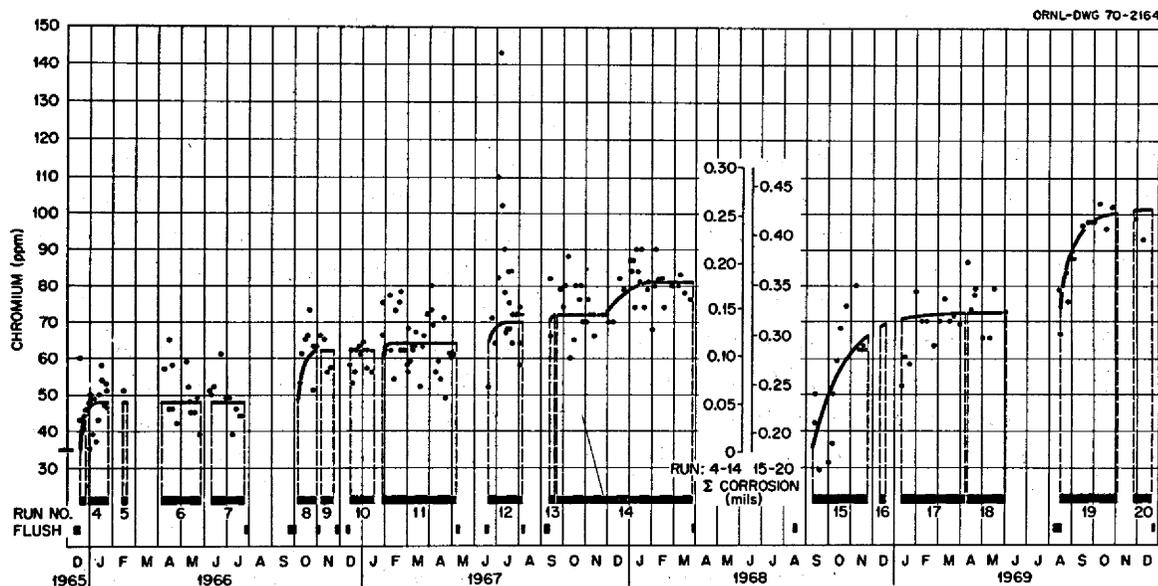
Fig. 3. Corrosion of the MSRE fuel circuit in  $^{235}\text{U}$  and  $^{233}\text{U}$  power operations, as measured by chromium concentration in the fuel salt.

and the concentration of chromium in salt samples was the primary indicator of corrosion. Figure 3 shows chromium concentrations observed in the MSRE fuel over the years of power operation. The step-down in chromium concentration in the salt in 1968 was effected by processing the salt after the  $^{235}\text{U}$  fluorination. The total increase in chromium in the 4700-kg charge of fuel salt is equivalent to leaching all of the chromium from the 852 ft<sup>2</sup> of INOR-8 exposed to fuel salt to a depth of about 0.4 mil.

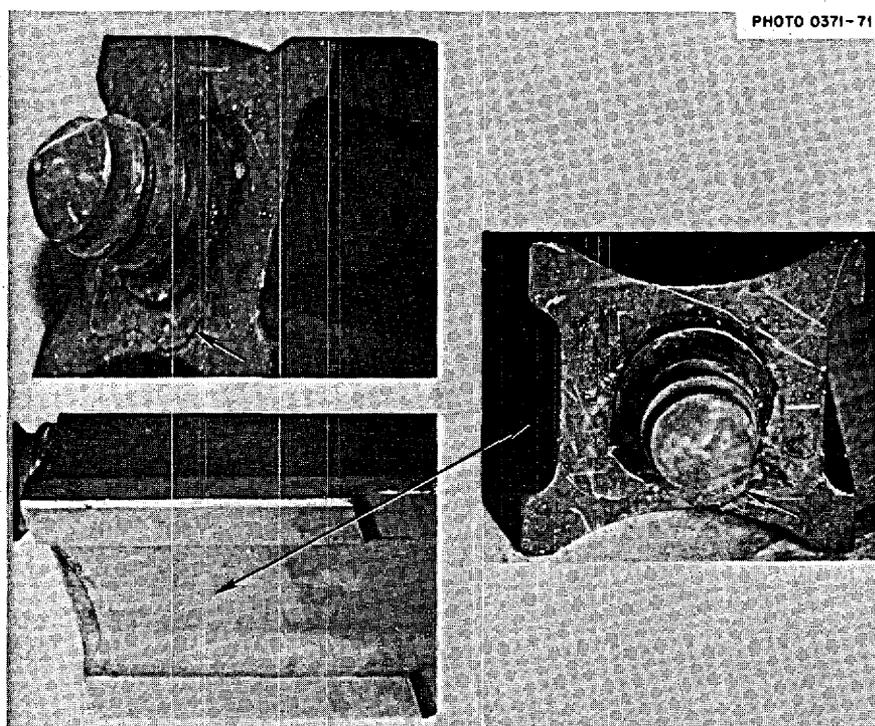
There was a crack in the graphite around the INOR-8 lifting stud that was screwed into the top of the bar. This crack extended about halfway around the bar, as shown by the short arrows in Fig. 7. The long arrow indicates the same channel in the different views. The small punch mark visible in the top view was made to indicate the fuel channel toward the center of the reactor, with a control rod on one side and the surveillance sample basket on the other side. The crack in the graphite did not affect the integrity of the bar, since it was on the end, and several threads remained to secure the lifting stud. The crack was probably caused by the approximate twofold difference in thermal expansion of graphite and INOR-8.

Fig. 7. Top of the graphite moderator element. The short arrows show the crack originating at the INOR-8 lifting stud and extending partway around the graphite block. The long arrow indicates the same channel in the different views. The crack was probably caused by the approximate twofold difference in thermal expansion between the INOR-8 and the graphite during thermal cycling of the reactor.

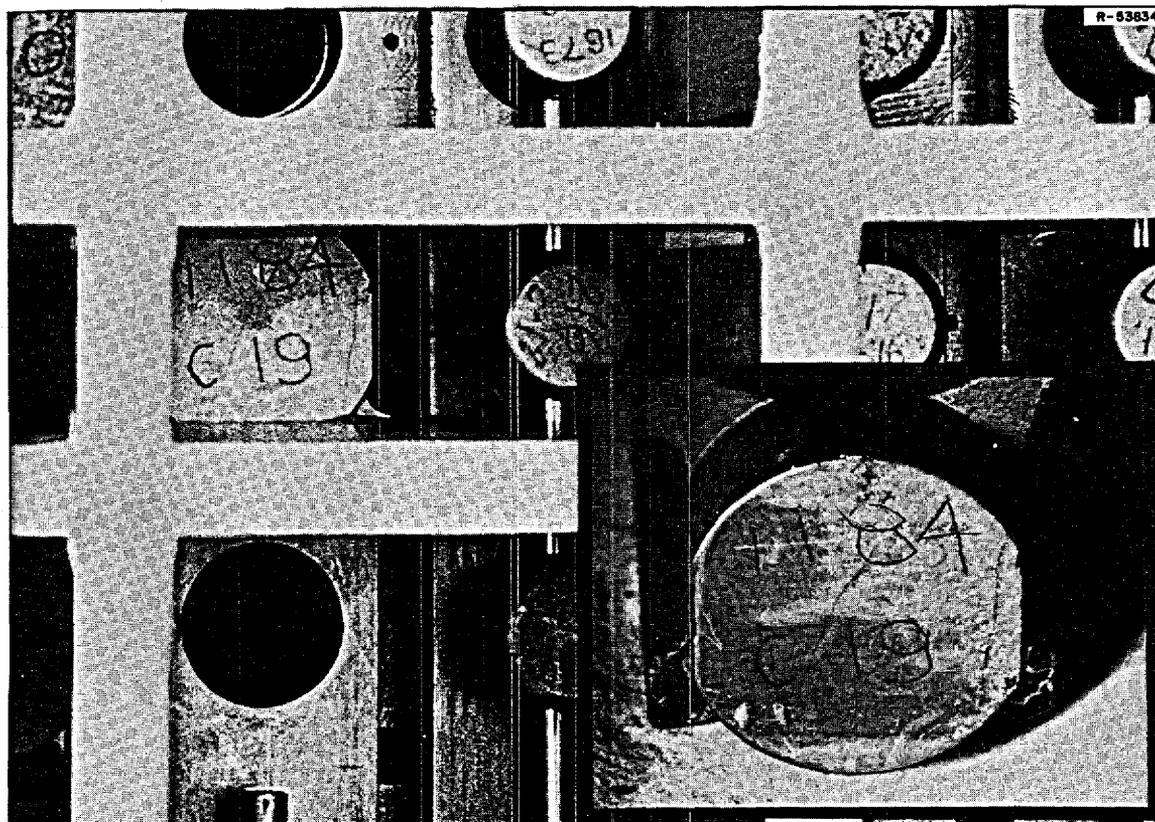
Fig. 8. Comparison of the bottom positioning stud on the graphite moderator element when initially installed in the MSRE and after operation. The large picture was made before the reactor was operational, and the small picture in the lower right corner was made in the hot cells after the moderator element had been at temperature for over three years.

exposure to molten salt). There is no apparent change, as the small cracks and the small chip missing from the bottom are apparent in both photographs, and the numbers are just as legible as before operation.

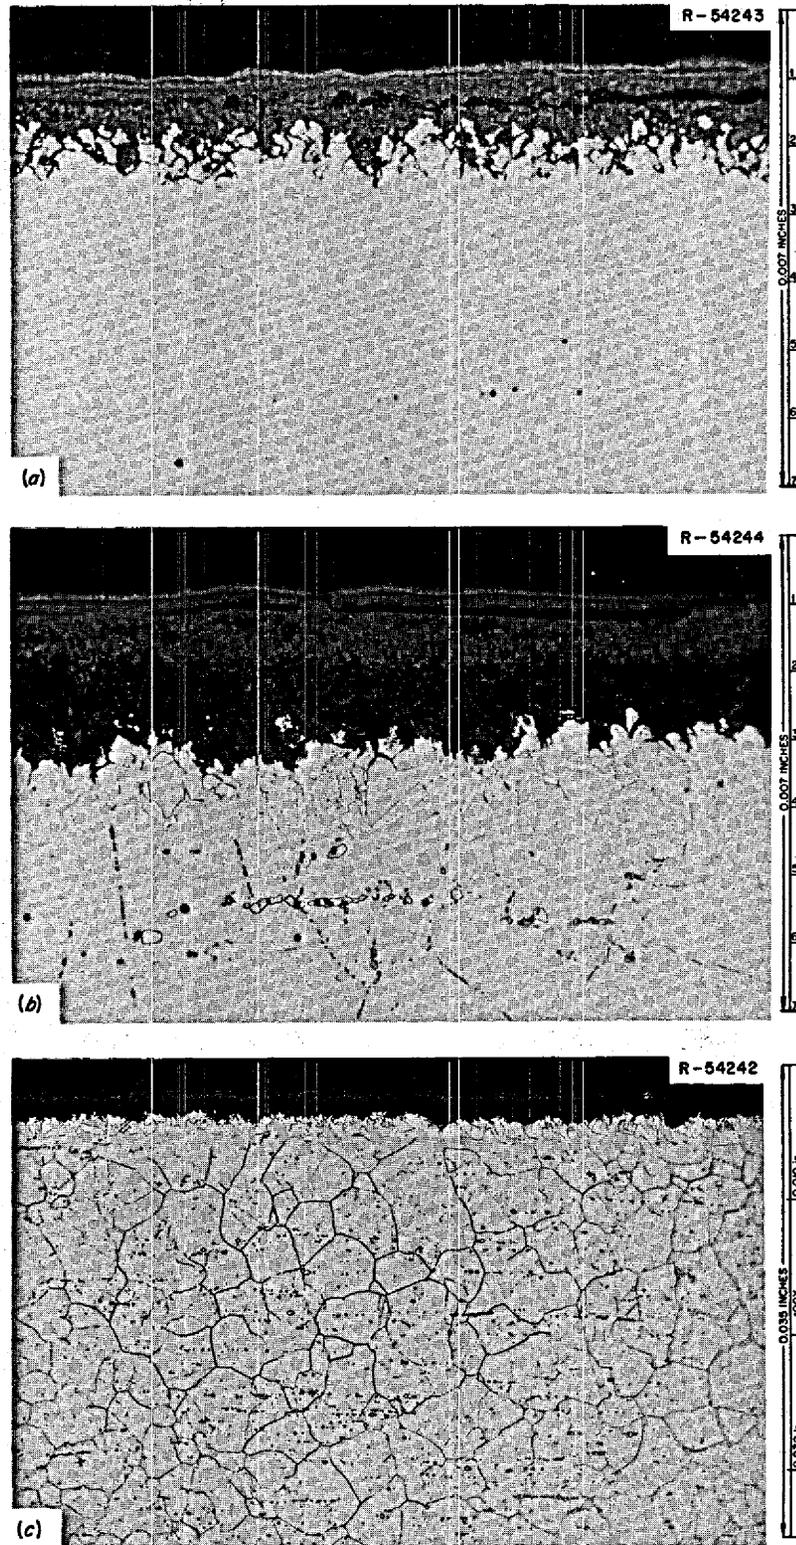
Samples of the control rod thimble and the spacer sleeve were cut and examined to determine their condition at the end of service. Typical photomicrographs of the inside of the thimble tube are shown in Fig. 13. This surface was oxidized to a depth of about 2 mils by the cell environment of nitrogen containing 2 to 5%  $O_2$ . The oxidation process modified the microstructure to a depth of 4 mils, likely by the selective removal of chromium.

Fig. 13. Inner surface of INOR-8 control thimble in as-removed condition. This surface was exposed to cell environment of  $N_2$  containing 2 to 5%  $O_2$ . (a) As polished; (b) etched; (c) etched, typical microstructure. Etchant: aqua regia. Reduced 30.5%.

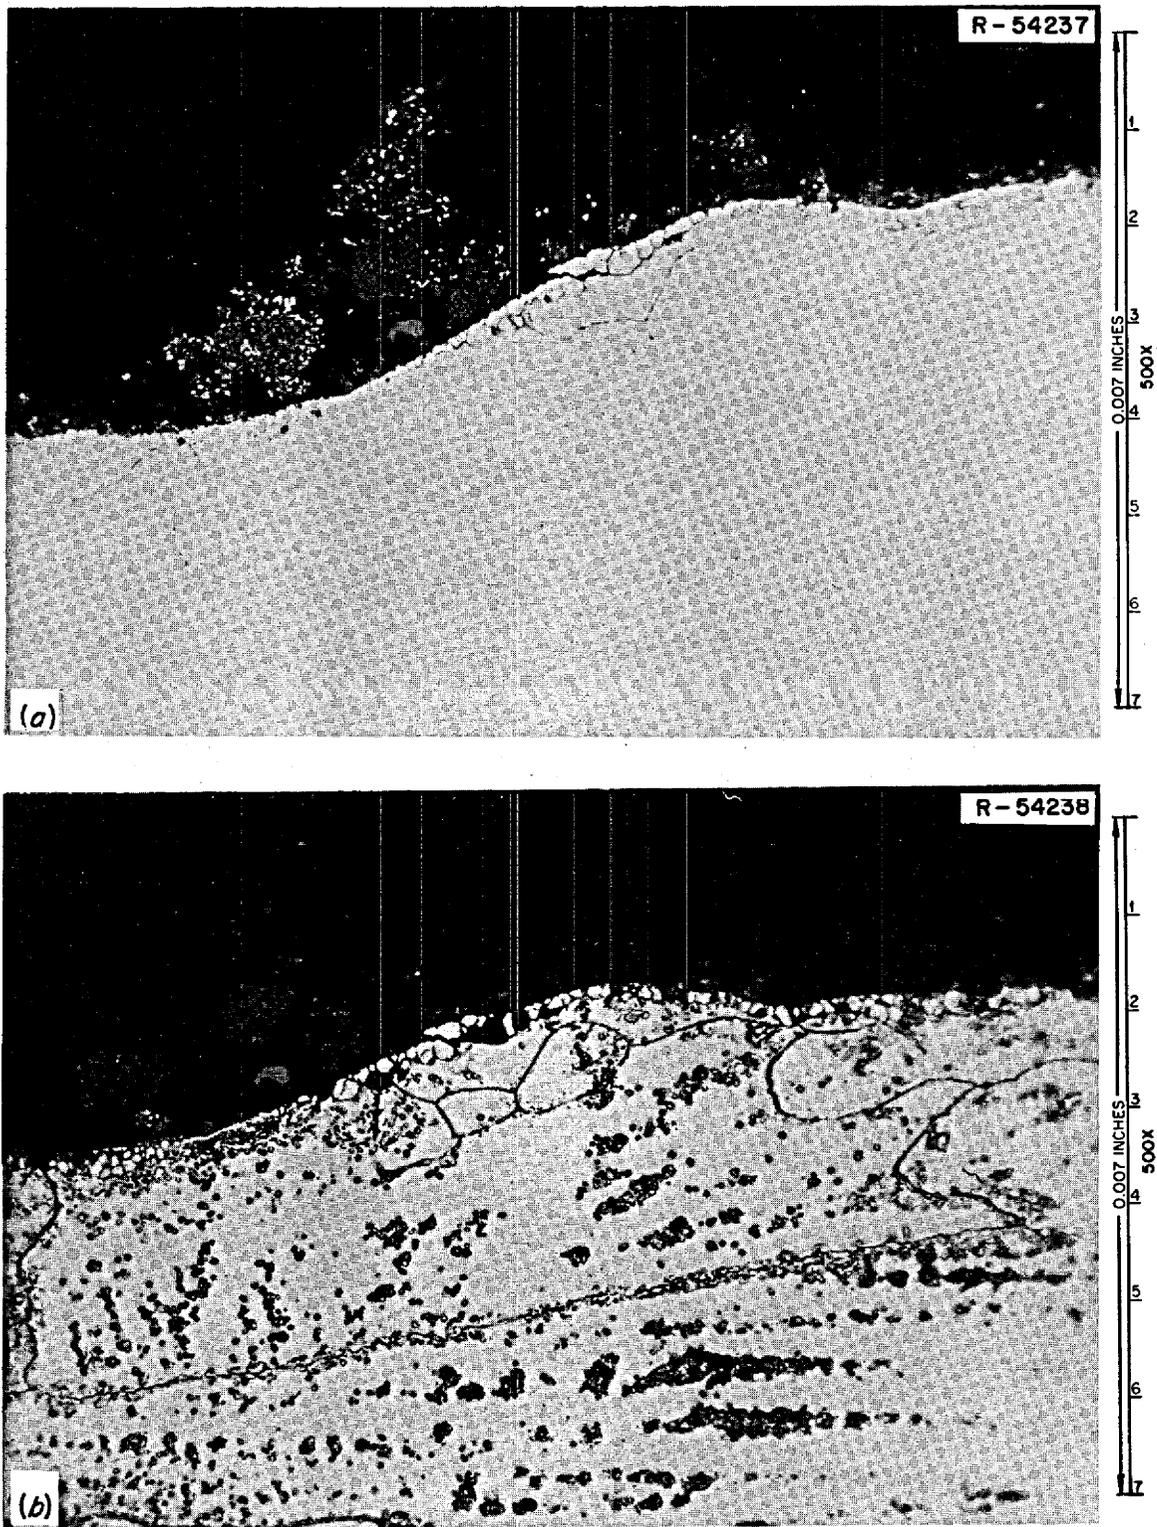
Photomicrographs of one of the weld beads are shown in Fig. 14. All of the surface shown was exposed to flowing fuel salt. Some grains were dislodged near the surface, and grain boundaries are visible in the as-polished condition to a depth of 1 to 1.5 mils.

Fig. 14. Outer surface of INOR-8 control rod thimble showing weld deposit made to hold spacer sleeve. The weld surface was exposed to flowing salt. (a) As polished; (b) etched with aqua regia.

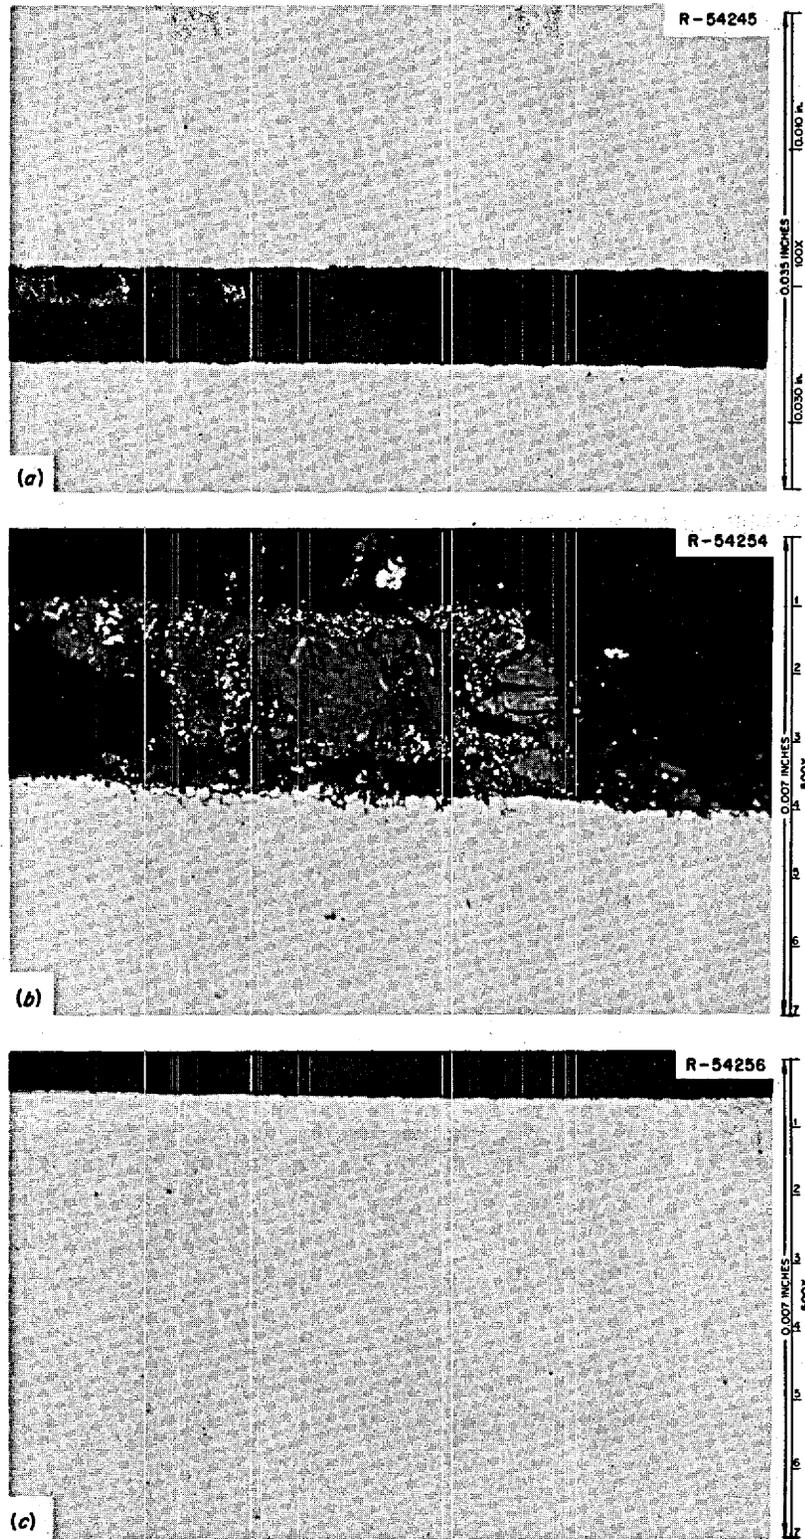
Photomicrographs involving the interface between the thimble and sleeve are shown in Fig. 15. Figure 15(a) shows the annular region with a separation of about 7 mils and some salt present. Few surface irregularities are visible at a magnification of 100x, indicating that they are considerably below 1 mil. Figure 15(b) is a 500x view of the thimble and shows some surface cracks to a depth of 0.3 mil. The outside of the sleeve is shown in Fig. 15(c); a few grain boundaries to a depth of about 1 mil are visible. Additional photomicrographs of the sleeve are shown in Fig. 16. The sleeve material does not appear to have received much work, since the carbide is very inhomogeneously distributed. Grain size is larger than usual away from the stringers. The inner and outer surfaces both have modified structures. A higher magnification view of the inner surface [Fig. 16(b)] shows that much of the modification is a high density of primary carbide. The outer surface [Fig. 16(c)] has a shallow layer of small grains, likely due to a working operation.

Fig. 15. As-polished surfaces of INOR-8 control rod thimble and sleeve. (a) Annulus between thimble and sleeve; thimble surface is in upper part of picture. (b) Outside surface of control rod thimble, showing presence of some salt and shallow surface cracking. (c) Outside surface of sleeve; surface exposed to flowing fuel salt.

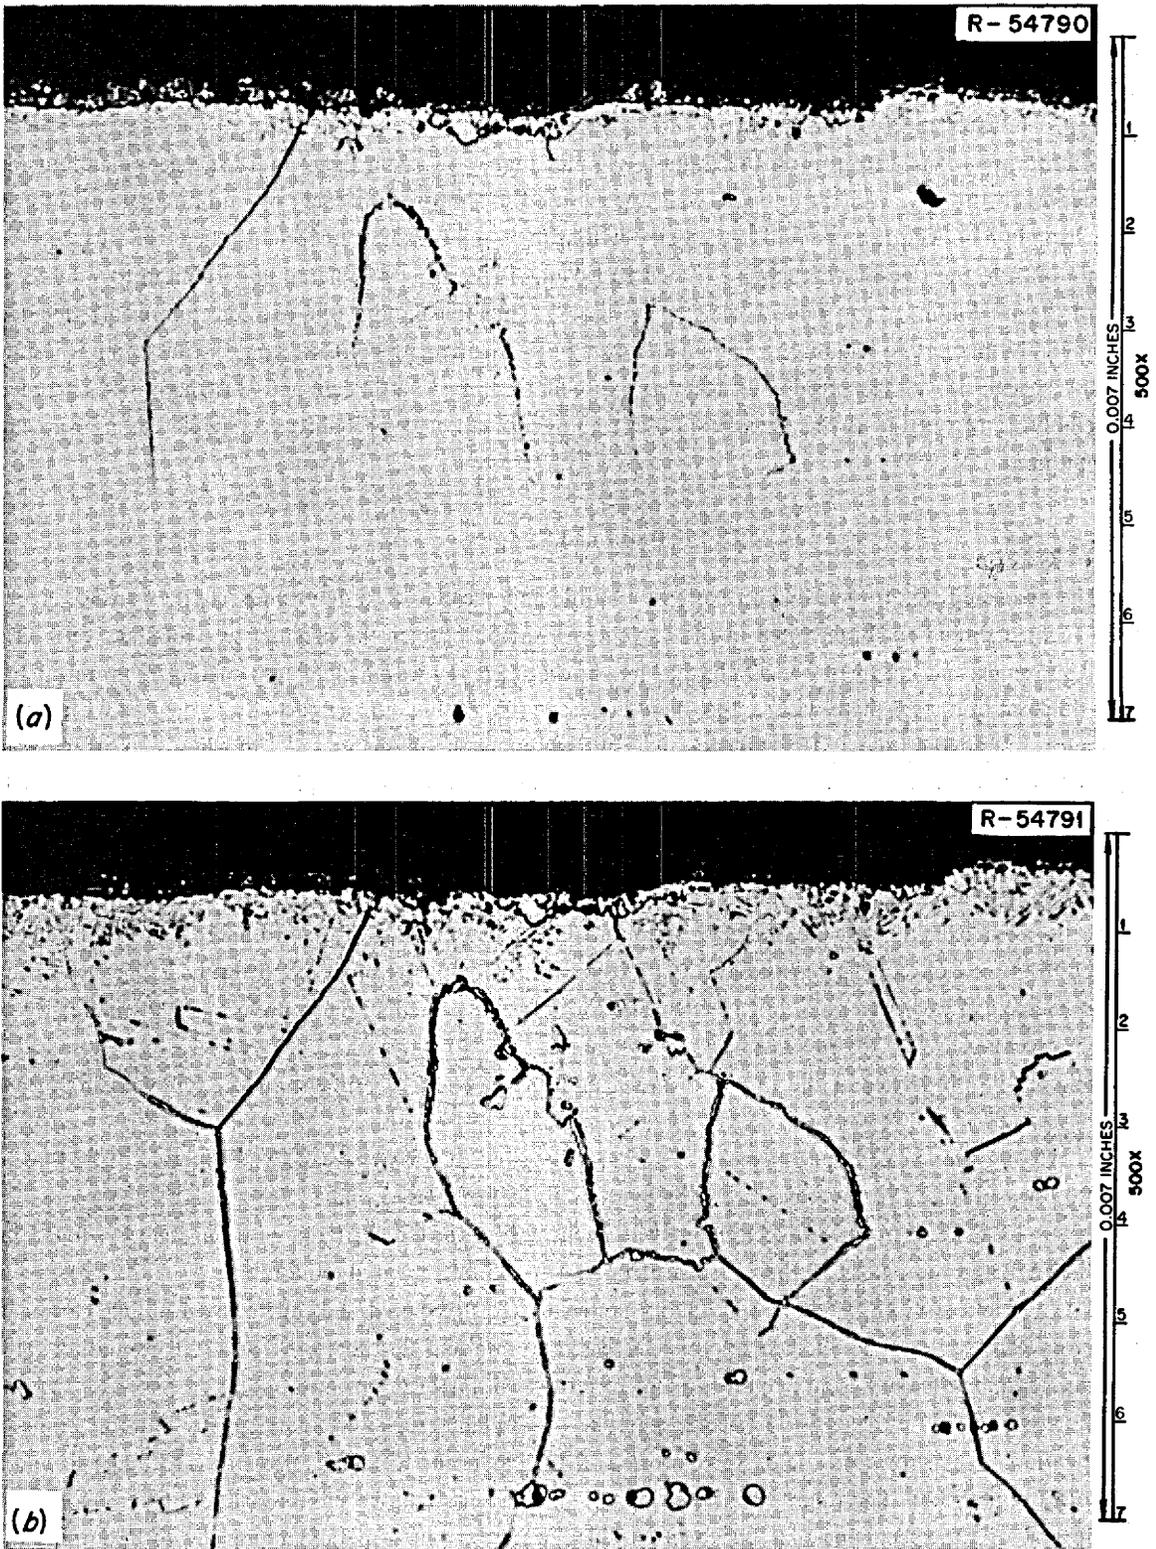
A second cut was made away from the sleeve, and typical photomicrographs are shown in Fig. 17. This part of the thimble was exposed to flowing salt. Some of the grain boundaries are visible in the as-polished condition to a depth of about 4 mils, and there is some surface modification [Fig. 17(a)]. Etching [Fig. 17(b)] delineates more of the grain structure and shows the shallow surface modification.

Fig. 17. INOR-8 control rod thimble where it was exposed directly to flowing salt. (a) As polished; (b) etched with aqua regia.

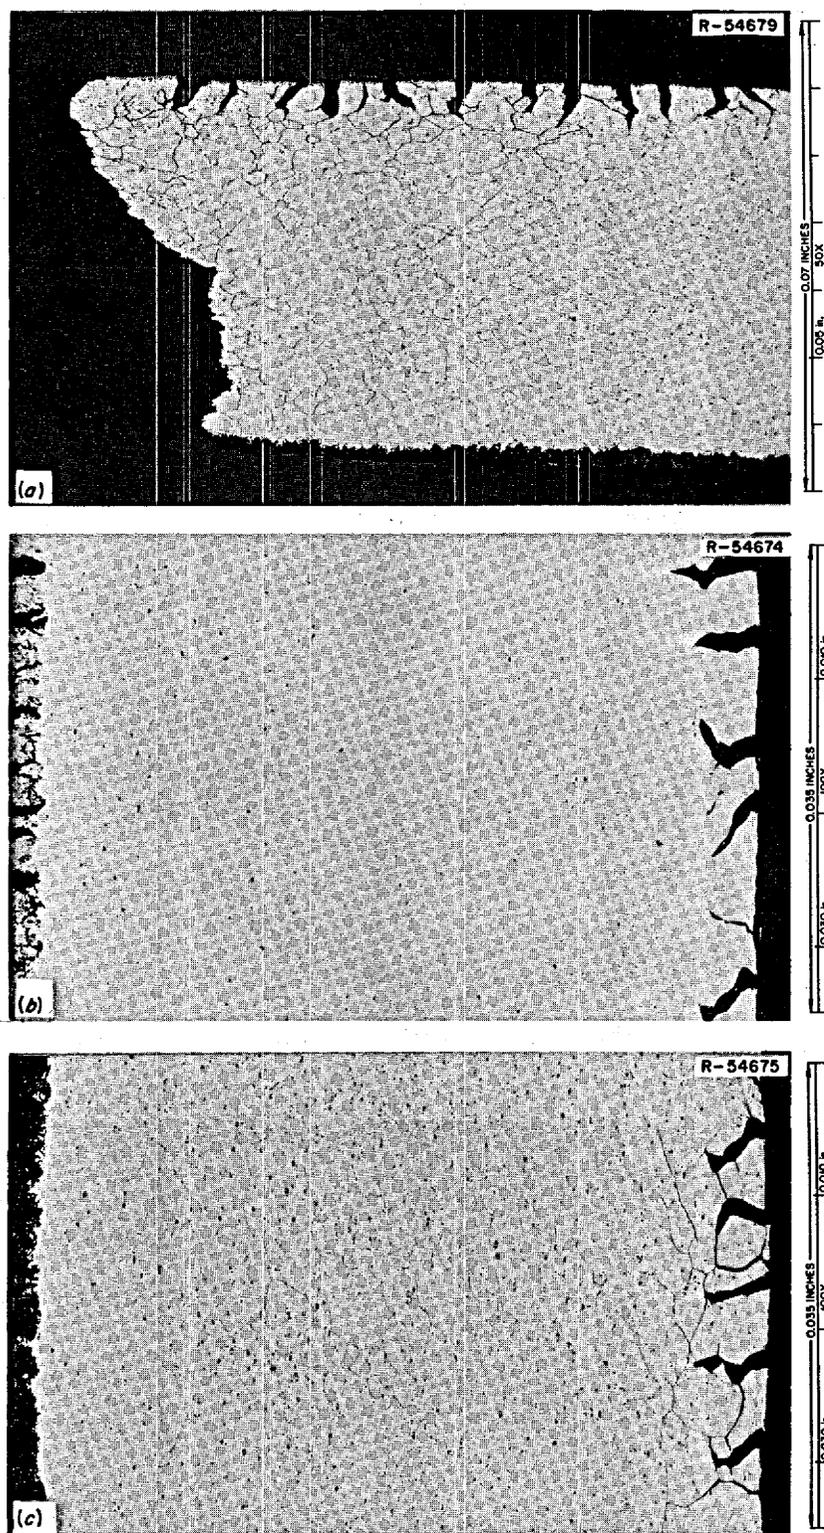
Several of the specimens that had been strained were examined metallographically to determine the extent of cracking during straining. Photomicrographs of the control rod thimble, which was exposed to flowing salt, are shown in Fig. 20. The inside surface was oxidized, and the oxide cracked as the specimen was strained. The oxide should be brittle, but it is important that these cracks did not penetrate the metal.

Fig. 20. INOR-8 control rod thimble specimen exposed to flowing salt and tested at 25°C. (a) Fracture – dark edge is oxide on inner surface of tube; cracks formed on outer surface; etched. (b) Cracks in outer surface of tubing as polished. (c) Cracks in outer surface of tubing; etched. Etchant: aqua regia. Reduced 30.5%.

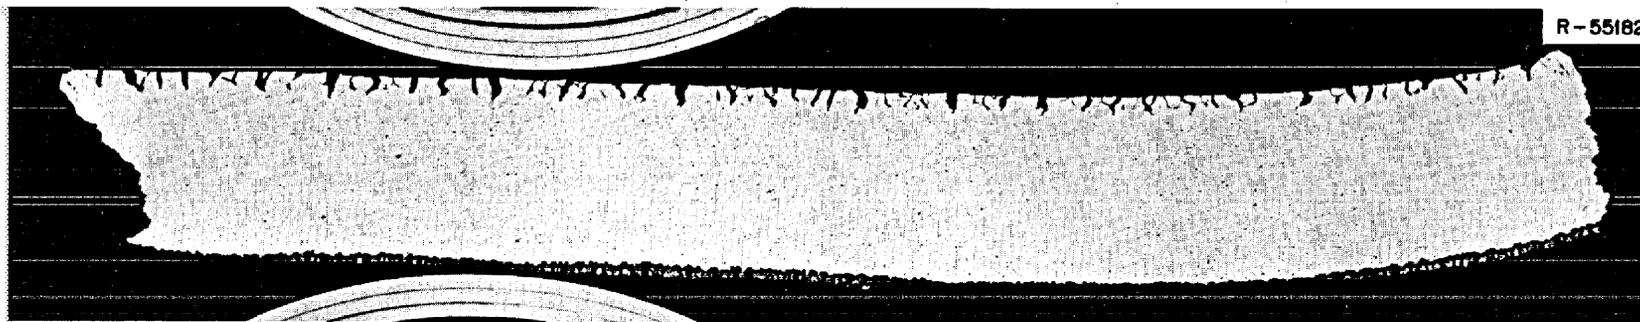
**Fig. 21. Deformed section of INOR-8 control rod thimble. Fracture is on the left. The upper surface was in contact with flowing salt; the lower surface was exposed to the cell environment of  $N_2$  plus 2 to 5%  $O_2$ . The sample is about 0.06 in. thick.**

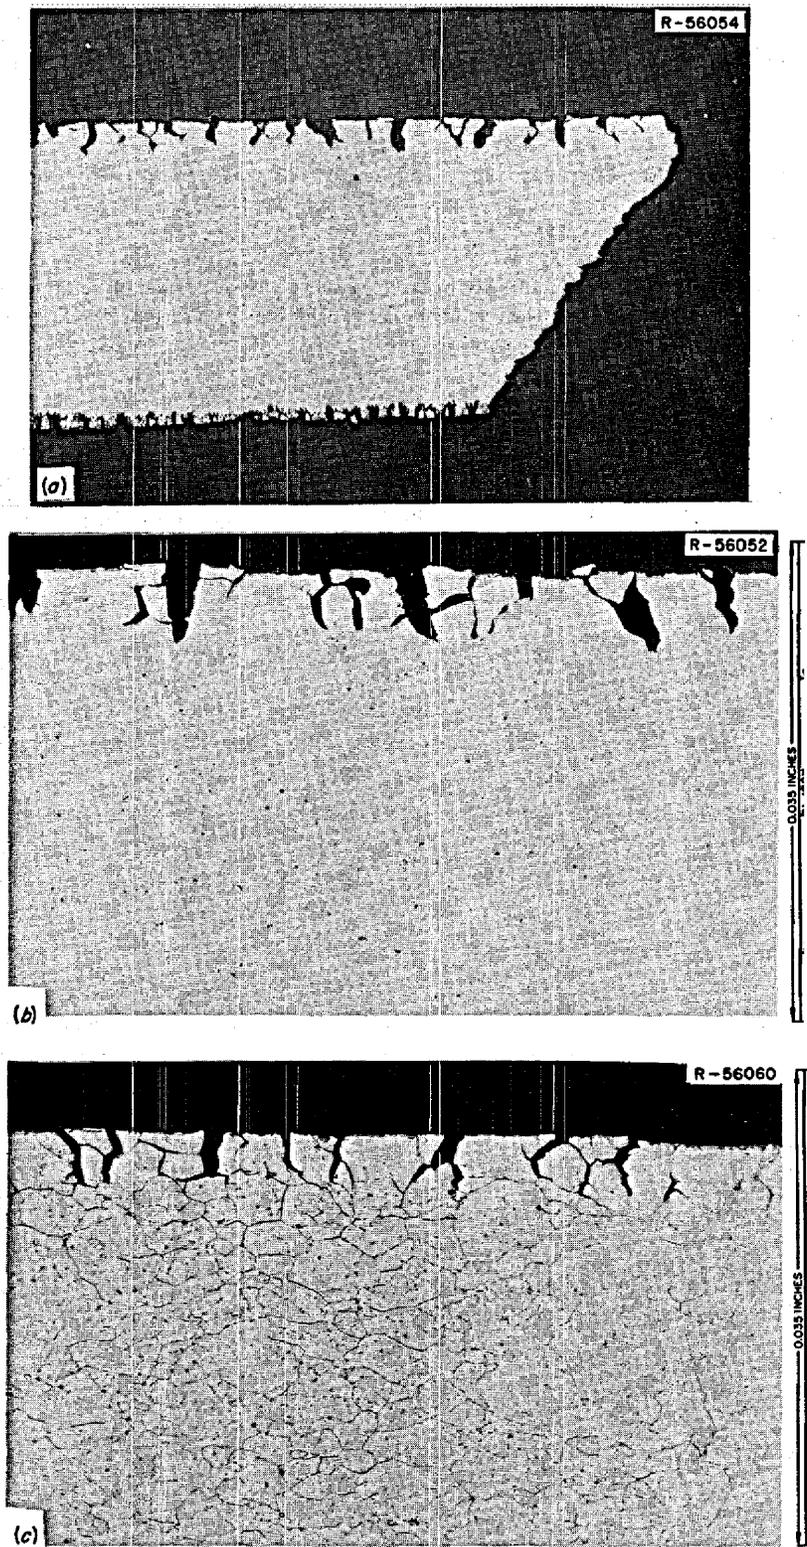
Fig. 22. INOR-8 control rod thimble exposed to fuel salt under a spacer sleeve and tested at 25°C. (a) As-polished view of fracture, 40X. (b) As-polished view of cracks. (c) Etched view of cracks. Etchant: aqua regia. Reduced 30.5%.

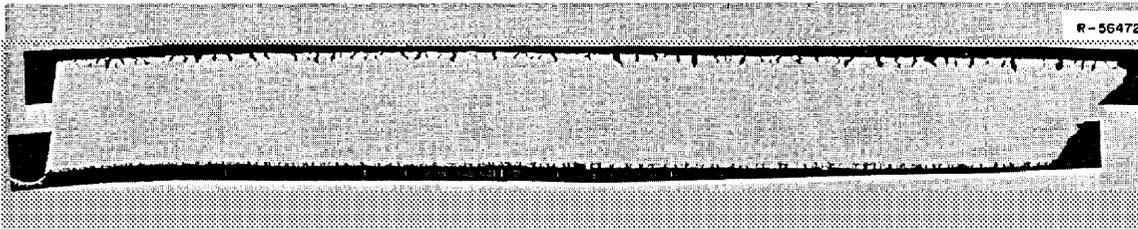
Fig. 23. Composite photograph showing density of cracking along edge of portion of deformed INOR-8 control rod thimble. 9.5X. The sample is 0.58 in. long. The fracture is on the right, the upper surface was exposed to fuel salt, and the lower surface was exposed to the cell environment of  $N_2$  plus 2 to 5%  $O_2$ .

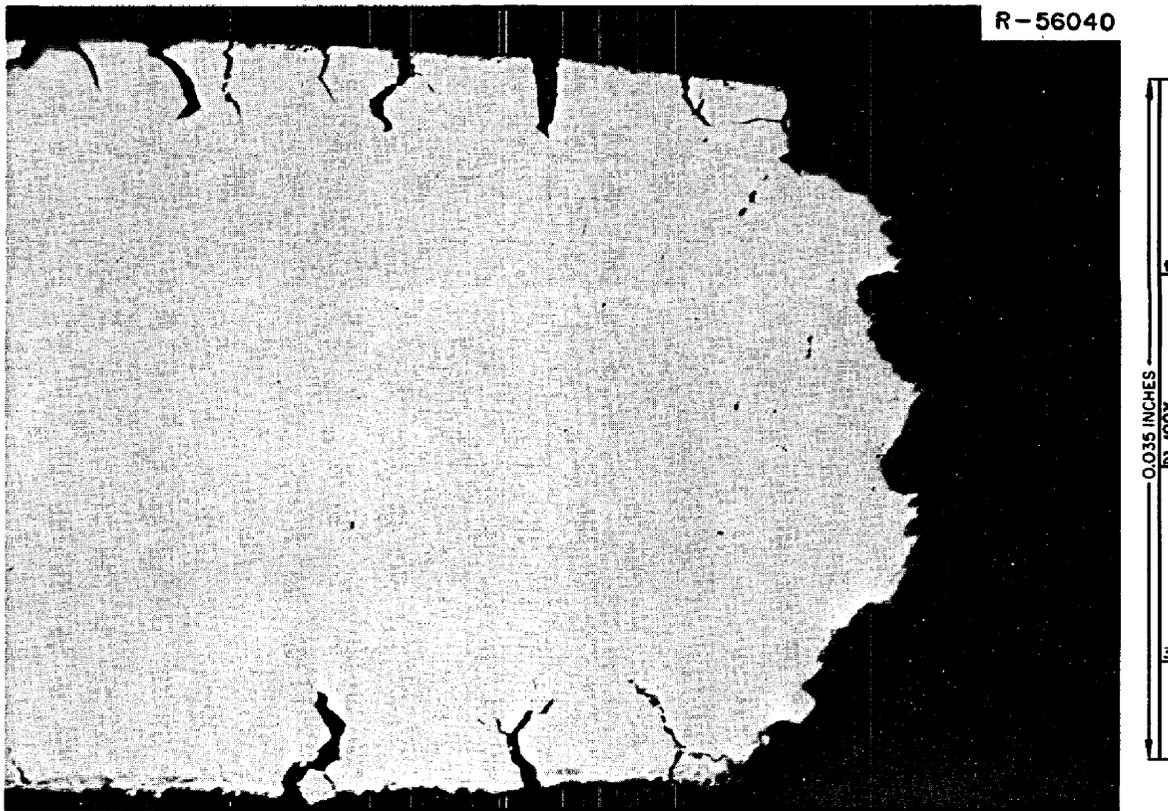
Fig. 24. Section of INOR-8 spacer sleeve tested at  $25^\circ C$ ; as polished. The upper surface was exposed to almost static fuel salt, and the lower surface was exposed to rapidly flowing fuel salt.

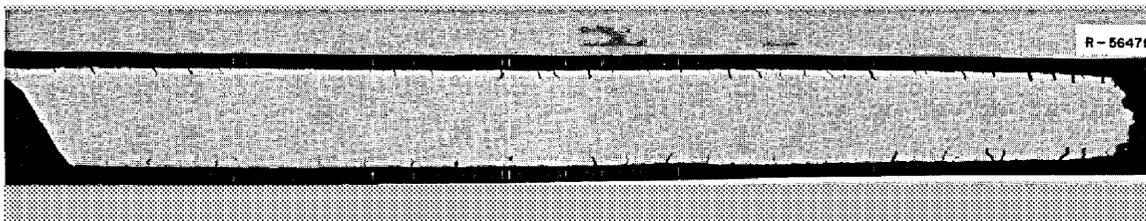
Fig. 25. Composite photograph comparing density of cracking on sides of INOR-8 spacer sleeve exposed to almost static salt (top) and to flowing salt (bottom). 11X. The sample is 0.52 in. long. Reduced 43%.

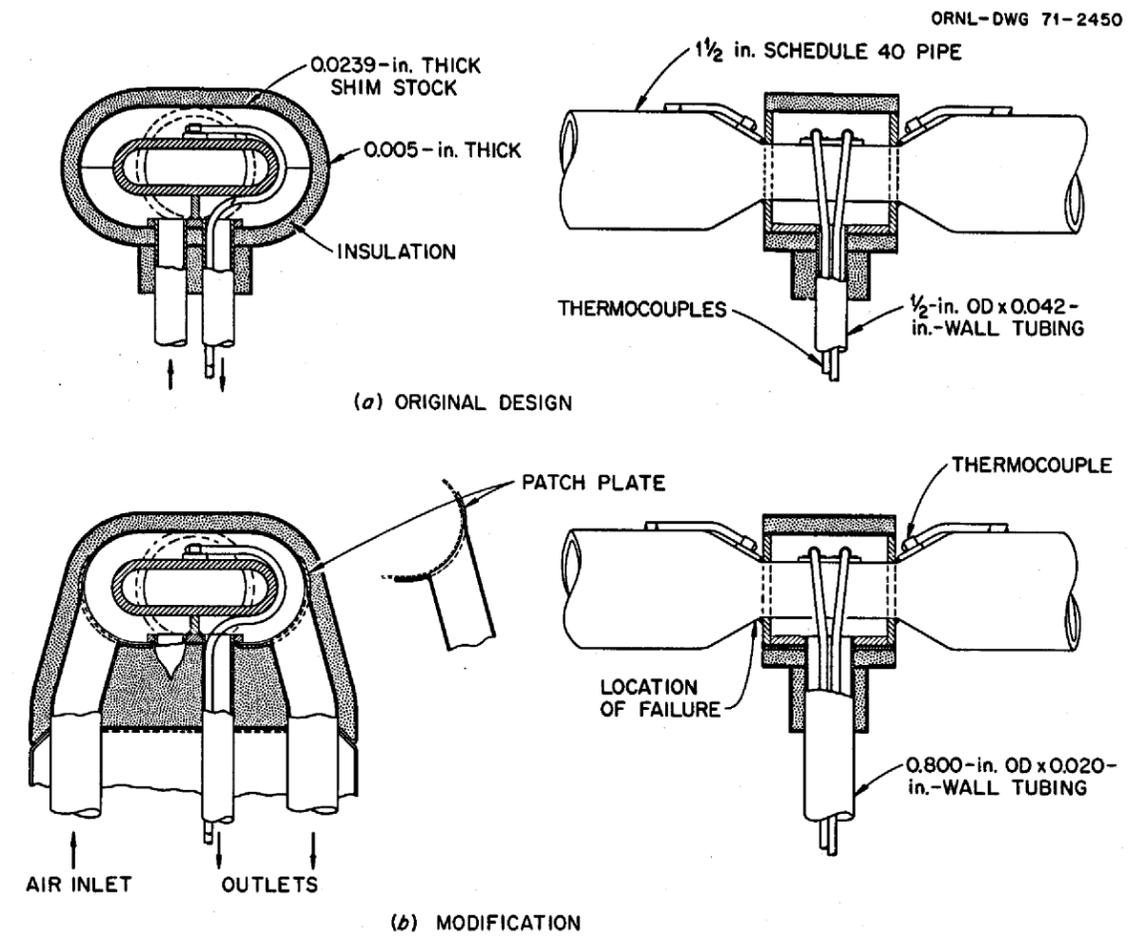
Fig. 28. Diagram showing possible cause of freeze-valve failure after modification.

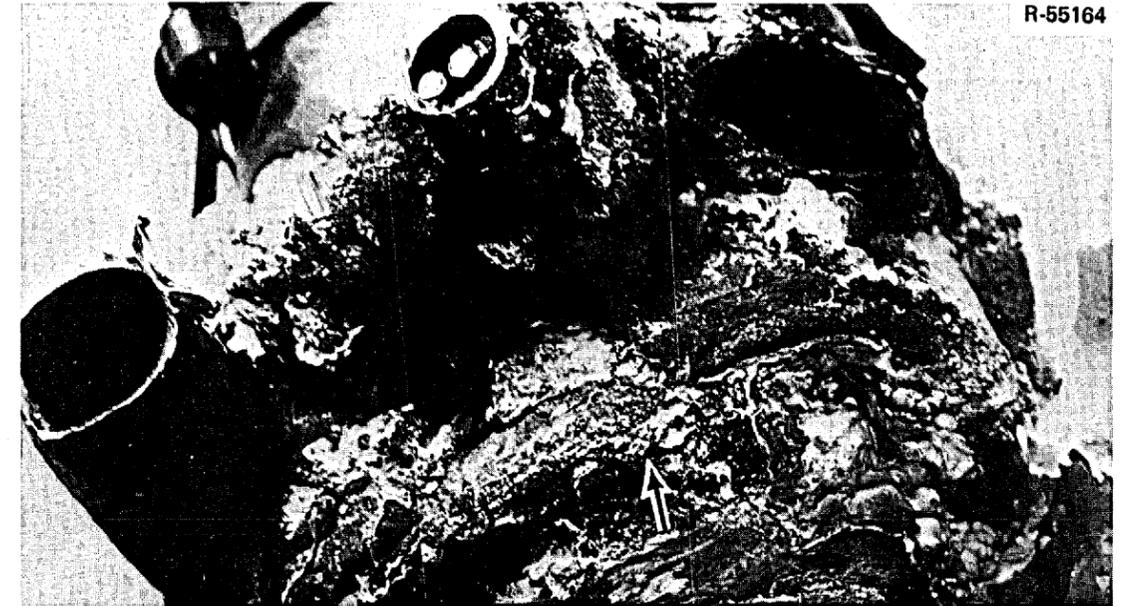
Fig. 31. Closeup of the bottom of freeze valve 105 showing INOR-8 gas inlet and outlet line of type 304 stainless steel that was corroded completely. The crusty substance is the salt. Note that there is no salt in the air annulus.

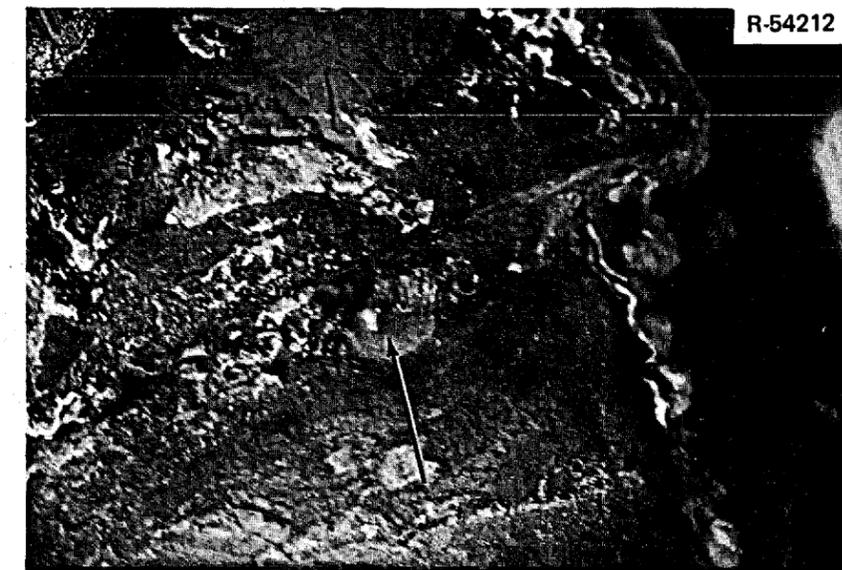
Fig. 32. Weld at one end of cooling shroud. The crack begins at the round salt stain and proceeds for about 1 in. along the pipe. The arrow points to the salt stain with the crack at  $90^\circ$  to the arrow.

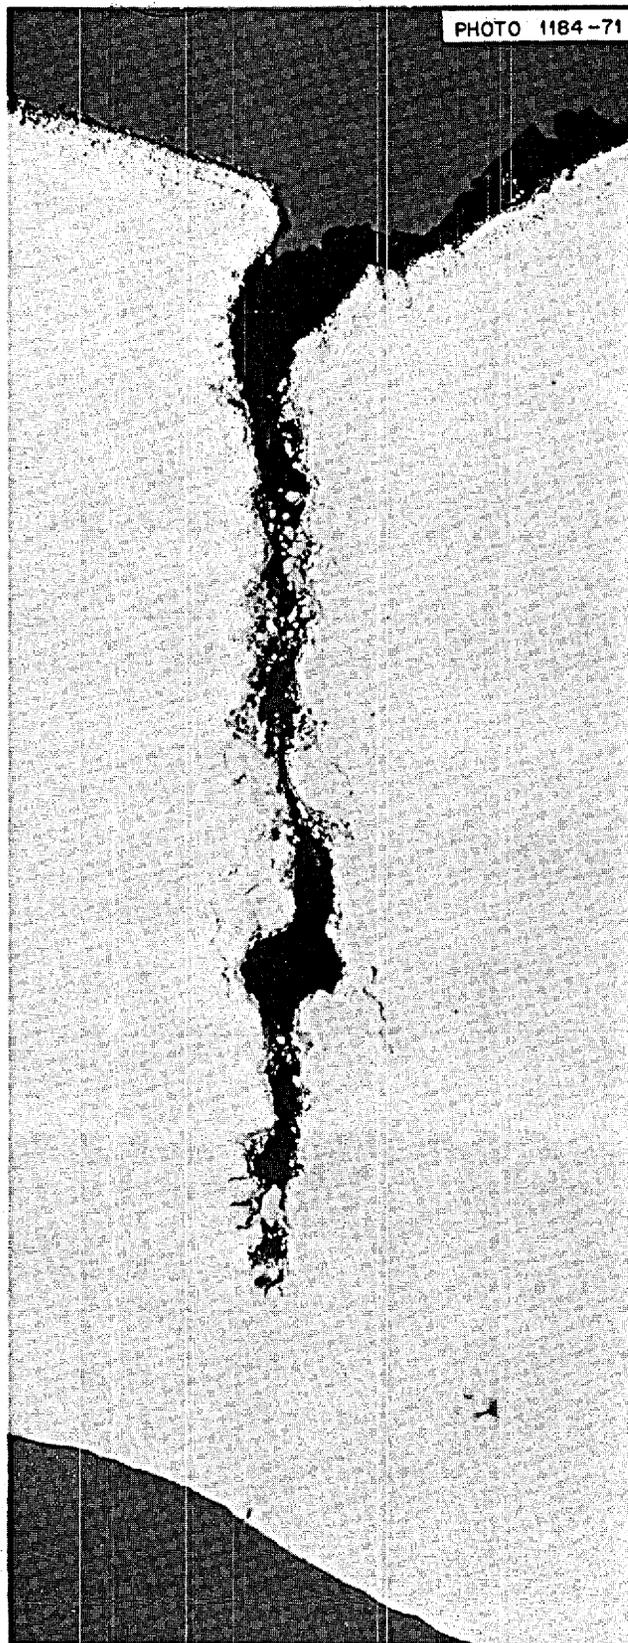
Fig. 33. INOR-8 tube wall of freeze valve 105 where the failure occurred. As polished, 50X. Bottom surface was exposed to fuel salt and the upper surface to air, with some salt after the leak occurred. Reduced 15%.

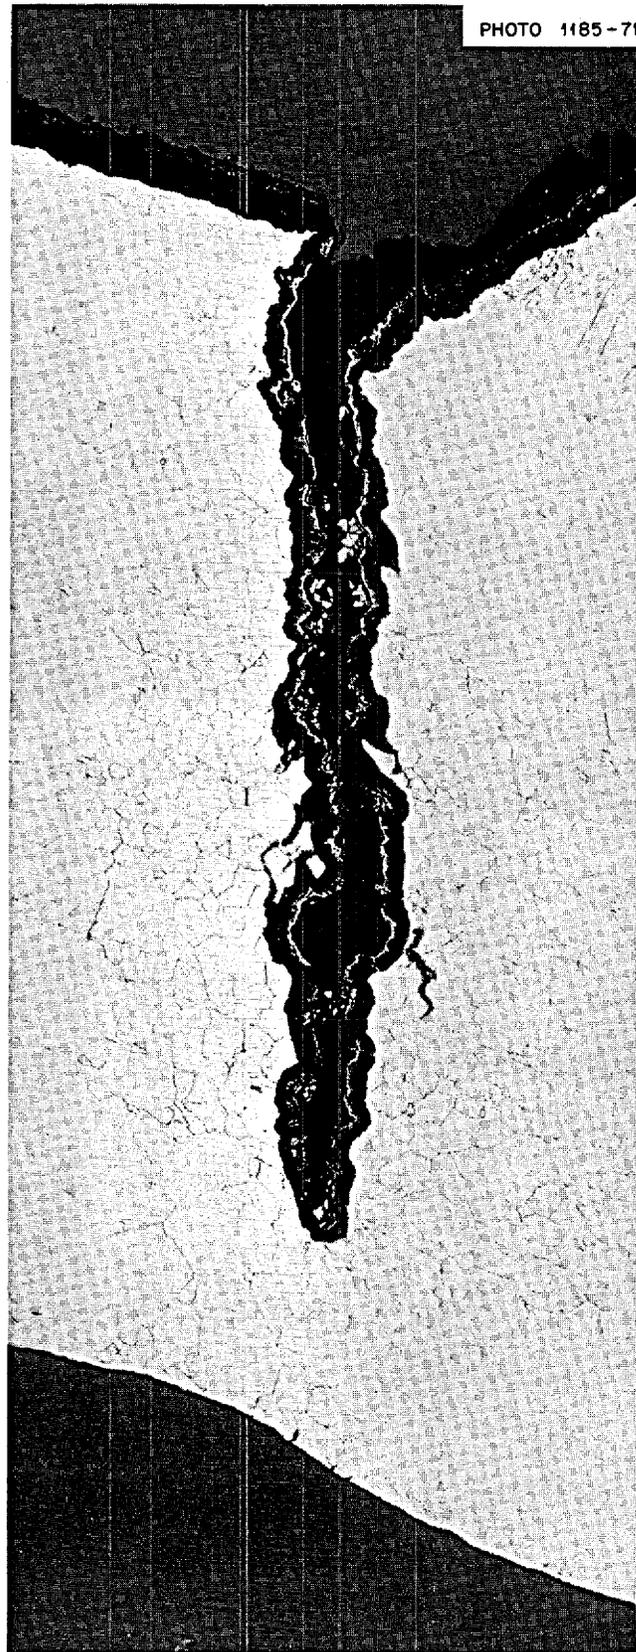
Fig. 34. INOR-8 tube wall of freeze valve 105 where the failure occurred. The weld supports the end of the cooling shroud; the failure occurred outside the cooling shroud. Etchant: aqua regia. 50X. Reduced 15%.

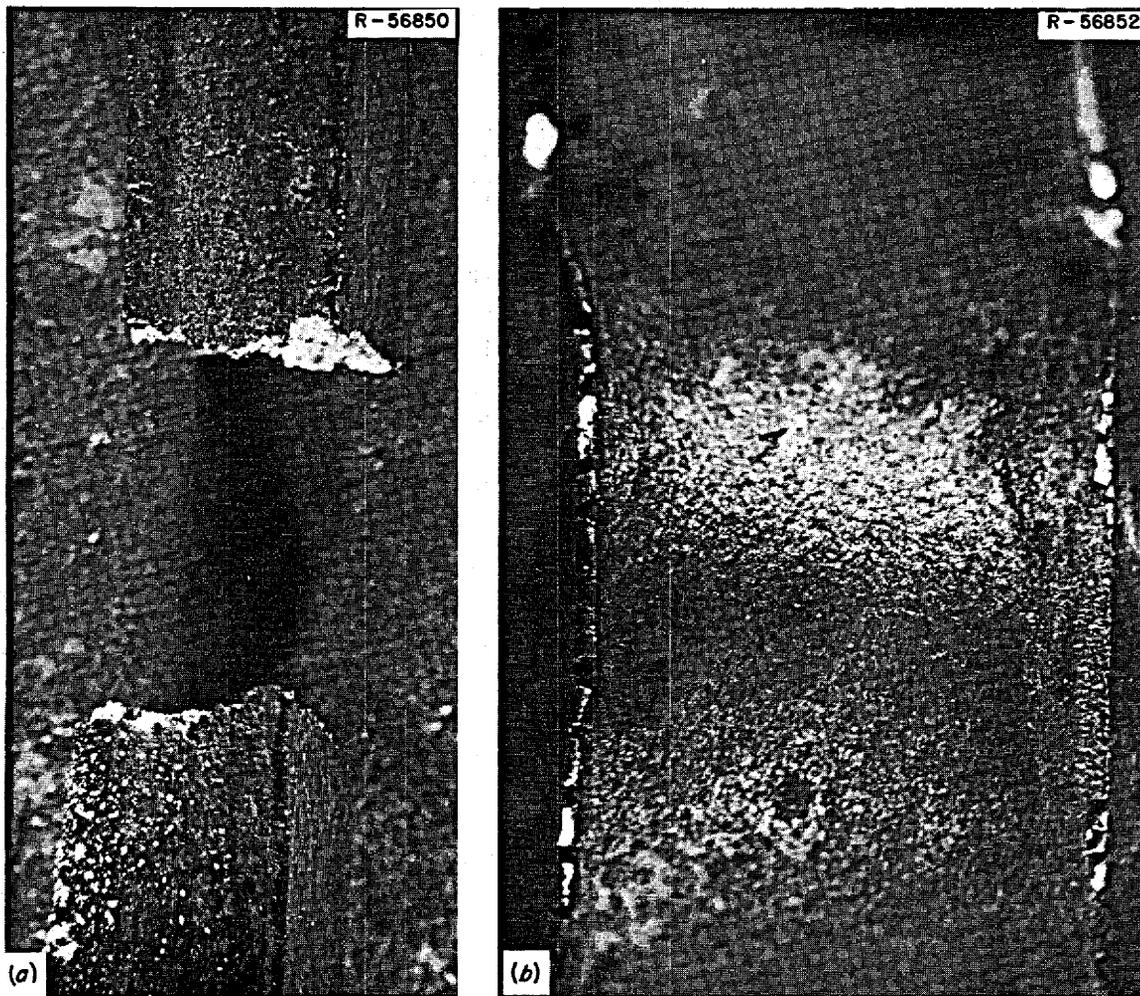
Fig. 35. INOR-8 surfaces exposed to salt in freeze valve 105 after deformation at 25°C. (a) Fracture of ring specimen pulled in tension. Note surface cracks near fracture. 4X. (b) Surface of bend specimen. Note some cracks on surface and edge cracks. 7X. Reduced 18.5%.

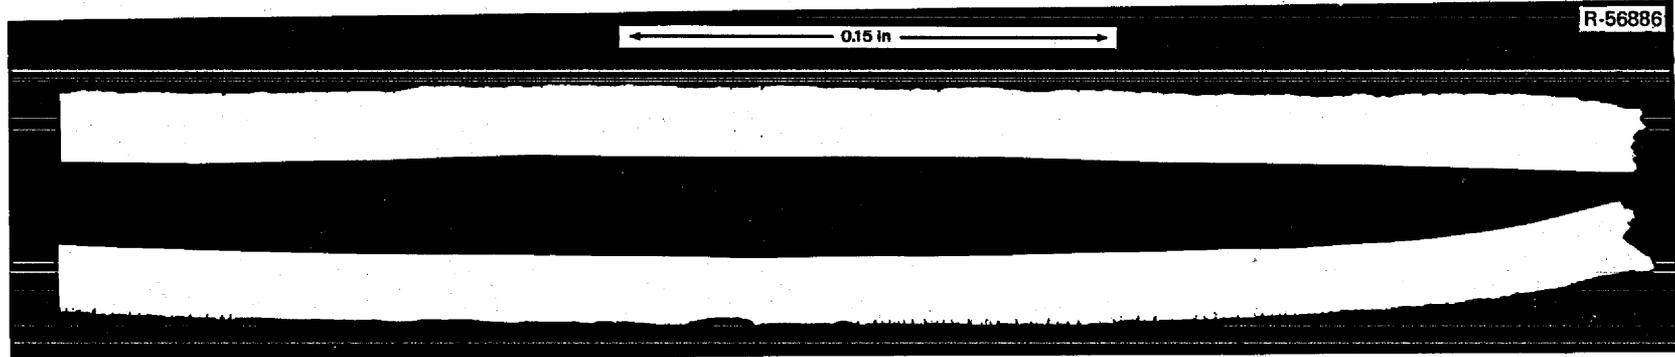
Fig. 36. Composite of photomicrographs of INOR-8 ring from freeze valve 105 that was pulled in tension. Upper surface was exposed to salt and the lower surface to the cell environment of  $N_2$  plus 2 to 5%  $O_2$ . Top portion is the tension side, and the lower part is the compression side.
