ORNL-TM-4174

# POSTIRRADIATION EXAMINATION OF MATERIALS FROM THE MSRE

**POSTIRRADIATION EXAMINATION OF MATERIALS FROM THE MSRE**

**DECEMBER 1972**

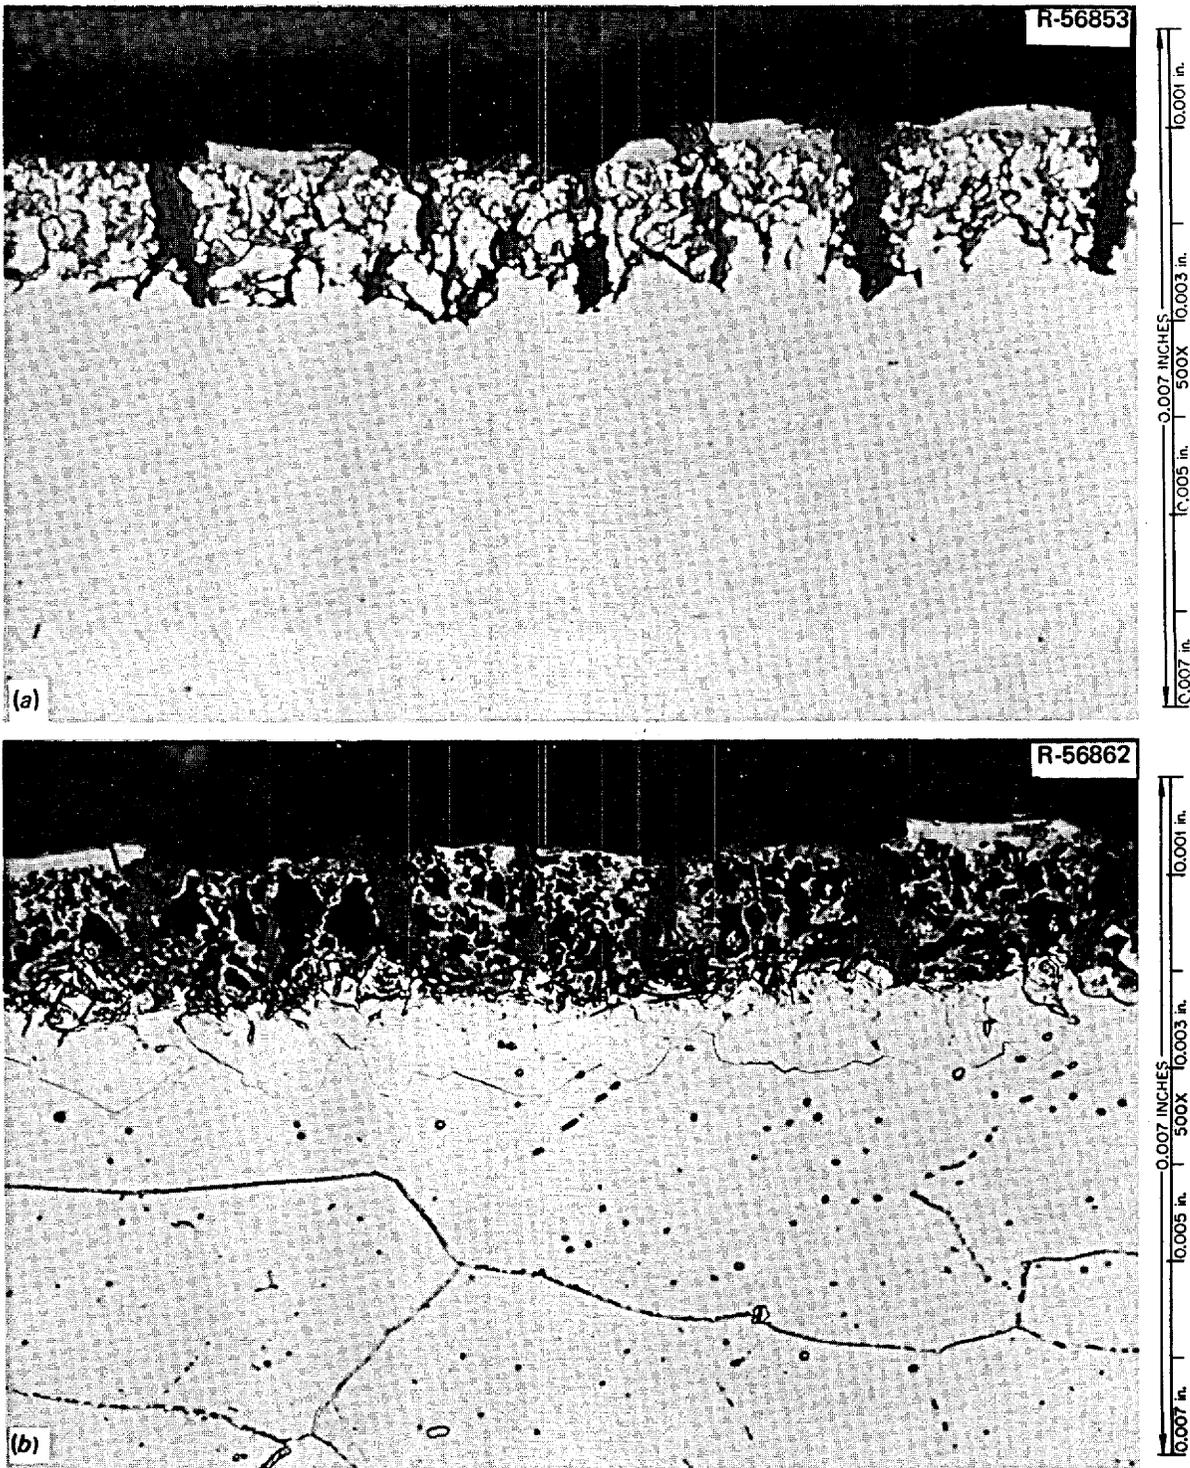
Fig. 37. INOR-8 tensile sample of freeze valve 105 showing the oxide that formed on the outside of the pipe. The cracks penetrated only the depth of the oxide. (a) As polished; (b) etched with lactic acid, HNO<sub>3</sub>, HCl.

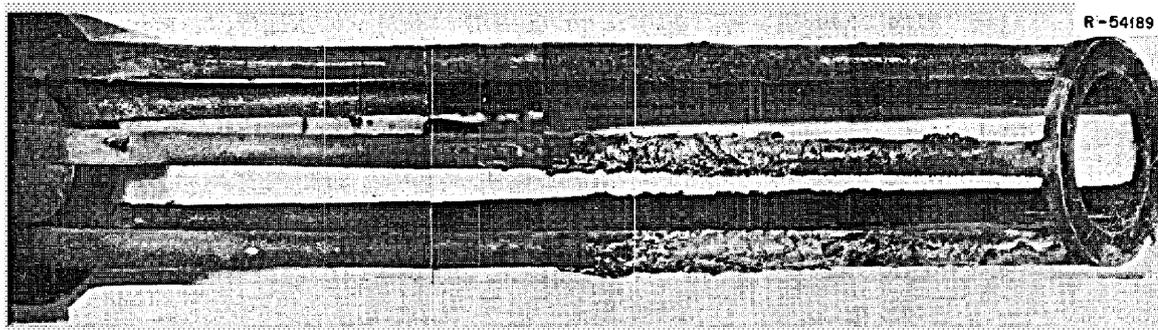
Fig. 42. Sampler cage. The assembly is 8.5 in. high. The salt-vapor interface corresponds with the region of highest material deposition.

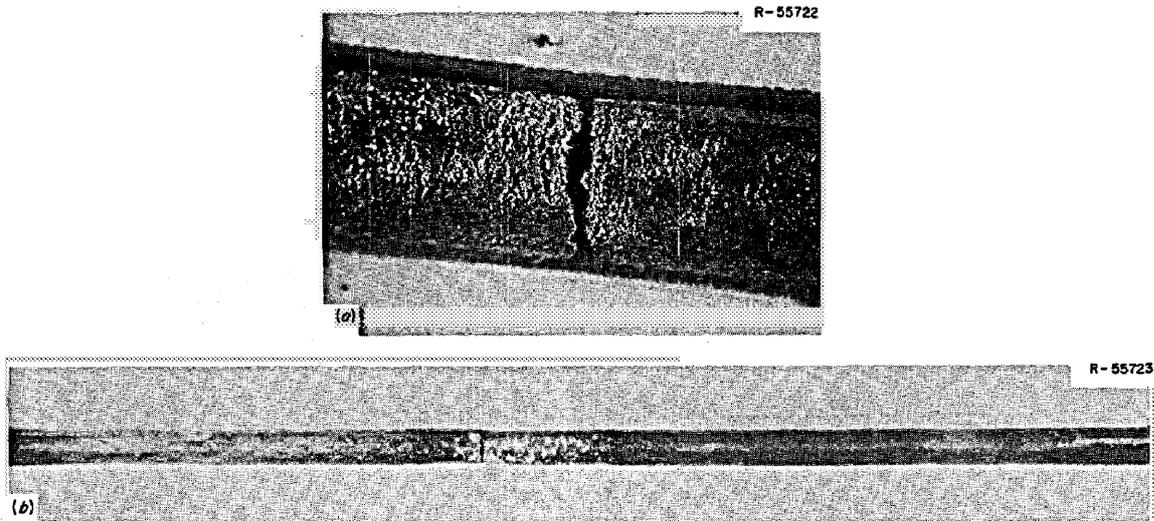
Fig. 47. Tensile-tested INOR-8 sampler cage rod from pump bowl. Rupture occurred near the average liquid-vapor interface. (a) Rupture area showing extensive surface cracking. (b) Composite of entire rod, with top at right. Rod diameter is  $\frac{1}{4}$  in.

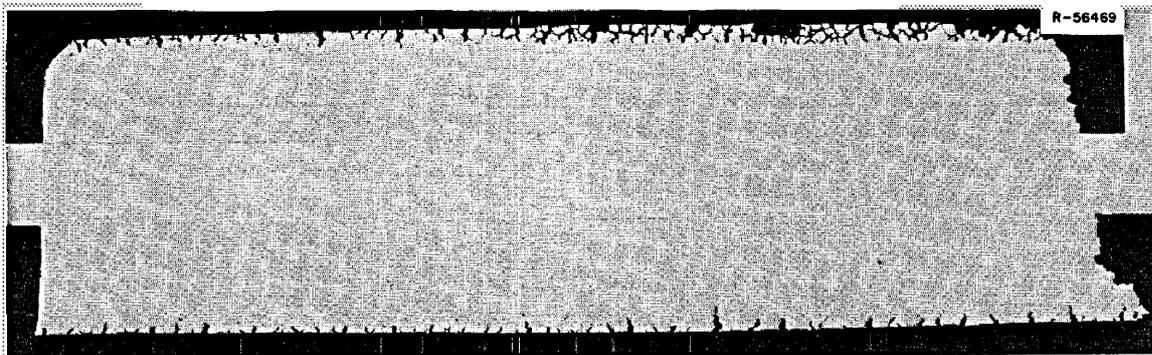
Fig. 48. Section of INOR-8 sample cage rod that was deformed at  $25^{\circ}\text{C}$ .  $9.2\times$ . The fracture (right) occurred at the salt-vapor interface. The rod is immersed further in the liquid from right to left. The length of the sample is 0.63 in.

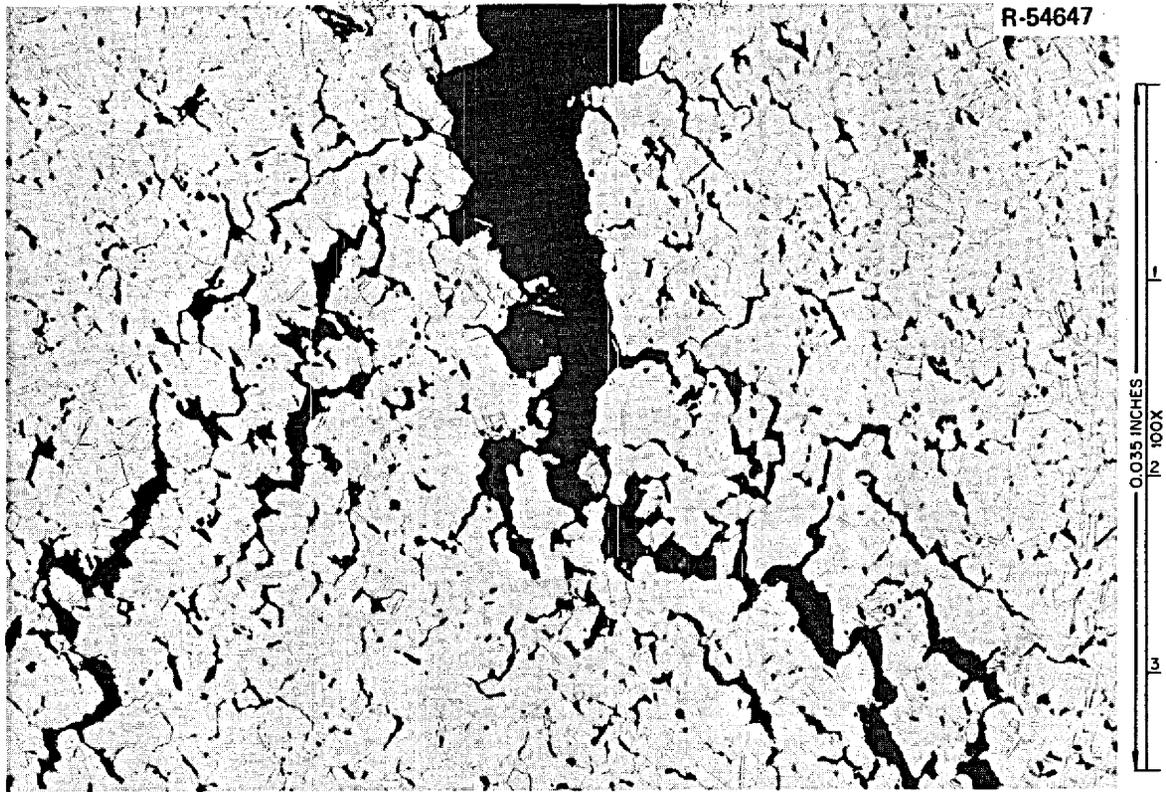
Fig. 64. Section of copper capsule showing extensive intergranular cracking.

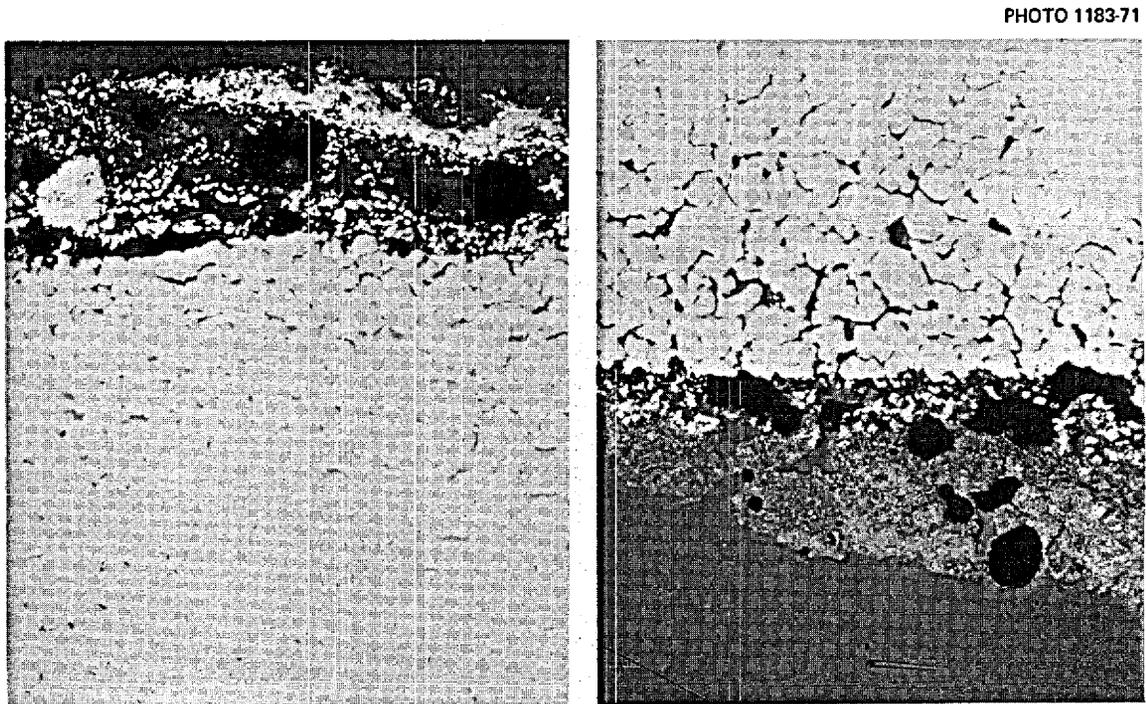
Fig. 65. Photomicrographs of copper MSRE fuel sampler showing layers on outside surface (left) and inner surface (right).

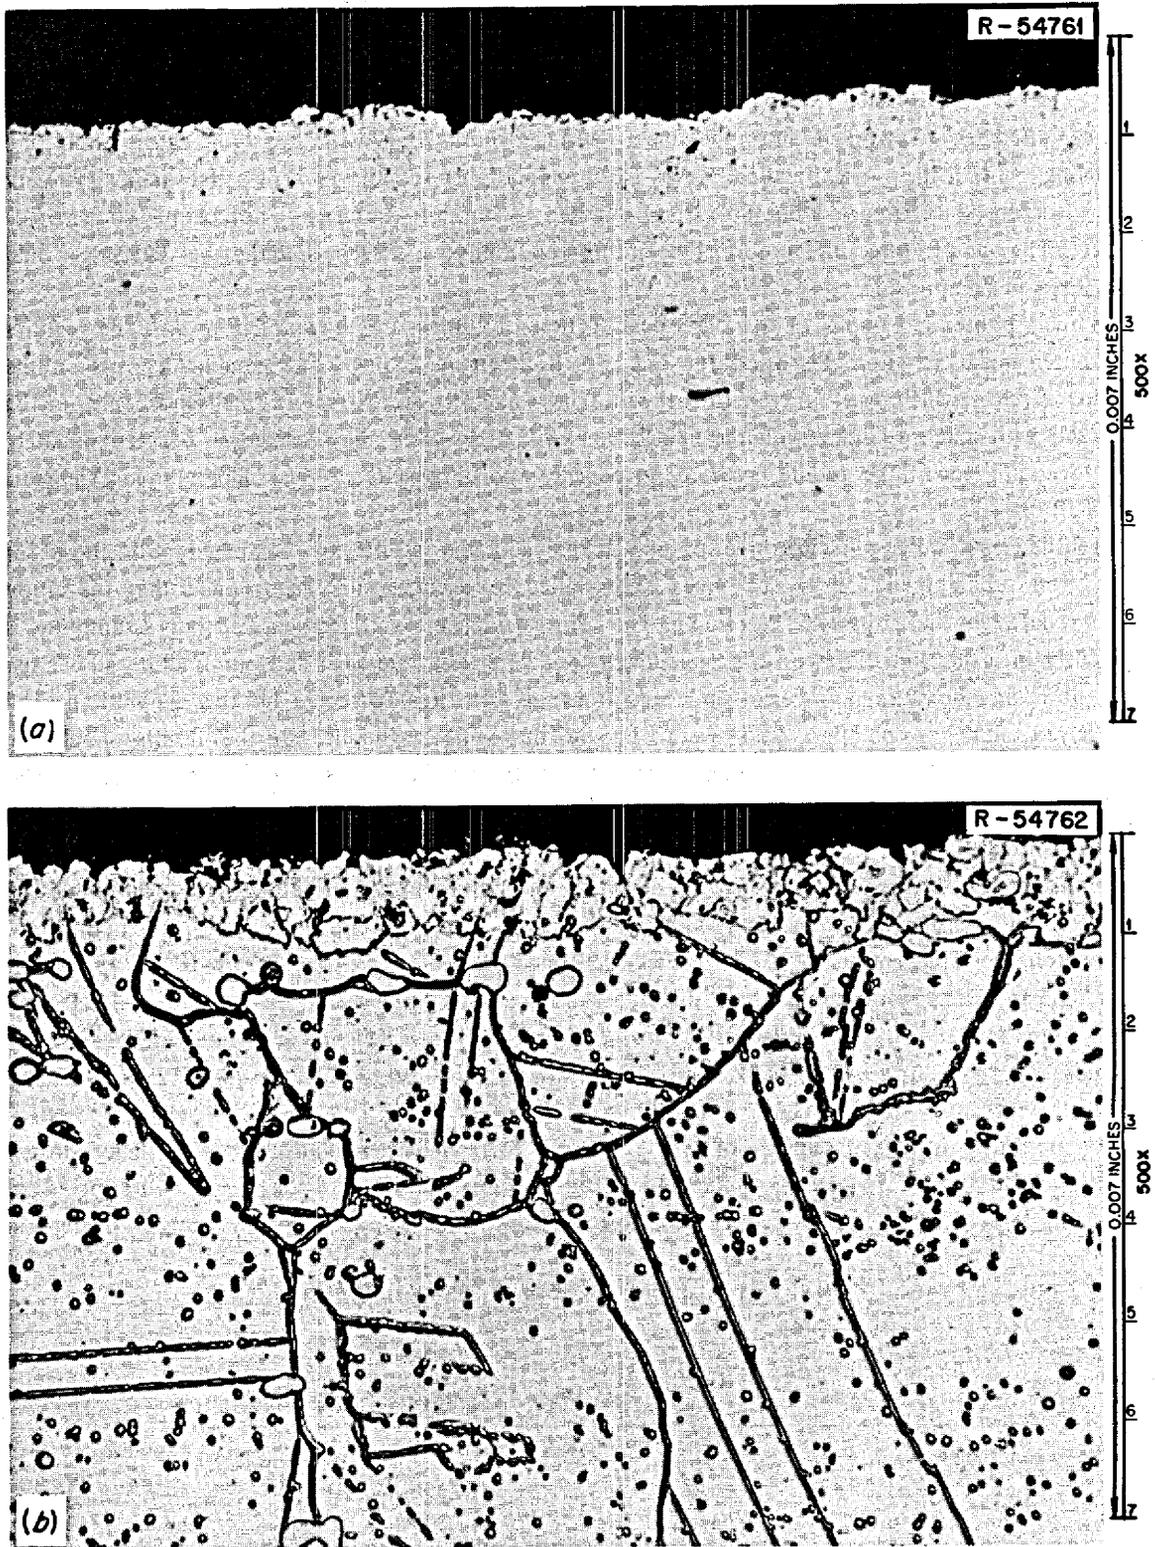
Fig. 71. Inside surface of INOR-8 primary heat exchanger shell. The surface was exposed to fuel salt, and the modified structure to a depth of about 1 mil is apparent. (a) As polished; (b) etched with aqua regia.

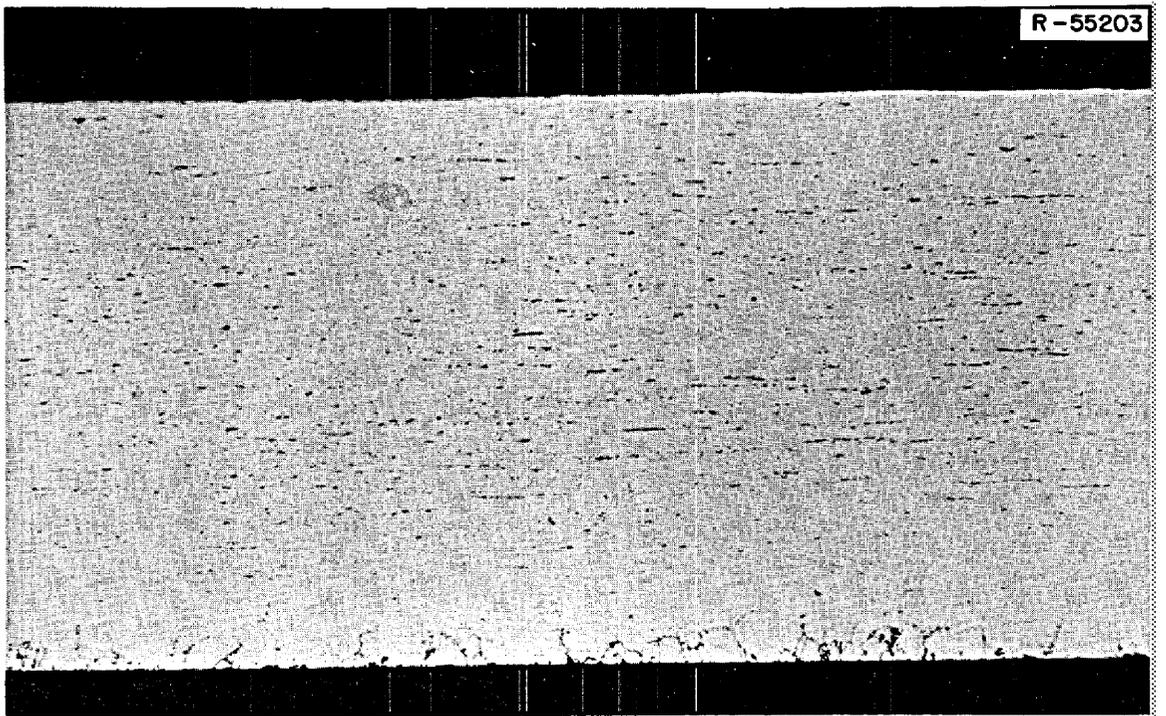
Fig. 76. INOR-8 heat exchanger tubing in the unstressed condition. The side with the small cracks was exposed to fuel salt, and the other was exposed to coolant salt.

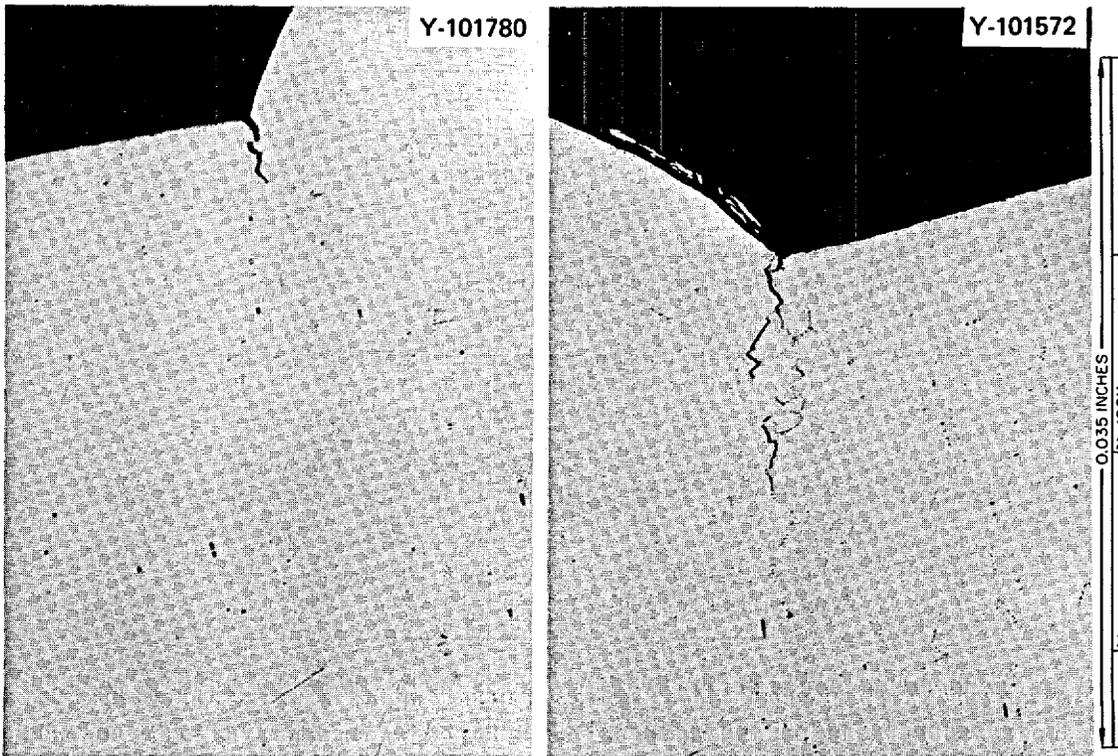
Fig. 86. Cracks in the root pass of the inlet weld. The cracks occurred at the fusion line and likely resulted from the poor fit-up of the parts. As polished.

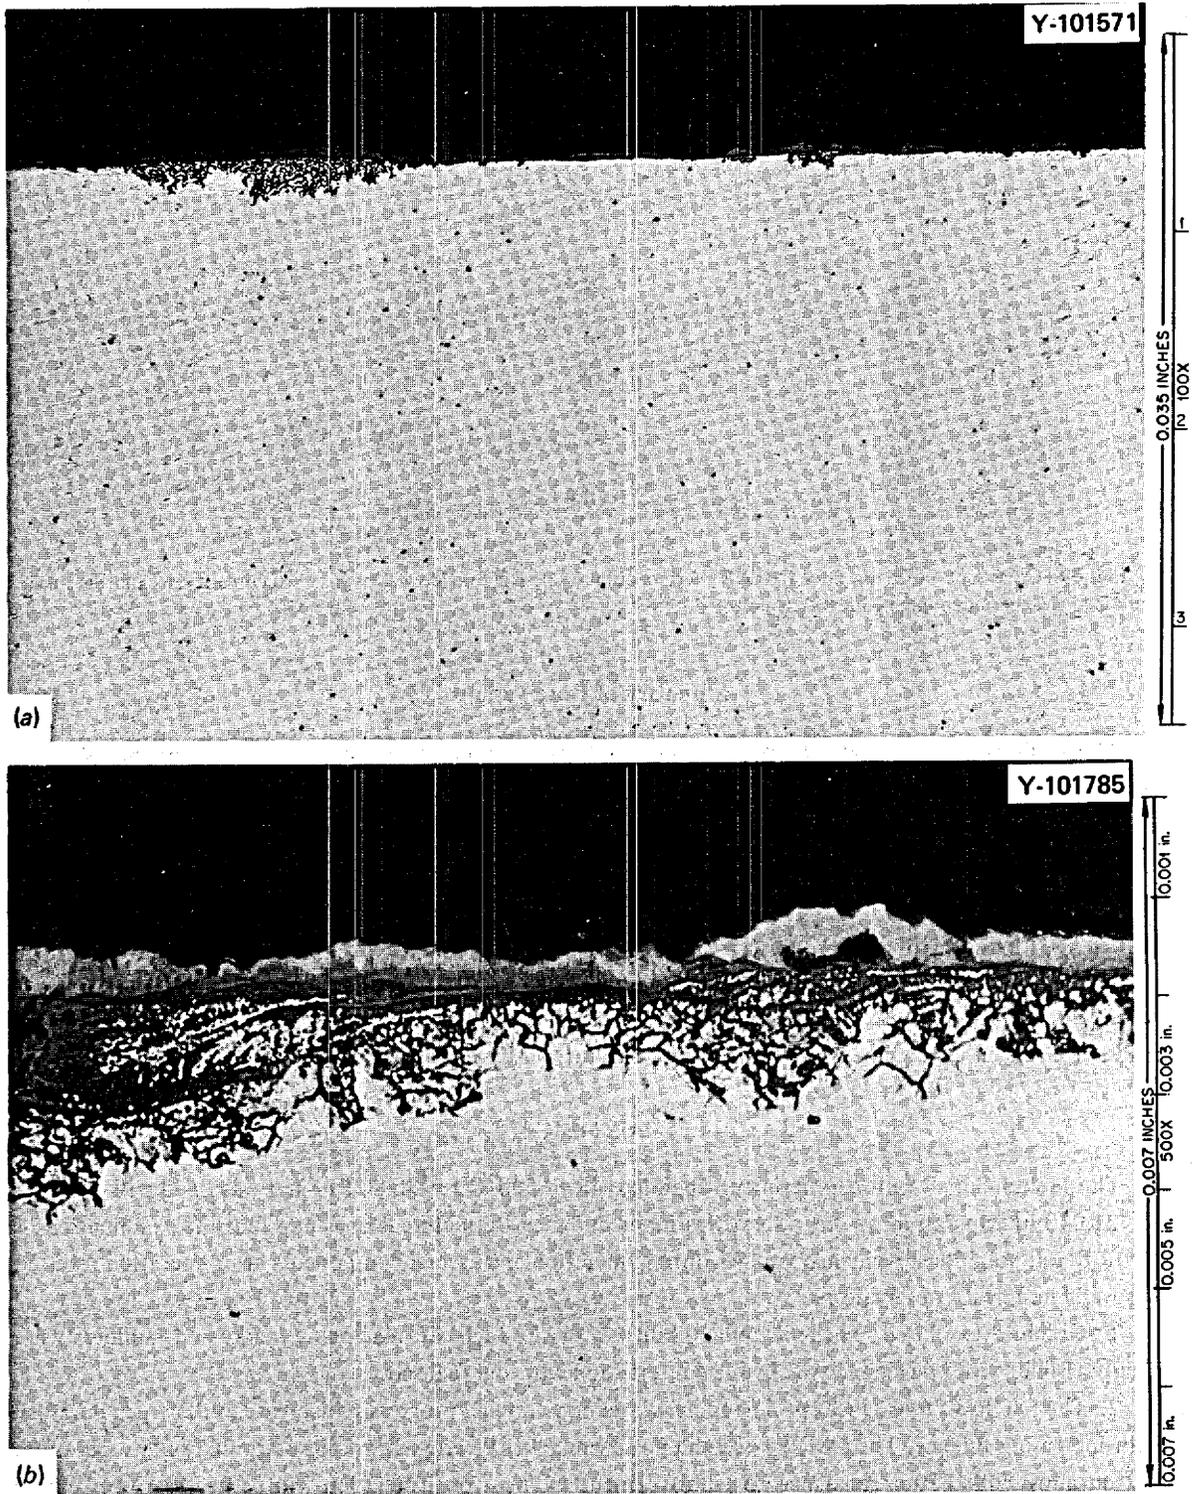
Fig. 88. Oxide formed on the outside of the 5-in. INOR-8 coolant line. As polished. (a) 100X; (b) 500X.
