# Applying Crowbar Voltage Glitches to nRF52 and CC253x/4x Microcontrollers

Jonathan Rudman

University of Birmingham

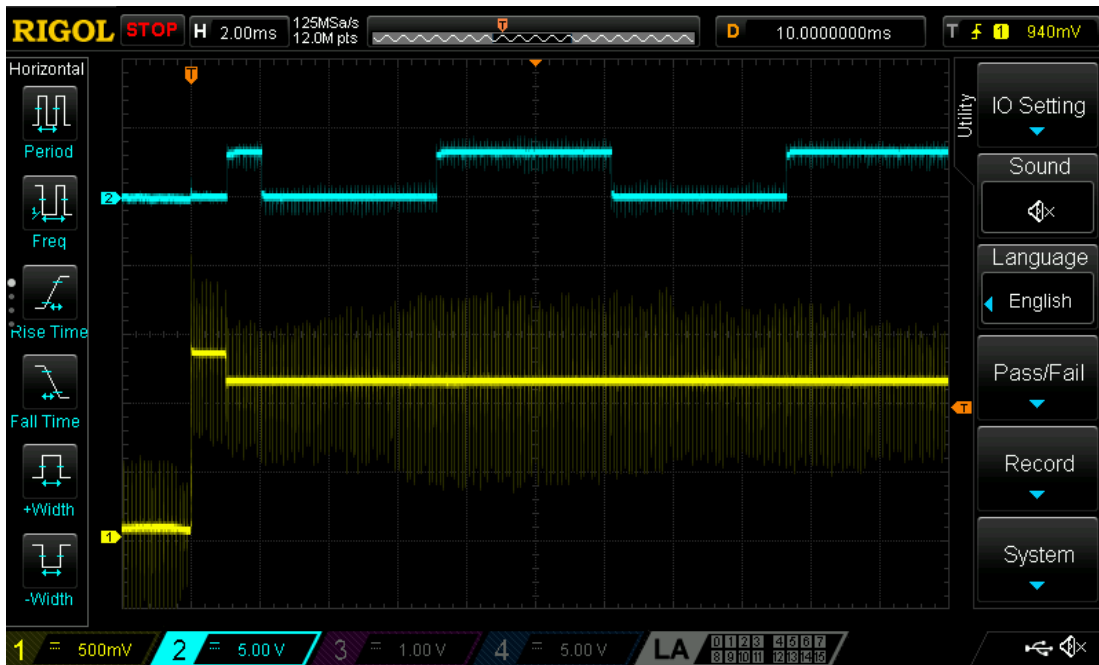
Figure 1: The pin toggling application functioning normally, with no glitch. Trace 1 (yellow) is the CPU core voltage and trace 2 (blue) is the pin being toggled by the application. Trigger  $T$  points to the moment the nRF52832 becomes powered.

The process of finding a suitable glitch width can also be used to diagnose any problems with the glitching setup because in most cases where the CPU voltage is glitched, a fault should occur in the execution of the running application. O’Flynn uses a `for` loop containing a counter incrementation, nested in another `for` loop, to show how the counter incrementation is skipped when both loops are complete (or when the jump to the start of the loop is skipped) and the counter is printed [1]. Due to the added complexity of relying on printing to a buffer—requiring the use of another serial connection in this case—a simple GPIO pin toggling application was created, flashed and an oscilloscope was connected to that pin to observe the effect of a glitch [13]. Normal operation of this application is shown in figure 1.

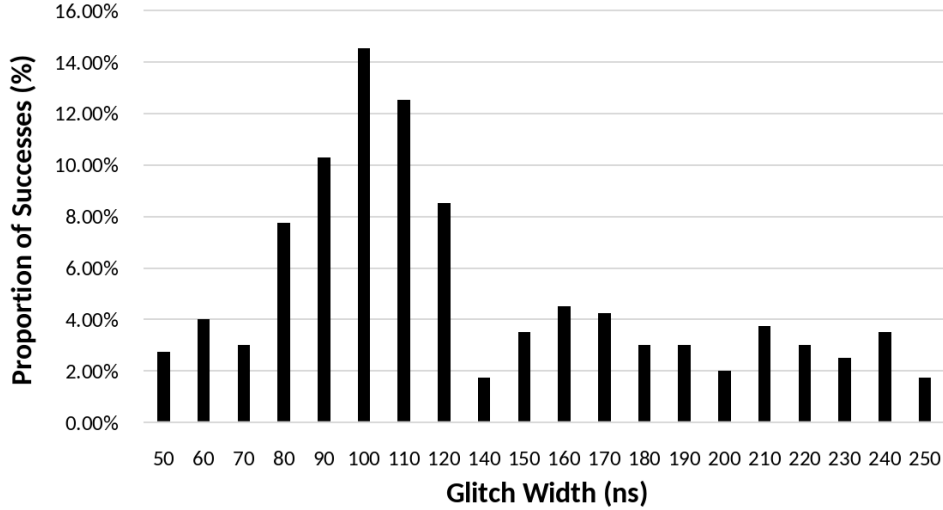
Figure 4: Glitch width vs. proportion of successes (out of 399 successes) for the nRF52832.

After applying a successful glitch (see section 2.4), widths for 399 successful glitches were recorded and the proportion of glitch successes for each glitch width is shown in figure 8. A successful glitch is a glitch on the NVMC activity outlined in section 2.3.2 which bypasses CRP and allows the firmware to be dumped. Figure 4 shows that the optimal glitch width is between 80ns and 120ns. It’s important, for future crowbar glitch campaigns on the nRF52832 CPU core, that the glitch width range is reduced to this identified range, if the intent is to speed up causing a CRP bypass. Although there have been successes outside of the 80 – 120ns range, successful glitches can be made even more likely in the 80 – 120ns range by repeating with the same parameters, as this counteracts jitter (the critical section occurring earlier or later in the next power cycle).

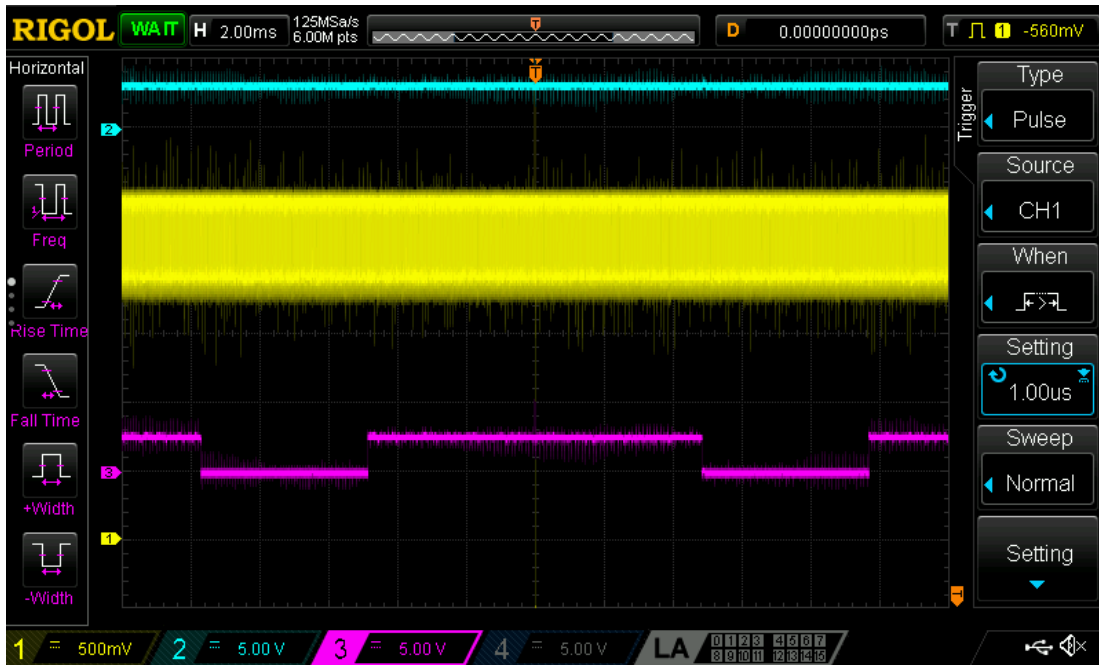
Figure 12: The CC2541 pin toggling application with a 50ns crowbar glitch at trigger  $T$ , causing the pin toggle instruction to be skipped and the STATE pin remains high for another 5ms. Trace 1 (yellow): DCOUPL, trace 2 (light blue): RESET\_N, trace 3 (purple): STATE on the development board (the pin being toggled).

successful glitch in the application, seen in figure 12. The smallest glitch width for a successful glitch to the pin toggling application was 50ns. 80ns is the maximum glitch width before the microcontroller resets, as seen in figure 13, where a 90ns width was used. The initialisation pattern is visible in trace 1 (DCOUP\_L) in figure 13 and figure 11, which shows the same pattern when powered on.

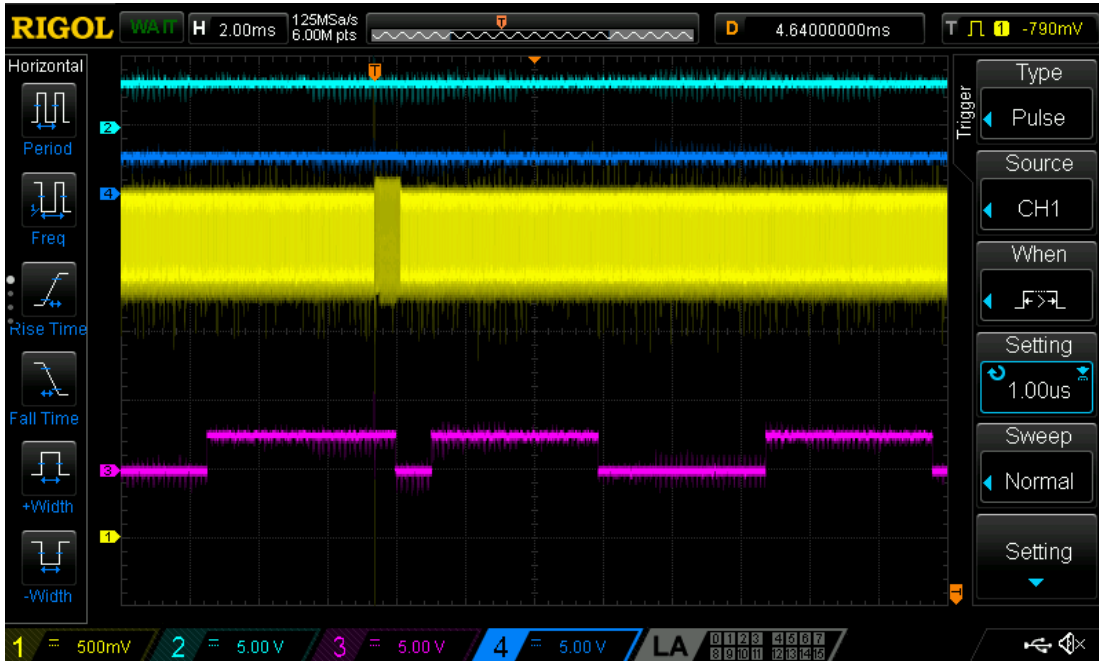
Figure 13: The CC2541 pin toggling application with a 90ns crowbar glitch at trigger  $T$ , causing a reset, visible in the pattern in trace 1 and the initial 1ms pin toggle in trace 3, at the start of the application. Trace 1 (yellow): DCOUPL, trace 2 (light blue): RESET\_N, trace 3 (purple): STATE on the development board (the pin being toggled), trace 4 (dark blue): Debug Data.

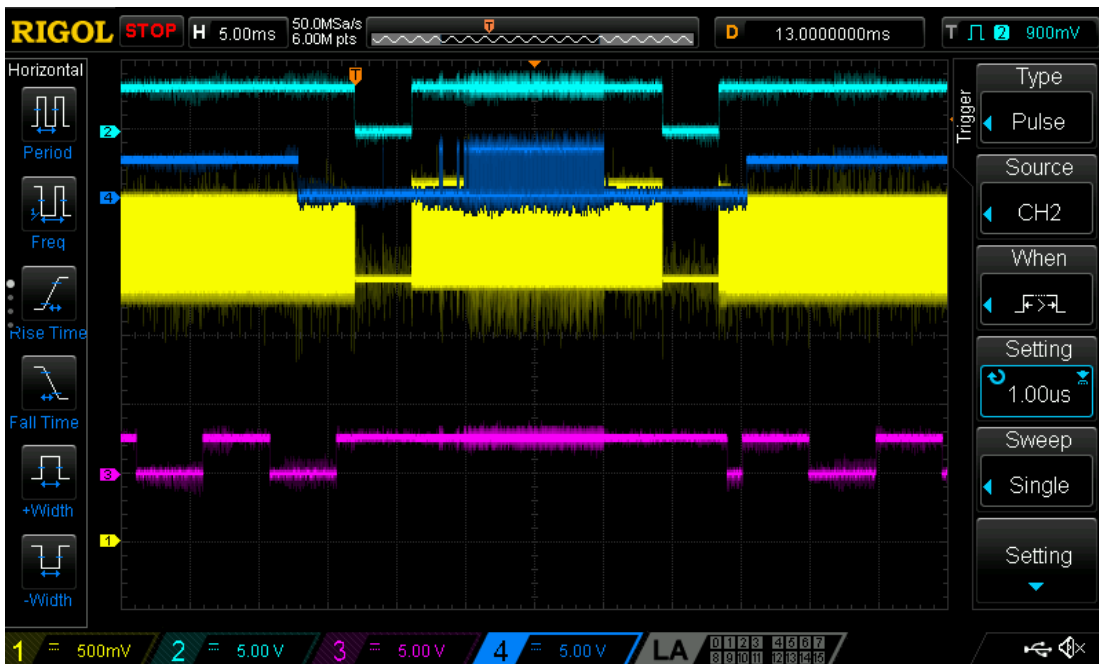
Figure 14: Using `cc-tool` to read basic info about the CC2541: what its debug status is and its name and flags. Trace 1 (yellow): DCOUPL, trace 2 (light blue): RESET\_N, trace 3 (purple): STATE on the development board (the pin being toggled), trace 4 (dark blue): Debug Data.

In figure 14, it can be seen that before and after every debugging command is sent to the CC2541 by the CC Debugger, RESET\_N is held low while two falling edge transitions are forced on Debug Clock. It can be assumed that after every reset out of debug mode, the CC2541 reinitialises and CRP data is moved from flash again, if it is handled by the CPU at all. The assumption of this reinitialisation is fair because setting the debug lock with `cc-tool --lock debug` enables CRP for all subsequent debug commands, as seen below.

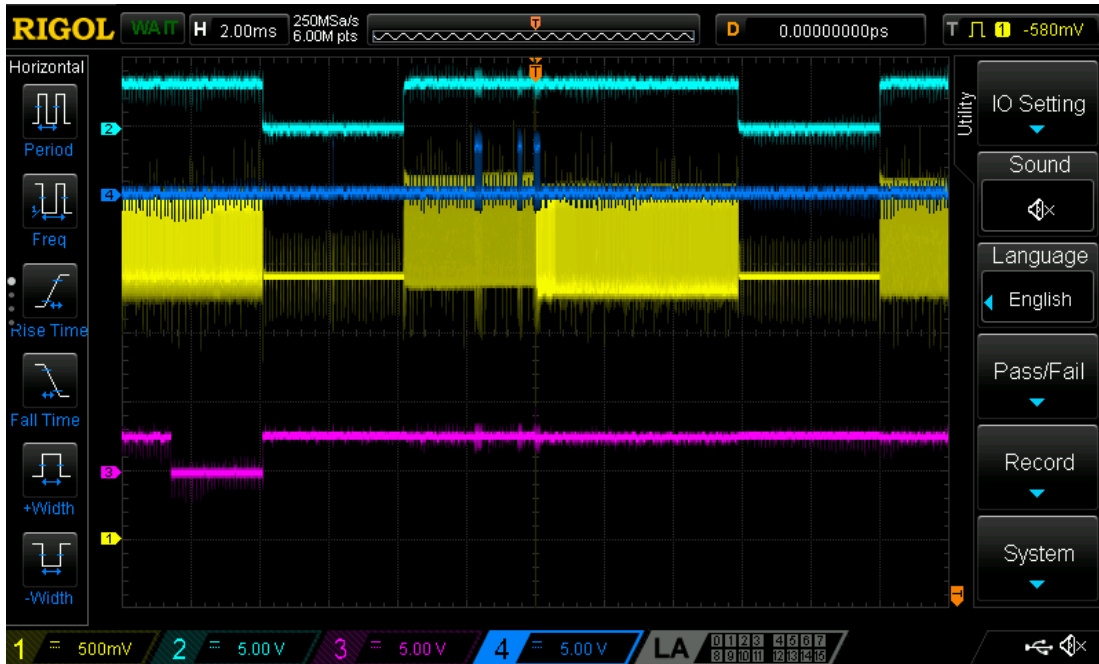
Figure 15: The CC2541 glitch during debug communication which was initially thought to be successful. Notice how trace 3 doesn’t start toggling again because the application has been wiped. Trace 1 (yellow): DCOUPL, trace 2 (light blue): RESET\_N, trace 3 (purple): STATE on the development board (the pin being toggled), trace 4 (dark blue): Debug Data.

The second time `cc-tool` did not print a “Target is locked” message after glitching was also when the glitch was applied during debug communications, specifically around the section of activity on trace 4 (Debug Data) and marked by trigger *T* in figure 15. CRP was only disabled at the expense of erasing the flash, which defeats the purpose of the attack because the flash containing the original application can’t then be dumped. Figure 15 shows that after the second time `RESET_N` is pulled low, the pin toggling application doesn’t start again. Future power cycles also don’t restart the pin toggling application and the device remains unlocked, and any dump of the flash produces an empty binary.
