ORNL-2832
UC-25 - Metals, Ceramics, and Materials

CORROSION ASSOCIATED WITH FLUORINATION
IN THE OAK RIDGE NATIONAL LABORATORY
FLUORIDE VOLATILITY PROCESS

A. P. Litman
A. E. Goldman

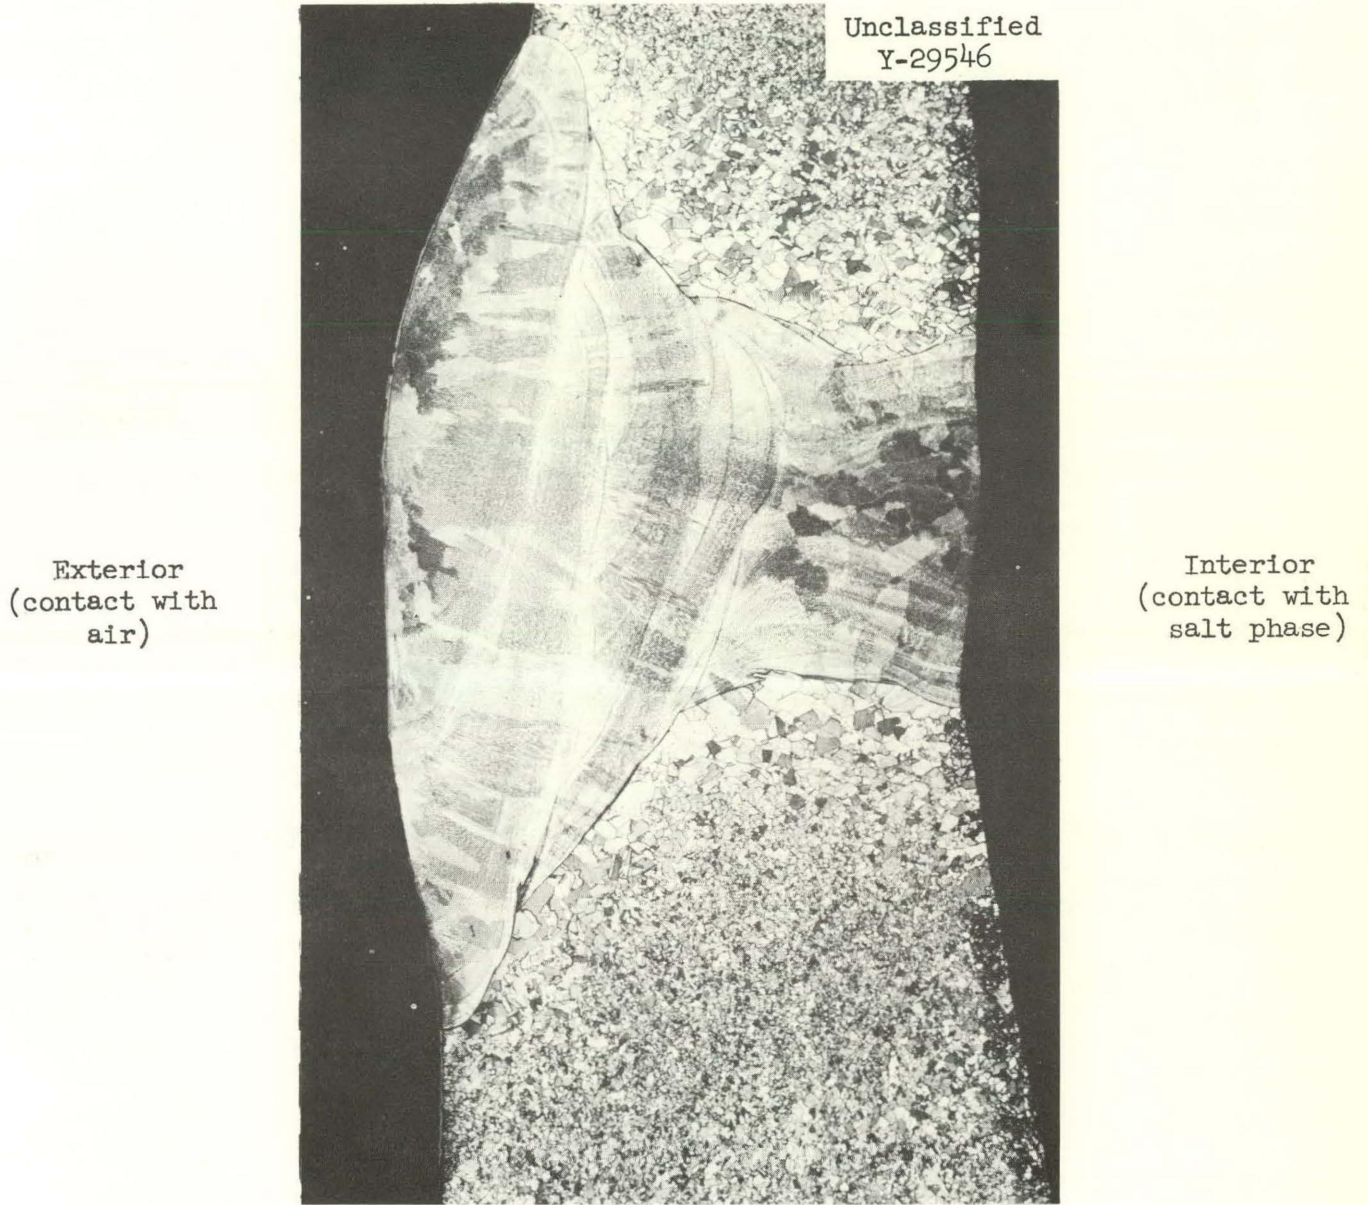
Fig. 9. Macrostructure of Section Through Girth Weld 47 in. Below Top Flange of Mark I VPP Fluorinator. Etchant: Acetic, nitric, hydrochloric acid. 10 X.

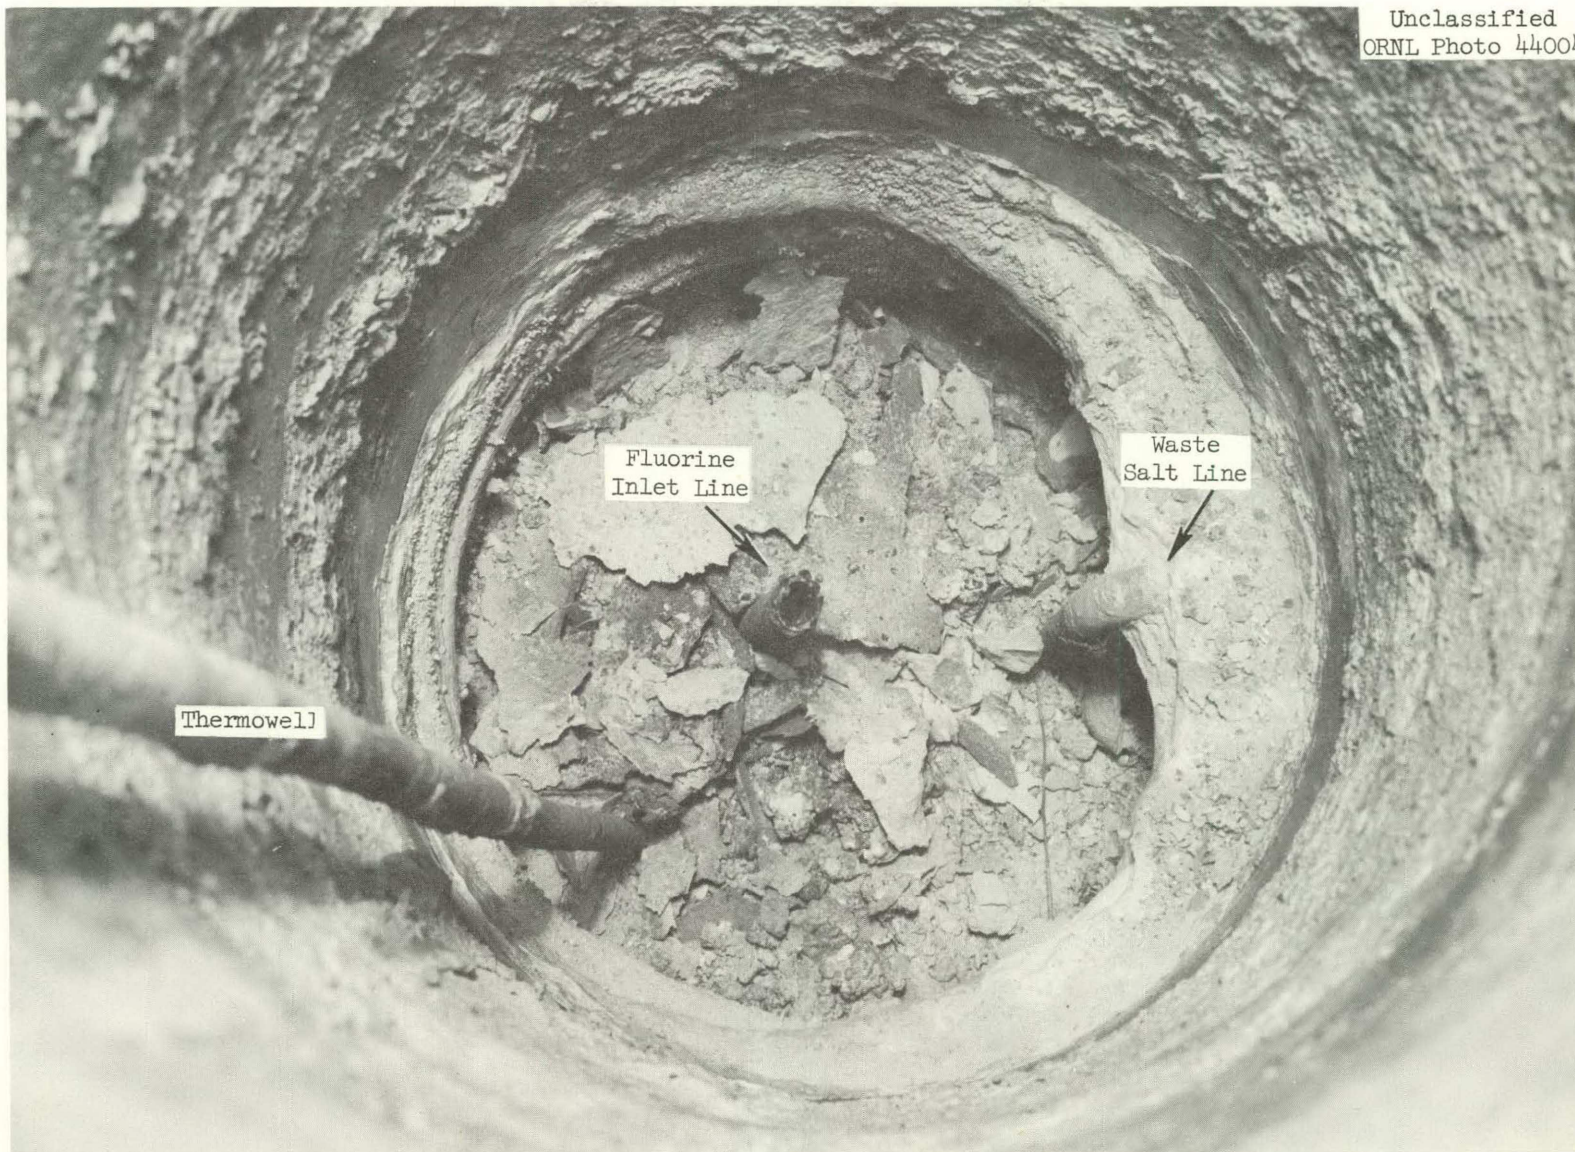
Fig. 14. Interior of Mark II VPP Fluorinator After Run L-4. (Fluorine inlet cut off prior to taking of photograph.)

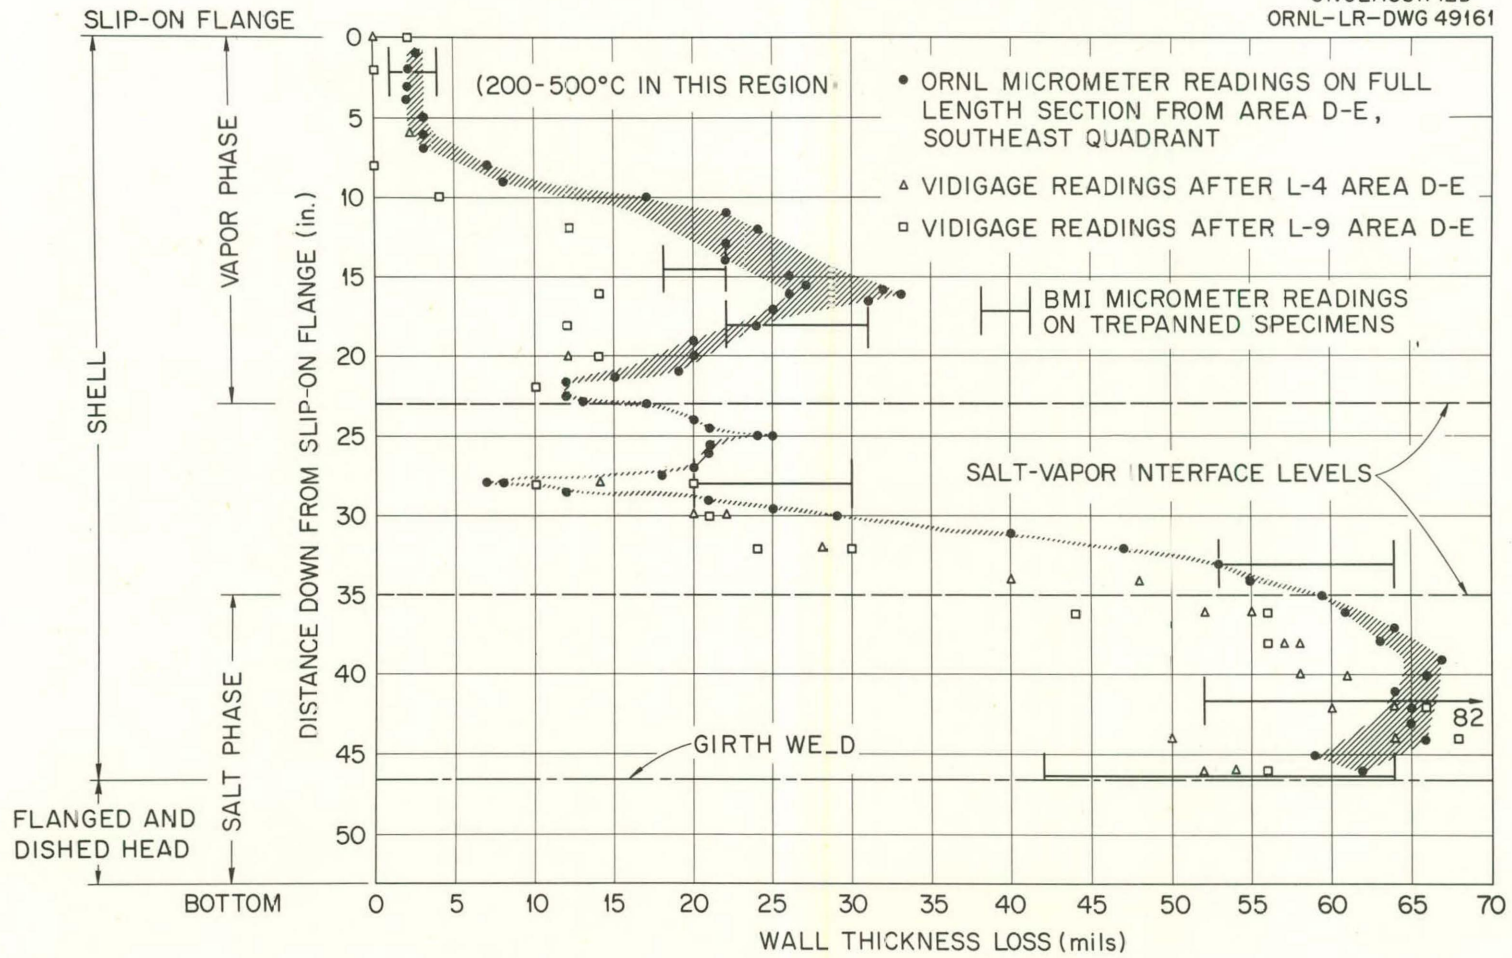
Fig. 18. Corrosion Profile of Mark II VPP L Nickel Fluorinator.

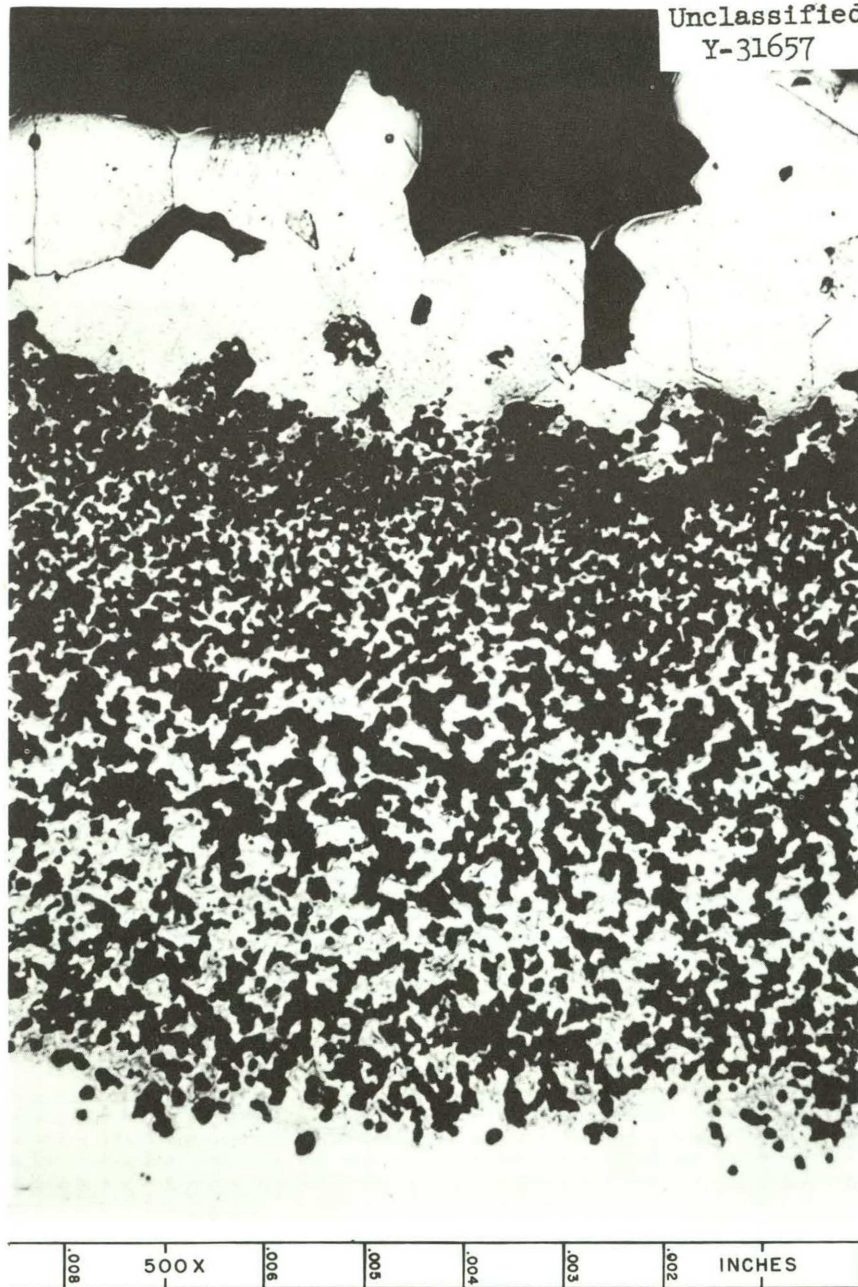
Fig. 51. Surface Layers on Sample from Vapor Region of INOR-8 Miniature Test Fluorinator No. 2. Etchant: Potassium cyanide-ammonium persulfate. 500X.

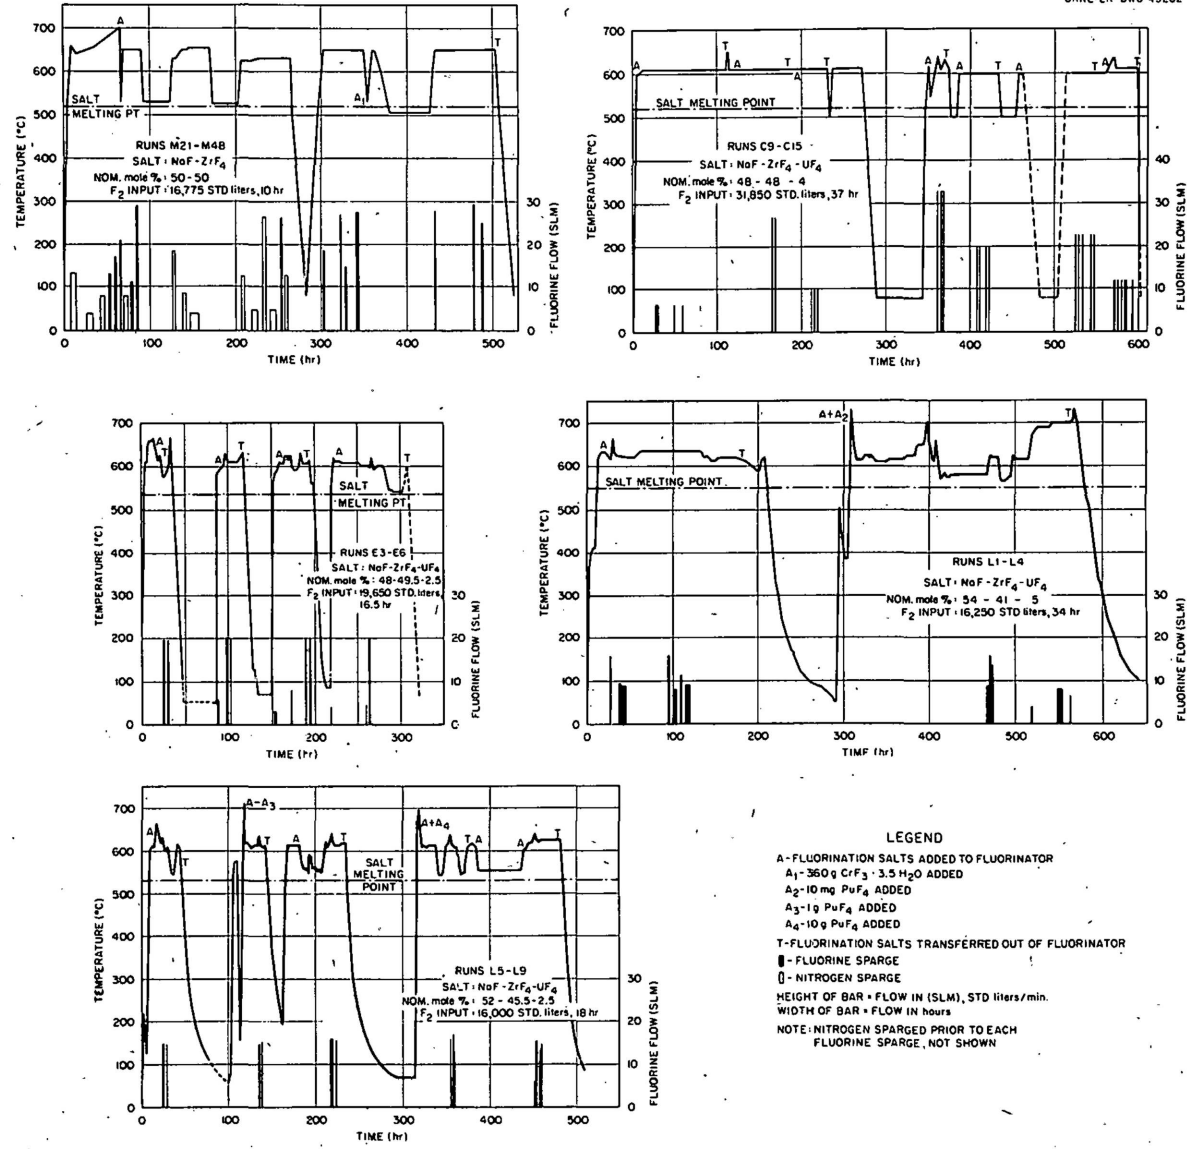
Fig. 54. Comparison of Process Details for Various VPP Run Groups When Corrosion Scouting Specimens Were in Place.

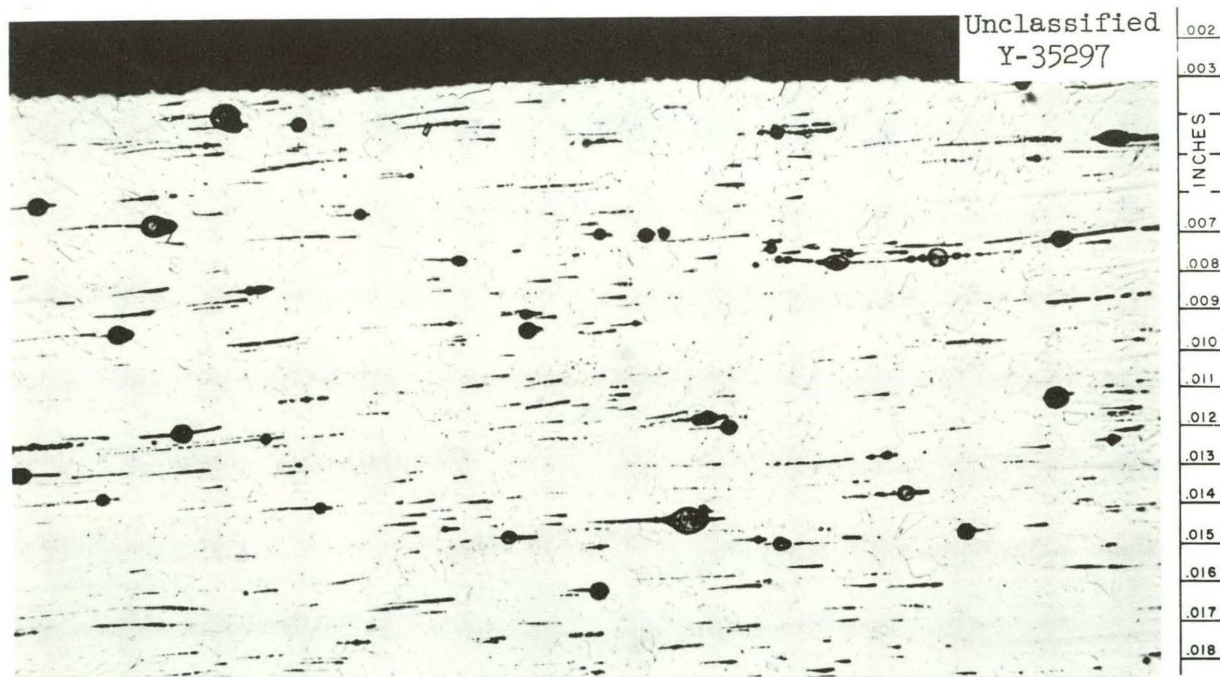
Fig. 66. Section of Vapor Region Sample from OFHC Copper Corrosion Specimen (Runs E-3-E-6:7) Showing Typical Surface and Microstructure. Etchant: $\text{NH}_4\text{OH}:\text{H}_2\text{O}_2$. 200X.

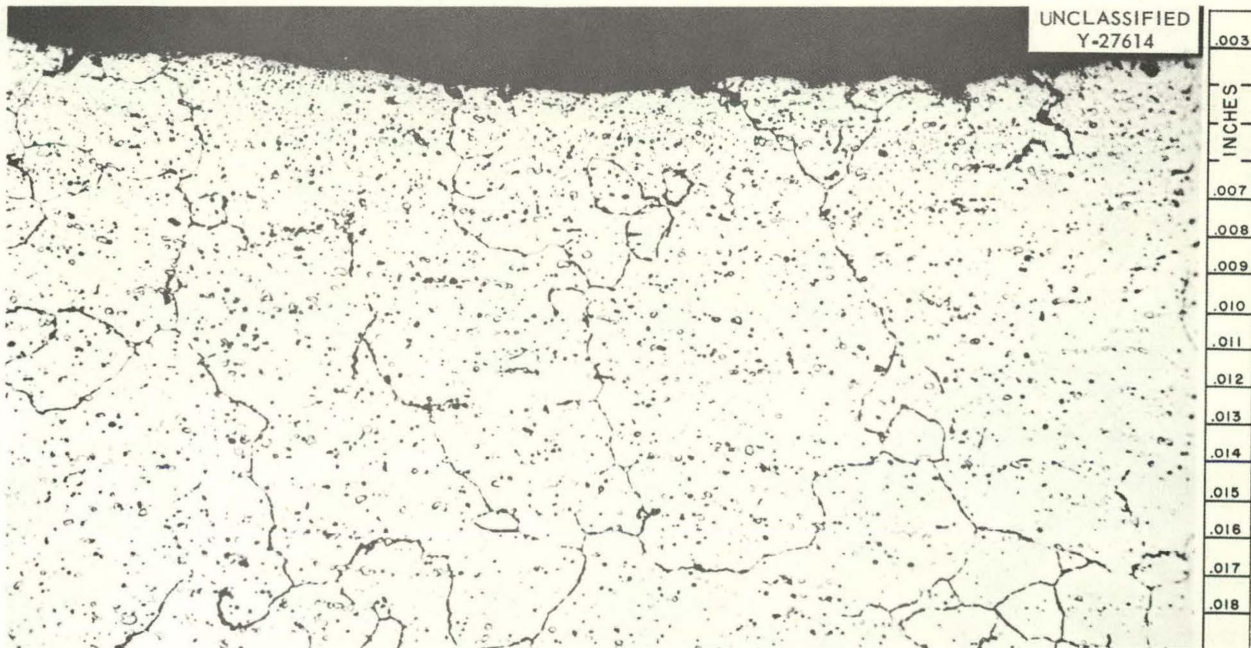
Fig. 75B. Portion of Fig. 75A. Typical Surface and Microstructure. Etchant: Chromium regia. 200X.

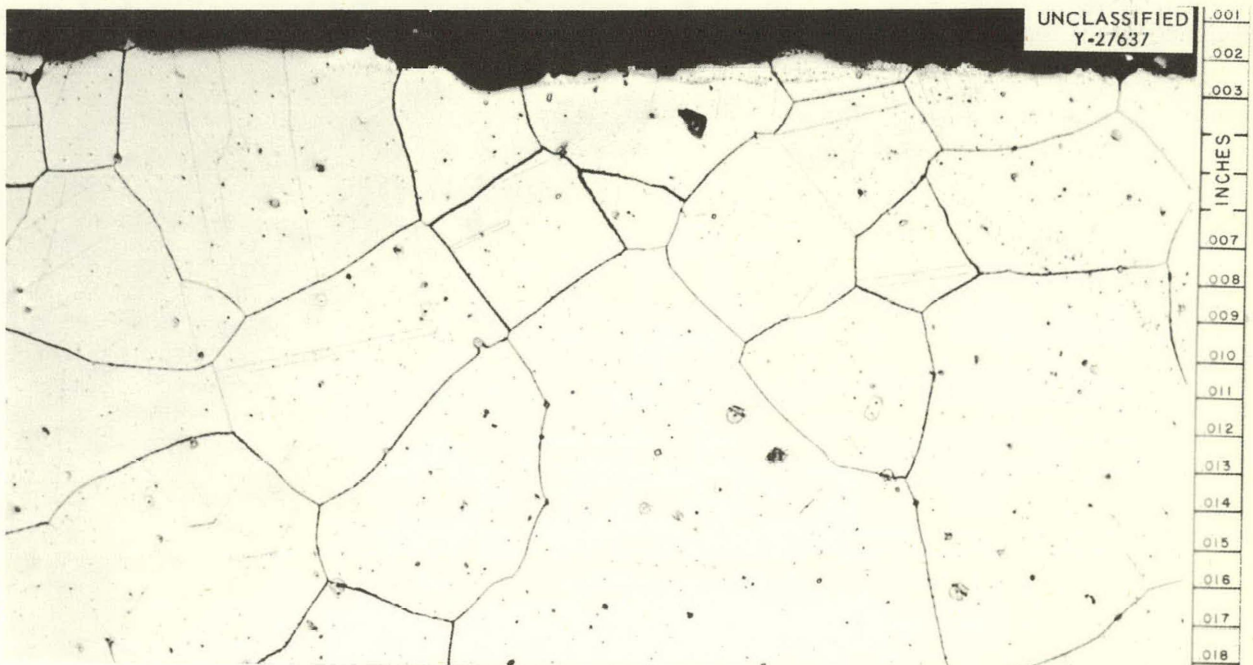
Fig. 77B. Portion of Fig. 77A. Typical Surface and Microstructure, Etchant: Aqua regia. 200X.
