ORNL-3124
UC-25 - Metals, Ceramics, and Materials

INOR-8-GRAPHITE-FUSED SALT
COMPATIBILITY TEST

For the purpose of evaluating the compatibility of graphite and INOR-8 in a dynamic fluoride fuel medium, INOR-8 Forced Convection Loop No. 9354-5 was operated 8850 hr. The loop operated at a maximum temperature of 1300°F and circulated a fluoride fuel of the system $\text{LiF-BeF}_2\text{-UF}_4$. Post-test examinations of the graphite and loop components revealed no apparent corrosion or carburization problems.

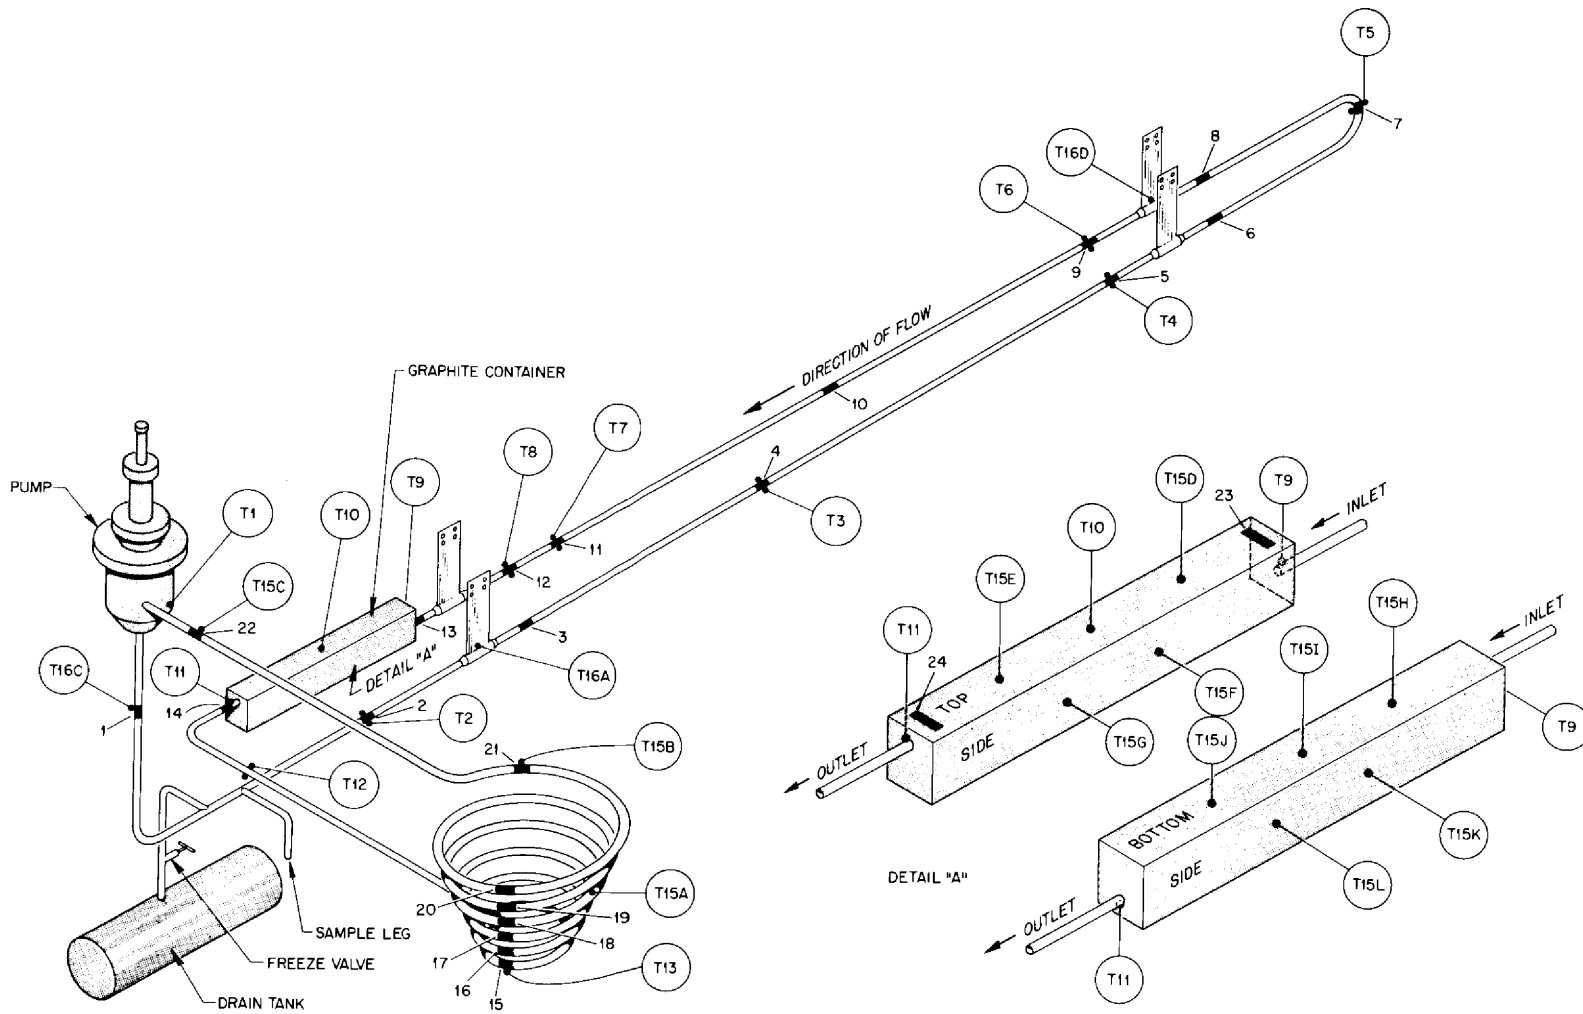
Fig. 1. Molten Salt Corrosion Loop No. 9354-5 Containing Graphite Specimens. Showing thermocouple and specimen locations.

The graphite container, completely constructed of INOR-8, was installed in a horizontal position at the outlet of the second heater leg (Fig. 1). Gas entrapment in the container was prevented by placing the inlet at the lower portion of the end plate and the outlet at the upper portion of the opposite end plate, as shown in Figs. 1 and 2.

Specimens of the loop components were also removed from positions indicated in Fig. 1 and were examined metallographically for evidence of carburization and attack by the fluoride mixture. Samples of the salt circulated were submitted to the Analytical Chemistry Group for optical microscopy, x ray, and wet chemical analyses.

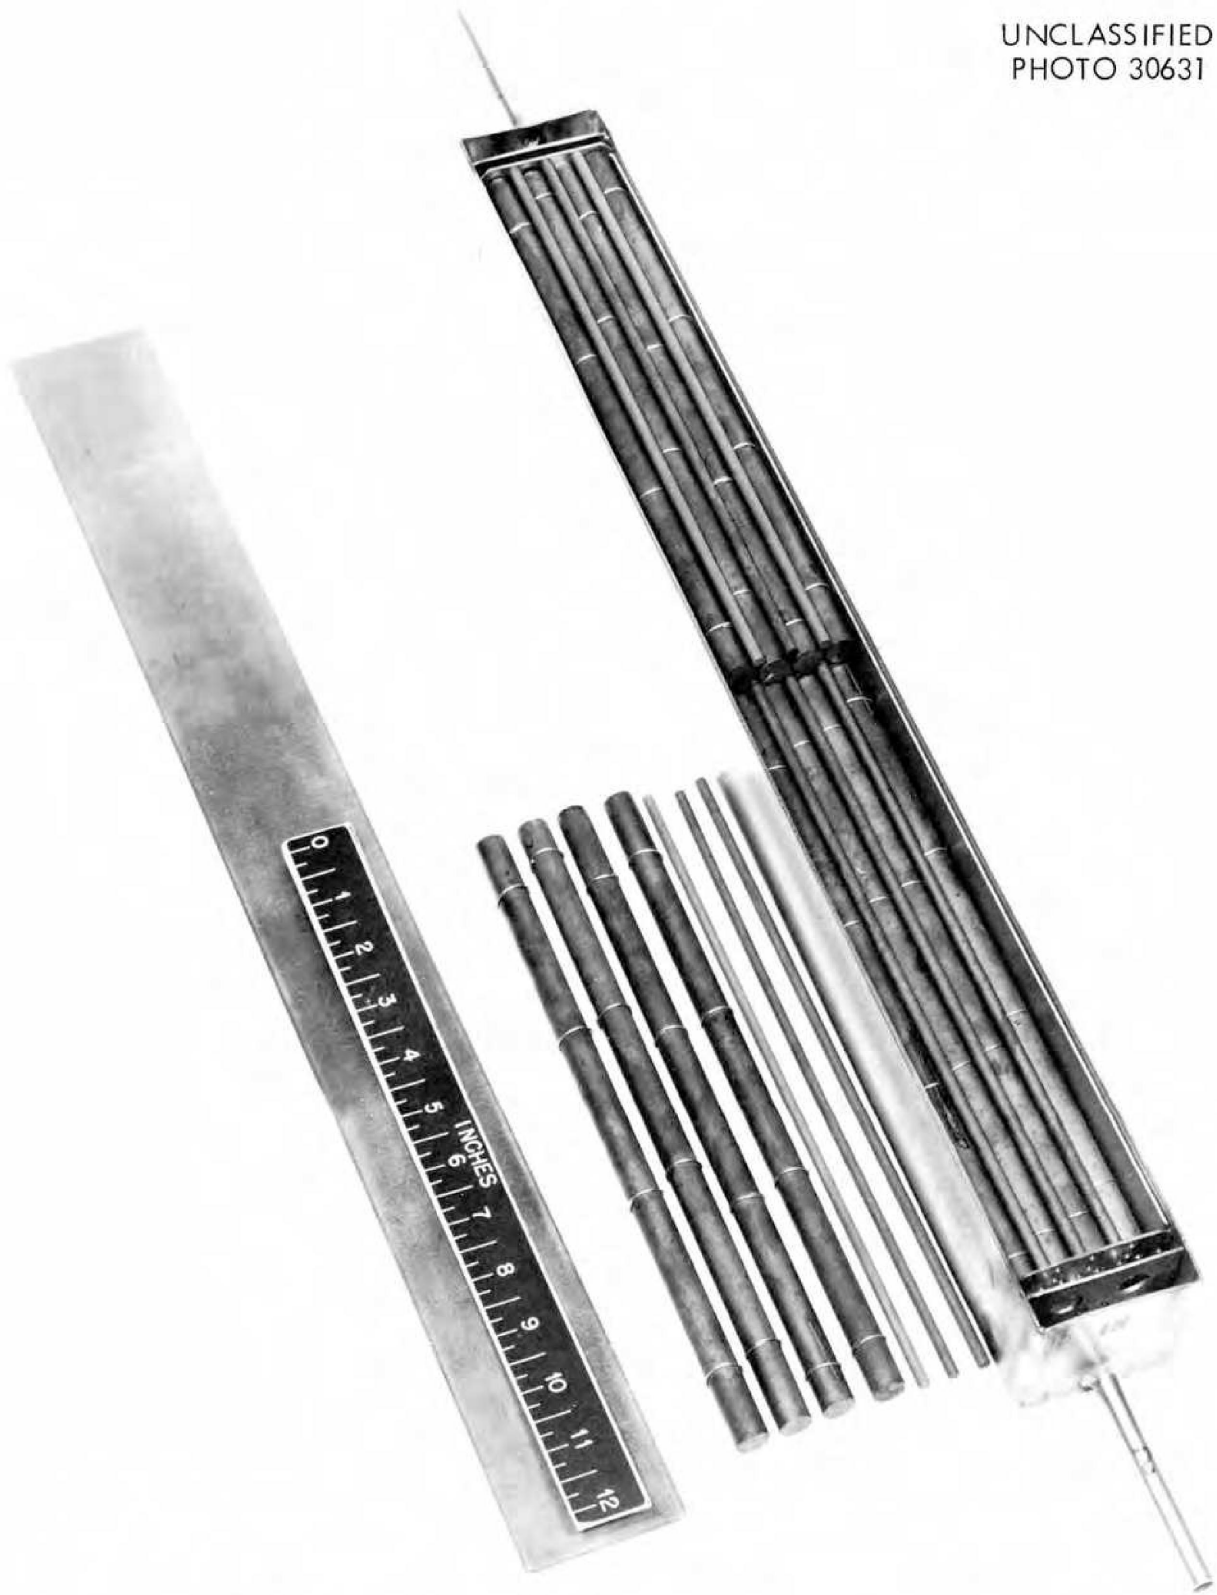
Figure 2 shows the INOR-8 container filled with graphite rods before the cover was attached. The container, fabricated from 0.060-in. sheet, was in the form of a rectangular box 24 in. long by 2-1/2 in. square. Orifice plates were placed at the ends to hold the rods in place and to distribute the flow to the spaces between the rods. Baffles were also welded in between the orifice plate and the end of the container to aid in the distribution of flow.

Fig. 2. Graphite Container Before Installation in Loop.

Before the graphite rods were installed, they were calipered and weighed by the Reaction Processes Group of the Reactor Chemistry Division. Figures 2 and 3 show the horizontal array in which the graphite rods were stacked. Space was maintained between each of the rods and the sides of the box by means of 0.035-in.-diam Hastelloy W (nominal composition listed in Table 1) wire spacers wound around the 1/2-in.-diam rods. These spacers were staggered along successive layers of rods so that a flow area between the rods was maintained.

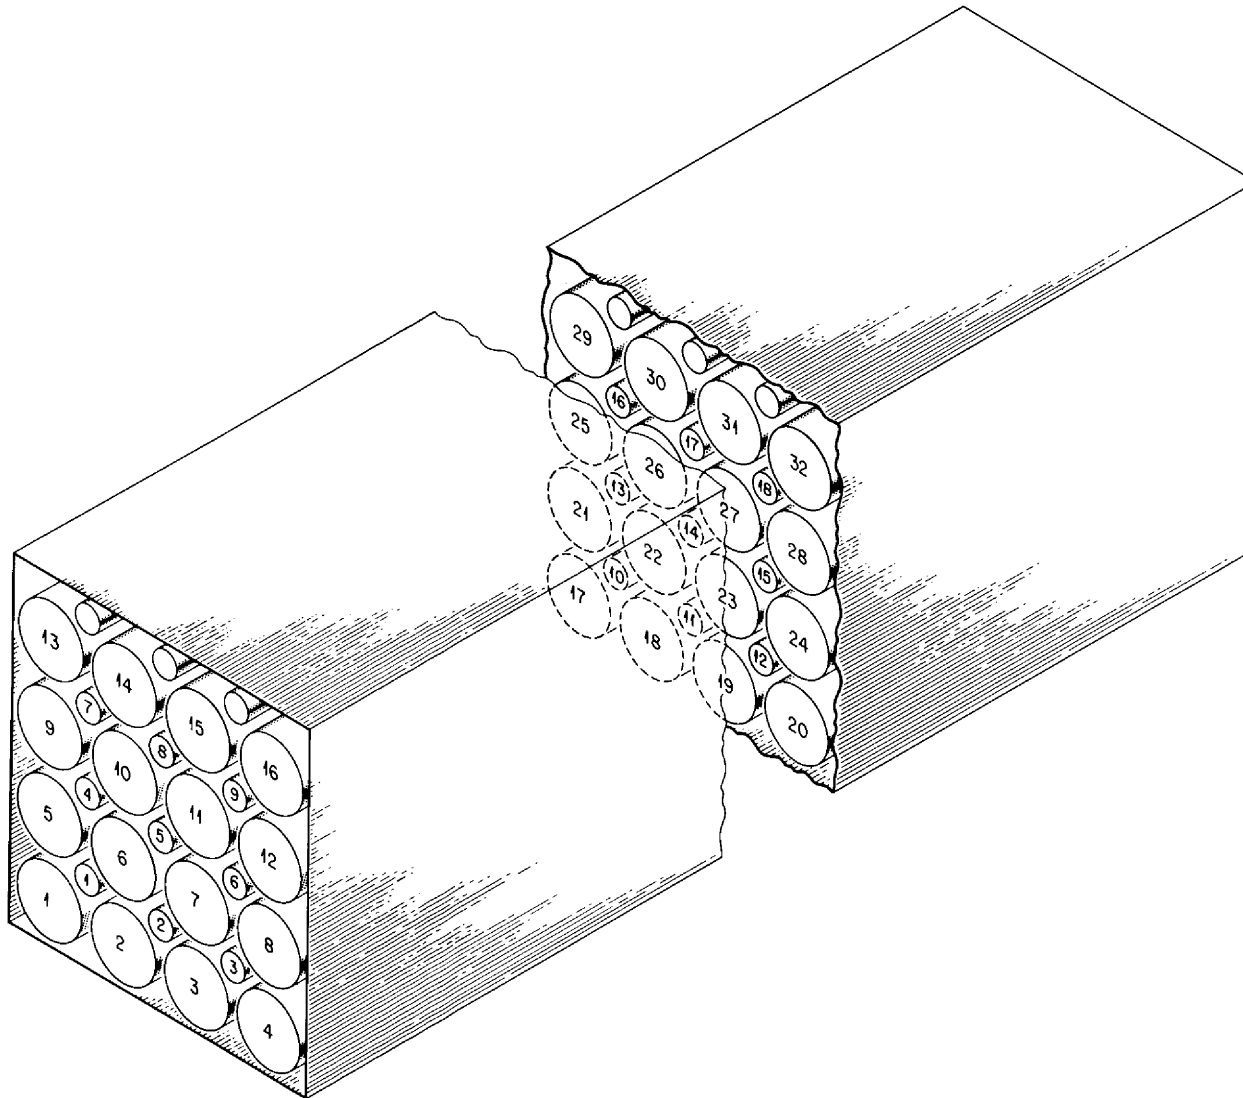
Fig. 3. Numbering Scheme for Positioning Graphite Rods.

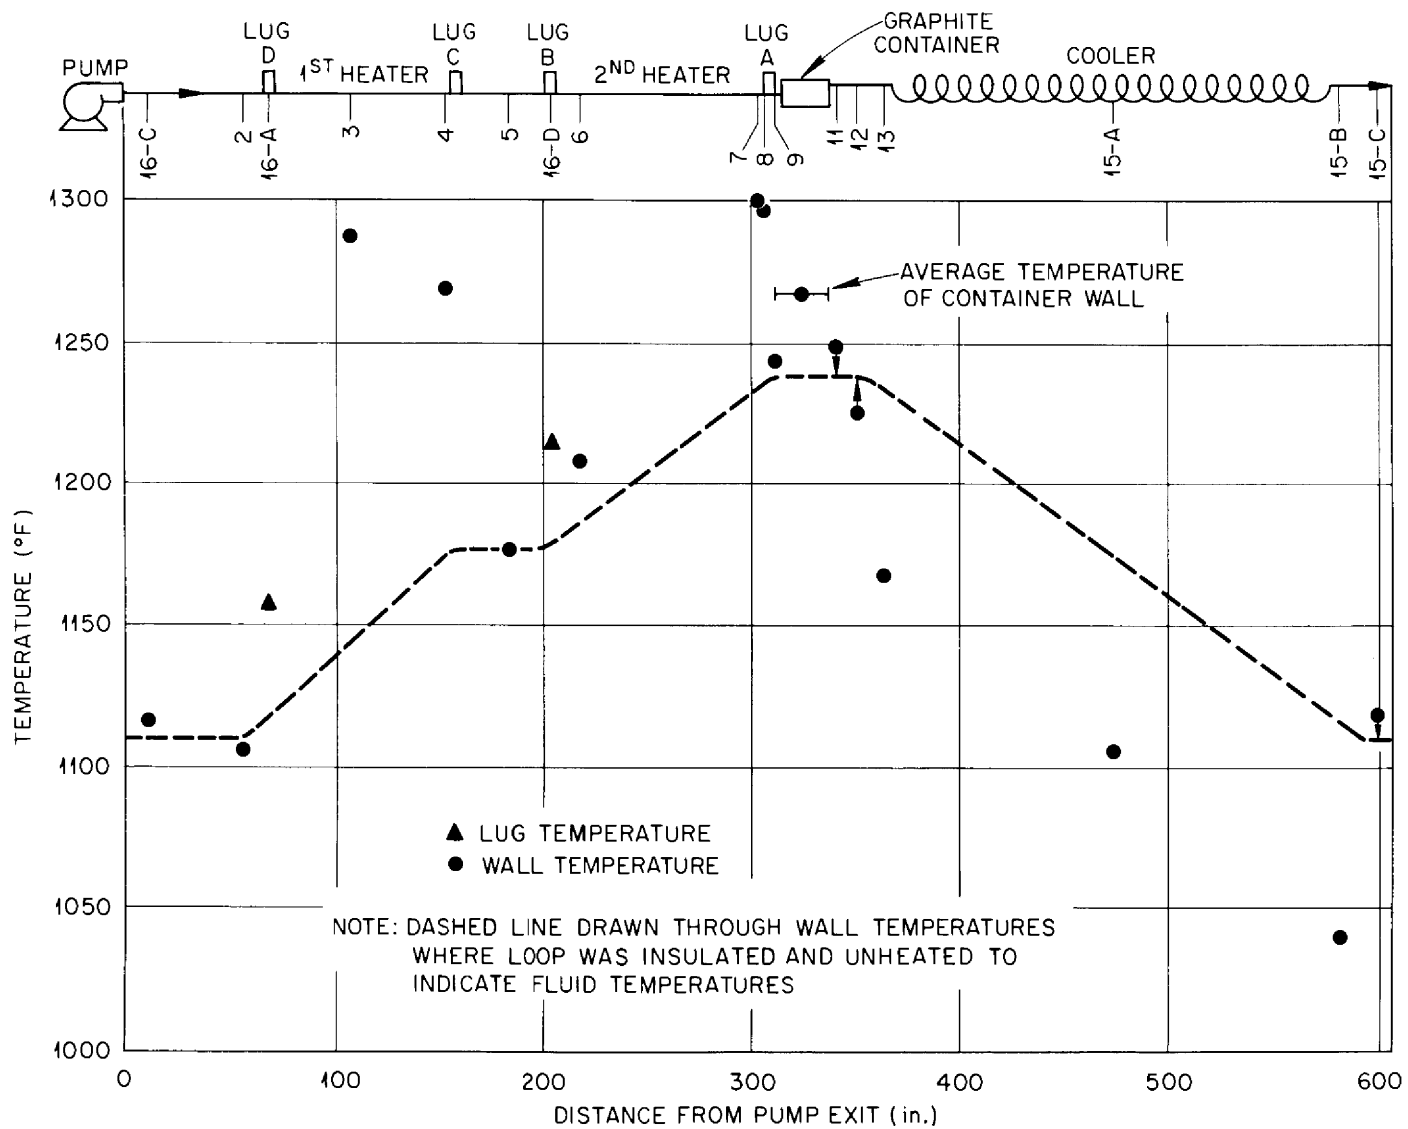
Fig. 4. Average Wall Temperatures for INOR-8 (with Graphite Insert)
Loop No. 9354-5.

The averages of loop temperatures, which were recorded once per day, are shown in Fig. 4. External heat was applied to the graphite container during operation to maintain the temperature at the outlet (TC No. 11) approximately equal to the temperature at the inlet (TC No. 9). The maximum wall temperature of the container, as recorded by TC's No. 7 and No. 8, was maintained at 1300°F.

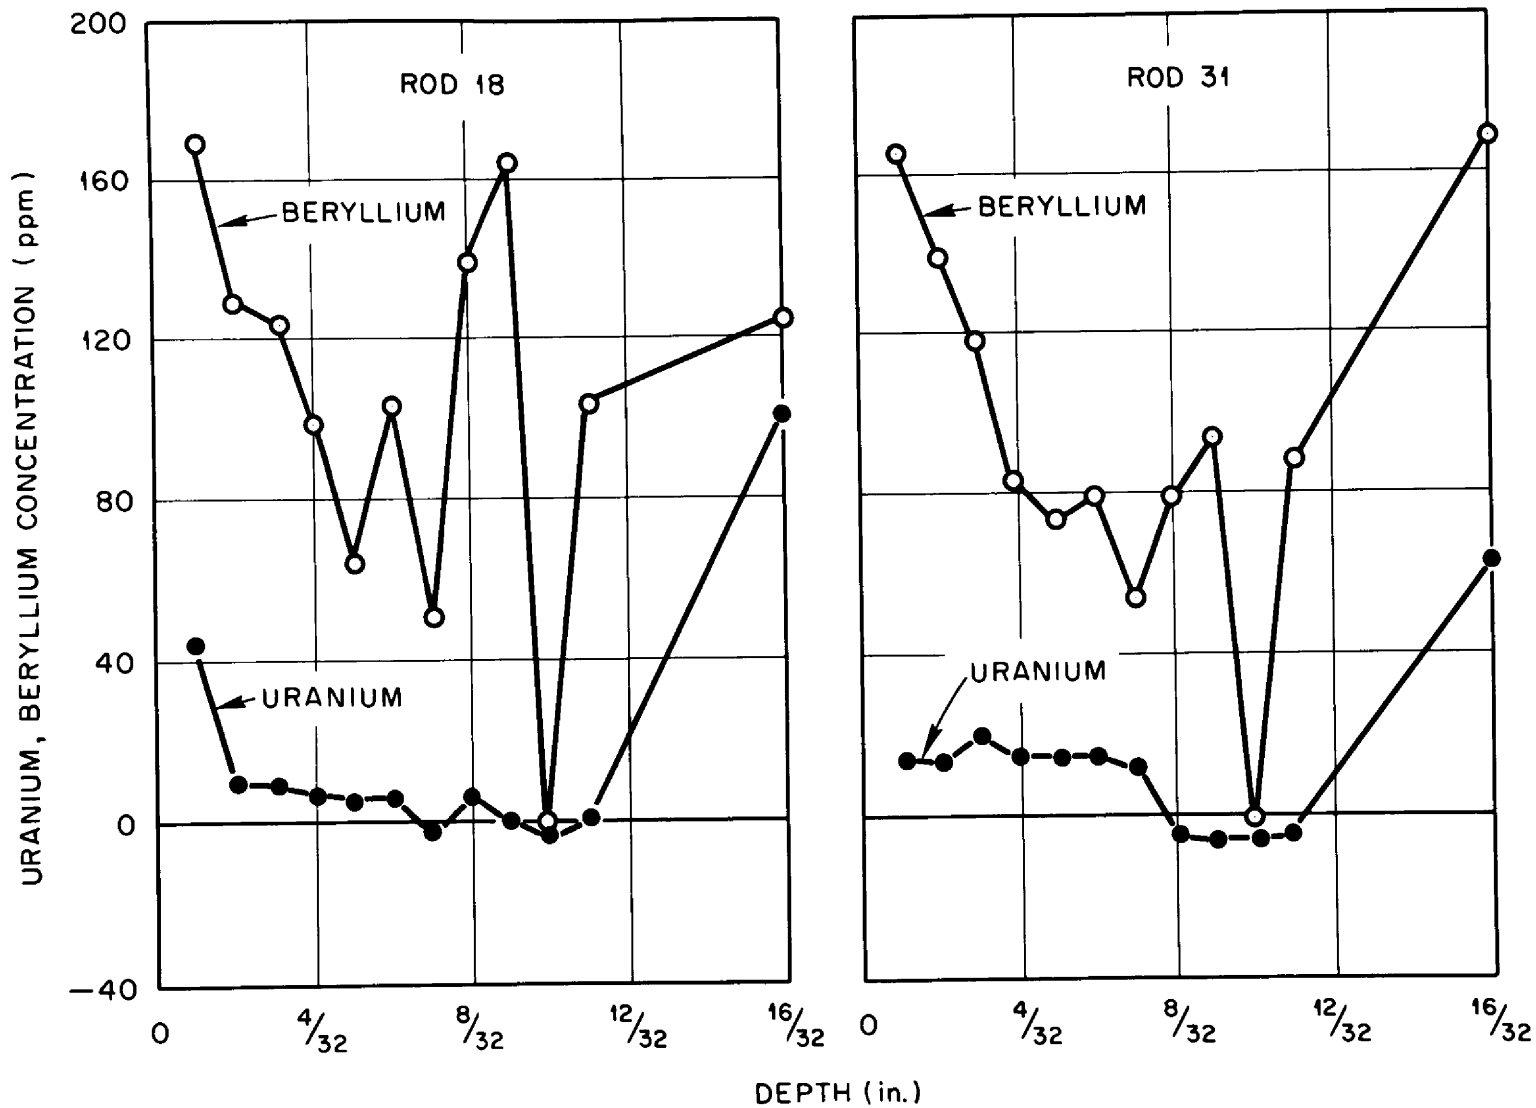
Fig. 5. Penetration of an Impervious Graphite by $\text{LiF-BeF}_2\text{-UF}_4$.

Chemical Analysis.- Machined increments of graphite specimens were submitted for chemical analysis. Successive cuttings, 1/32 in. in depth, were taken from two of the larger diameter rods until center portions of less than 3/16-in. diam were left. These portions and "as-received" impervious graphite "blanks" were then ground to -100 mesh in a mortar and pestle, which was thoroughly scoured with Ottawa Sand according to the recommendations of the Analytical Chemistry Division after each grinding. All graphite samples were submitted for an analysis of the uranium and beryllium concentrations. Two machine cuttings, 1/32 in. in depth, were taken from four additional rods. These results are given in Table 2 with the beryllium and uranium concentrations graphed as a function of penetration depth in Fig. 5. Only a very slight migration of salt to the center of the graphite is noted.

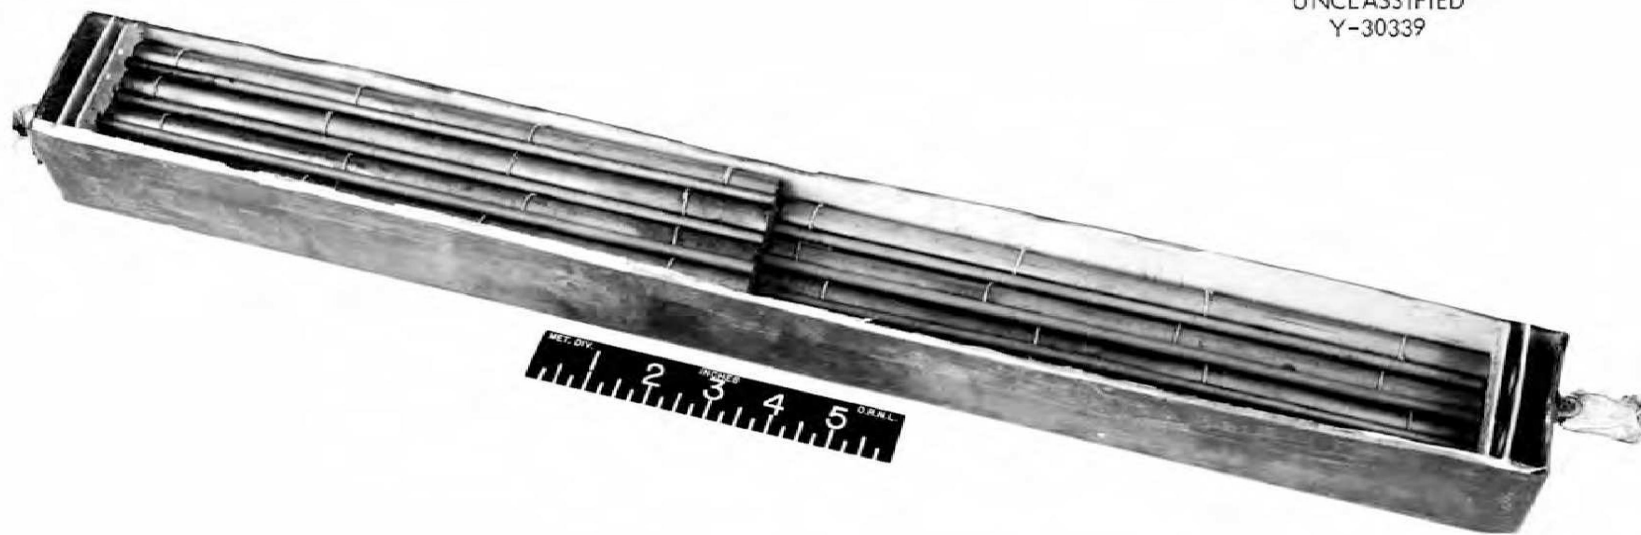
Fig. 6. Graphite Container After Test.

Physical Analysis.- Macroscopically, there was no change in the rods. None of the samples was broken or distorted and, except for the bottom layer of rods that was covered with solidified melt, the salt did not adhere to the graphite, as shown in Fig. 6. The weight and dimensional changes observed for the rods after contact with circulating fluorides are listed in Table 3. The dimensional changes for the thirteen 1/2-in.-diam rods corresponded to an average loss of less than 0.5 mil in diameter which approximates the probable error of the measurements. Otherwise, there was no evidence of erosion. Weight losses, which ranged from negligible to 0.05% and averaged 0.02%, could be attributed to desorption of residual gases from the graphite. No statistically significant differences were noted in the thirteen 1/2-in.-diam rods as compared with the eight 3/16-in.-diam rods for which weight data were available.

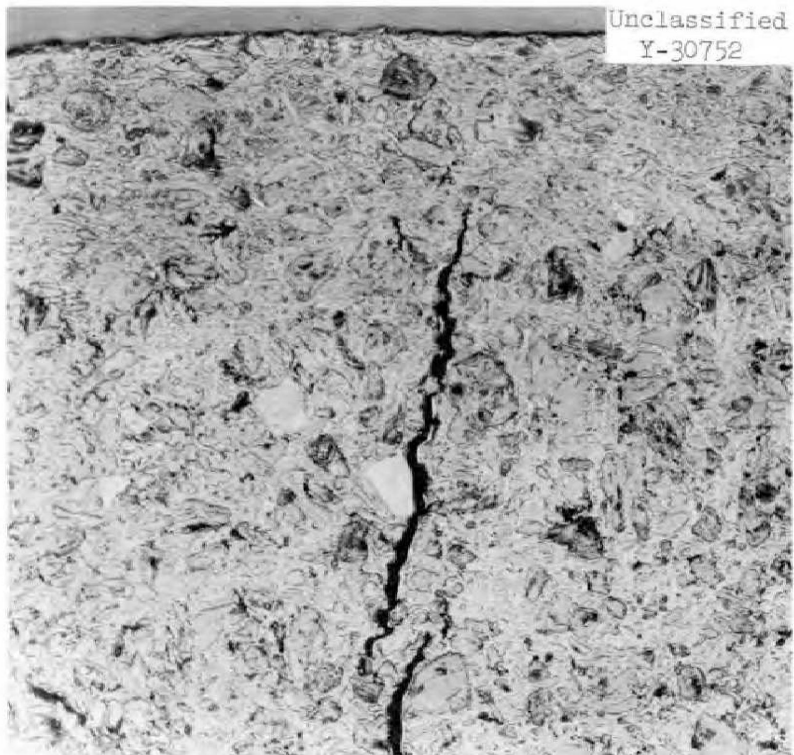
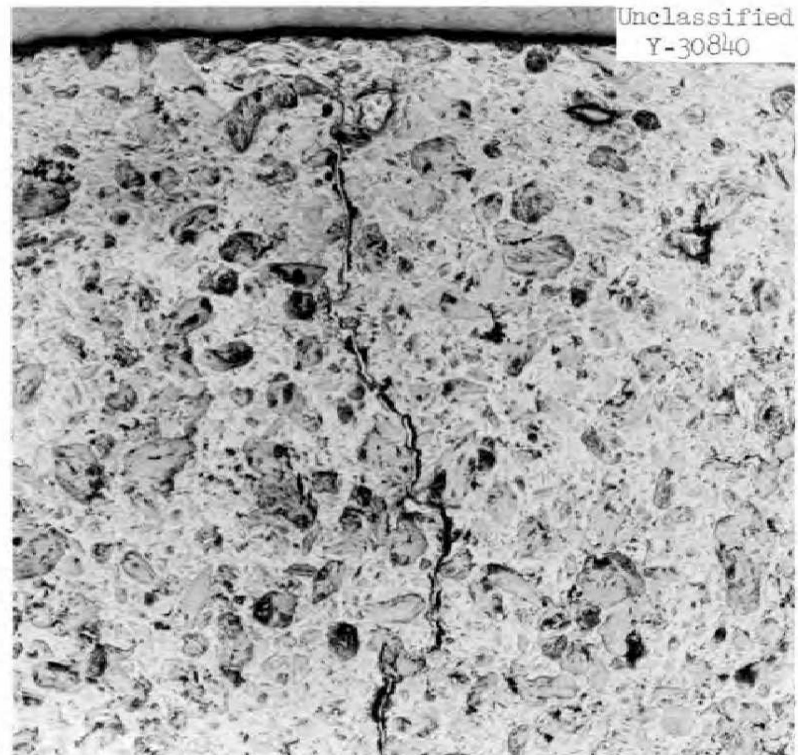
Fig. 7. Low Permeability Graphite: Typical Microstructure of 1/2-in.-diam Rods (a) As-Received and (b) After a One-Year Exposure to $\text{LiF-BeF}_2\text{-UF}_4$ (62-37-1 mole %). As polished. 100X

The typical microstructures of the graphite in the "as-received" and after-test conditions are compared in Fig. 7. In both conditions the graphite characteristically exhibited small, uniform, and widely scattered voids. Because of the extremely small size of the voids, it was not possible to identify fuel in them by simple microscopic examination.

Both the 3/16-in.-diam and 1/2-in.-diam rods had radial laminations or cracks in sections transverse to the axes of the rods, Fig. 7. The laminations were 0.010 to 0.075 in. long and approx 0.001 in. wide in a 3/16-in.-diam rod and were 0.030 to 0.150 in. long and 0.001 to 0.002 in. wide in 1/2-in.diam rods. There appeared to be fewer laminations in the 3/16-in.-diam rods than in the 1/2-in.-diam rods. The majority of the laminations began and terminated inside the rods. Only a few extended to the curved surfaces of the rods. The test apparently had no effect on the laminations.

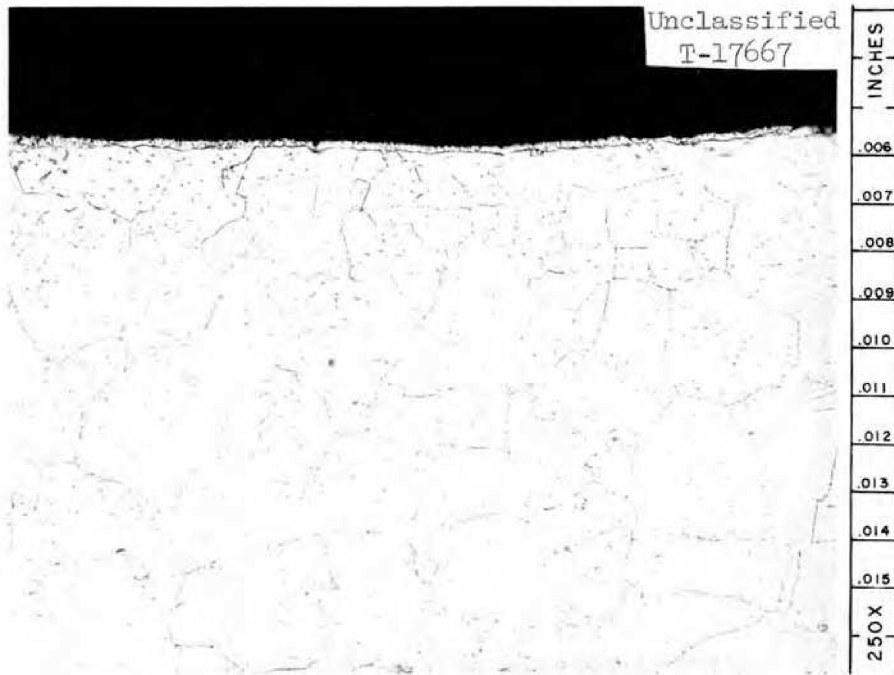
Fig. 8. Appearance of Specimen Removed from End of the First Heater
Leg. Etchant: 3 parts HCl, 2 parts H₂O, 1 part 10% Chromic acid. 250X

As evidenced in Figs. 8, 9, and 10, the metallographic appearance of the loop specimens gave no indication of surface carburization, carbide precipitation being no heavier at the exposed surfaces than below.

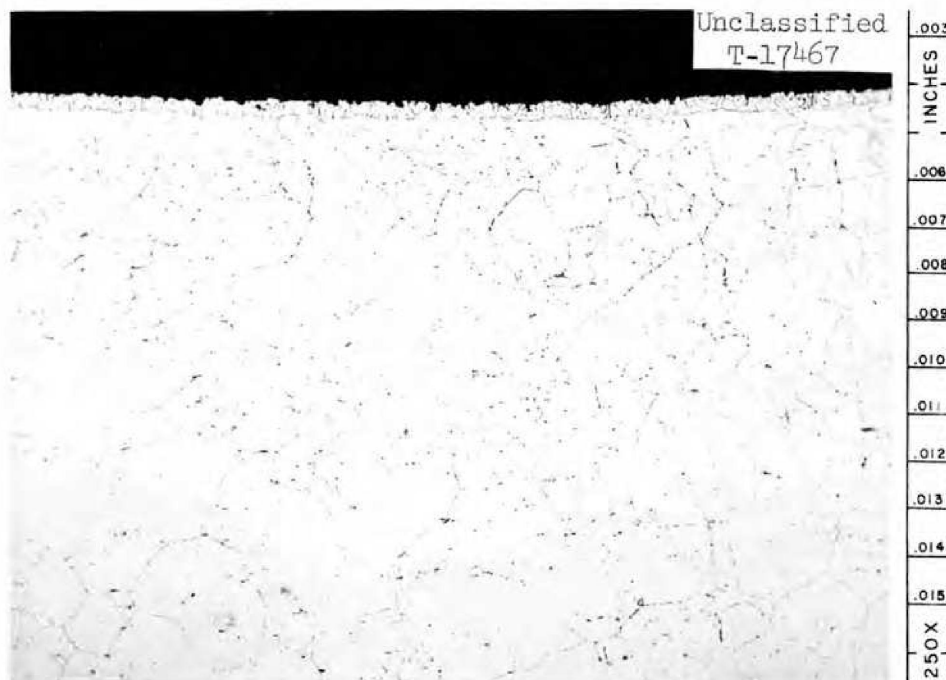
Fig. 9. Appearance of Specimen Removed from End of the Second Heater
Leg. Etchant: 3 parts HCl, 2 parts H₂O, 1 part 10% Chromic acid. 250X

A semiquantitative analysis of the film was also carried out by use of an electron-beam microprobe.¹³ This analysis was accomplished by aiming the electron beam directly on the inside diameter surface of specimen No. 11 (Fig.9)

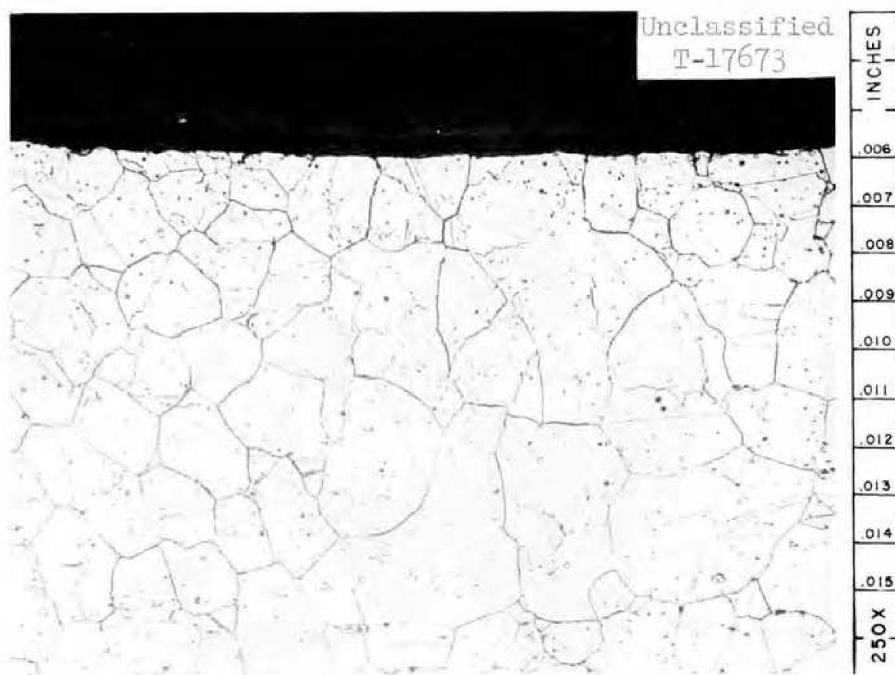
Fig. 10. General Appearance of Cooler Coil. Etchant: 3 parts HCl, 2 parts H₂O, 1 part 10% Chromic acid. 250X

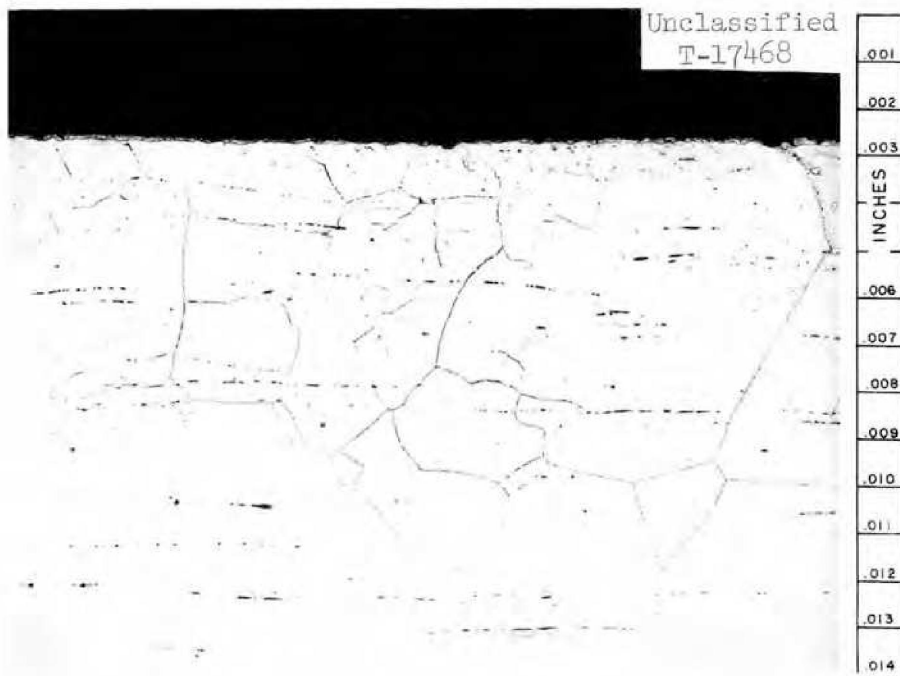
Fig. 11. Specimen Removed from Top of Box Containing Graphite Rods.
Etchant: 3 parts HCl, 2 parts H₂O, 1 part 10% Chromic acid. 250X

Graphite Container.- Metallographic examination of specimens removed from the entrance and exit of the graphite container revealed no attack and no evidence of carburization. As in the case of the specimens removed from the loop, a very light surface film was found along the interior surfaces of the box (Fig. 11).

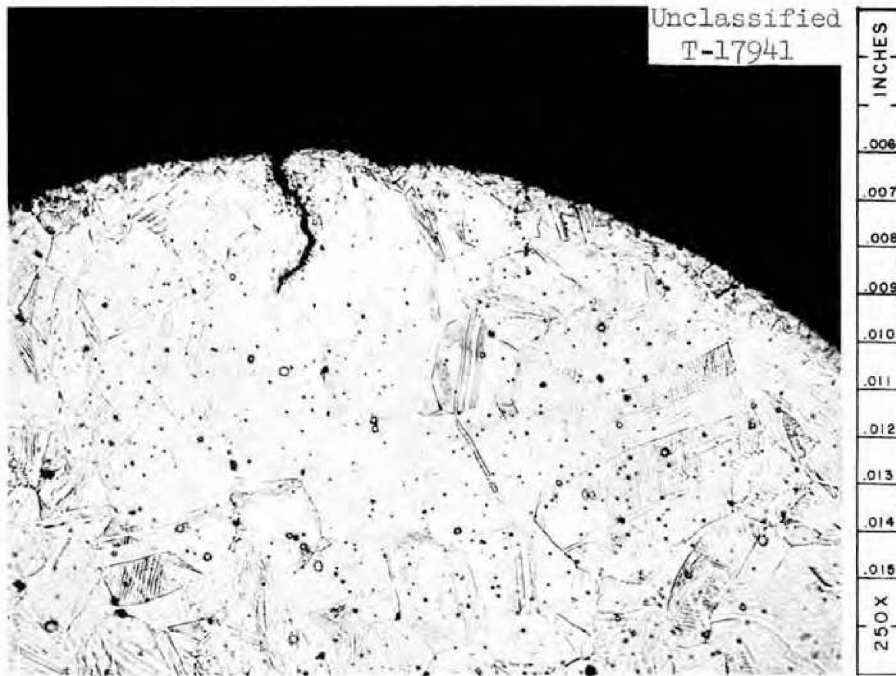
Fig. 12. As-Received Microstructure of Hastelloy W Spacer Wires.
Etchant: 3 parts HCl, 2 parts H₂O, 1 part 10% Chromic acid. 250X

Hastelloy W Spacer Wires.- As described previously,¹² 0.035-in.-diam wires circled each of the graphite rods stacked in the container to maintain a fixed flow annulus between each of the rods. Since these spacer wires were in direct contact with graphite, they were examined particularly for evidence of carburization. Metallographic examination of the after-test wires showed them to have a microstructure distinctly different from that of the "as-received" material, as shown in Figs. 12 and 13.

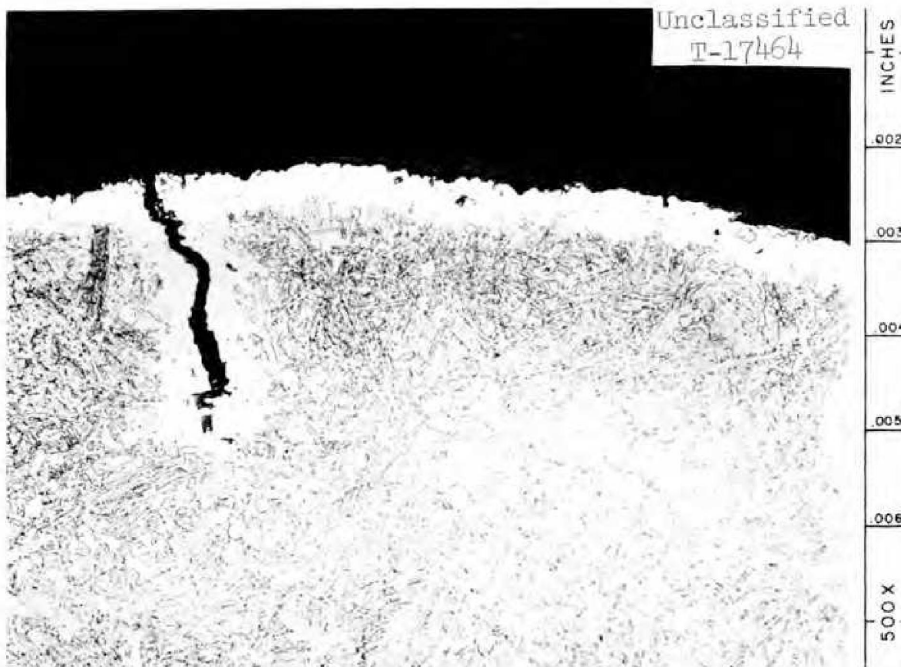
Fig. 13. Typical Microstructure of Hastelloy Spacer Wires After Test.
Etchant: 3 parts HCl, 2 parts H₂O, 1 part 10% Chromic acid. 500X

Hardness determinations, which utilized a Tukon Hardness Tester, indicated hardnesses from 411 to 435 DPH in the before-test specimens and from 435 to 469 DPH in the after-test specimens. Since Hastelloy W is subject to aging at the temperature range to which it was exposed, a hardness increase for this material would be expected with or without carburization. However, the analyses also showed that the carbon content had increased significantly from a before-test level of 0.028% to an after-test level of 0.055%.

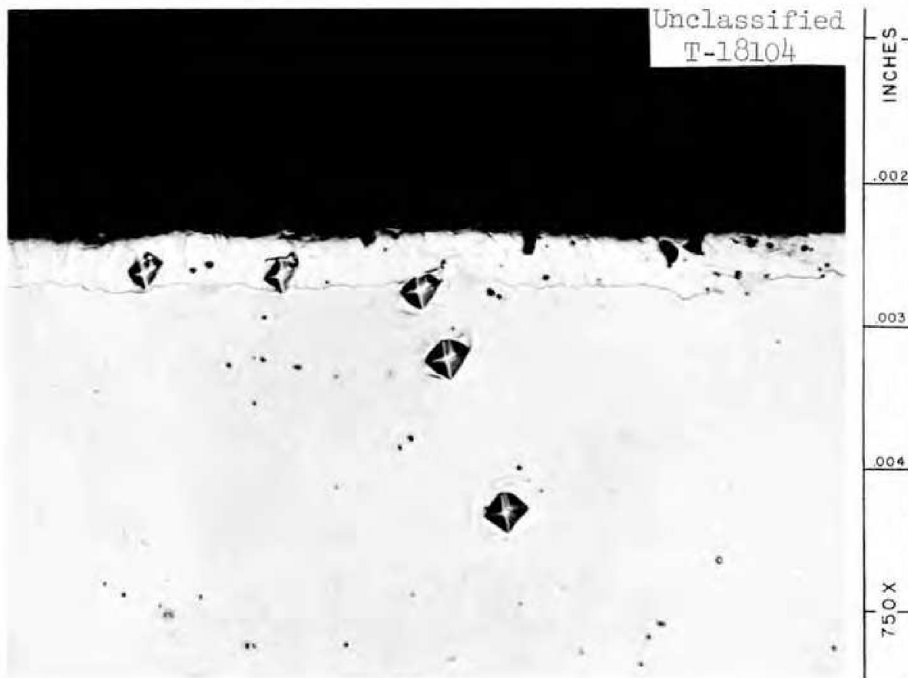
Fig. 14. Microhardness Measurements Made on Specimen Removed from Second Heater Leg. Etchant: None. 750X.

specimen No. 11, on which the thickest layer was found, were determined using a Bergman Microhardness Tester and a 1-g load. On the basis of the 1-g load, the film was found to have a VHN of 518, while the Vickers hardness number for the parent metal was 269 (Fig. 14). A check of the base metal using the Tukon Hardness Tester with a 200-g load indicated a VHN of 218. Thus, the absolute magnitudes of the hardness values yielded by the Bergman tester would appear to be slightly high; nevertheless, they demonstrate that the film is approximately twice as hard as the parent metal.
