ORNL-3500  
UC-25 - Metals, Ceramics, and Materials  
TID-4500 (23rd ed.)

FABRICATION OF THE HEAT EXCHANGER  
TUBE BUNDLE FOR THE MOLTEN-SALT  
REACTOR EXPERIMENT

R. G. Donnelly  
G. M. Slaughter

**OAK RIDGE NATIONAL LABORATORY**  
operated by  
**UNION CARBIDE CORPORATION**  
for the  
**U.S. ATOMIC ENERGY COMMISSION**

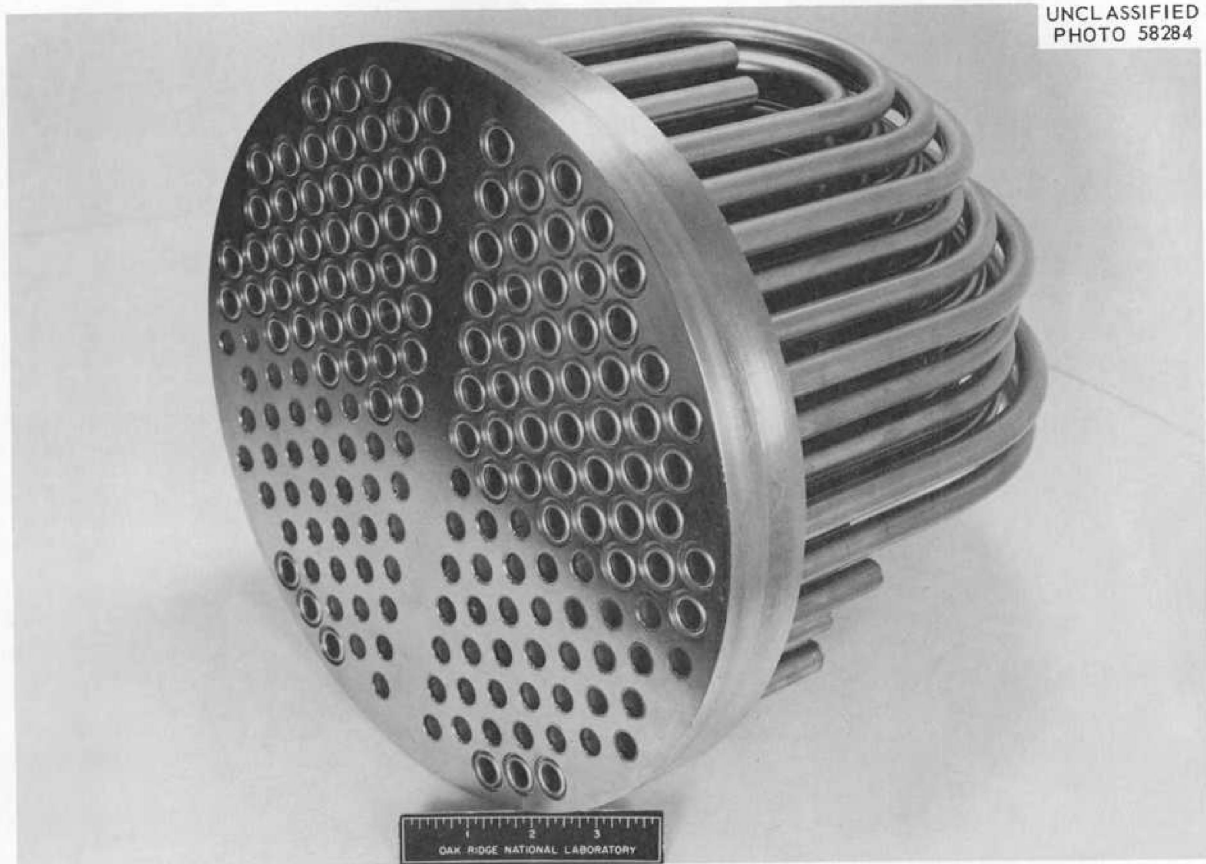
Fig. 7. Proof-Test Assembly Containing Short U-Tubes.

A proof test of all welding, brazing, and assembly conditions and techniques was carried out on a subsize 12-in.-diam assembly containing 98 joints with some short U-tubes. The unit is shown in Fig. 7. The header plate was drilled to the heat exchanger configuration to simulate

actual heat flow conditions during brazing. As an economy measure, the trepanning, drilling of the feeder holes, and application of brazing alloy was limited to only half the tubes. Dummy stainless steel tubes were tack-welded in the remaining holes.

Inspection of the completed assembly revealed no weld defects and excellent brazes in all joints except one, this one joint being completely unbrazed. Metallographic examination of this joint revealed small metal chips in the joint and a complete lack of wetting by the brazing alloy. The apparent cause of this condition was inadequate cleaning of the parts before assembly. Therefore, the importance of cleanliness to the brazing operation was greatly emphasized. Special handling and assembly procedures were instituted, and a full-time inspector was assigned to the job.
