OAK RIDGE NATIONAL LABORATORY

DATE: August 13, 1958
SUBJECT: Screening Tests of Mechanical Pipe Joints
for a Fused Salt Reactor System
TO: Distribution
FROM: W. B. McDonald, E. Storto, A. S. Olson

ABSTRACT

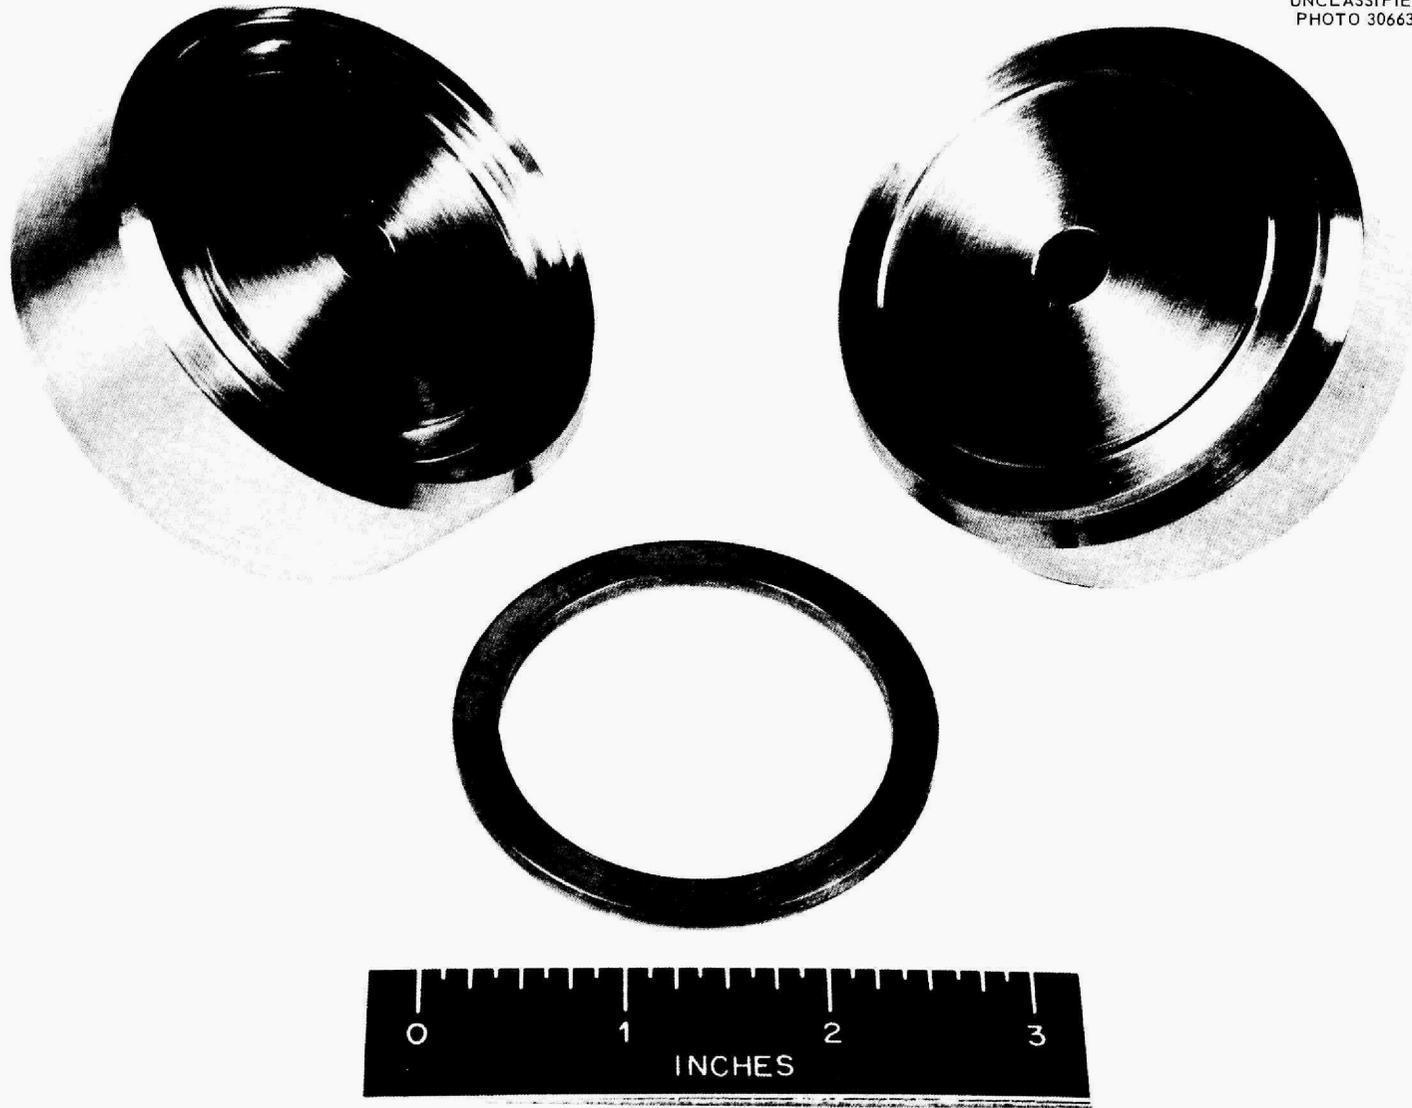
Fig. 5. Parts of Indented Seal Flange Before Testing.

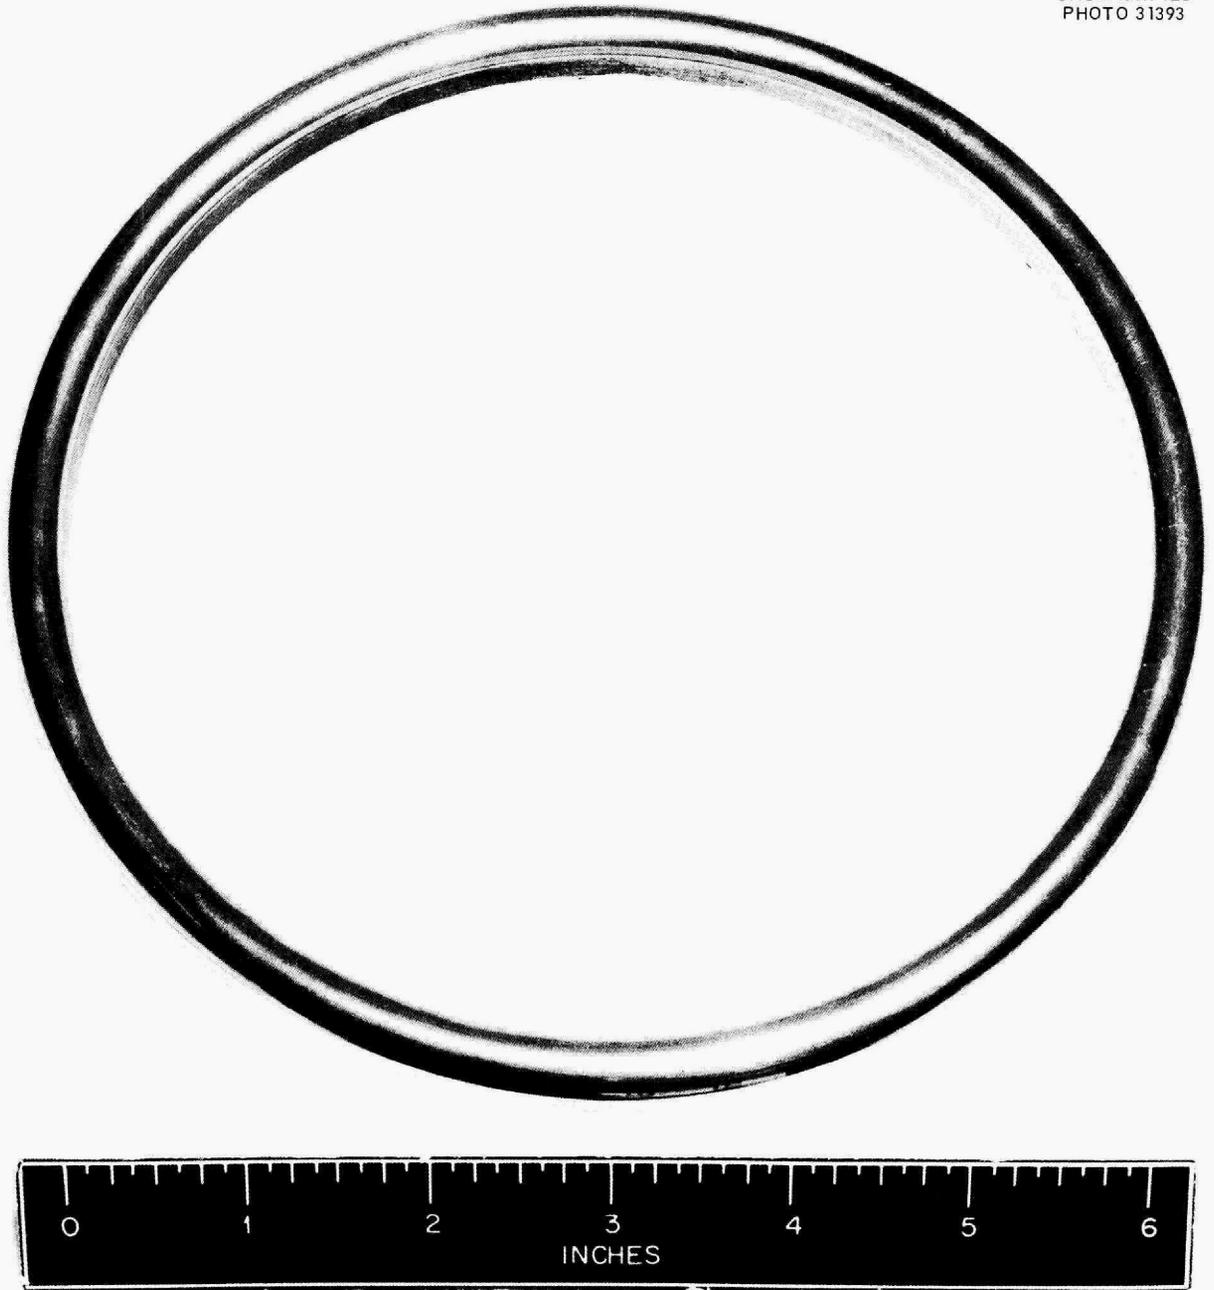
Oxidation of the copper seal rings was negligible. The rings had the same bright appearance after testing as they did originally. The Inconel flanges showed no noticeable salt corrosion. The flanges and seal rings are shown after the completion of Test No. 4 in Figs. 19 and 20.

Fig. 20. Copper Seal Ring from Small Freeze Flange After Test 4.

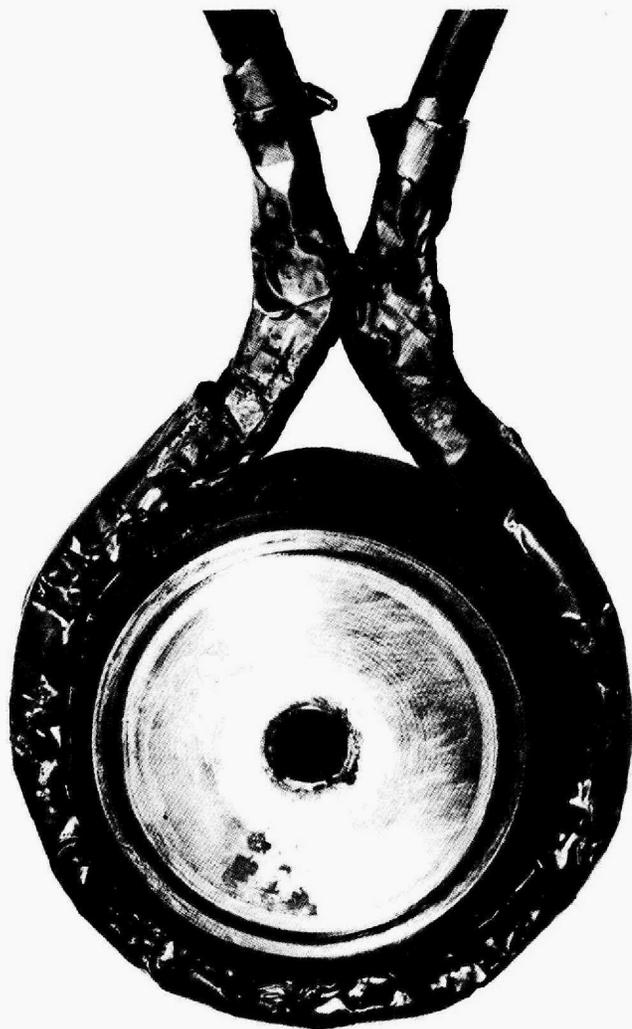
Fig. 30. Indented Seal Flange with Nickel-Plated Armco Iron Gasket After Testing.

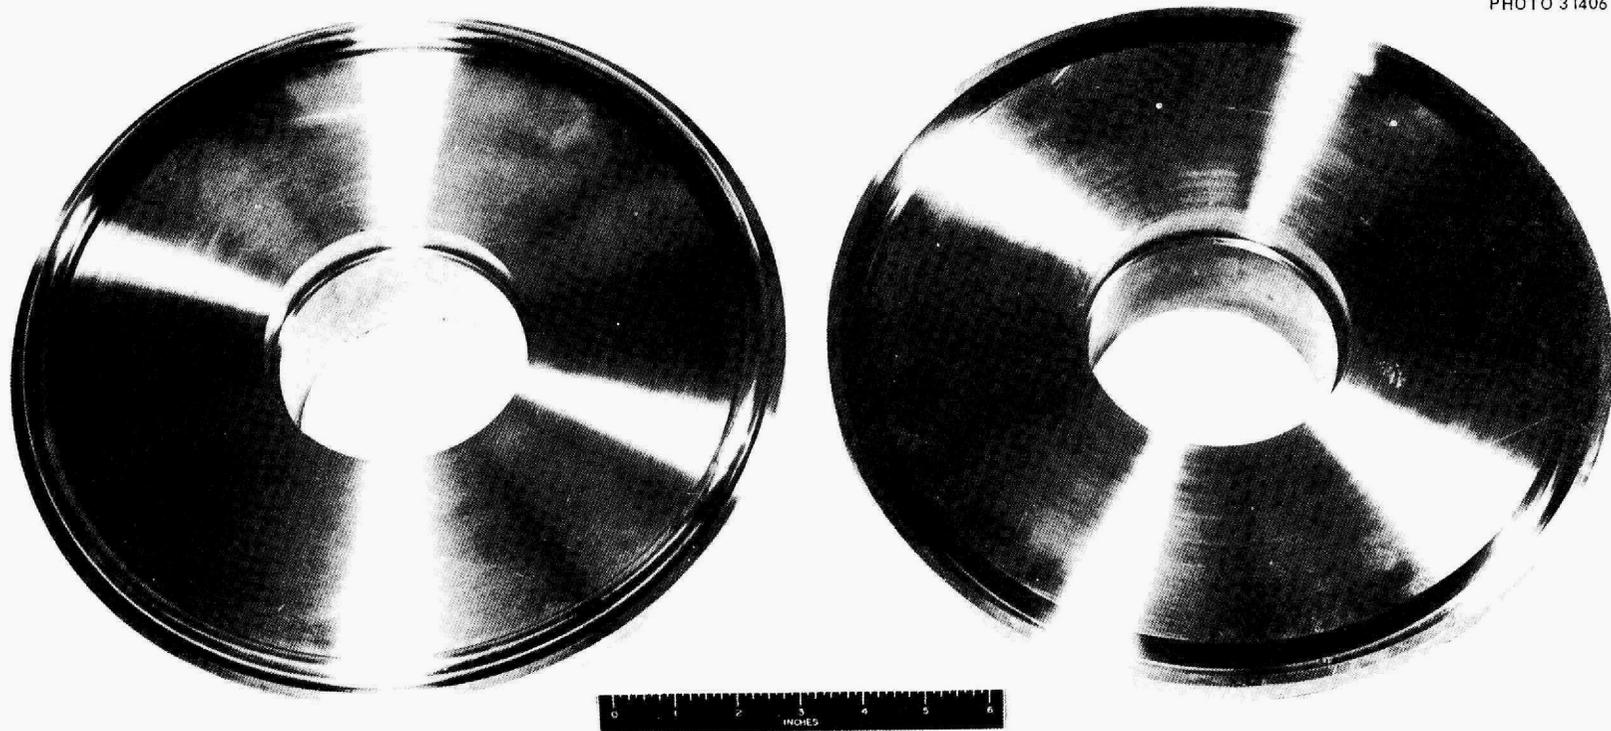
Fig. 33. Large Freeze Flange Shown Open with Copper Seal Ring in Place.

A larger size freeze flange joint has been fabricated. It is shown assembled in Fig. 32. The flange is shown open with the copper seal ring in place in Fig. 33. The principle of operation is identical to the small size flange tested and described above. Provision has been made on the ring seal for monitoring the gas leak rate during operation. Two such flanges have been fabricated for testing with molten salt in a loop, shown schematically in Fig. 34. The welding necks on the flanges will match a 4-inch, schedule 40 pipe. An unusual feature of the large flange is the use of a special clamp, made in two sections, which holds the flanges around their entire circumference. The clamp is shown in the assembly photograph, Fig. 32. Holes were placed in the webs to reduce heat conduction from the salt to the seal ring area. A metal screen will be inserted in the space between the flange faces to reduce the hold-up volume of salt,
