ORNL-TM-4189

EVALUATION OF HASTELLOY N ALLOYS  
AFTER NINE YEARS EXPOSURE TO BOTH  
A MOLTEN FLUORIDE SALT AND AIR AT  
TEMPERATURES FROM 700 TO 560°C

**METALS AND CERAMICS DIVISION**

DECEMBER 1972

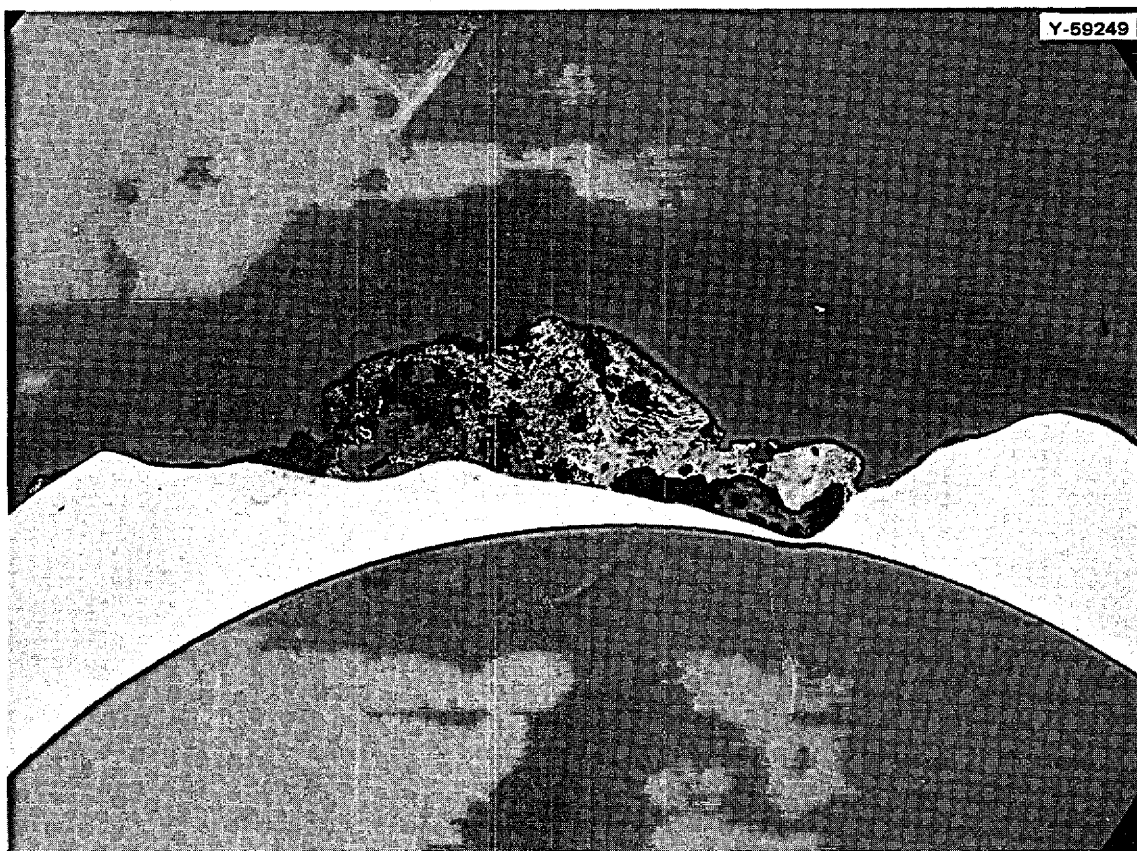
Fig. 7. Cross section of oxidized region adjacent to hole in failed section of loop. As polished, about 14X.

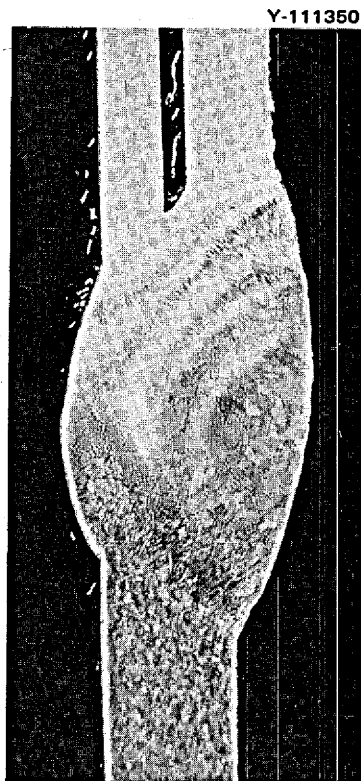
Fig. 29. Weld joining standard Hastelloy N tubing (top, right) and spacer (top, left) to modified Hastelloy N-2% Nb tubing (below). Left side exposed to salt at 665°C; right side exposed to air. Etched with glyceria regia. 12X.
