CORROSION BY MOLTEN FLUORIDES

ORNL-1491

METALLURGY DIVISION

Interim Report — September 1952

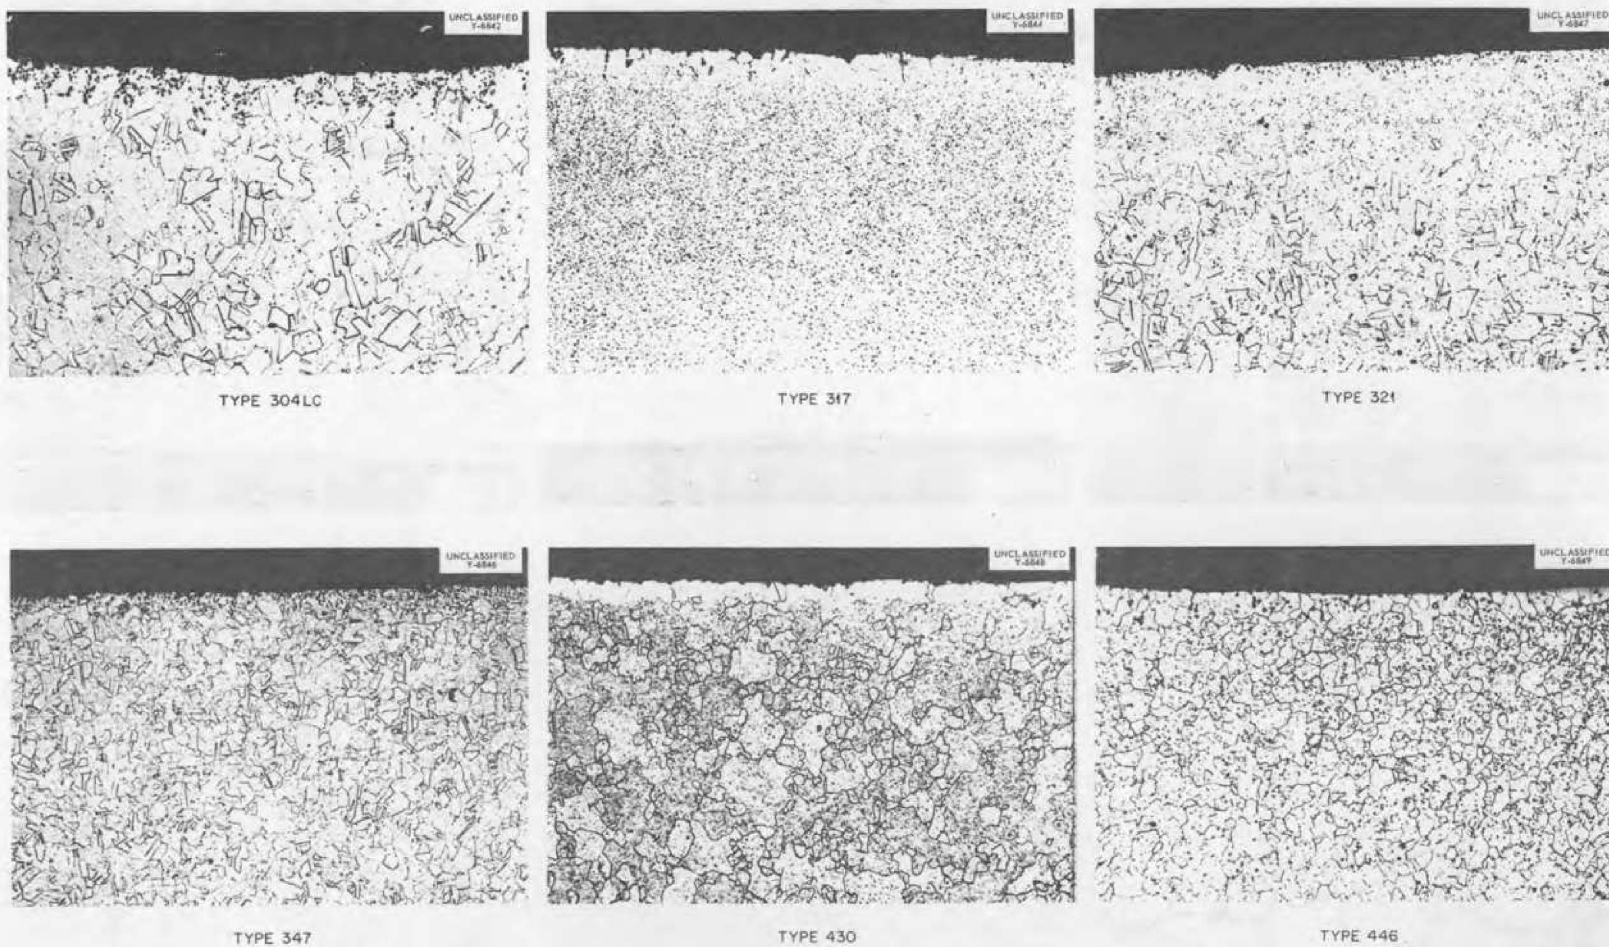
Screening Tests. A series of screening tests of various materials in molten fluoride mixture No. 14 were made. These tests were made with dehydrated, unpretreated fluoride mixture for 100 hr at 816°C under static vacuum. The results of these tests are given in Table 1. Molybdenum, columbium, Monel, Stellite No. 25, and nickel plus 1/4% zirconium alloy were apparently unattacked. All of the 300 series stainless steels tested (304 ELC, 309, 310, 317, 321, 347) were attacked to a depth of 1 mil or less, except types 304 ELC and 309, which were attacked to a depth of 2 mils. Four-hundred series stainless steels (only two types) were not attacked over 1 mil. Z nickel was the most severely attacked material of those tested, being affected to a depth of 5 mils. Figures 2 and 3 show typical samples of the types of attack observed.

Fig. 2. Static Corrosion Tests of Stainless Steels in Fluoride Mixture No. 14 for 100 hr at 1500°F. Original magnification 250X, reduced 58%.

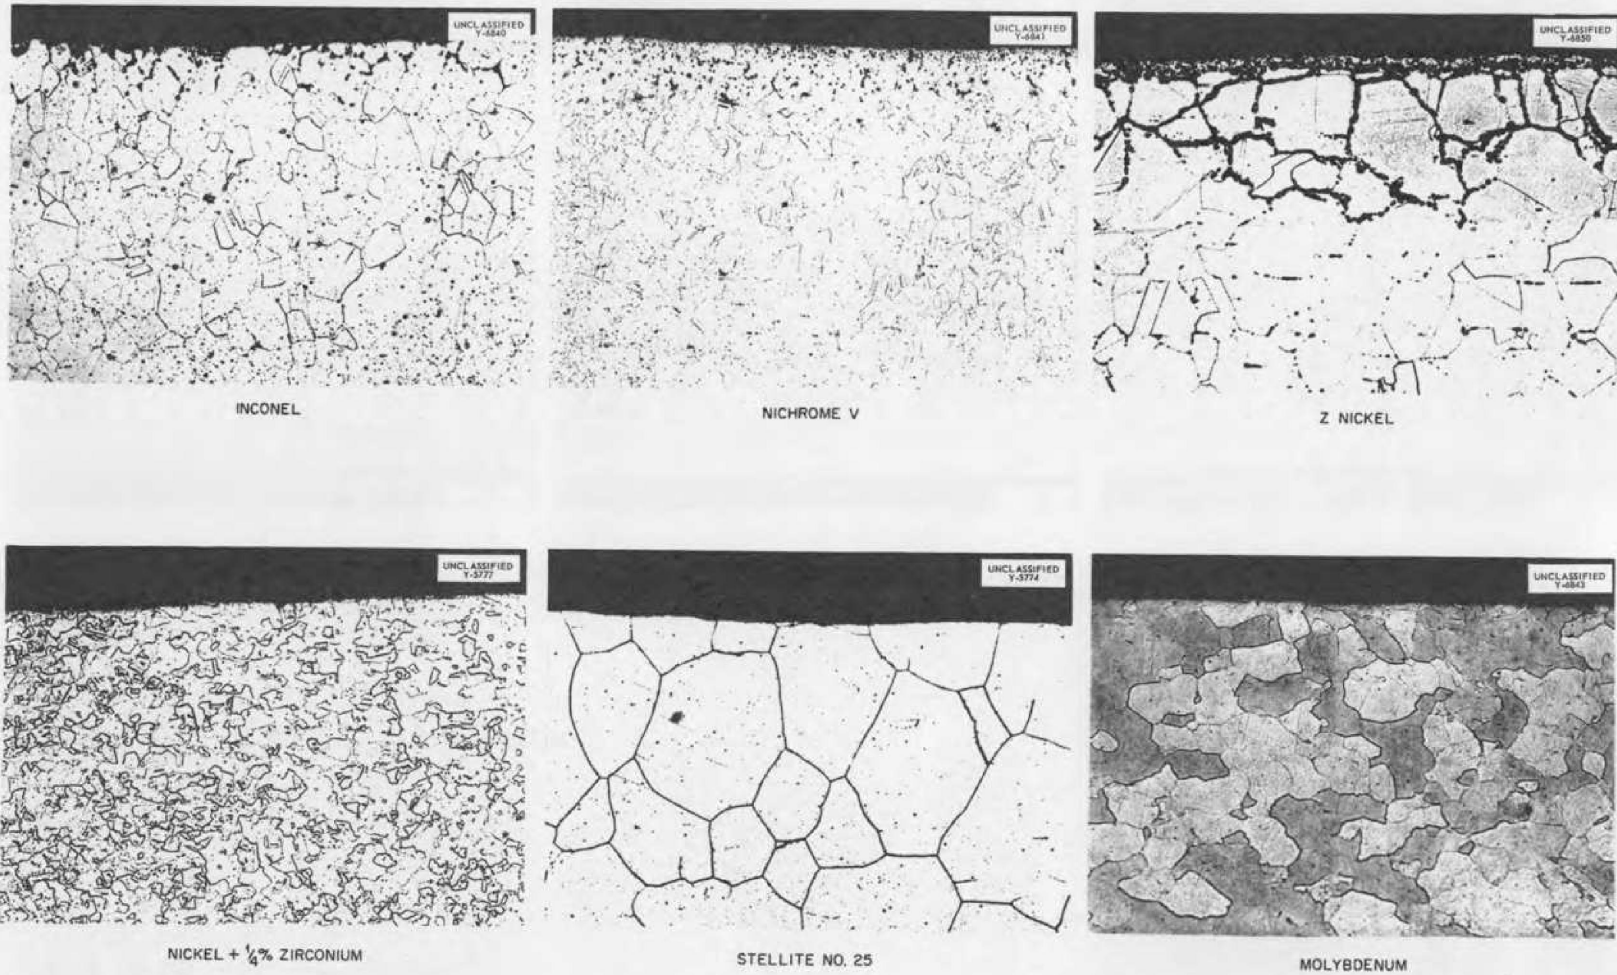
Fig. 3. Static Corrosion Tests in Fluoride Mixture No. 14 for 100 hr at 1500°F. Original magnification 250X, reduced 58%.

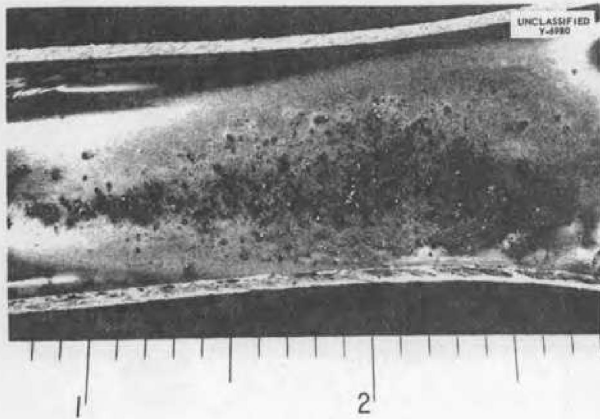
A seesaw test run with nickel–1/4% zirconium alloy showed severe mass transfer effects. Figure 4 shows this test.

Fig. 4. Cold End of Nickel-1/4% Zirconium Alloy Seesaw Test Specimen Run for 216 hr at a Hot-End Temperature of 798°C and a Cold-End Temperature of 610°C.

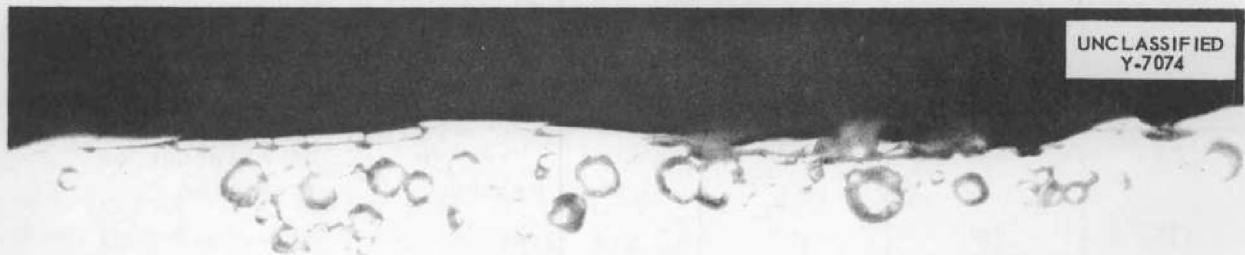
Figure 5 shows results obtained at different temperatures. Figure 6 shows the type of layer formed at temperatures of 1200°C and above. It is believed that this film acts as a barrier to the diffusion of chromium and thus prevents the formation of voids. X-ray-diffraction patterns of this film show it to be UO_2.

Fig. 6. Layer Formed on Inconel at 1200°C by Exposure to Fluoride Mixture No. 14 in Static Test for 200 Hours. 1000X.

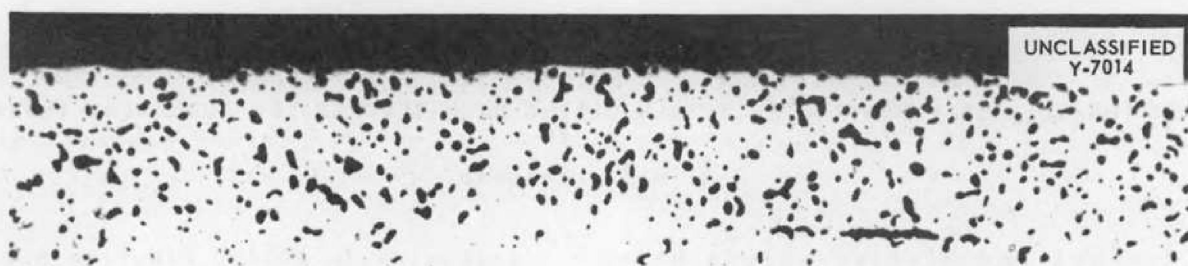
Fig. A1. Subsurface Voids Usually Encountered After Inconel or Stainless Steels Contact Molten Alkali Fluoride at Temperatures of About 816°C for 100 Hours. Inconel, unetched, 250X.

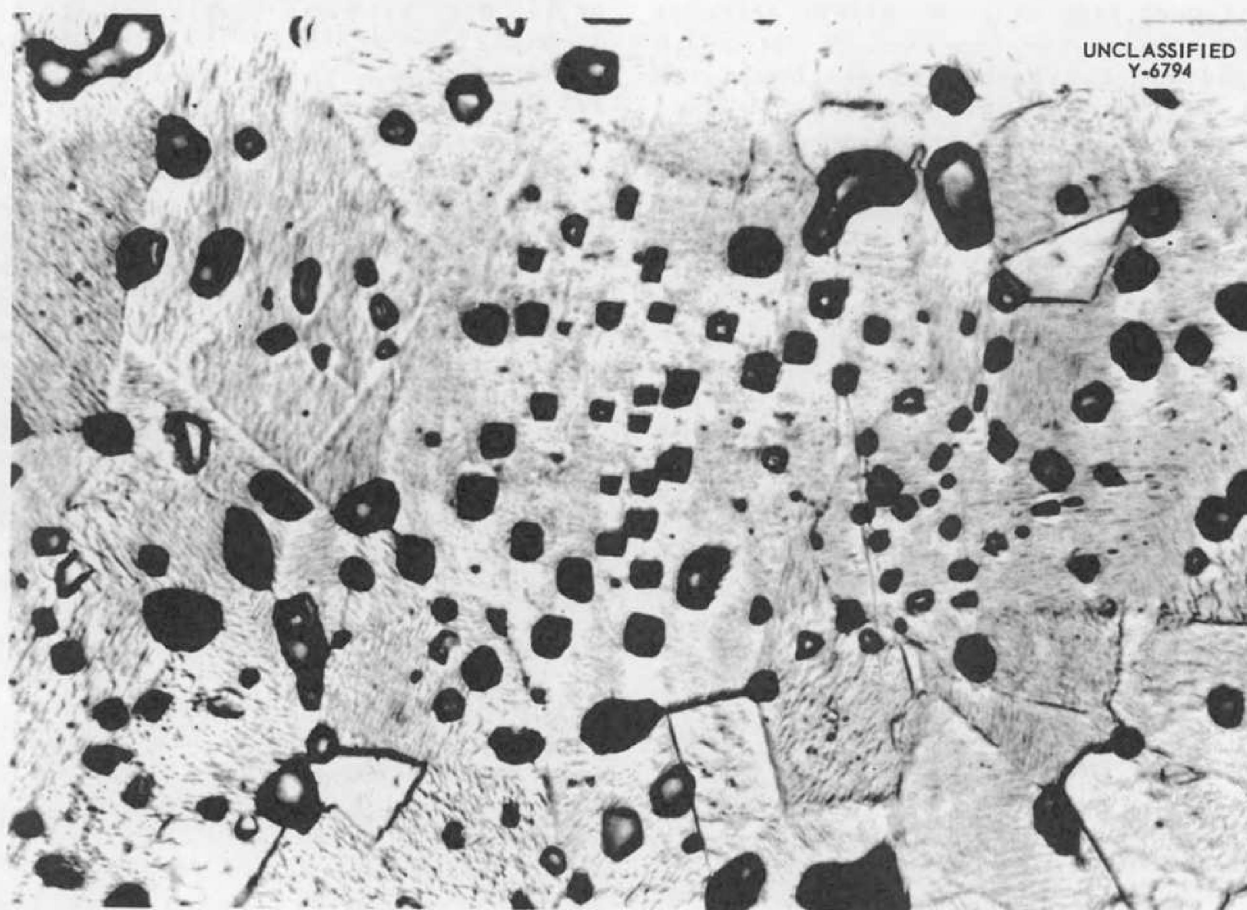
Fig. A2. Appearance of Subsurface Voids at High Magnification. Etched, 2000X.

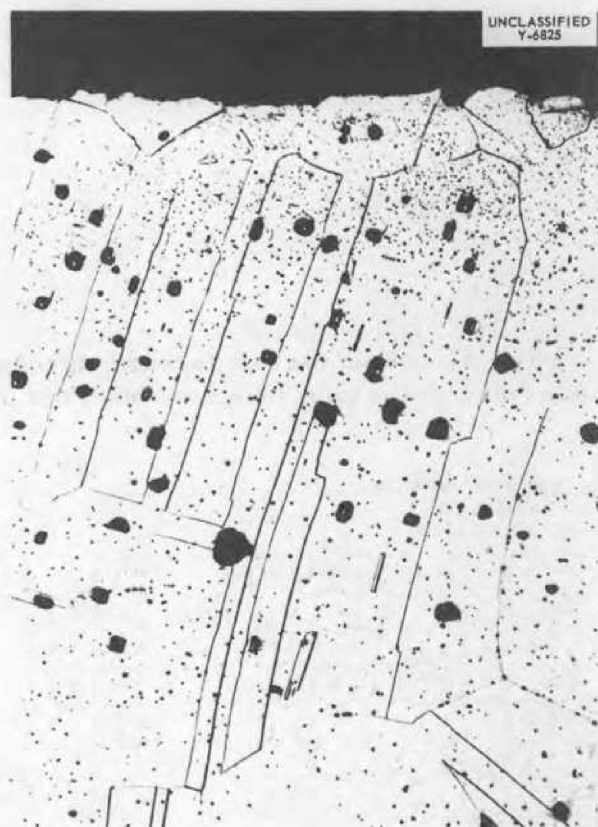
High-Temperature Vacuum Treatment. The high vapor pressure of chromium relative to that of iron or nickel suggests that high-temperature vacuum treatment would also be a suitable means of producing a chromium gradient. Specimens of Inconel and an 80% Ni–20% Cr alloy were exposed to a vacuum of 0.1 mm Hg for 42 hr at 1375°C and then furnace-cooled. Both samples showed many subsurface voids; the voids in Inconel appeared to be spherical, whereas those in the 80% Ni–20% Cr alloy were angular. These are shown in Fig. A3.

Fig. A3. Section of 80% Ni–20% Cr Alloy After 42-hr Exposure to Vacuum at 1375°C. Void shape bears some relationship to twin lines; note similarity to Fig. A2. Etched. Original magnification 250X, reduced 32%.

The voids shown in Fig. A3 are of two sizes. The larger ones are believed to have occurred at temperature in the usual manner, whereas in the case of the smaller ones, it is interesting to visualize them as having occurred on cooling. Rough approximations of vacancy densities at several temperatures based on the formula of Mott and Gurney[6] indicate that such a theory is not improbable. Hence, it may be assumed that there is a temperature coefficient of "solubility" for vacant atoms such as there is for foreign atoms.

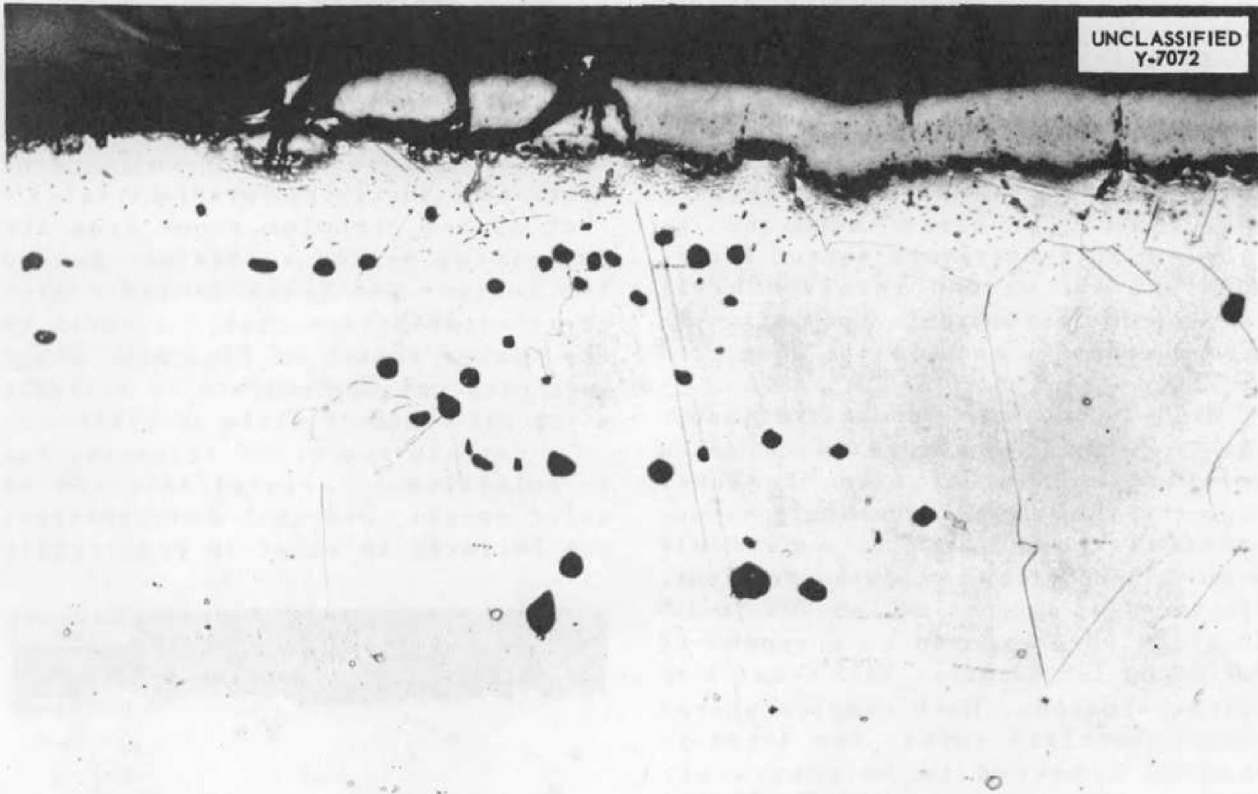
An Inconel specimen was therefore exposed to air at 1250°C for 200 hours. After oxidation, metallographic examination revealed the usual oxide layer on the surface and in the adjacent grain-boundary areas. In addition, subsurface voids were observed as anticipated; these are shown in Fig. A4.

**Fig. A4.** **Section of Inconel Specimen After 200-hr Exposure to Air at 1250°C.**

Note void formation beneath oxidized region. Unetched, 250X.
