ORNL-3253
UC-25 - Metals, Ceramics, and Materials

CORROSION OF VOLATILITY PILOT PLANT
MARK I INOR-8 HYDROFLUORINATOR
AND MARK III L NICKEL FLUORINATOR
AFTER FOURTEEN DISSOLUTION RUNS

OAK RIDGE NATIONAL LABORATORY
operated by
UNION CARBIDE CORPORATION
for the
U.S. ATOMIC ENERGY COMMISSION

FEB - 9 1962

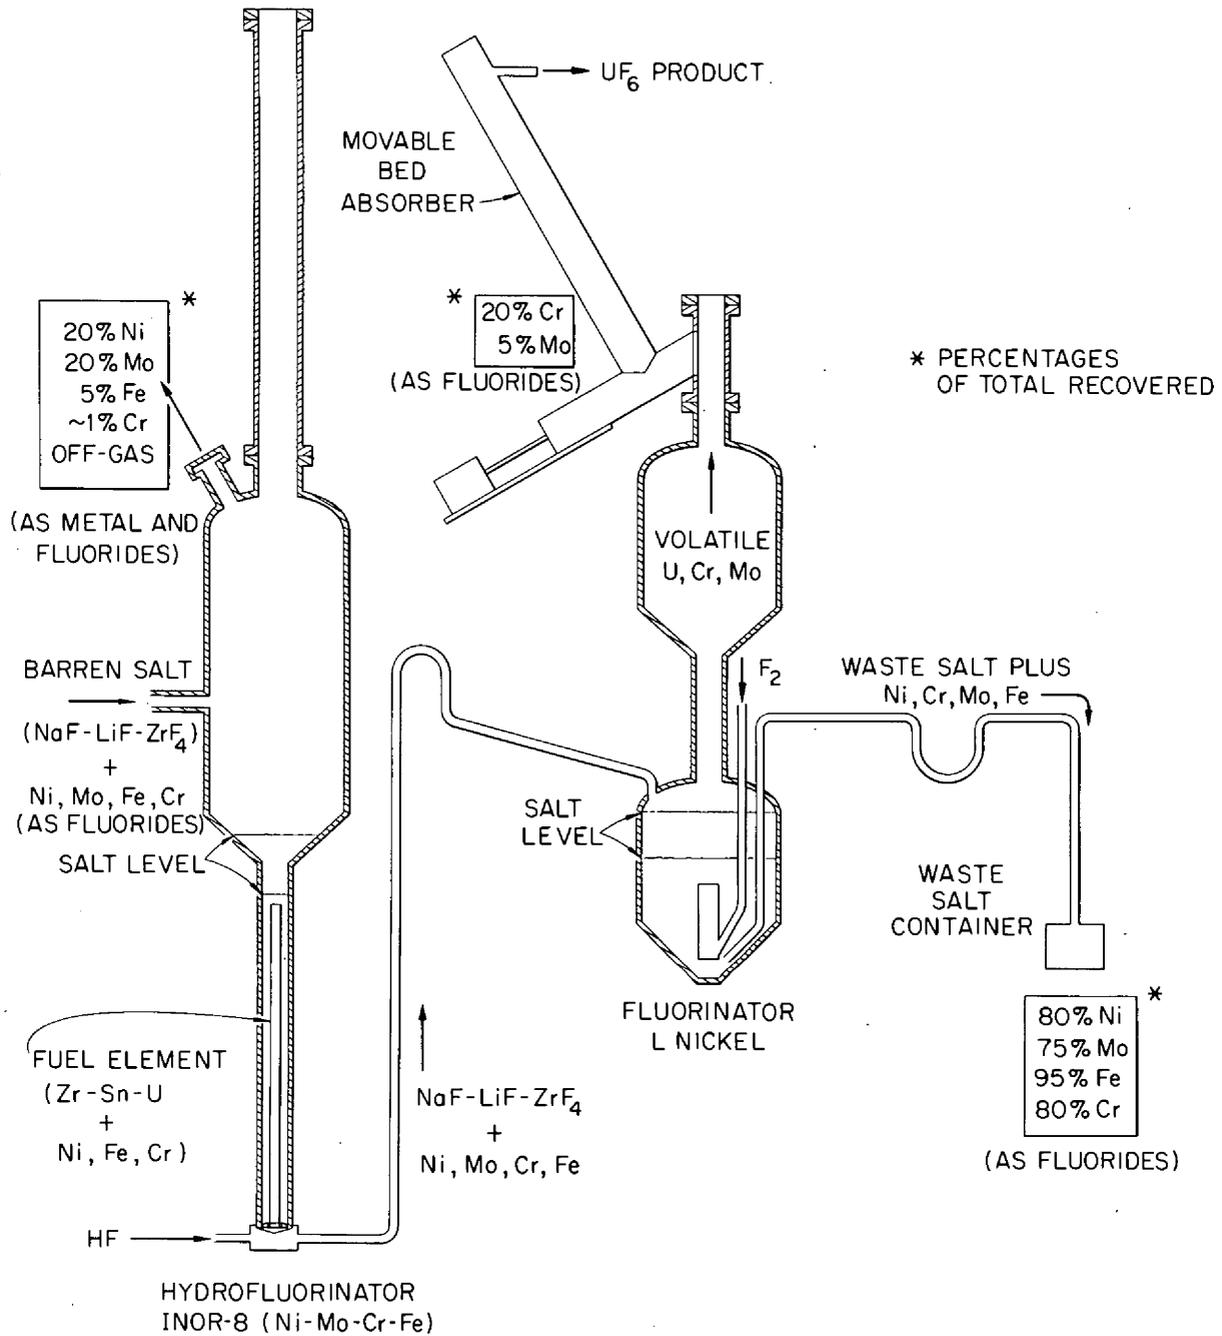
Chemical analyses of the off-gas stream from the hydrofluorinator, of the waste salt from the VPP, and of the movable-bed absorber have been studied¹⁰⁻¹³ as a means of estimating past and future corrosion of the dissolver vessel. Figure 4 shows the transport paths of Ni, Mo, Cr, and Fe during the 14 dissolution runs, and approximate mean percentages of the total of each element found either as a metal or as a fluoride. Quantitatively, during each run considerably more Ni, Cr, and Fe were found in the waste salt, movable-bed absorber, or off-gas system than had been introduced into the system from the feed salts or the fuel elements. This was the first positive indication of hydrofluorinator corrosion. On the other hand, only about half the molybdenum introduced from the feed salt was found in other regions of the process system.^{11,12} Other work⁸ indicates that the molybdenum may be plating out in the hydrofluorinator and/or possibly¹⁴ combining as an intermetallic compound with nickel in the INOR-8. The transport and final disposition(s) of molybdenum are being investigated.

Fig. 4. Transport Paths of Ni, Mo, Cr, and Fe in the VPP Fluoride Volatility Process During 14 Dissolution Runs. Percentages are approximate means of the totals of each element found in the off-gas system, movable-bed absorber, and waste salt.

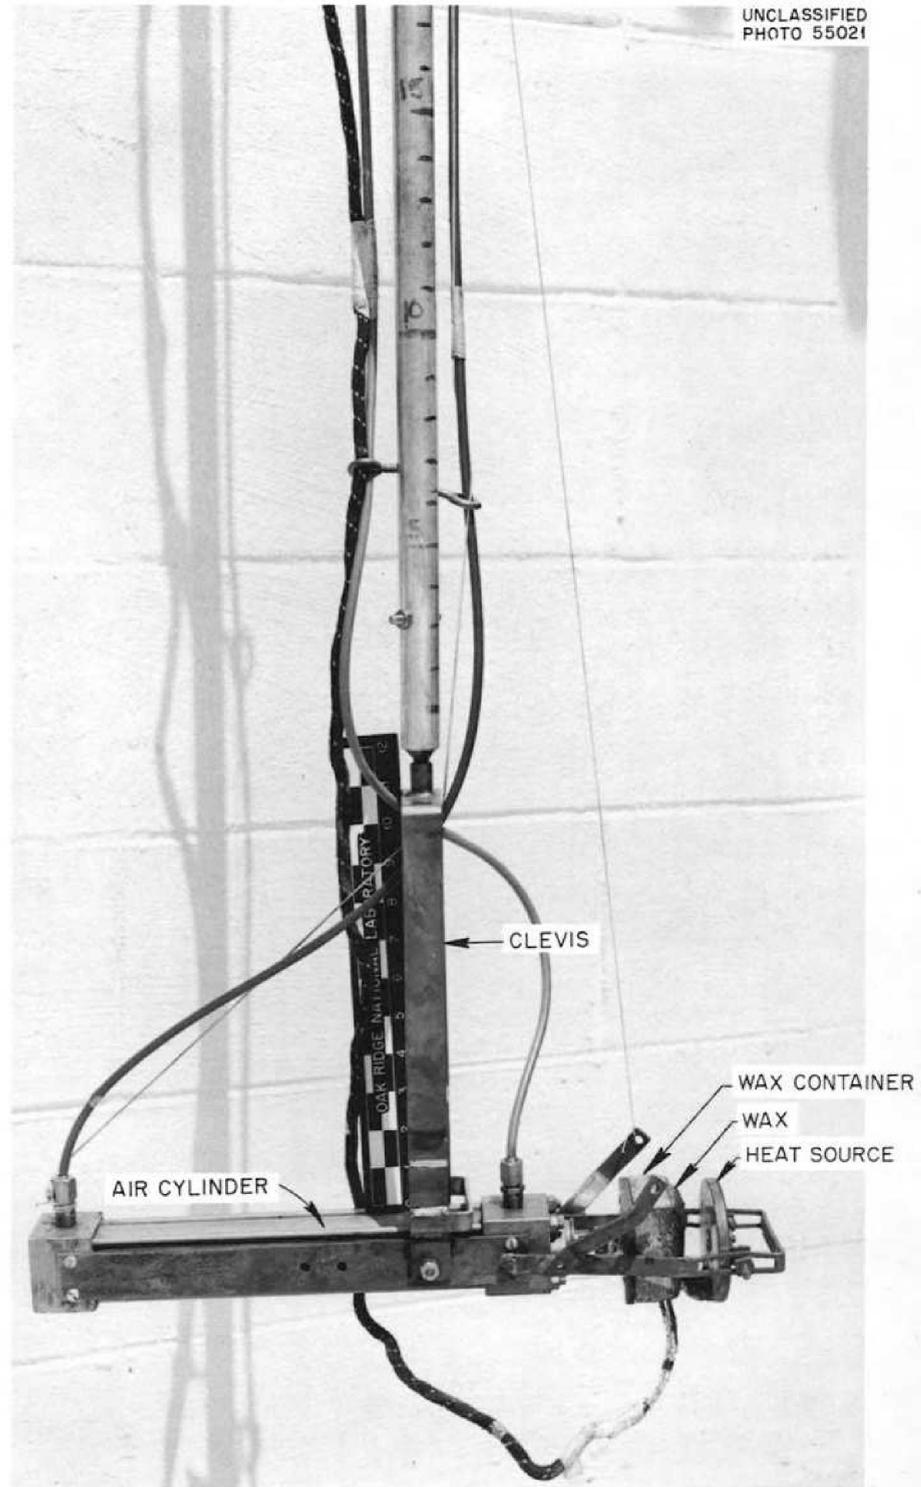
wax to a suitable temperature, and activating the air cylinder to press the softened wax against the wall of the vessel. Figure 5 shows the replication device in mockup position during heating. Since the device, as presently designed, requires large internal clearances, only portions of the top cylinder of the hydrofluorinator could be replicated.

Fig. 5. Wax Replication Device Used for Obtaining Impressions of Pits in the VPP Hydrofluorinator. In order to insert or remove device through the fuel charging chute, the air cylinder was positioned vertically within the clevis.
