2362
ORNL-4829

INTERGRANULAR CRACKING OF INOR-8 IN THE MSRE

H. E. McCoy
B. McNabb

NOVEMBER 1972

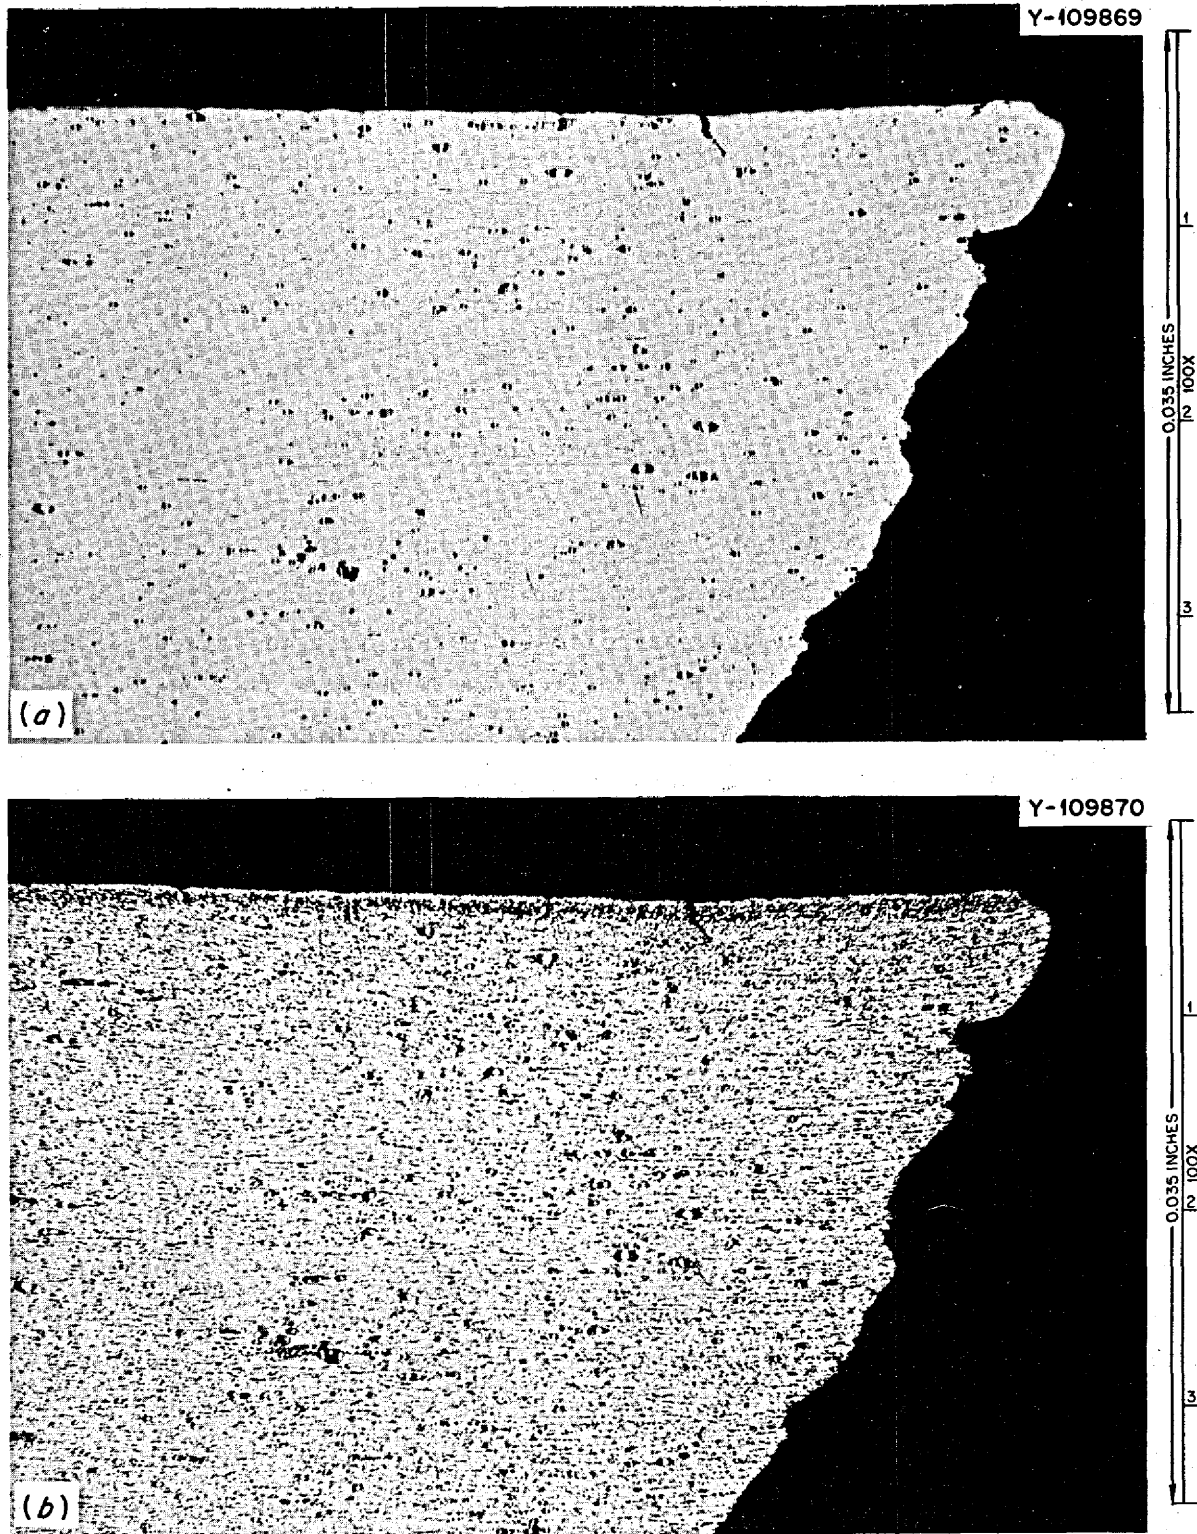
The only visible change in the specimens as a result of their exposure was that the originally shiny specimens of INOR-8 had developed a bright gray-white matte surface.¹⁵ The microstructure of one of the specimens after it was fractured at 25°C is shown in Fig. 7. No grain-boundary cracks are visible. The 1-mil surface layer that etched more darkly caused some concern at first. However, as will be brought out later, the modified surface layer was present on control specimens as well as on those exposed in the core and, on a series of specimens, showed no systematic variation with exposure time. Further work showed that it was likely cold-work from machining causing carbides to precipitate more readily near the surface. (See later discussion of possible connection to surface cracking.)

Fig. 7. Microstructure of INOR-8 Sample Held Above 500°C for 3306 hr During the "Zero-power" Run of the MSRE. (Fuel was in system 1090 hr.) (a) As polished. (b) Etched with glyceria regia. The material is cold worked, and the grains are not delineated by etching.

The important point to be noted here is that INOR-8 specimens exposed to fuel salt for a considerable period of time before the generation of substantial nuclear power (and fission-product inventories) showed no intergranular surface cracks upon testing at 25°C.

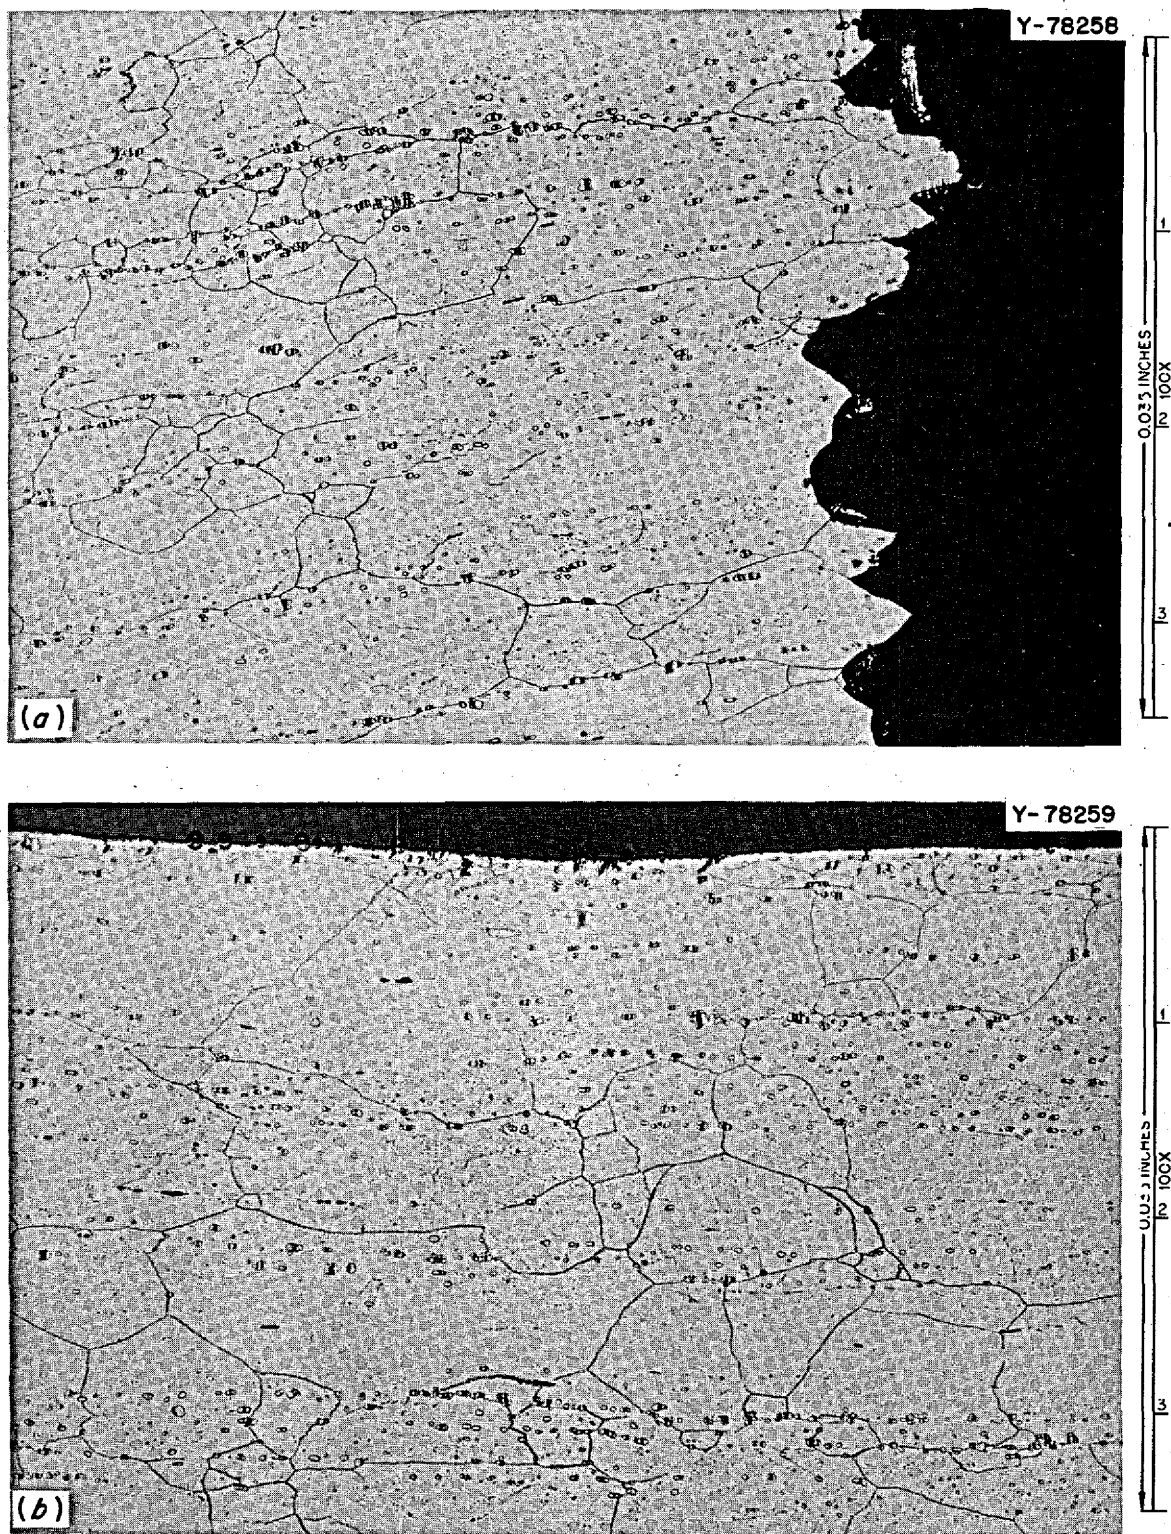
Fig. 10. Photomicrographs of Control Specimen DC-24 from Heat 5085 Tested at 25°C and at a Strain Rate of 0.05/min. (a) Fracture. (b) Edge of specimen about 1/4 in. from fracture. Etchant: glyceria regia.

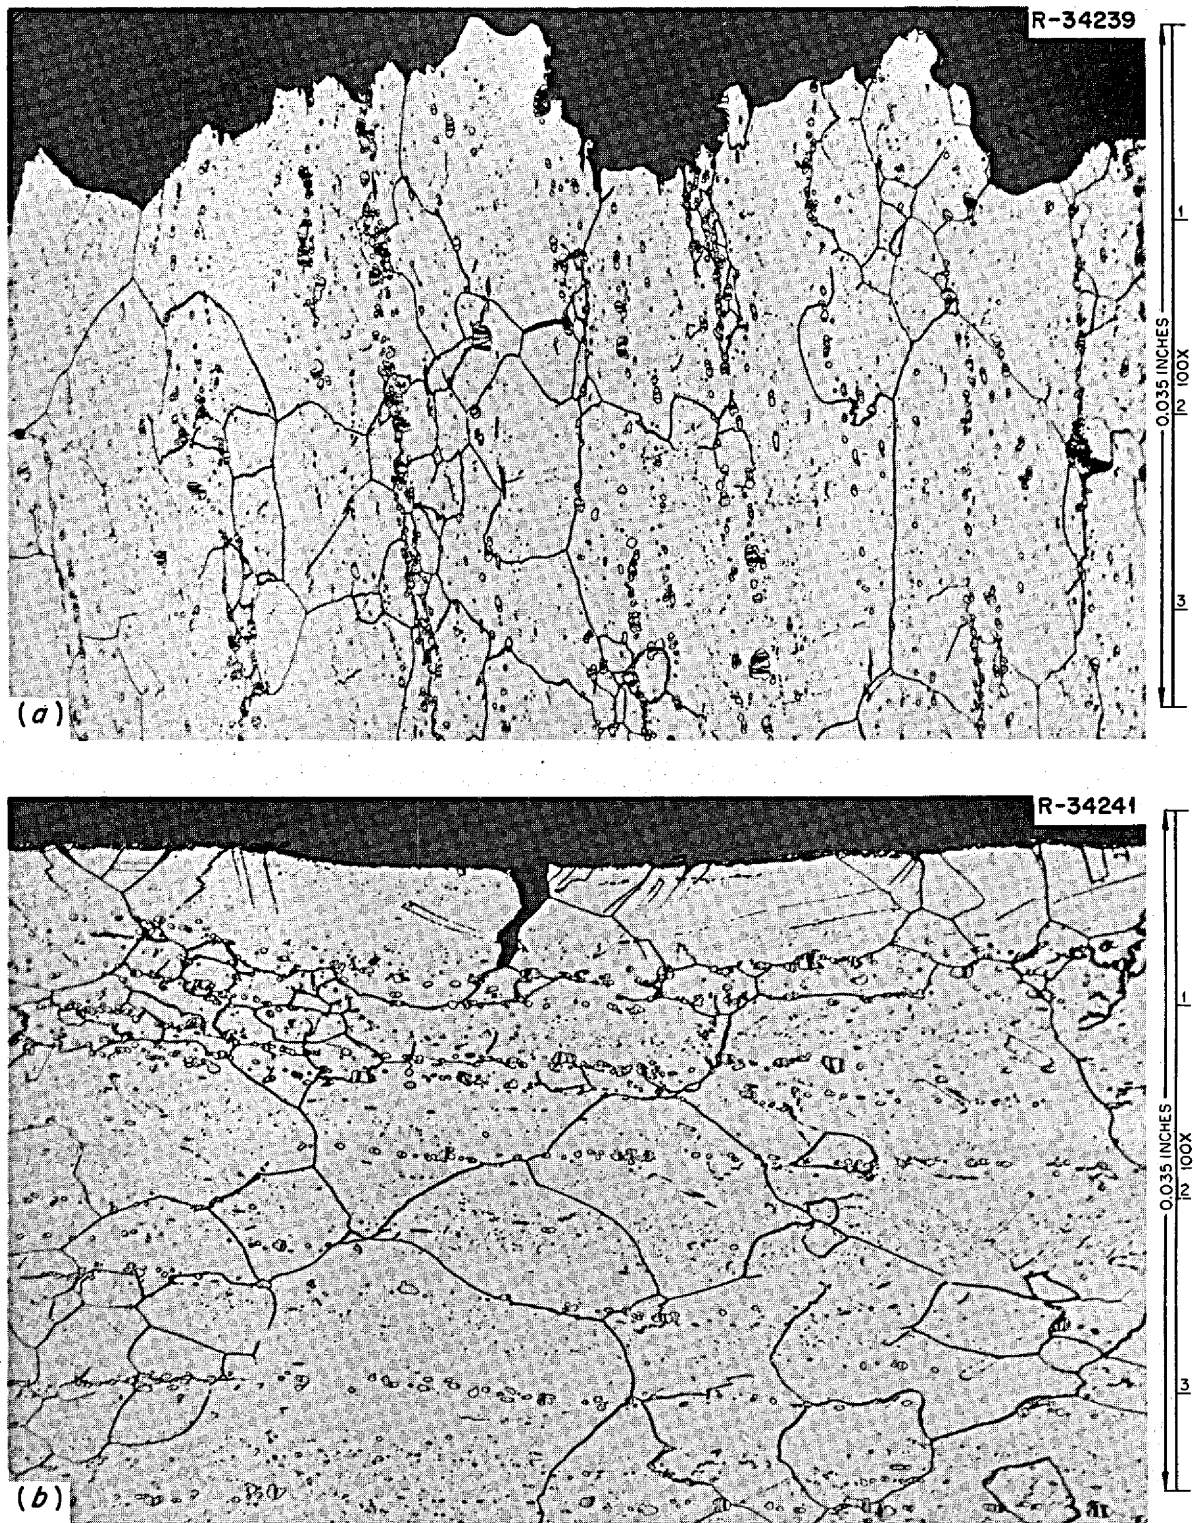
Fig. 11. Photomicrographs of Surveillance Specimen A-16 from Heat 5085 Tested at 25°C and at a Strain Rate of 0.05/min. (a) Fracture. (b) Edge of Specimen about 1/4 in. from fracture. Etchant: glyceria regia.

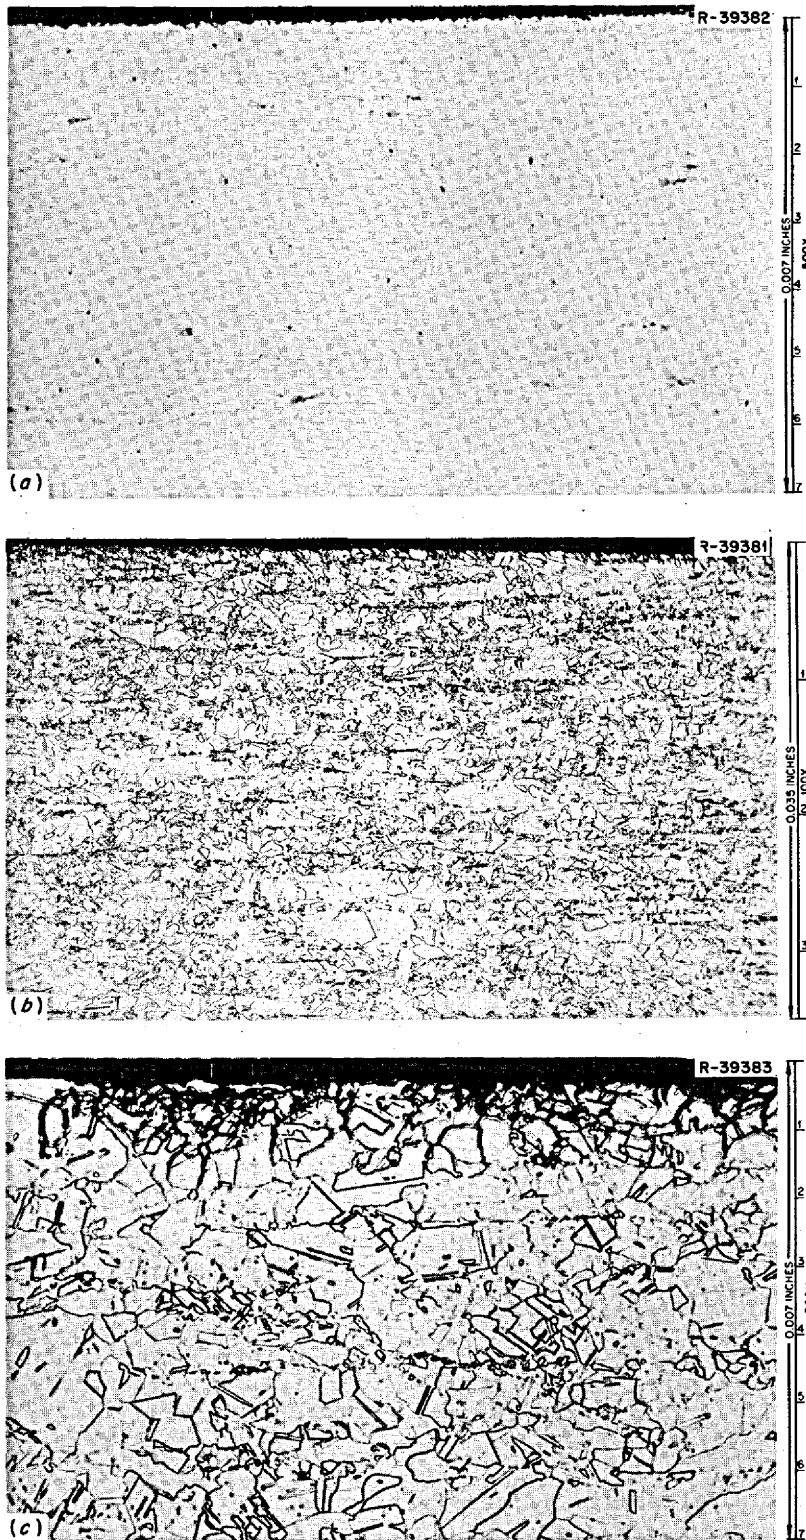
Visual inspection showed the core specimens to be very slightly discolored but otherwise apparently unaffected. Photomicrographs of specimens (unstrained) after exposure are shown in Figs. 13 and 14. (The unusually fine grain size is due to the fabrication history of the specimens, which included 100-hr anneals at 870°C.) The as-polished views of specimens of both heats show some evidence of grain boundary modifications to a depth of 1 to 2 mils, and both show some tendency to etch more readily near the surface.

Fig. 13. Photomicrographs of Zirconium-Modified INOR-8 (Heat 21554) Removed from the MSRE after 5554 hr above 500°C. Edge exposed to flowing salt. (a) As polished. 500x. (b) Etchant: aqua regia. 100x. (c) Etchant: aqua regia. 500x. Reduced 30%.

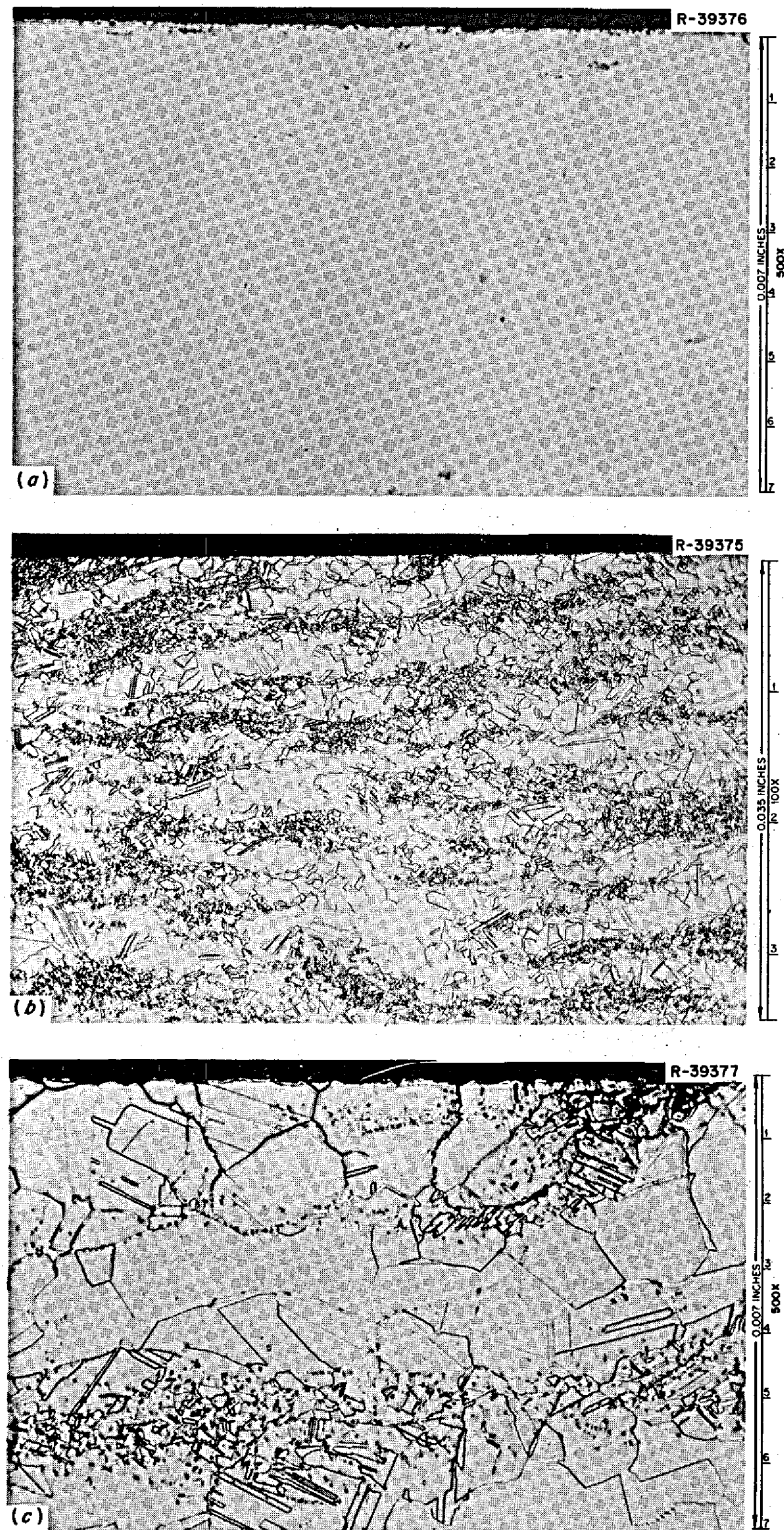
Fig. 14. Photomicrographs of Titanium-Modified INOR-8 (Heat 21545) Removed from the MSRE After 5554 hr above 500°C. Edge exposed to flowing salt. (a) As polished. 500x. (b) Etchant: aqua regia. 100x. (c) Etchant: aqua regia. 500x. Reduced 33%.

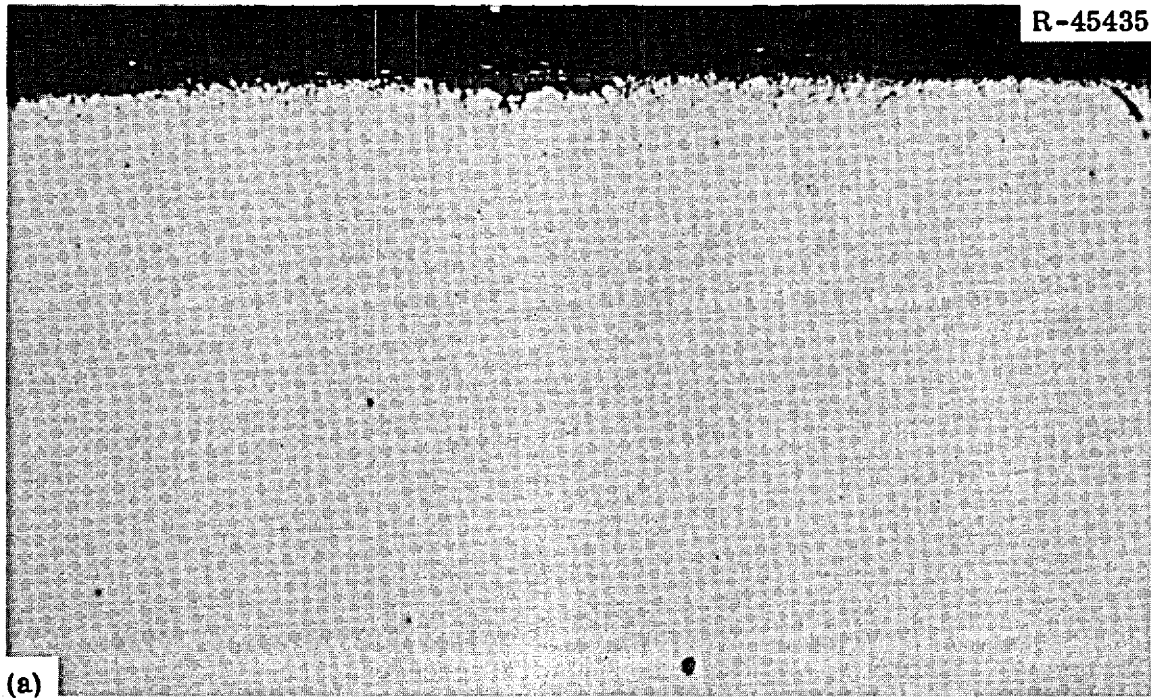
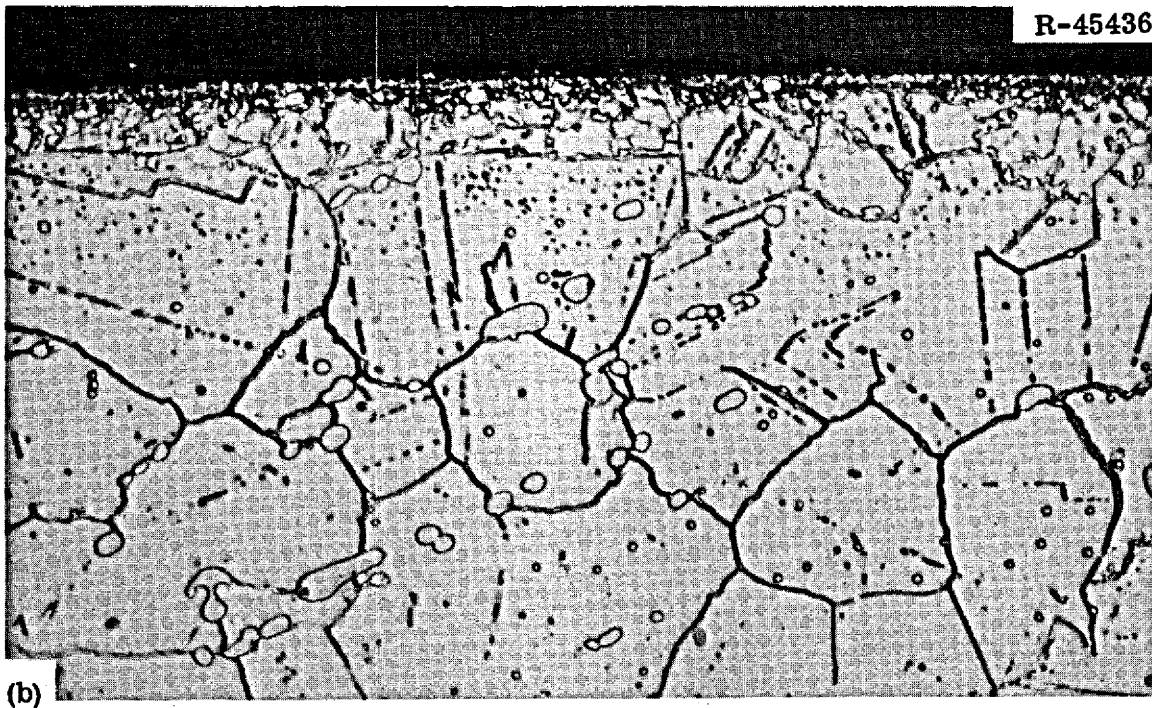
Stringers RR2, with the standard heats, had been exposed 2 to 4 times as long as the standard alloy specimens in the first group. (The factor depends upon which exposure index is used; see Table 3.) Effects of the longer exposure were evident in metallographic examinations of unstrained specimens. Figures 19 and 20 are of specimens of heats 5065 and 5085 exposed on stringer RR2 in the core. Some of the grain boundaries near the surface are visible in the as-polished condition, and a few appear to be opened as small cracks with a maximum visible depth of about 1 mil. The etched views show the large amounts of carbide precipitate that formed along the grain boundaries and the modified structure near the surface, which is thought to be due to working from machining. In samples of these heats exposed in the control facility, grain boundaries were not visible in as-polished samples. This is shown for heat 5065 in Fig. 21. As in the core specimens, however, etching brought out the carbide precipitate and the modified structure near the surface. The microstructure of control specimens of heat 5085 was quite similar.

Fig. 19. Photomicrographs of INOR-8 (Heat 5065) Surveillance Specimens Exposed to Fuel Salt for 11,933 hr above 500°C, 500x. Shallow reaction layer is seen near surface. (a) Unetched. (b) Etched (glyceria regia).

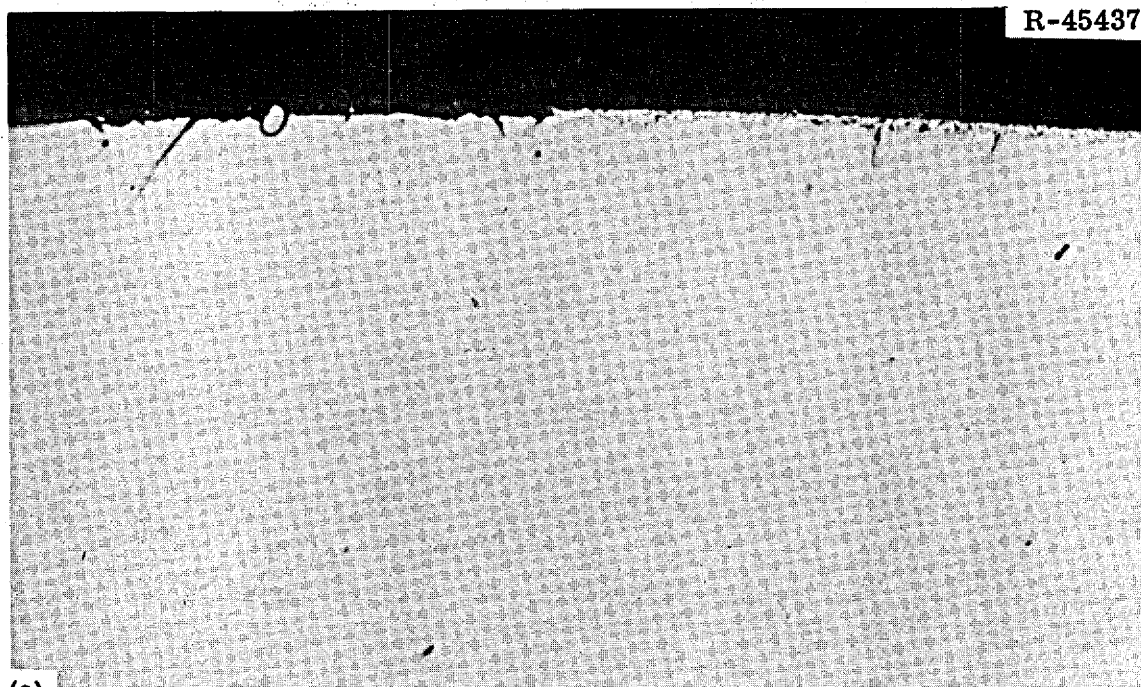
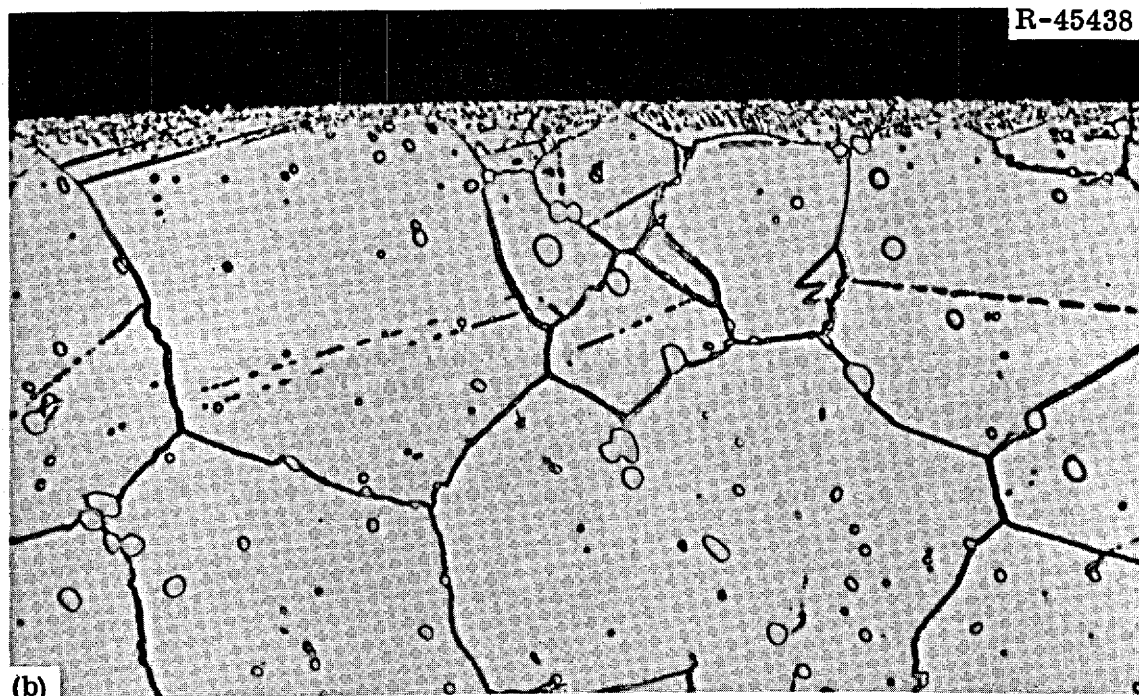
Fig. 20. Photomicrographs of INOR-8 (Heat 5085) Surveillance Specimens Exposed to Fuel Salt for 11,933 hr above 500°C. 500x. Shallow reaction layer is seen near surface. (a) Unetched. (b) Etched (glyceria regia).

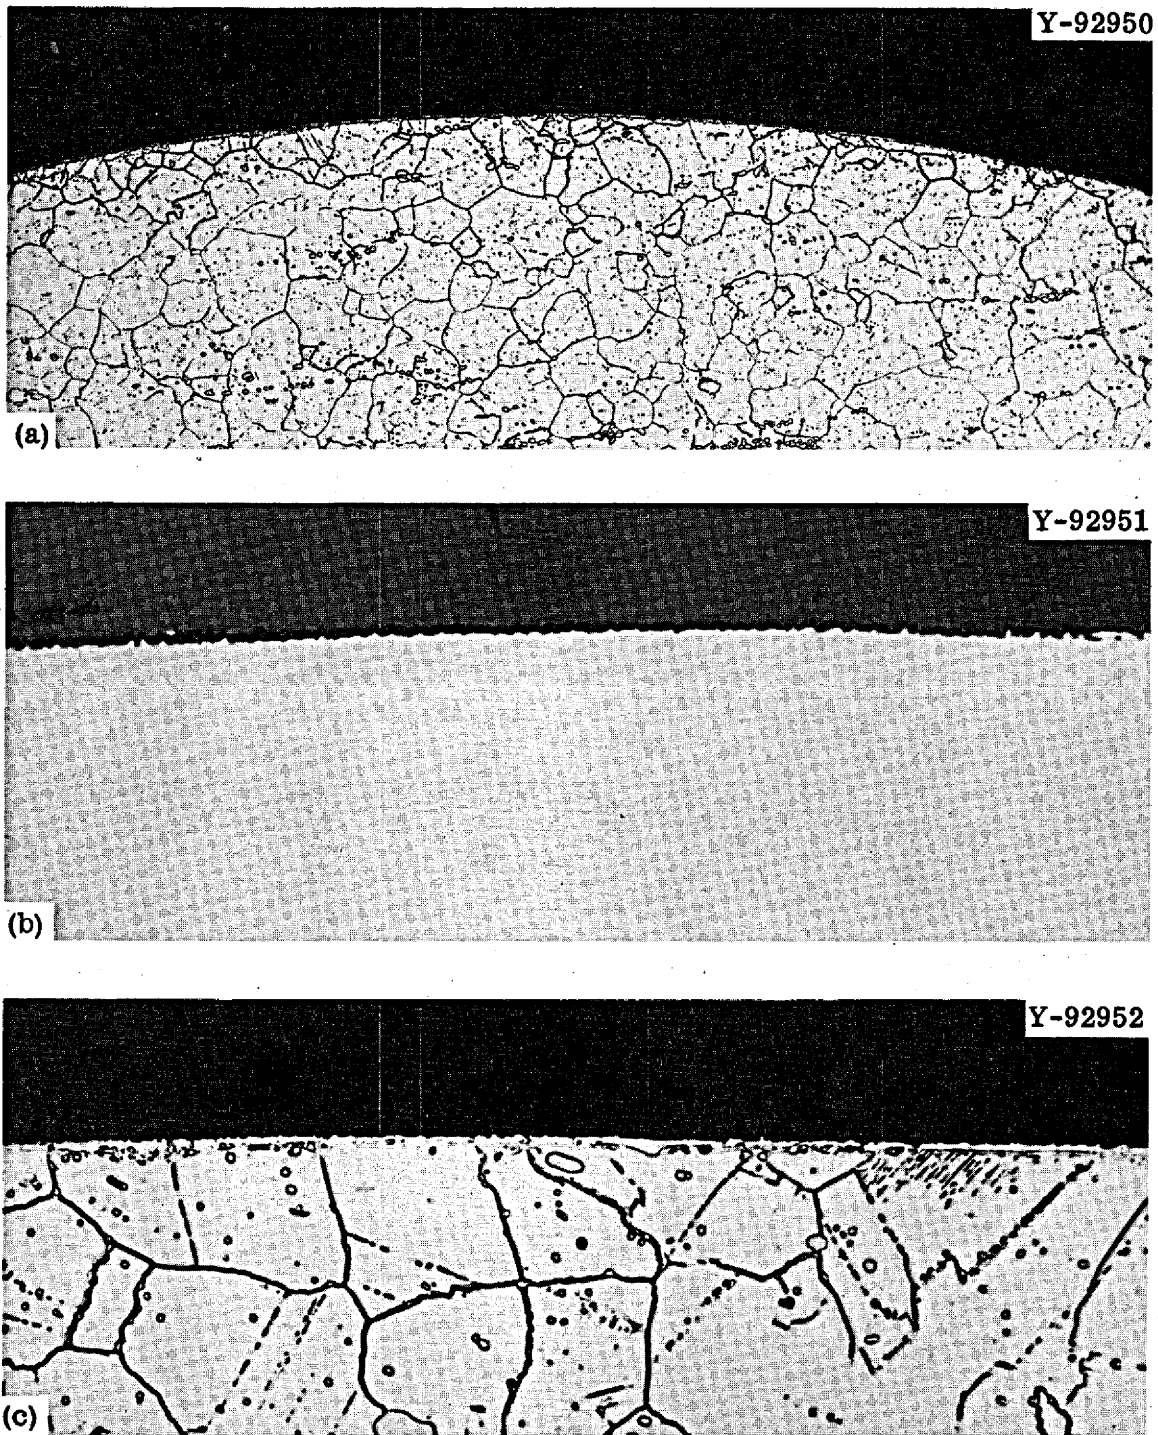
Fig. 21. Photomicrographs of INOR-8 (Heat 5065) Surveillance Control Specimens Exposed to Static Barren Fuel Salt for 11,933 hr above 900°C. Note the shallow reaction layer near the surface. (a) Etched. 100x. (b) As polished. 500x. (c) Etched. 500x. Etchant: glyceria regia.

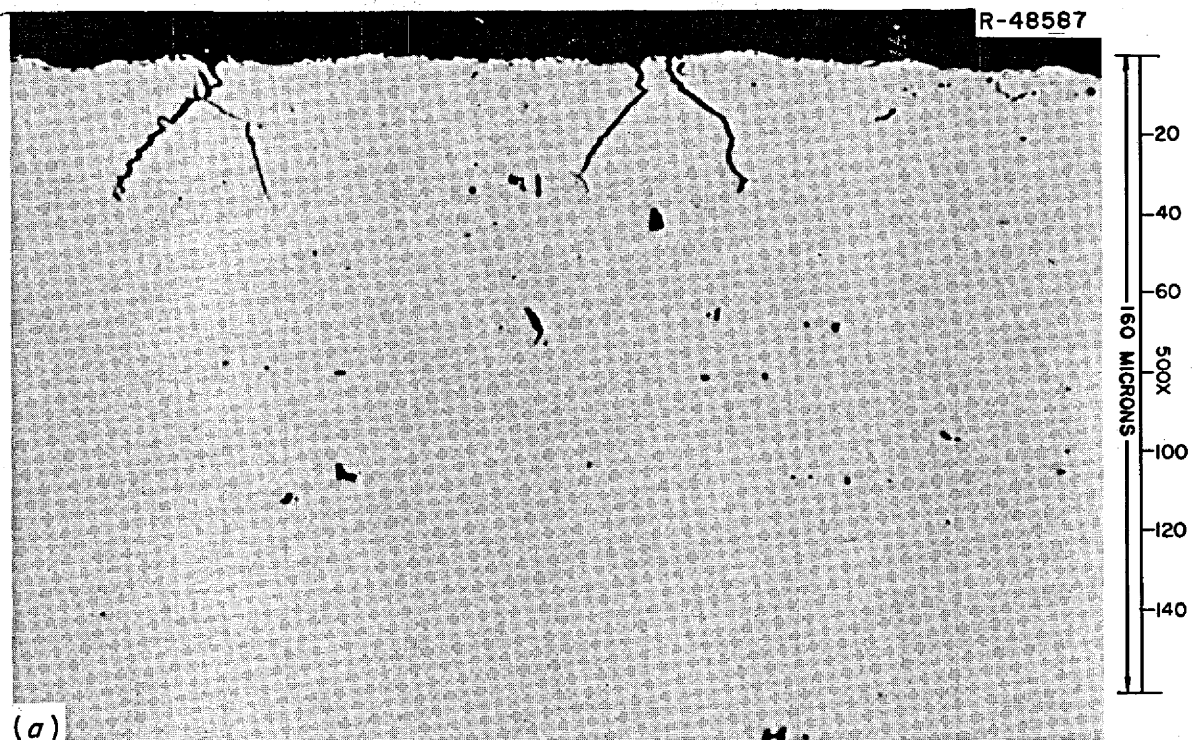
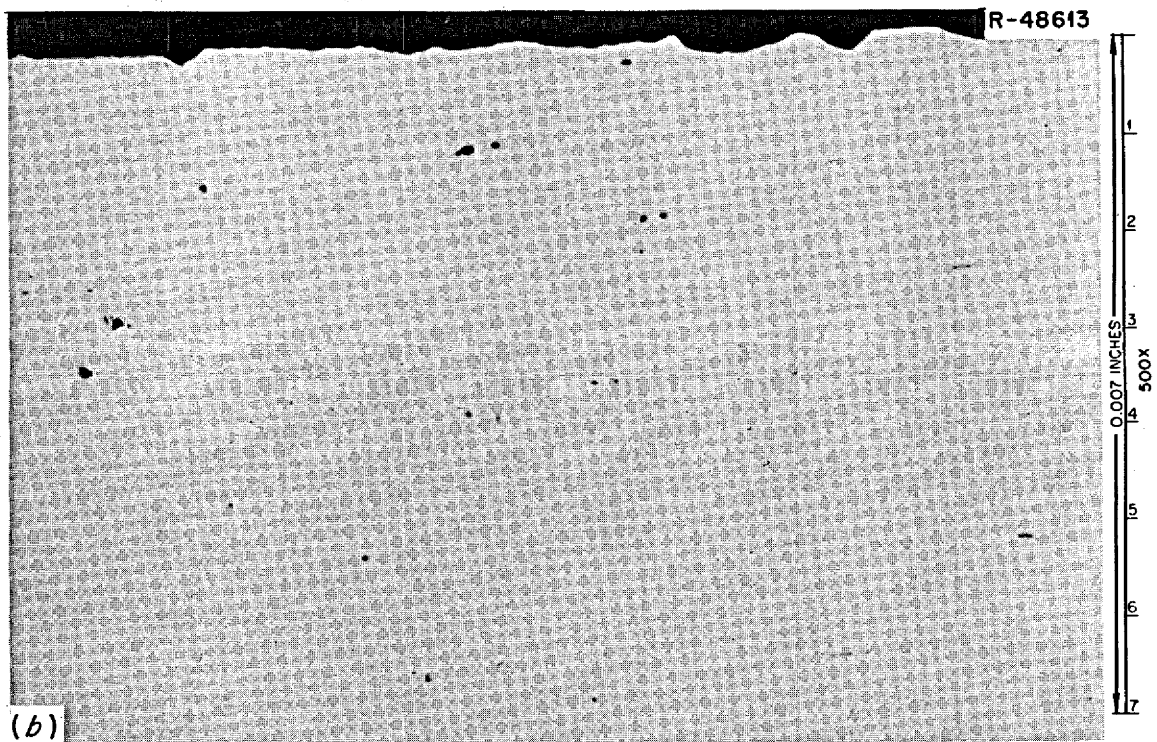
Cracking at the surface of unstrained material was even more evident in the examination of the straps that bound stringer RR2. These straps and those around the control stringer CR2 were of standard INOR-8 heat 5055. As shown in Fig. 22, the strap exposed in the core had cracks to a depth of about 1.5 mils. Cracks were distributed uniformly, both on surfaces exposed to flowing salt and those facing the graphite specimens. In contrast, the straps exposed in the control facility did not show any cracks. The straps after being formed, had been annealed for 1 hr at 1180°C and should not have been stressed thereafter since they expanded more at high temperature than did the graphite they enclosed.

Fig. 22. Photomicrographs of INOR-8 (Heat 5055) after Exposure to (a) the MSRE Core and (b) the MSRE Control Facility for 11,933 hr above 500°C. This material was used for straps for the surveillance assembly. As polished. 500x.

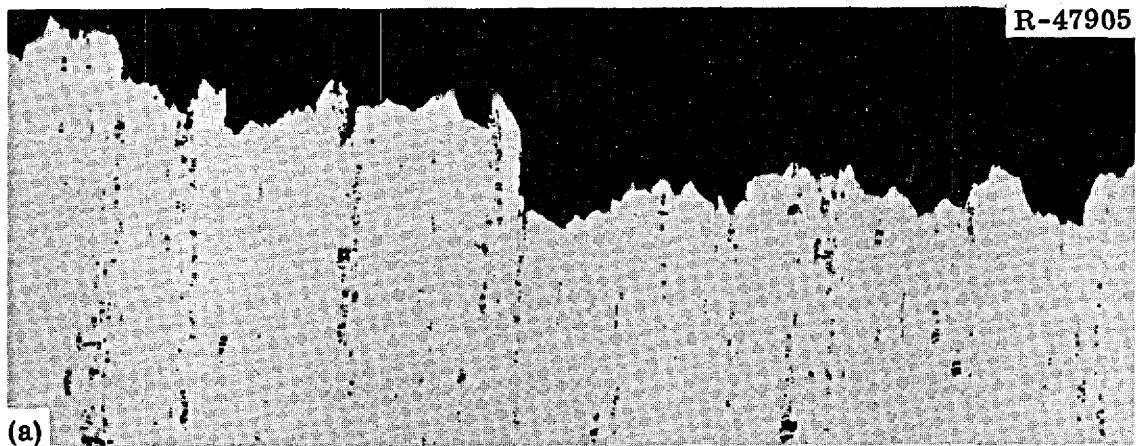
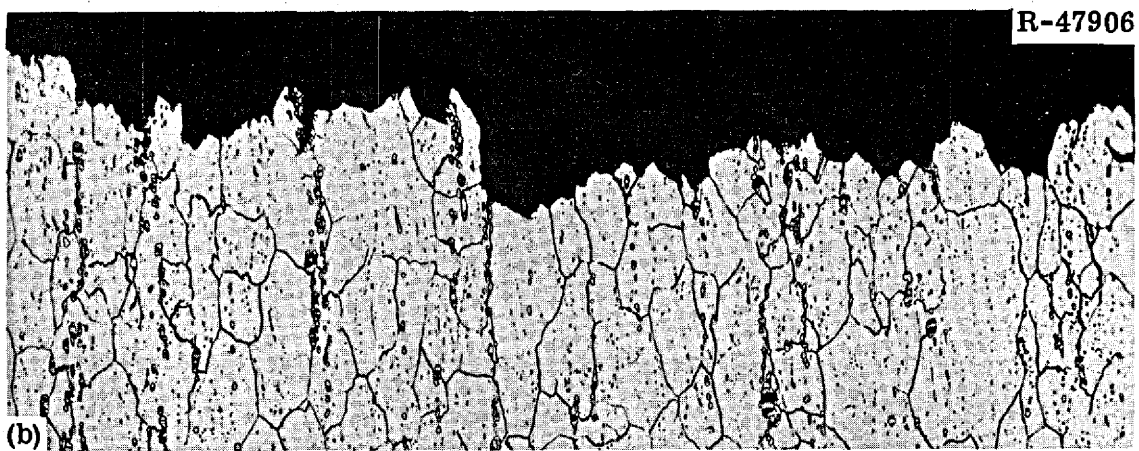
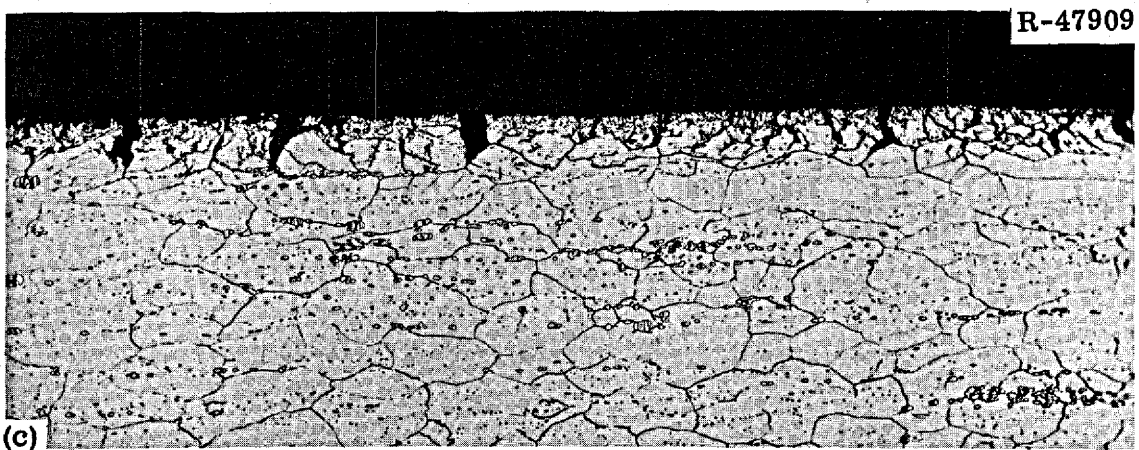
Microstructures of stressed samples of heat 5065 from the control facility and from the core are shown in Figs. 23 and 24, respectively. Numerous intergranular edge cracks are found in the sample from the core (Fig. 24) and very few in the sample from the control facility (Fig. 23). The fractures of both of these samples are largely intergranular at all locations and not just near the edge, which is further evidence that the reduction in fracture strain (Table 5) is due to carbide precipitation along the grain boundaries and not related to the intergranular cracking near the surface. Tested samples of heat 5085 from the control facility and the core are shown in Figs. 25 and 26, respectively. The as-polished views in the latter figure show some of the large carbide particles that fractured during testing.

Fig. 24. Photomicrographs of INOR-8 (Heat 5065) Sample Exposed to Fluoride Salt in the MSRE for 11,933 hr above 500°C and Then Tested at 25°C and a Strain Rate of 0.05/min. Thermal fluence was 9.4×10^{20} neutrons/cm². 100x. (a) Fracture, as polished. (b) Fracture, etched. (c) Edge of stressed portion. Etchant: aqua regia.

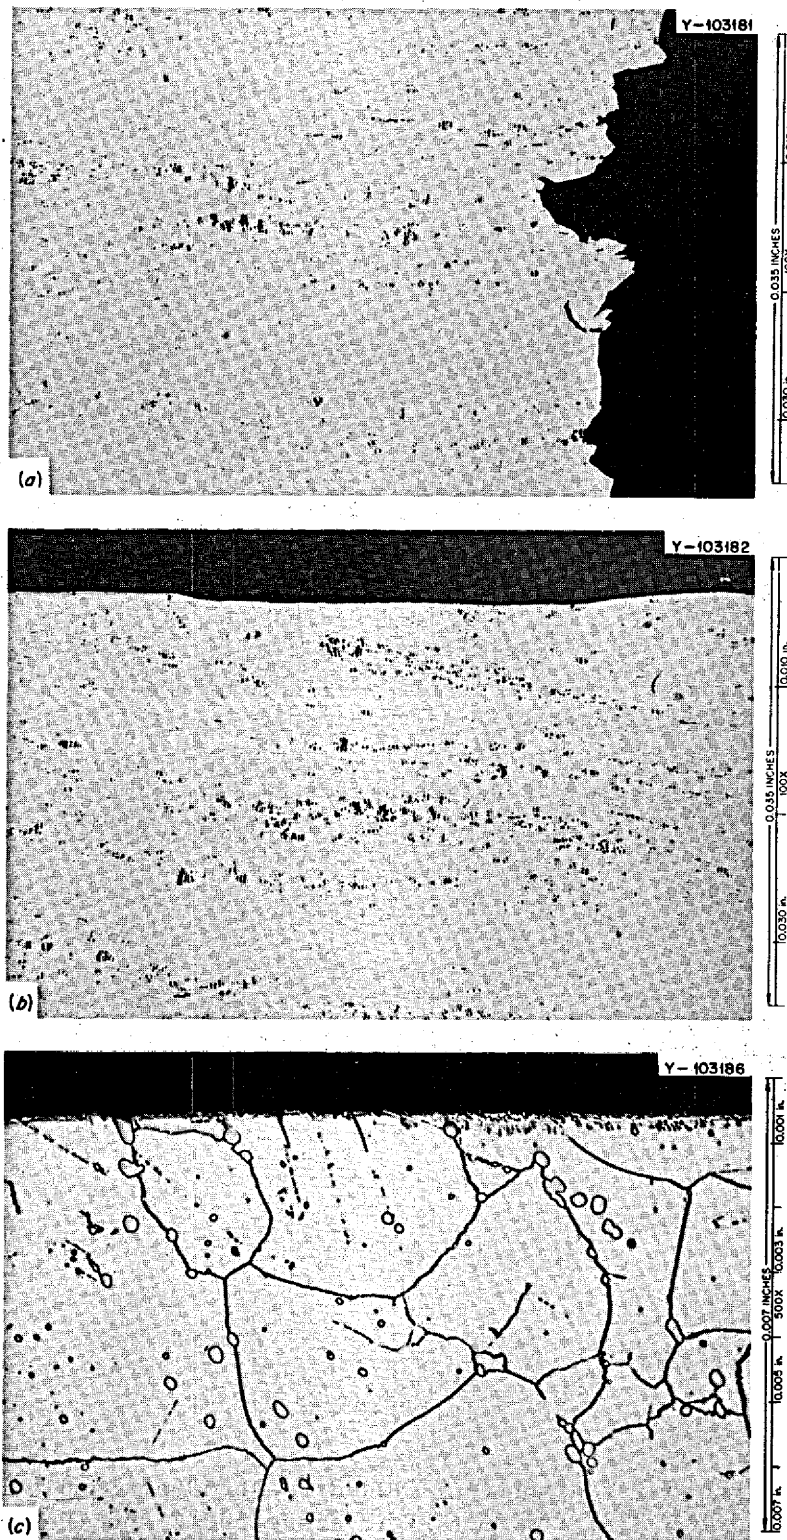
Fig. 25. Photomicrographs of INOR-8 (Heat 5085) Specimen Exposed to Depleted Static Fuel Salt for 11,933 hr at 650° and Strained at 25°C. (a) Fracture, as polished, (b) typical edge of gage section, as polished, (c) typical unstressed edge, etched with glyceria regia.

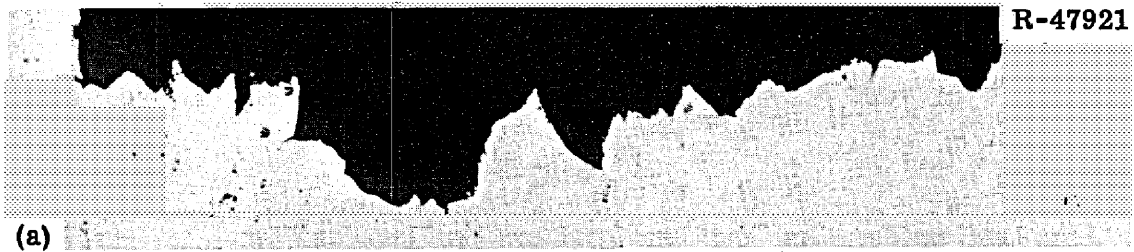
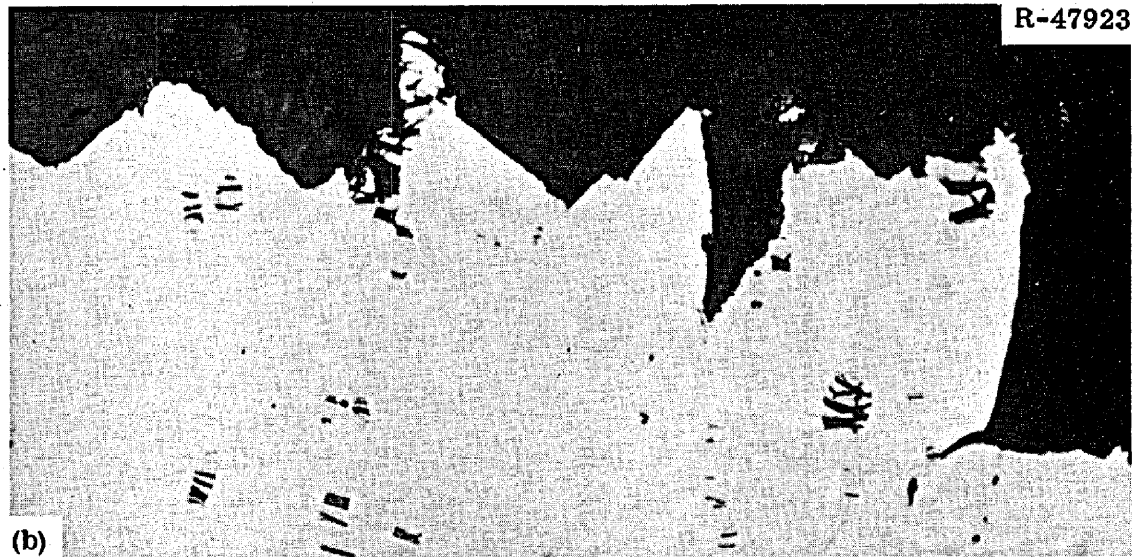
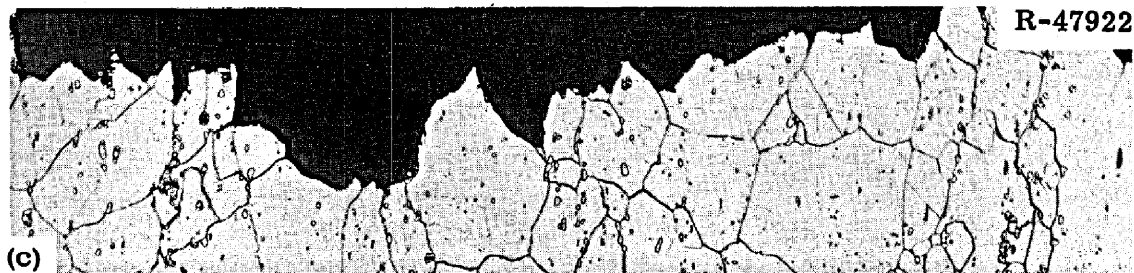
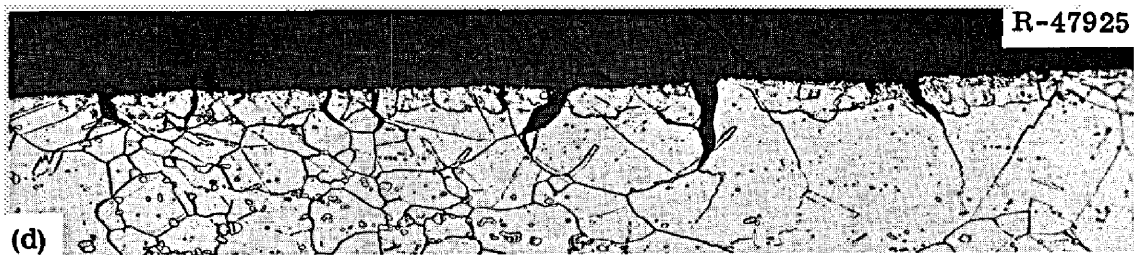
Fig. 26. Photomicrographs of INOR-8 (Heat 5085) Sample Exposed to Fluoride Salt in the MSRE for 11,933 hr above 500°C and then Tested at 25°C. Thermal fluence was 9.4×10^{20} neutrons/cm². (a) Fracture, as polished. 100x. (b) Fracture, as polished. 500x. (c) Fracture, etched. 100x. (d) Edge of stressed portion, etched. 100x. Etchant: aqua regia.

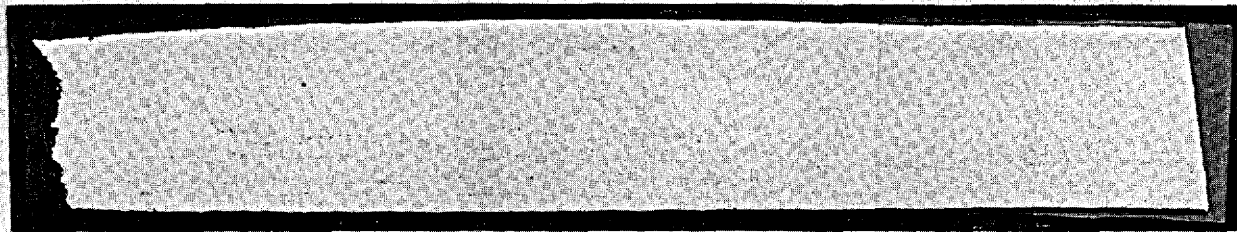
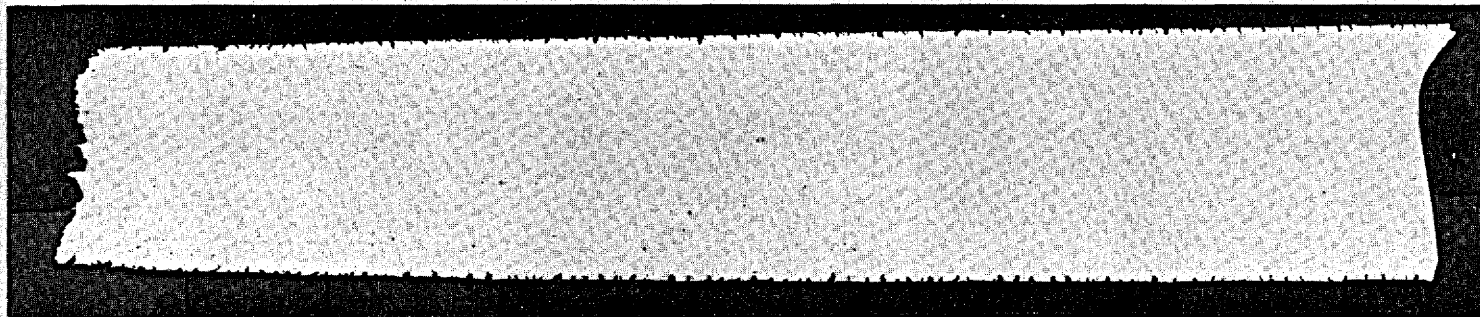
The samples that were fractured at 25°C were repolished at a later date, one-half of each fractured sample was photographed. The composite microstructures for heat 5065 are shown in Fig. 27. There are obviously more intergranular cracks in the sample exposed to the core than in the sample exposed in the control facility. There were 3 cracks per inch with an average depth of 1.0 mil in the control sample and 230 cracks per inch with an average depth of 1.8 mils in the sample from the core. A composite photograph of the tested portions of the heat 5085 sample is shown in Fig. 28. There were 134 cracks per inch along the edge of the sample from the core with an average depth of 1.9 mils. None were visible along the edge of the control specimen.

Fig. 27. Sections of Heat 5065 Tested at 25°C After Exposure to Fuel Salt for 11,933 hr above 500°C. Diameters of specimens are about 0.1 in. The fractures are on the left end.
