2362
ORNL-4829

INTERGRANULAR CRACKING OF INOR-8 IN THE MSRE

H. E. McCoy
B. McNabb

NOVEMBER 1972

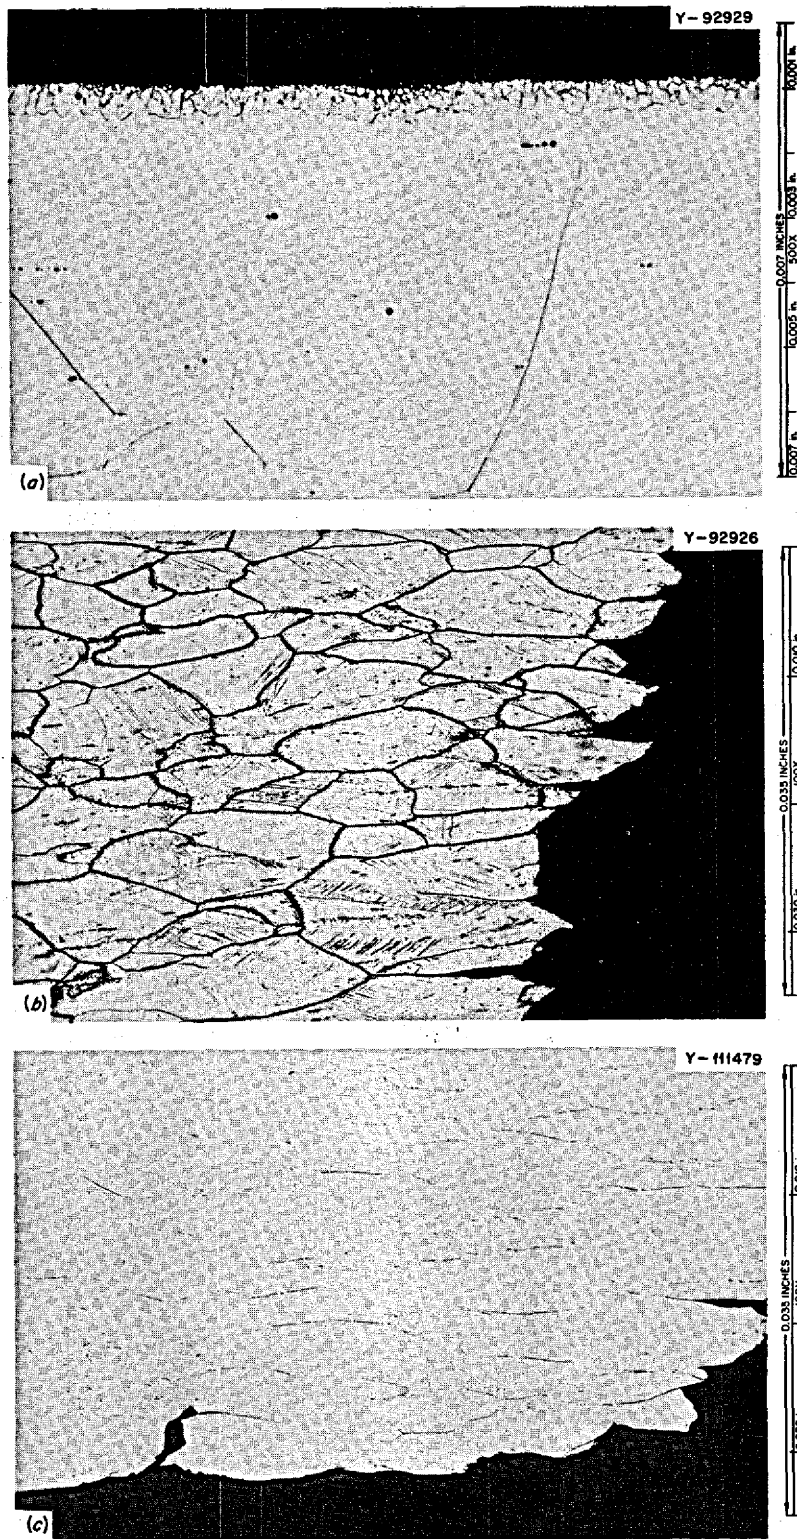
Figures 29 and 30 are photomicrographs of strained specimens of heat 67-502 (modified with 0.49% Ti and 2.15% W and containing 0.04% Fe). The specimen exposed in the control facility (Fig. 29) has its edges

Fig. 29. Photomicrographs of Alloy 67-502 (see Table 1) Exposed to Depleted Fuel Salt for 6379 hr Above 500°C and Tested at 25°C. (a) Edge of unstressed portion, (b) Fracture, (c) Edge of stressed portion. Figs (a) and (c) etched lightly. Fig. (b) etched more heavily with glyceria regia.

coated with small crystals of almost pure iron. (The control facility was constructed of material containing 4 to 5% Fe, so the transfer of Fe to an alloy that contained only 0.04% Fe is quite reasonable.) The sample strained 55% before fracture, and the fracture was mixed transgranular and intergranular. The edge was uneven from the large deformation, but there were very few intergranular separations. The sample from the core (Fig. 30) deformed almost as much (52%) before fracturing. In contrast to the control specimen, edge cracking occurred at almost every grain boundary. The cracks generally extended to a depth of about 5 mils, with the maximum depth being about 7 mils. However, as shown in the view of the fracture, this material tended to crack intergranularly and these internal cracks may have in some cases linked together with the surface cracks to make them extend deeper.

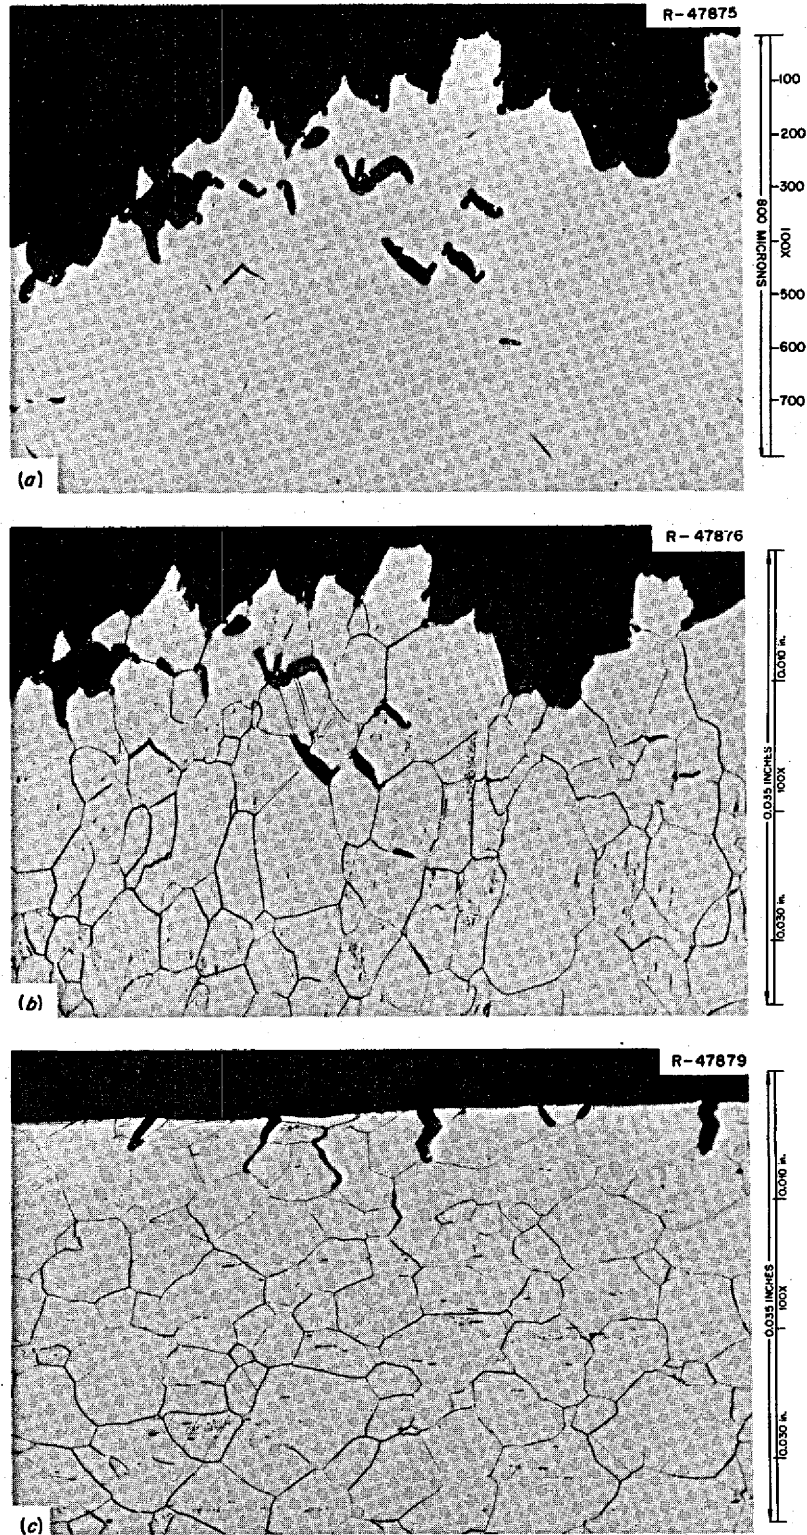
Fig. 30. Photomicrographs of Alloy 67-502 Sample Exposed to Fluoride Salt in the MSRE for 6379 hr Above 500°C and then Tested at 25°C. 100x. (a) Fracture, as polished. (b) Fracture, etched. (c) Edge of stressed portion, etched. Etchant: aqua regia. Reduced 33%.

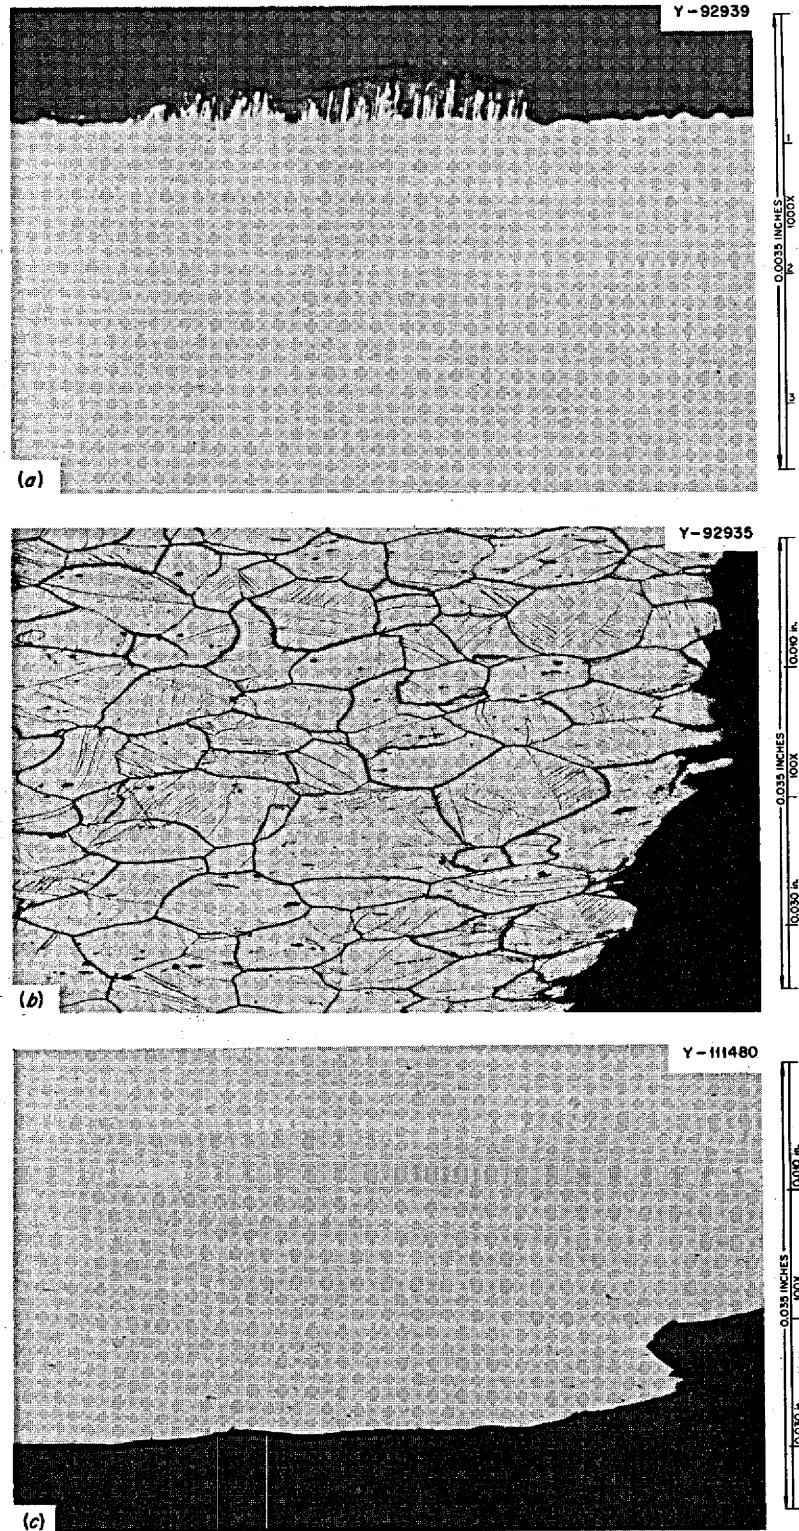
Photomicrographs of samples of heat 67-504 tested at 25°C after exposure in the control facility and in the core are shown in Figs. 31 and 32. This heat modified with 0.50% Hf, contained 0.07% Fe. As shown in Fig. 31, iron deposited on the surface of this heat as it did on 67-502. This sample, from the control facility, deformed 55% before failing with a mixed inter- and transgranular fracture. There were no intergranular edge cracks. The sample exposed in the core deformed 52% before fracture. The fracture was primarily transgranular but there were frequent edge cracks (Fig. 32). Most boundaries were cracked, but the cracks extended only to a depth of about 2 mils in the fields that were photographed.

Fig. 31. Photomicrographs of Alloy 67-504 (see Table 1) Exposed to Depleted Fuel Salt for 6379 hr Above 500°C and Tested at 25°C. (a) Edge of unstressed portion, (b) Fracture, (c) Edge of stressed portion. Figs (a) and (c) as-polished and Fig. (b) etched with glyceria regia. Reduced 33.5%.

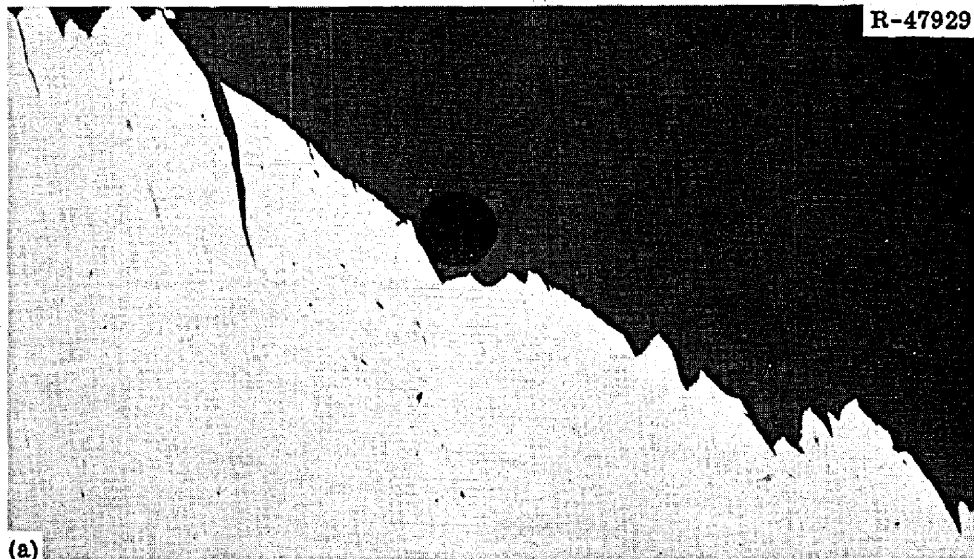
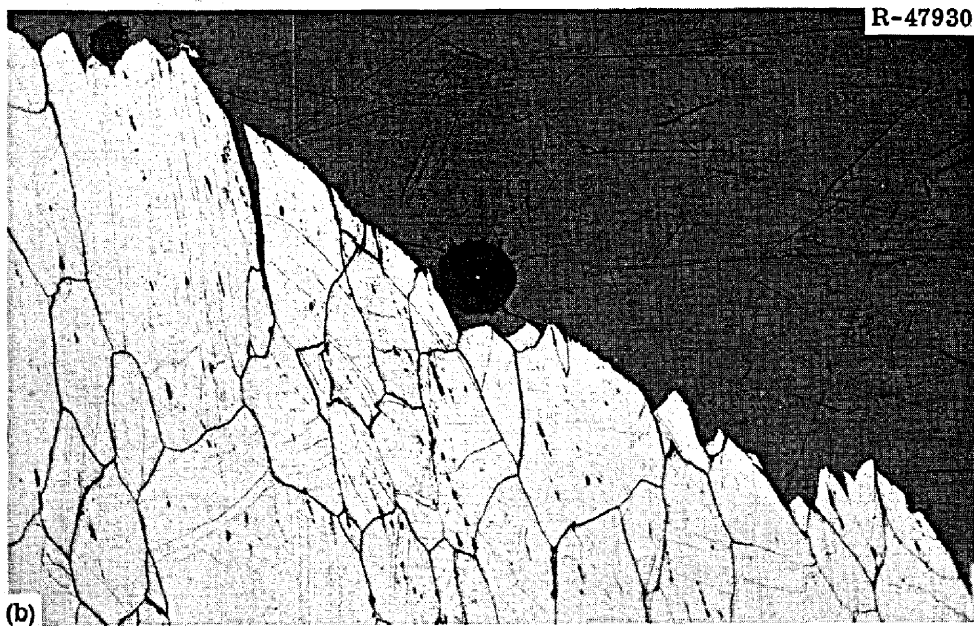
Fig. 32. Photomicrographs of INOR-8 (Heat 67-504) Sample Exposed to Fluoride Salt in the MSRE for 6379 hr Above 500°C and Tested at 25°C. 100x. (a) Fracture, as polished. (b) Fracture, etched. (c) Edge of Stressed portion, etched. Etchant: aqua regia. Reduced 14%.

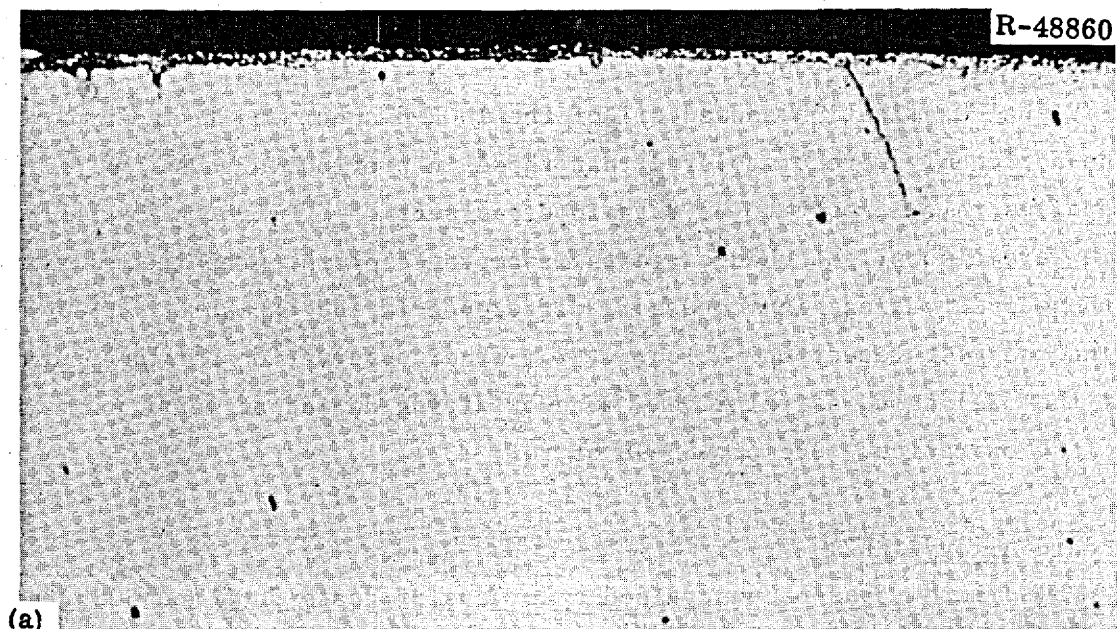
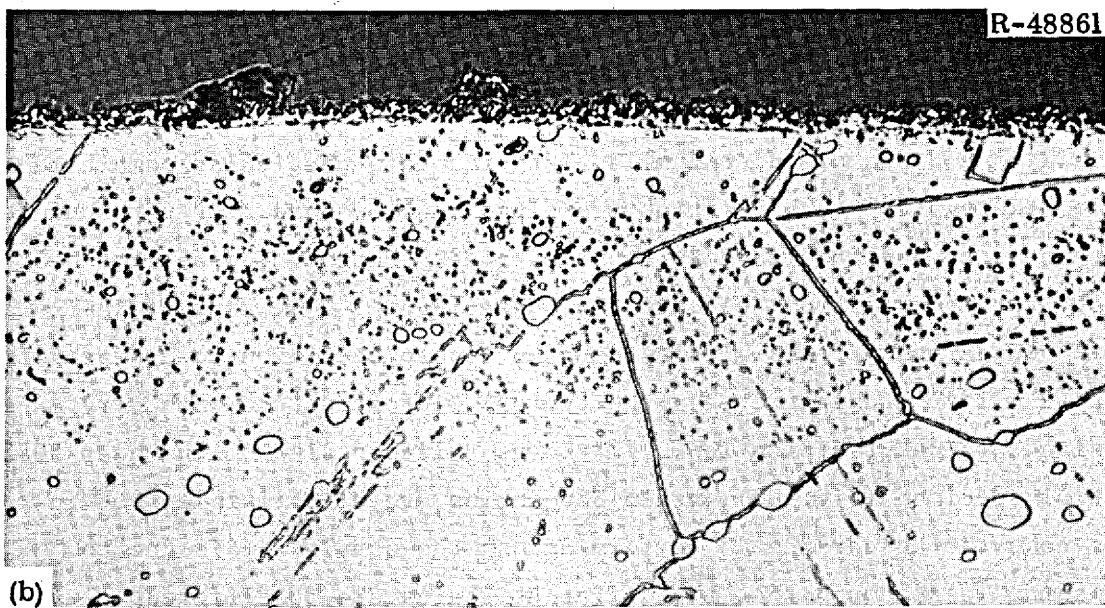
Photomicrographs of unstrained specimens of heats 5065 and 5085 from RL2 revealed many grain boundaries near the surfaces that were visible in the as-polished condition. The view of a specimen of heat 5065 in the as-polished condition, (Fig. 33) shows a thin surface layer (believed to be the cause of the visible discoloration) and some grain boundaries visible to a depth of about 2 mils. Etching this particular sample revealed the typical carbide structure plus a narrow band near the surface that seems to have a high density of carbide. Photomicrographs of heat 5085 after removal from the core are shown in Fig. 34. Many of the grain boundaries are visible in the as-polished condition to a depth of about 2 mils. Etching reveals the typical microstructure with very extensive carbide precipitation. In the as-polished view of the heat 5065 control specimen (Fig. 35), grain boundaries are also visible, but in this case the appearance is uniform across the sample and is due to polishing long enough that the different grains are at different elevations. Etching reveals the shallow surface modification and the typical carbide structure. The heat 5085 specimen from the control facility, shown in Fig. 36, was also slightly overpolished so that the grains are visible in the as-polished condition. Etching revealed the typical microstructure and the shallow surface modification.

Fig. 33. Typical Photomicrographs of INOR-8 (Heat 5065) Exposed to the MSRE Core for 19,136 hr Above 500°C. (a) As polished. (b) Etchant: aqua regia. 500x.

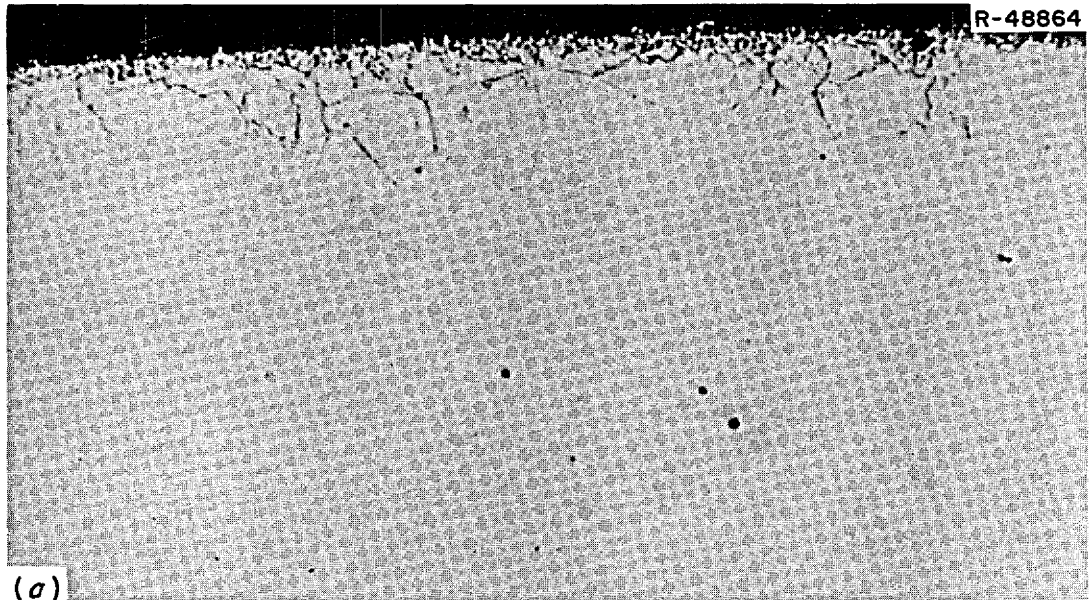
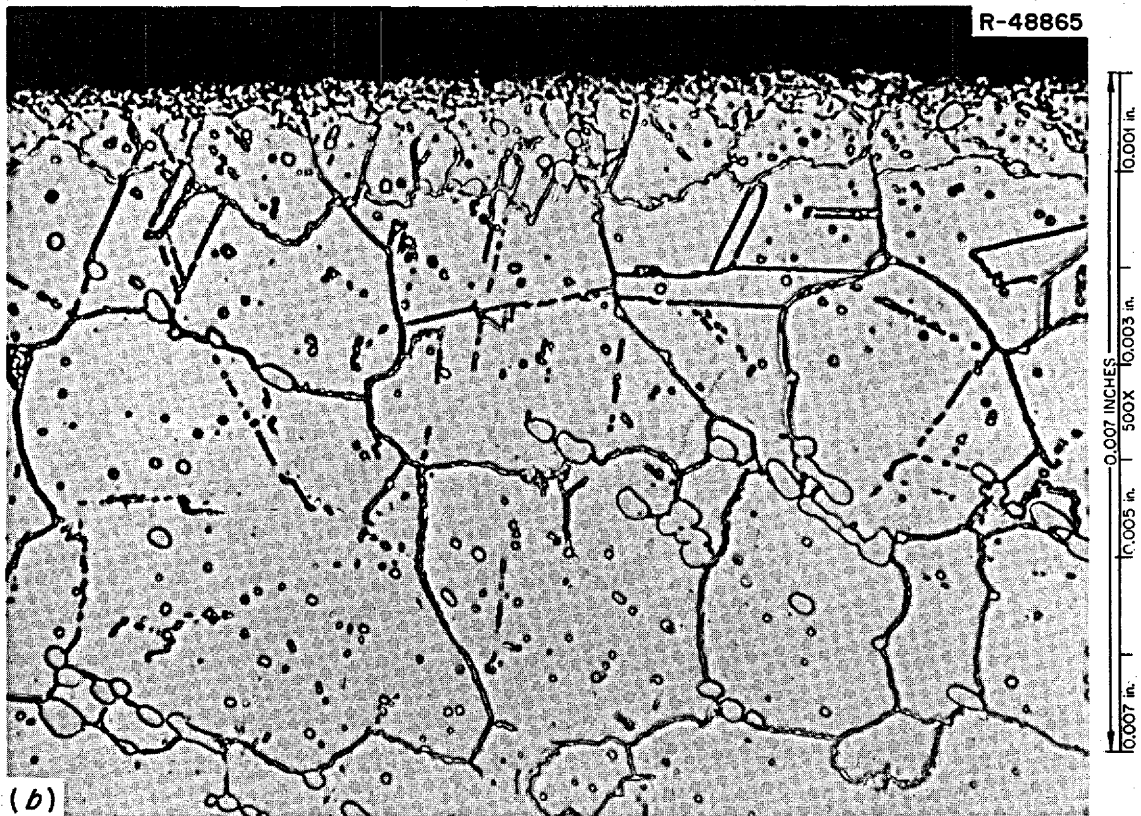
Fig. 34. Typical Photomicrographs of INOR-8 (Heat 5085) Exposed to the MSRE Core for 19,136 hr Above 500°C. (a) As polished. (b) Etchant: glyceria regia. 500x.

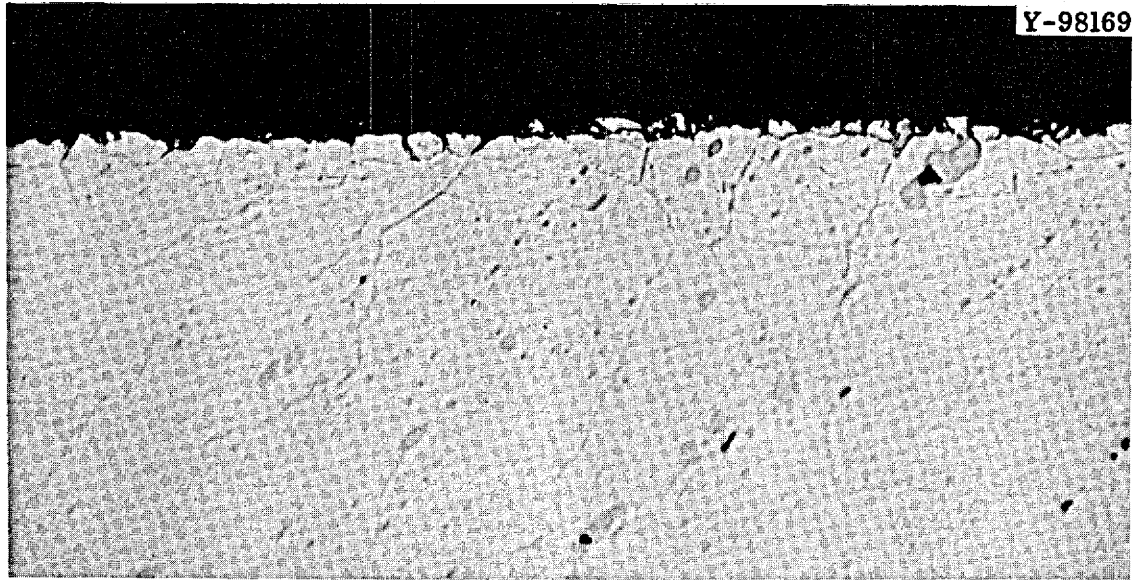
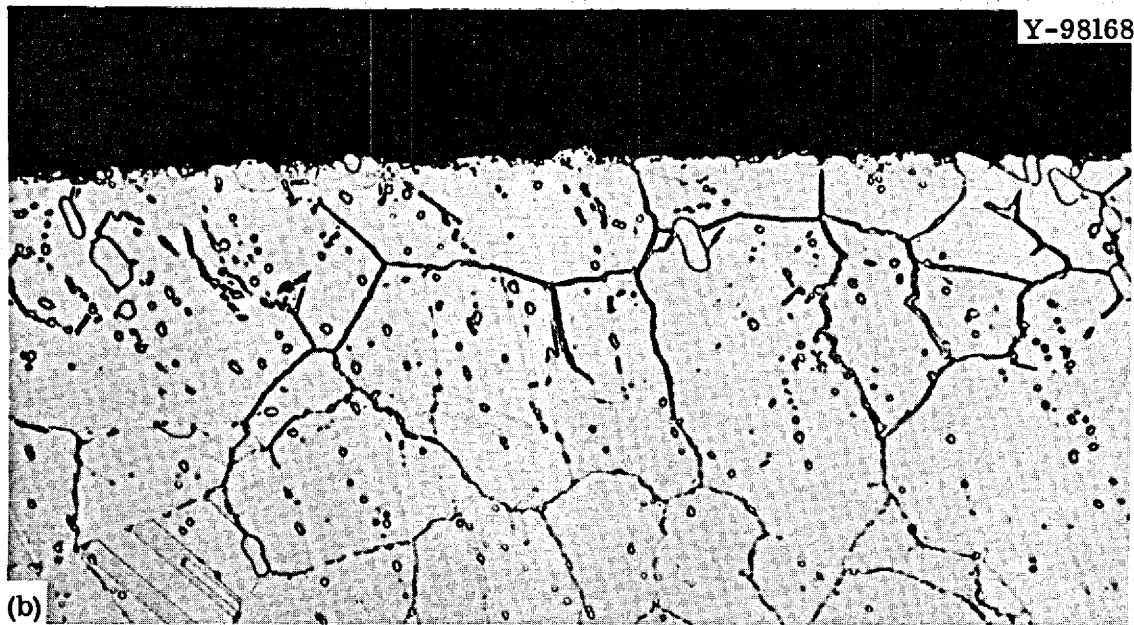
Fig. 35. Typical Photomicrographs of Heat 5065 After Exposure to Static Unenriched Fuel Salt for 19,136 hr Above 500°C. 500x. (a) As polished. (b) Etchant: glyceria regia.

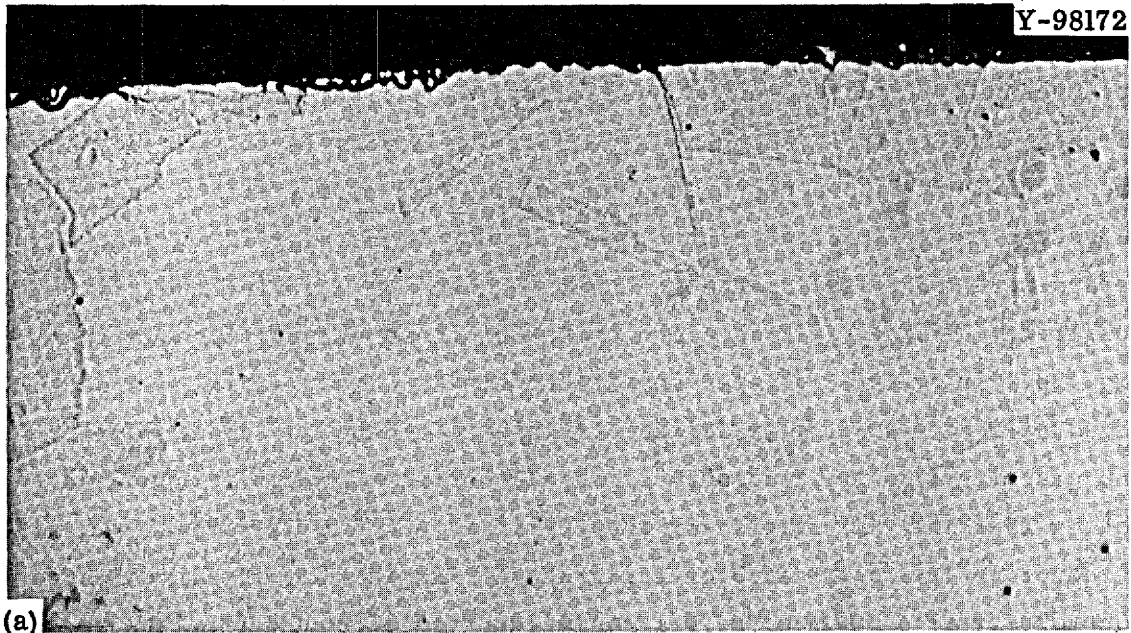
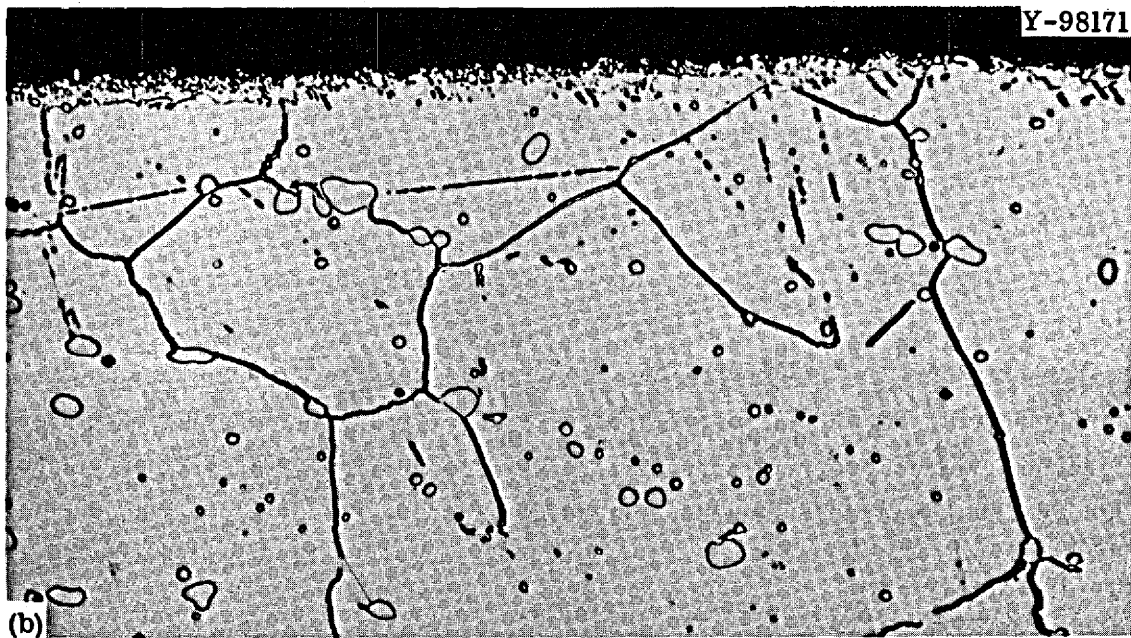
Fig. 36. Typical Photomicrographs of Heat 5085 After Exposure to Static Unenriched Fuel Salt for 19,136 hr above 500°C. 500x. (a) As polished. (b) Etchant: glyceria regia.

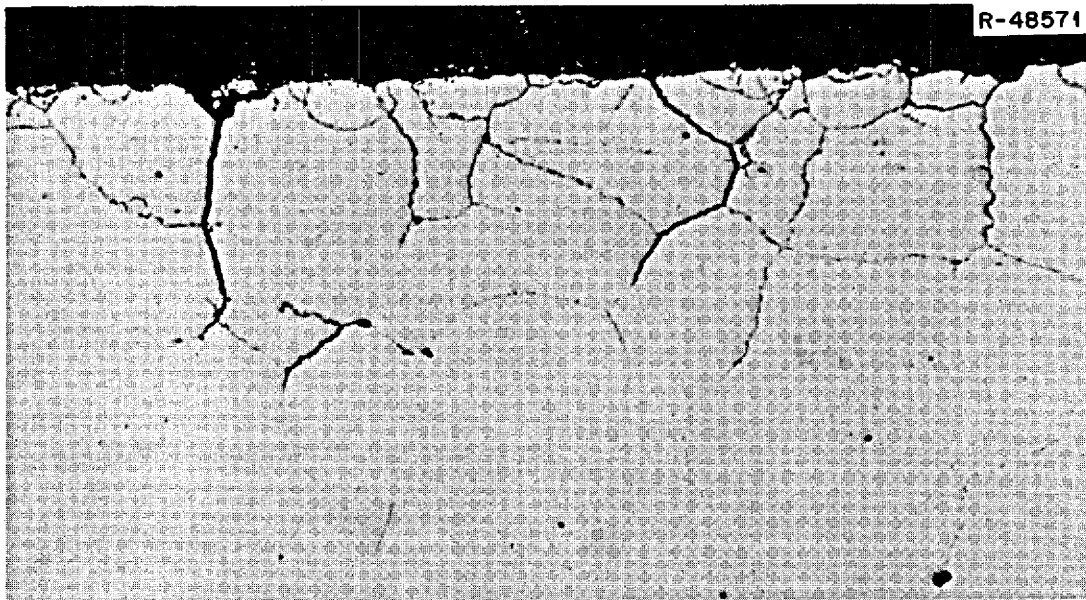
As in the previous set of core specimens, the straps of heat 5055 showed more cracks in the nominally unstrained condition than did the tensile specimens on the same stringer. A section of a strap from stringer RL2 that had been exposed, along with the specimens shown in Figures 33 and 34, is shown in Fig. 37. The cracks in this as-polished view are visible to a depth of about 3 mils, about twice as deep as in the strap exposed 12,000 hr during ^{235}U operation (Fig. 22). Heat 5055 straps were also used on the stringers exposed only during the ^{233}U operation (7200 hr). A specimen of one of these straps is shown in Fig. 38. In the as-polished condition, cracks were visible to a depth of about 1 mil; etching made them visible to a depth of about 3 mils. The cracking was quite uniform along all surfaces of the straps, indicating that the deformation of the 20-mil straps during removal was not a factor in the appearance of the cracks. Examination of unirradiated control straps failed to reveal a similar type of cracking.

Fig. 37. Typical Microstructure of INOR-8 (Heat 5055) After Exposure to the MSRE Core for 19,136 hr Above 500°C. This material was used for straps for the surveillance assembly. As polished. 500x.

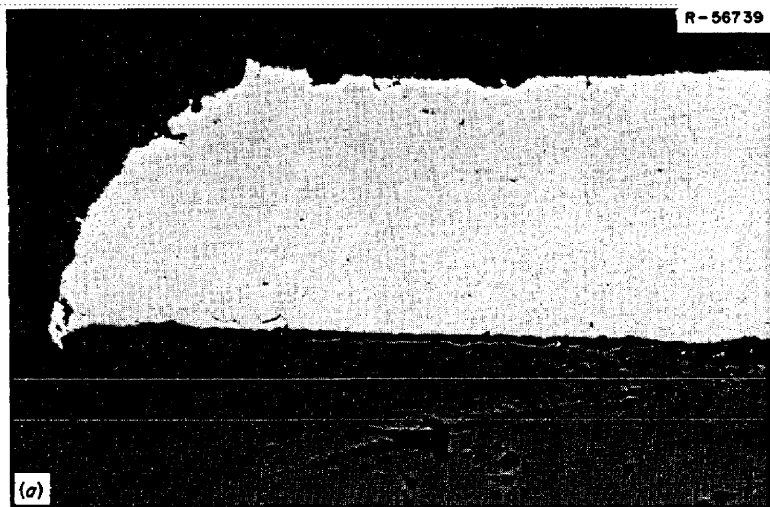
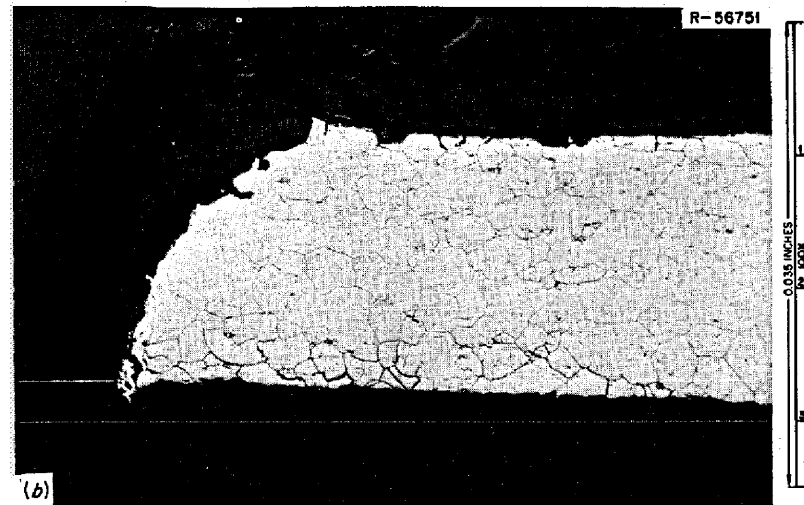
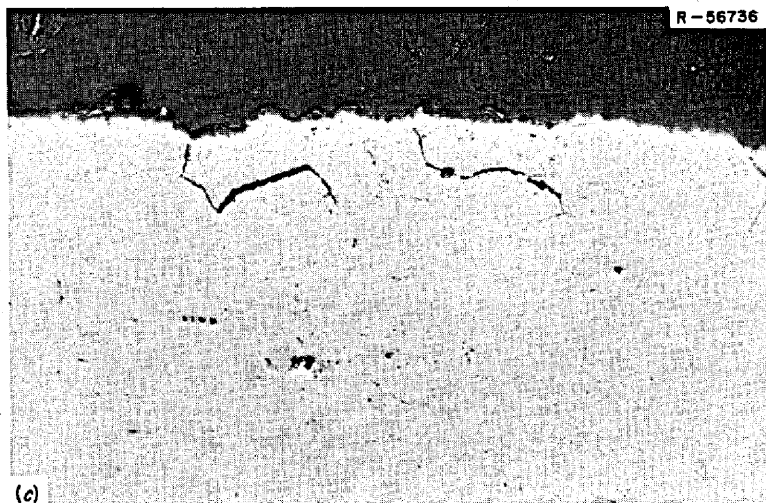
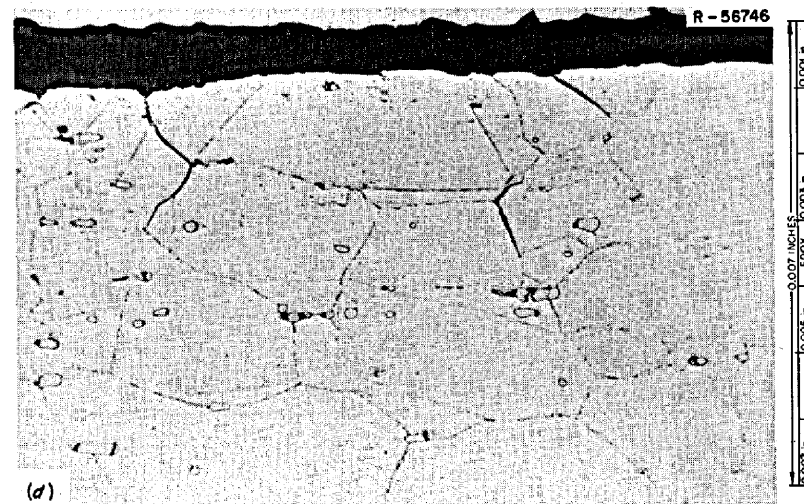
One other interesting specimen that showed extensive cracking was a piece of thin INOR-8 sheet (heat 5075) that had been attached to the strap shown in Fig. 38. The sheet had been rolled to 4 mils and annealed 0.5 hr at 1180°C . The edges of the foil were wrapped around the strap to hold the material in place. Thus the outside surface of the foil would have been exposed to flowing salt and the underside and the folded ends to salt that flowed less rapidly. The foil was extremely brittle and broke while it was being removed from the strap. The photomicrographs in Fig. 39 show that the foil had extensive grain boundary cracks, with many appearing to extend throughout the 4 mil thickness. In some areas the cracks were more numerous on the outside where the material was curved and was in contact with rapidly flowing salt. Photomicrographs of a strap and foil that were exposed to static salt in the control facility are shown in Figs. 40 and 41. The samples showed no evidence of intergranular cracking.

Fig. 38. Photomicrographs of INOR-8 (Heat 5055) Strap Exposed to the MSRE Core 7203 hr above 500°C. (a) As-polished view near cut (b) Etched view near cut (c) As polished view of outside edge (d) Etched view of outside edge. Etchant: Lactic acid, HNO_3 , HCl . Reduced 32%.

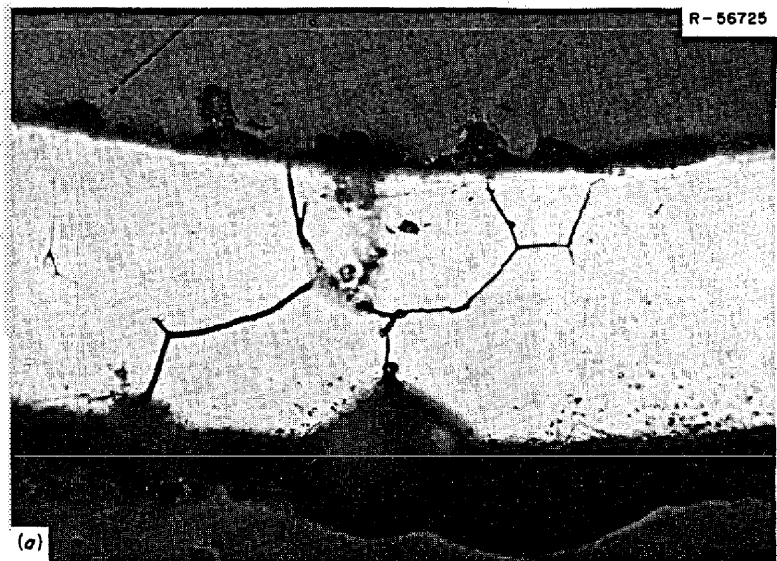
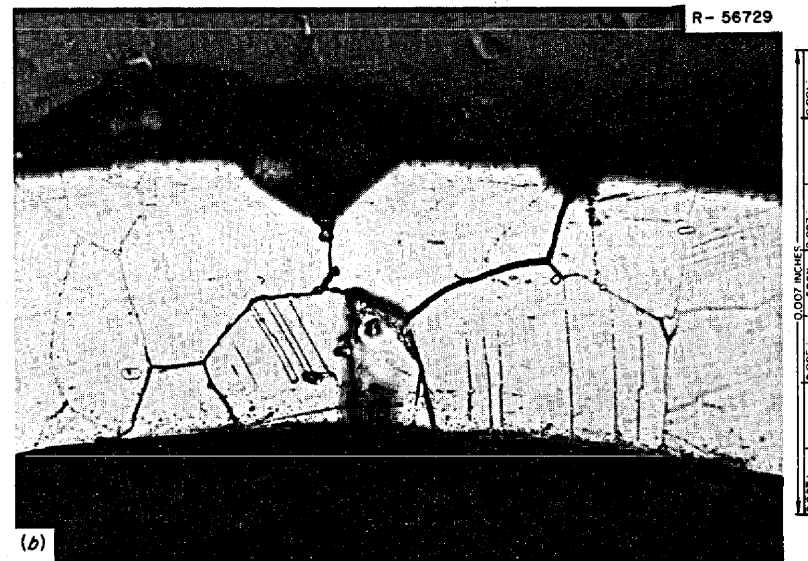
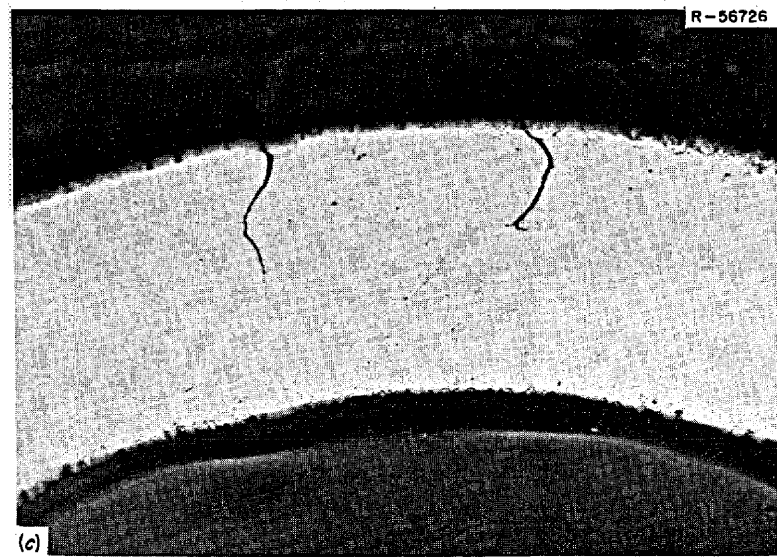
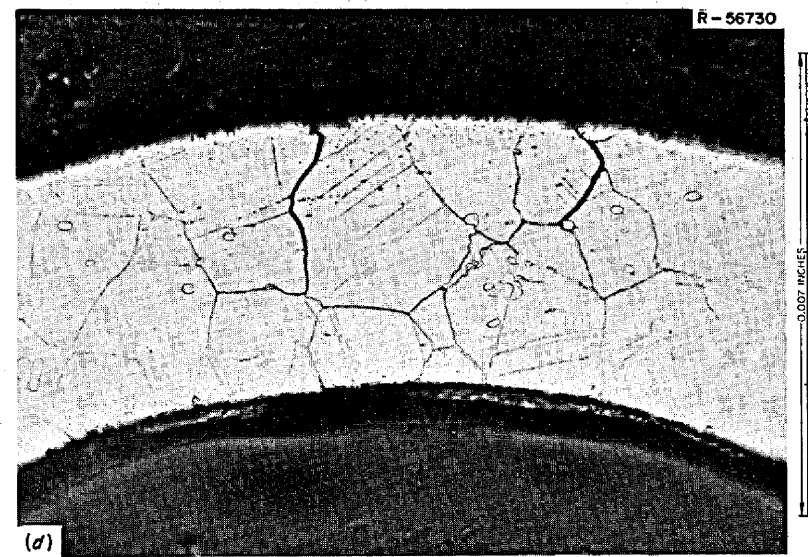
Fig. 39. Photomicrographs of Two Specimens From a Thin INOR-8 (Heat 5075) Foil that was Attached to the Strap Shown in the Previous Figure. The curvature was caused by forming before being inserted into the MSRE. (a) As polished (b) Etched (c) As polished (d) Etched. Etchant: Lactic acid, HNO_3 , HCl . Reduced 32%.

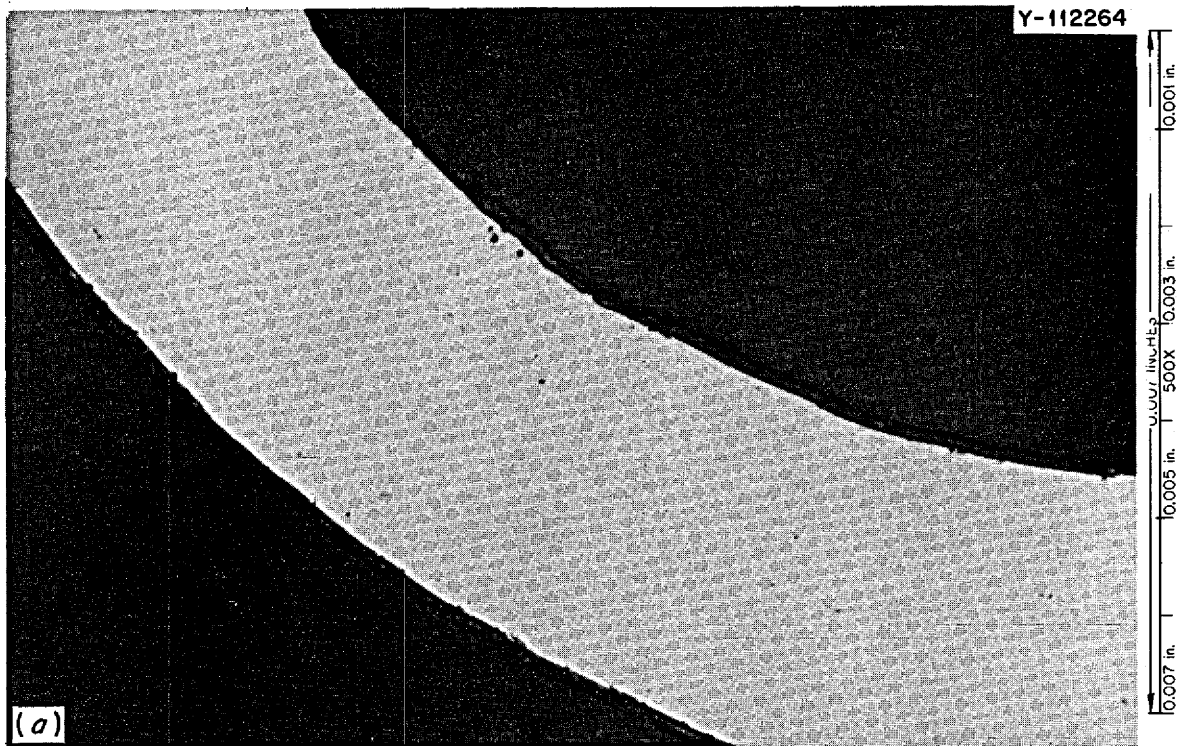
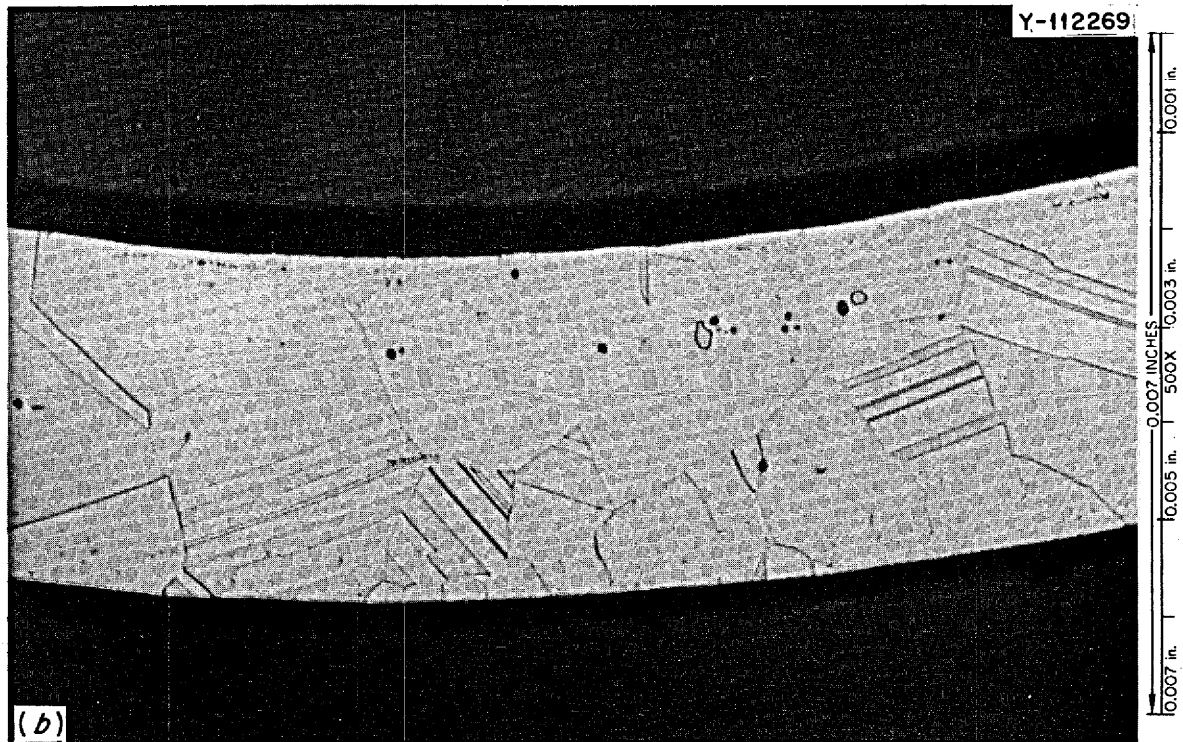
Fig. 41. Photomicrographs of a Thin INOR-8 (Heat 5075) Foil that was attached to the strap shown in the Previous Figure. (a) As Polished, (b) Etched with glyceria regia. 500x.

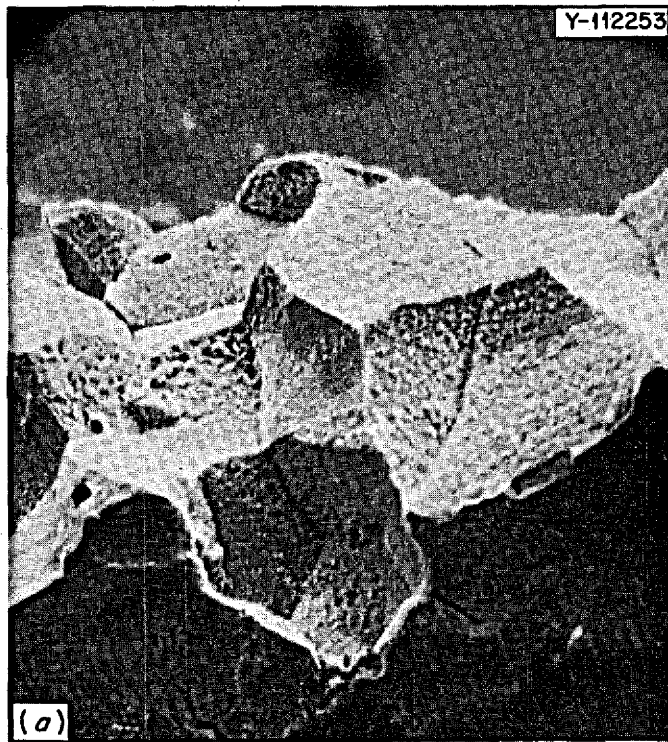
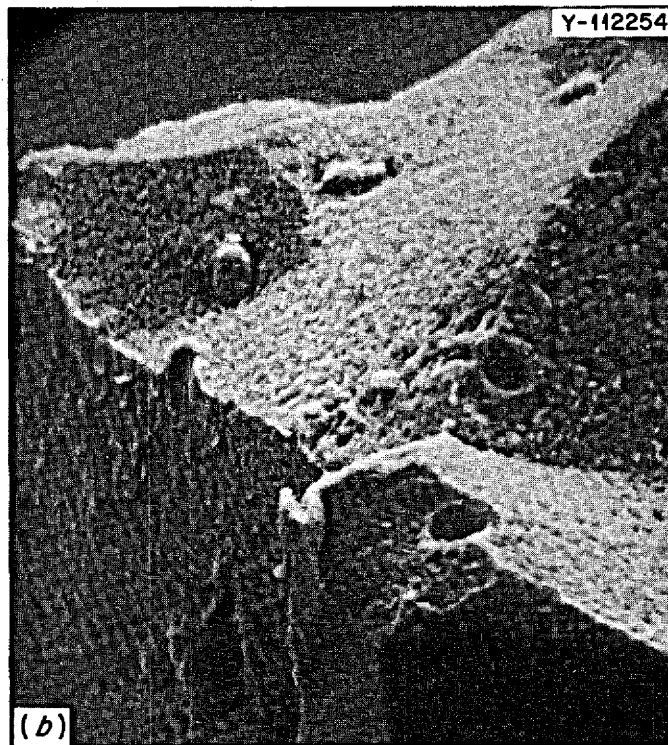
A fracture surface of the foil from the MSRE was examined by the scanning electron microscope (SEM) and Auger spectroscopy. The fracture is shown in Fig. 42 and is intergranular. The SEM with a dispersive x-ray analytical system indicated the presence only of the elements normally

Fig. 42. Scanning Electron Micrograph of INOR-8 (Heat 5075) Foil Exposed to the MSRE Core for 7203 hr Above 500°C. (a) Topographical view of fracture showing the surfaces of the fractured grain boundaries. 500x. (b) 1000x.

found in INOR-8. Auger electron spectroscopy indicated that Te, S, and Mo were concentrated in the boundaries. Definite confirmation of the presence of these elements was difficult because many of the spectra overlapped.

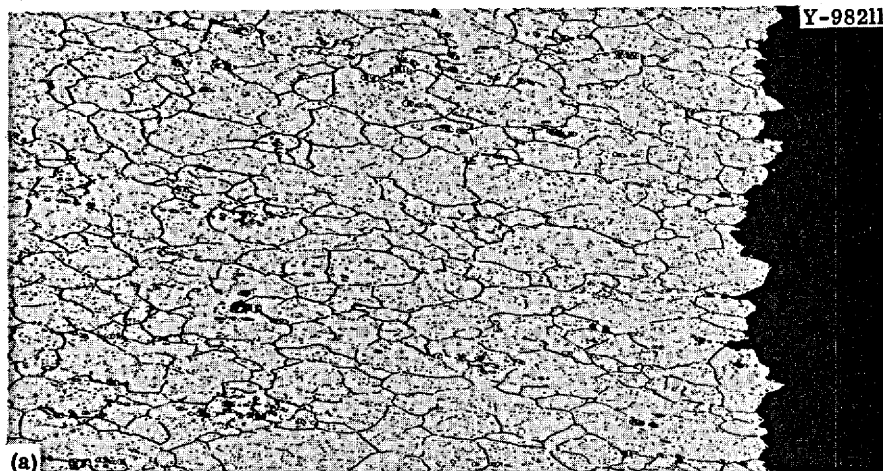
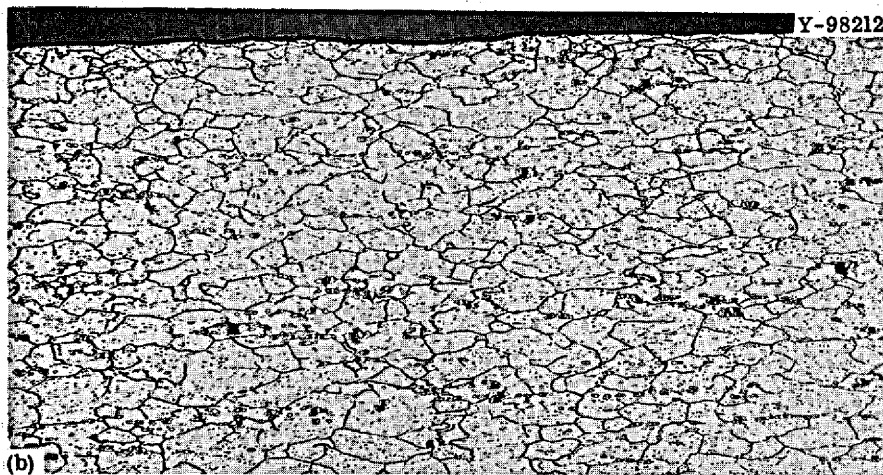
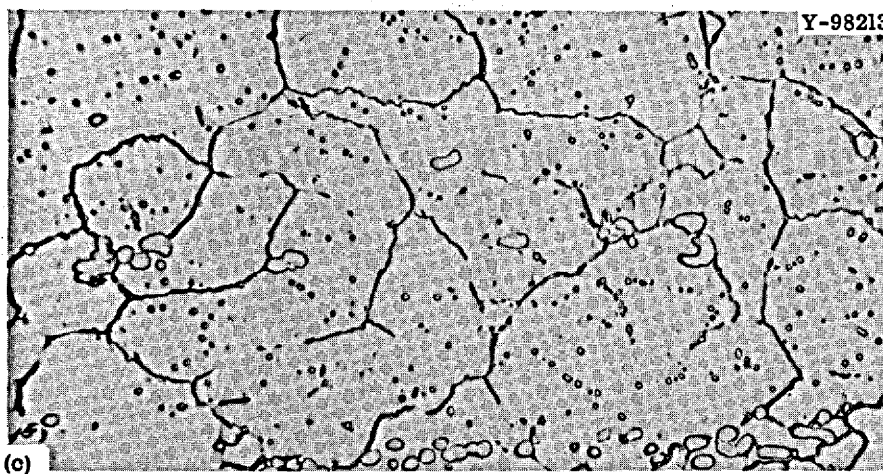
The control sample of heat 5065, whose microstructure is shown in Fig. 43, deformed 50% before fracture. The fracture is mixed intergranular and transgranular and no cracks formed along the edge away from the immediate vicinity of the fracture. The microstructure of a heat 5065 sample from the core is shown in Fig. 44. This sample deformed 43% and had a mixed fracture. Numerous intergranular cracks to a depth of about 5 mils formed along the gage length. Samples of heat 5085 from the control facility and the core are shown in Figures 45 and 46. The control sample failed after 41% strain with a mixed fracture. No intergranular cracks were visible in the field shown in Fig. 45. The sample of heat 5085 from the core that was tested at 25°C failed after much less strain (22%). As shown in Fig. 46, the fracture is mixed, and numerous intergranular cracks formed along the surfaces to a depth of 5 mils.

Fig. 43. Typical Photomicrographs of INOR-8 (Heat 5065) Sample Tested at 25°C After Being Exposed to Static Unenriched Fuel Salt for 19,136 hr above 500°C. Etchant: glyceria regia. (a) Fracture. 100x. (b) Edge near fracture. 100x. (c) Representative unstressed structure. 500x. Reduced 22%.
