2362
ORNL-4829

INTERGRANULAR CRACKING OF INOR-8 IN THE MSRE

H. E. McCoy
B. McNabb

NOVEMBER 1972

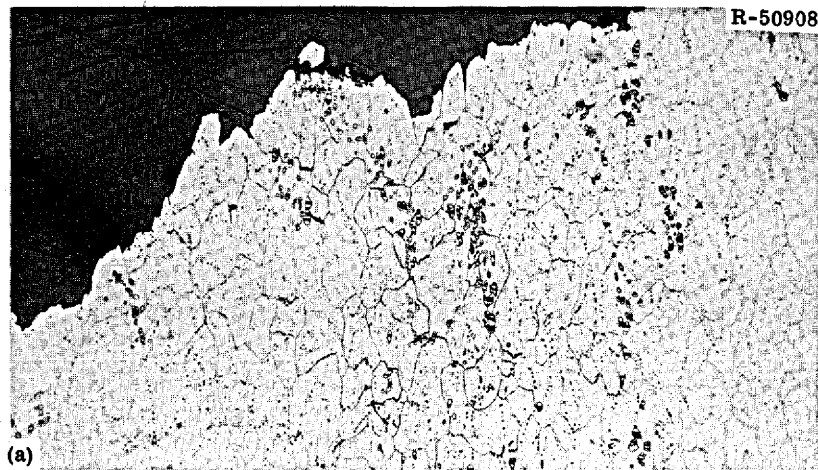
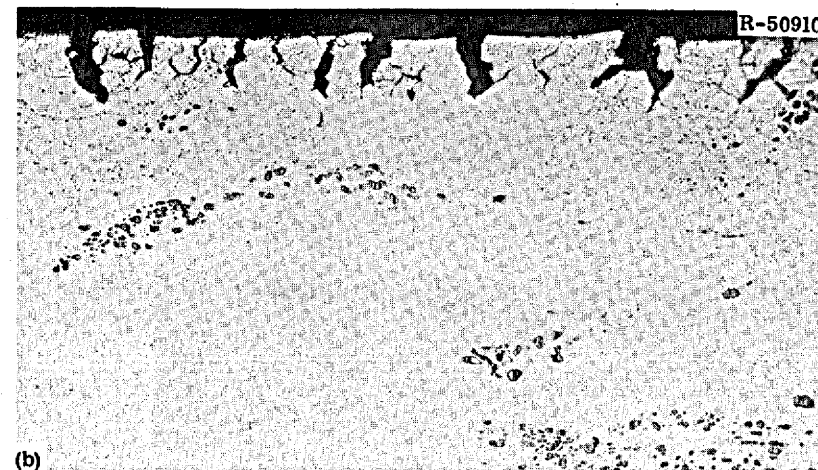
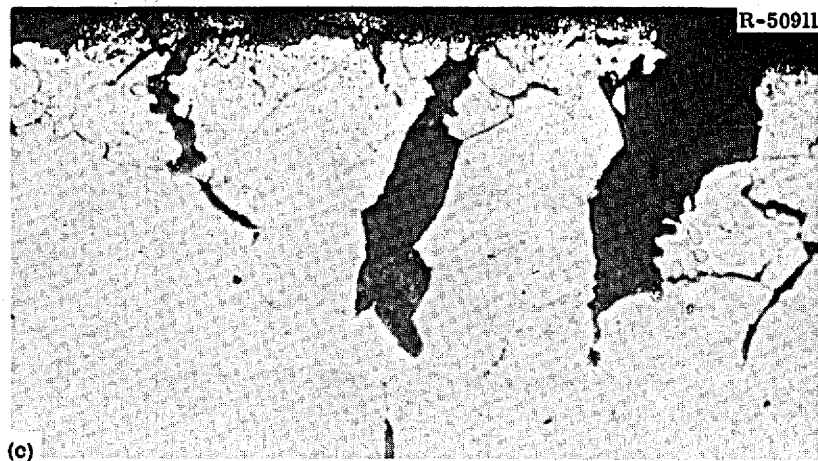
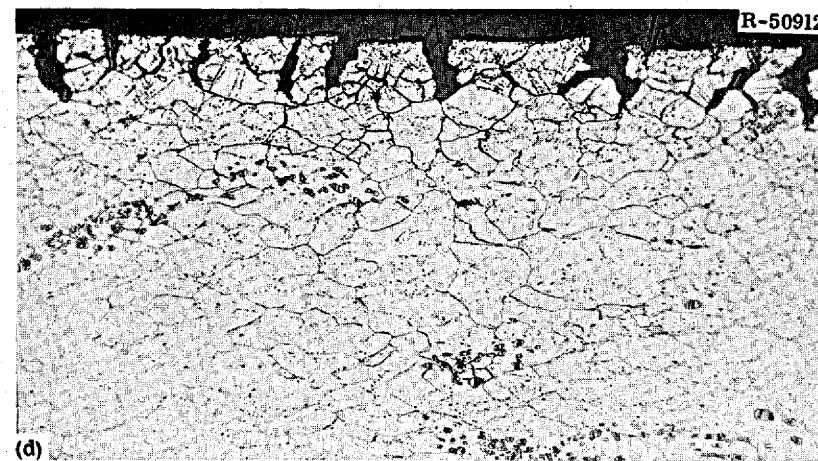
The control sample of heat 5065, whose microstructure is shown in Fig. 43, deformed 50% before fracture. The fracture is mixed intergranular and transgranular and no cracks formed along the edge away from the immediate vicinity of the fracture. The microstructure of a heat 5065 sample from the core is shown in Fig. 44. This sample deformed 43% and had a mixed fracture. Numerous intergranular cracks to a depth of about 5 mils formed along the gage length. Samples of heat 5085 from the control facility and the core are shown in Figures 45 and 46. The control sample failed after 41% strain with a mixed fracture. No intergranular cracks were visible in the field shown in Fig. 45. The sample of heat 5085 from the core that was tested at 25°C failed after much less strain (22%). As shown in Fig. 46, the fracture is mixed, and numerous intergranular cracks formed along the surfaces to a depth of 5 mils.

Fig. 44. Photomicrographs of INOR-8 (Heat 5065) Sample Tested at 25°C After Being Exposed to the MSRE Core for 19,136 hr Above 500°C and Irradiated to a Thermal Fluence of 1.5×10^{21} neutrons/cm². (a) Fracture, etched. 100x. (b) Edge, as polished. 100x. (c) Edge, as polished. 500x. (d) Edge, etched. 100x. Etchant: glyceria regia. Reduced 26%.

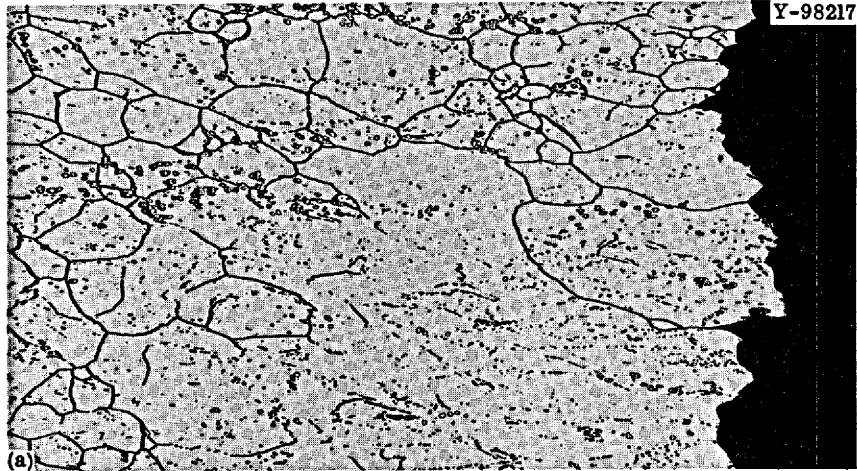
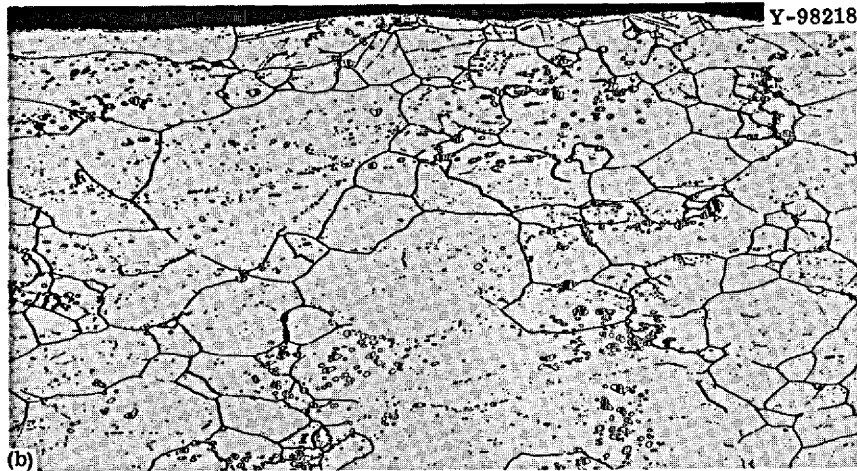
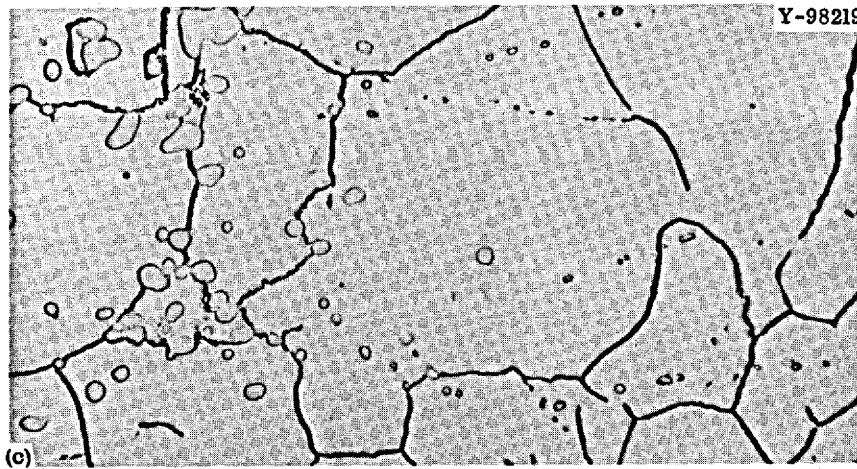
Fig. 45. Typical Photomicrographs of INOR 8 (Heat 5085) Sample Tested at 25°C After Being Exposed to Static Unenriched Fuel Salt for 19,136 hr Above 500°C. (a) Fracture, etched. 100×. (b) Edge near fracture, etched. 100×. (c) Representative unstressed structure, etched. 500×. Etchant: glyceria regia. Reduced 24.5%.

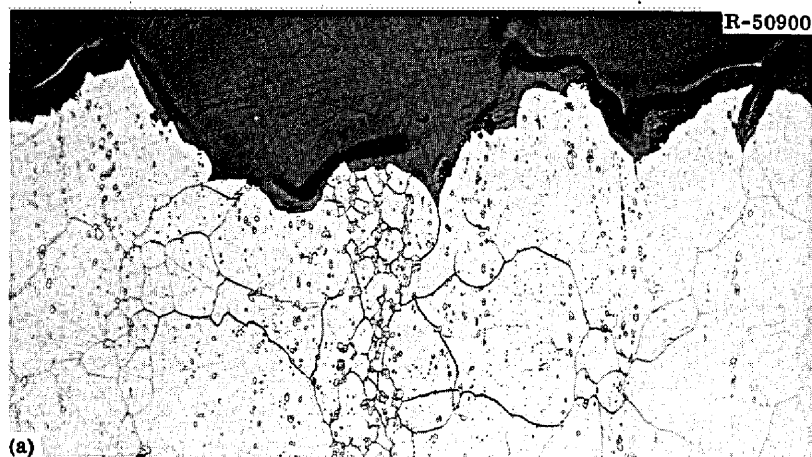
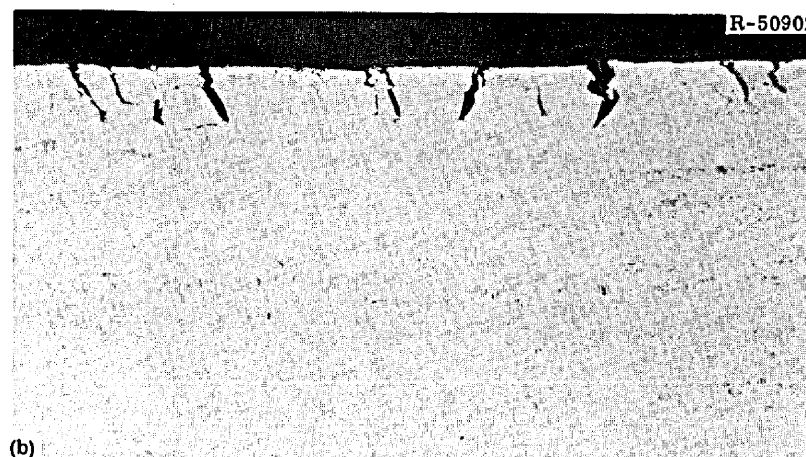
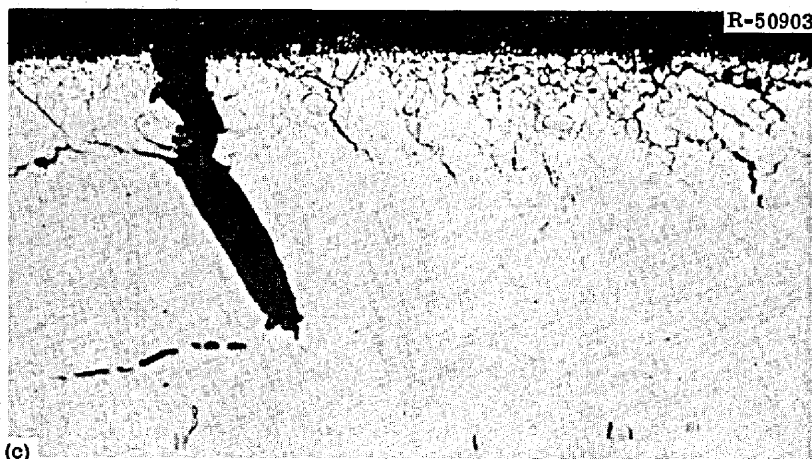
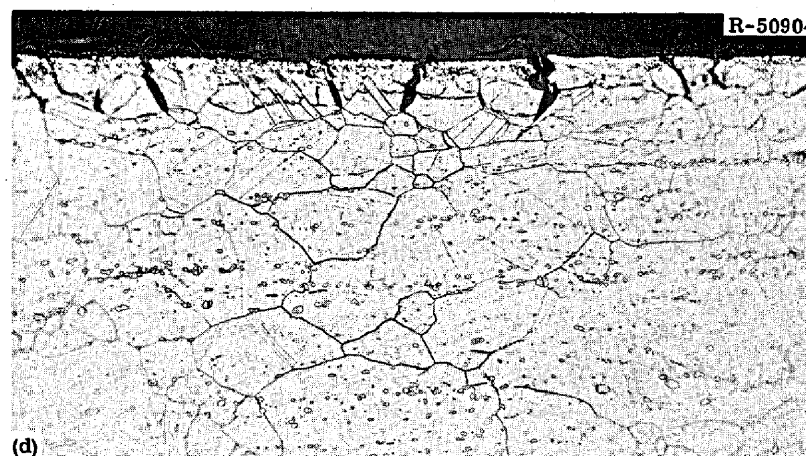
Fig. 46. Photomicrographs of INOR-8 (Heat 5085) Sample Tested at 25°C After Being Exposed to the MSRE Core for 19,136 hr Above 500°C and Irradiated to a Thermal Fluence of 1.5×10^{21} neutrons/cm². (a) Fracture, etched. 100x. (b) Edge, as polished. 100x. (c) Edge, as polished. 500x. (d) Edge, etched. 100x. Etchant: glyceria regia. Reduced 27%.

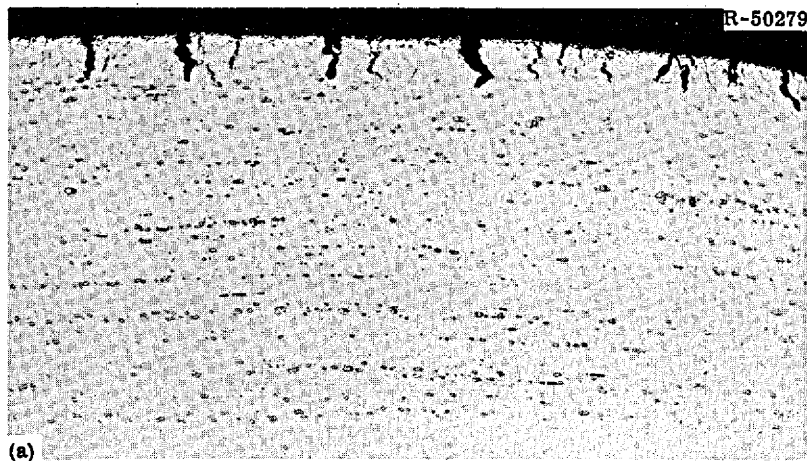
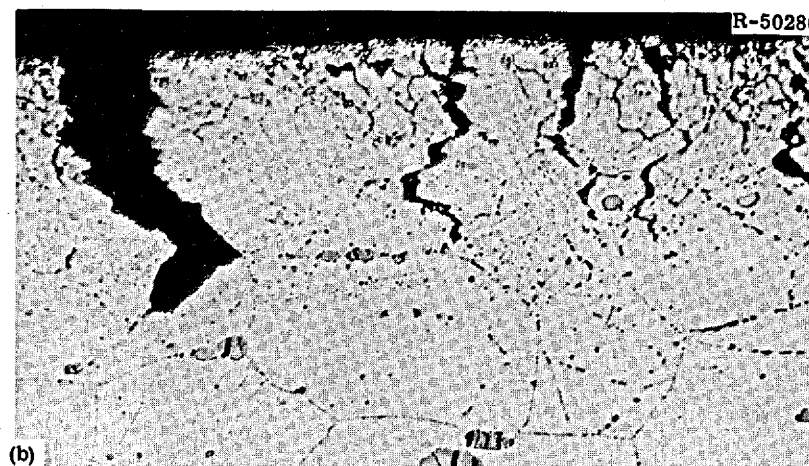
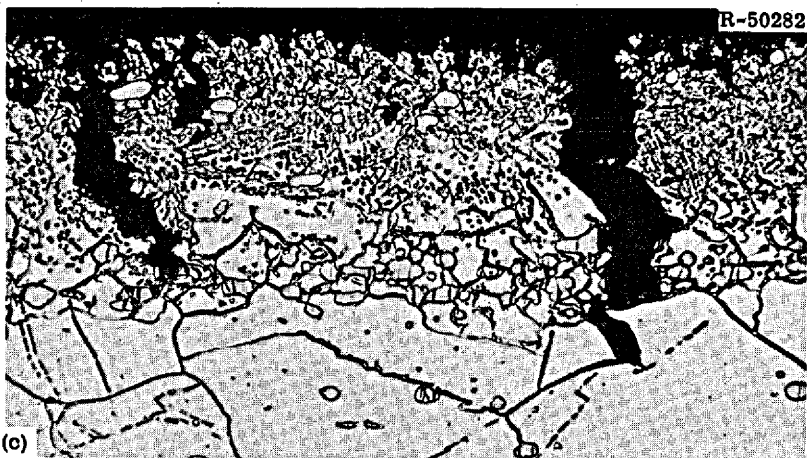
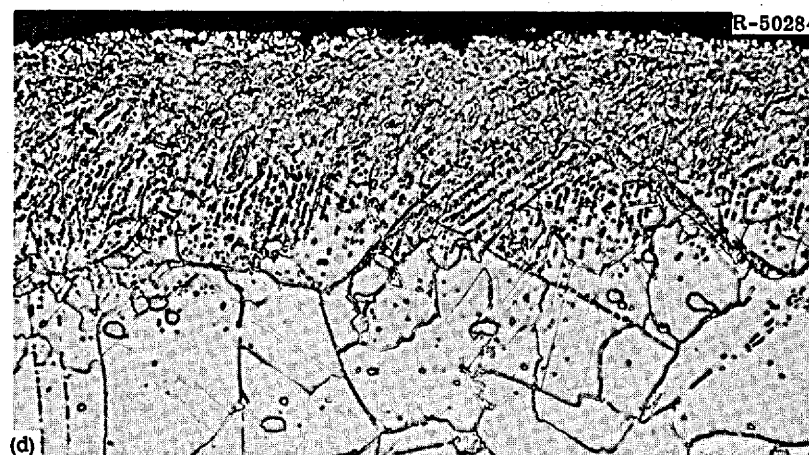
Fig. 49. Typical Photomicrographs of INOR-8 (Heat 5085) Sample Exposed to the MSRE Core for 19,136 hr Above 500°C. The sample was bent in a vise. (a) As polished, tension side. 100x. (b) As polished, tension side. 500x. (c) Etched, tension side. 500x. (d) Etched, compression side. 500x. Etchant: aqua regia. Reduced 27%.

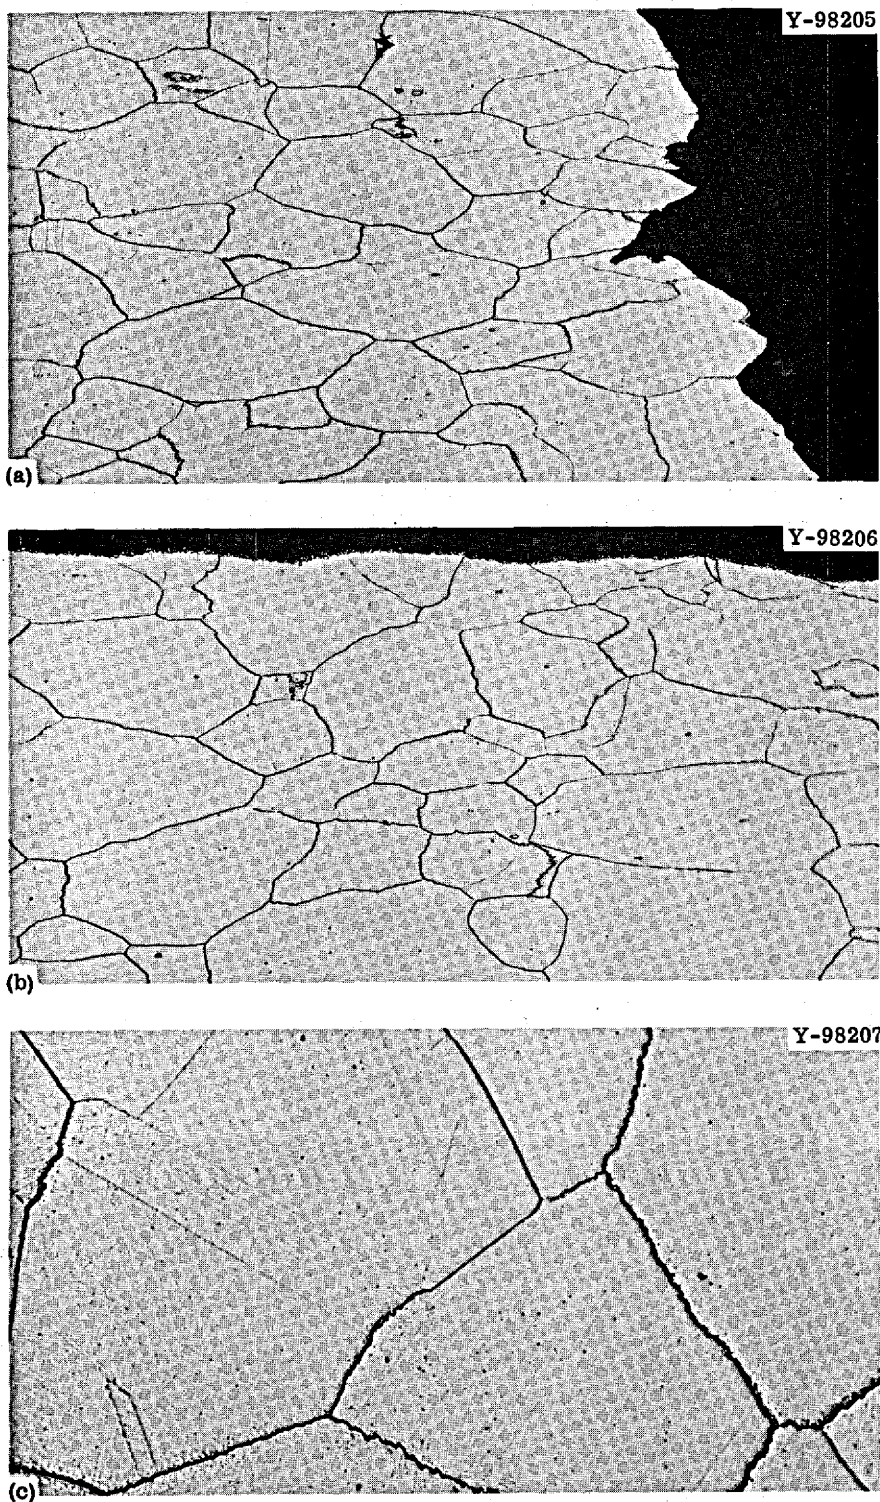
Fig. 50. Photomicrographs of a Modified INOR-8 (Heat 7320) Sample Tested at 25°C After Being Exposed to Static Unenriched Fuel Salt for 7203 hr Above 500°C. (a) Fracture. 100x. (b) Edge. 100x. (c) Typical unstressed microstructure. 500x. Etchant: glyceria regia. Reduced 22.5%.

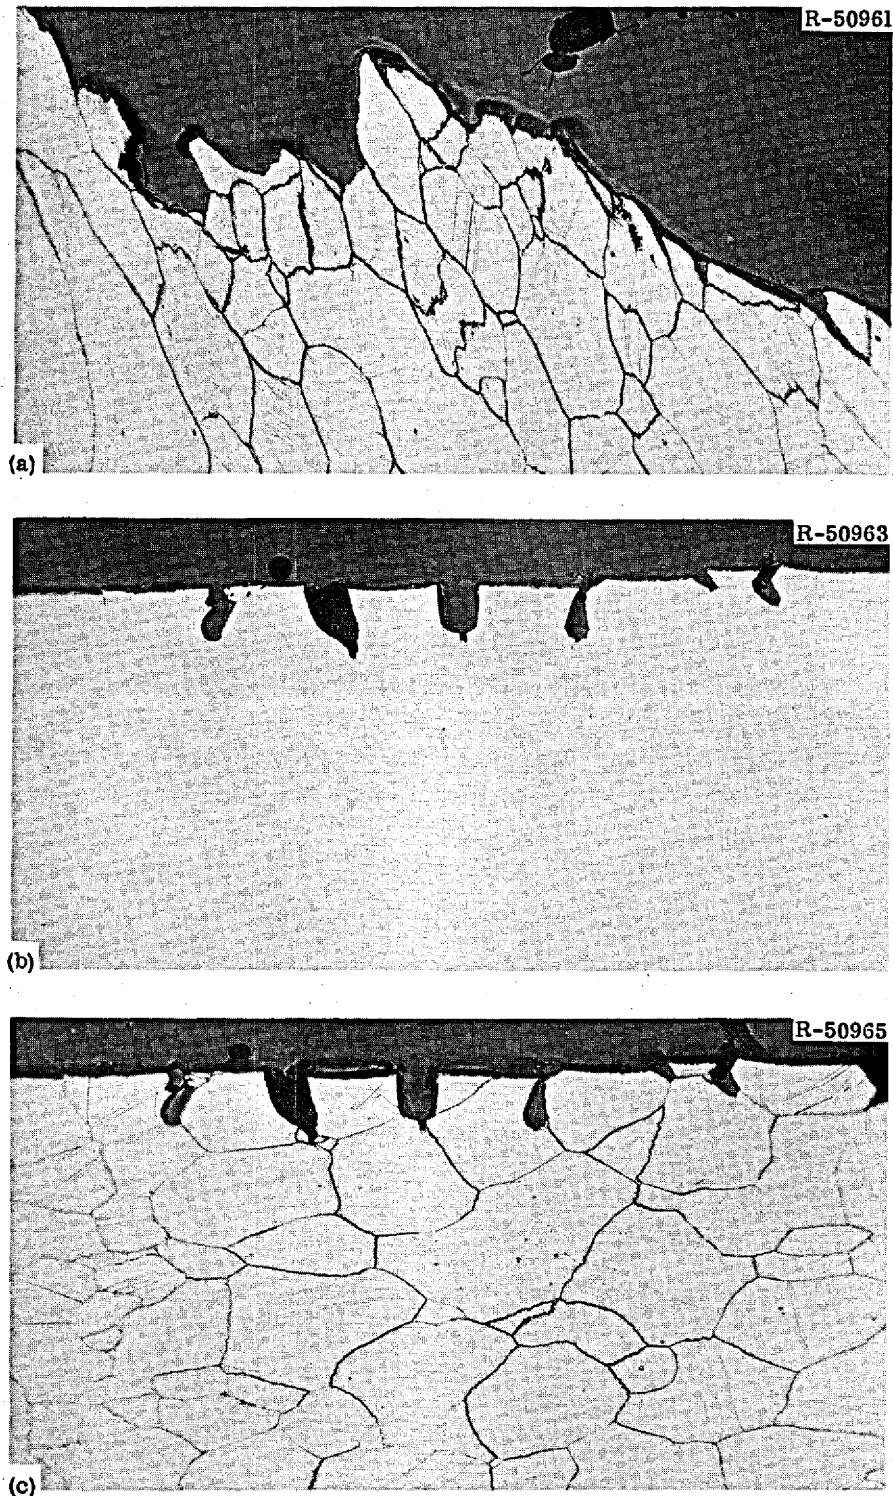
Fig. 51. Photomicrographs of a Modified INOR-8 (Heat 7320) Sample Tested at 25°C After Being Exposed to the MSRE Core for 7203 hr Above 500°C and Irradiated to a Fluence of 5.1×10^{20} neutrons/cm². (a) Fracture, etched, 100×. (b) Edge, as polished. 100×. (c) Edge, Etched. 100×. Etchant: glyceria regia. Reduced 22%.

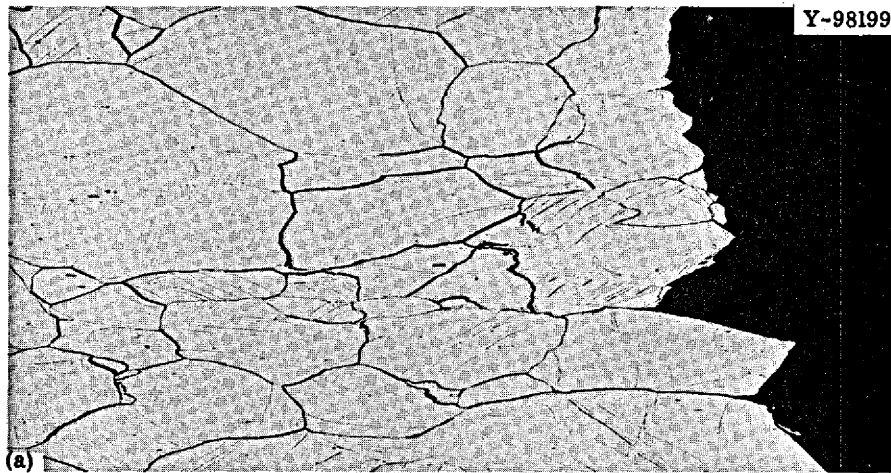
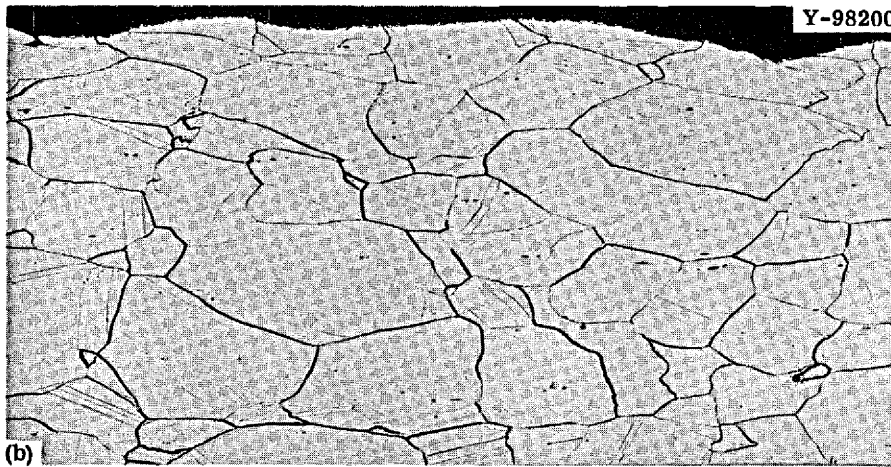
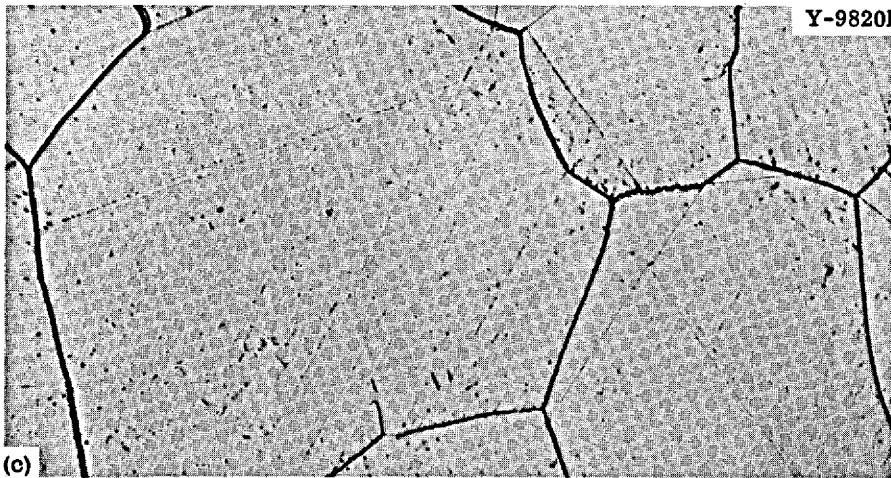
The specimens on stringers RR3 and RS4 were of two different heats of titanium-modified alloy: heat 7320, containing 0.65% Ti, and heat 67-551, containing 1.1% Ti. The 7200-hr exposure of these specimens had been entirely during the ^{233}U operation, in which the initial oxidation state was relatively high. The specimens were discolored and had much the same appearance as the standard heats. The samples were subjected to various mechanical property tests and some were examined metallographically. The microstructure of heat 7320 after exposure in the control facility and testing at 25°C is shown in Fig. 50. The sample deformed 50% before fracturing in a mixed mode. No edge cracks were visible. A similar sample that was exposed to the fuel salt is shown in Fig. 51. It failed after deforming 45%. Edge cracks were present along almost every grain boundary to a depth of 3 to 5 mils. Note that many of these cracks proceed to where the cracking grain boundary intersects another boundary. Note also that the crack tips are quite blunt indicating that they formed early during deformation and were simply spread by further deformation and did not propagate. Similar metallographic observations were made on heat 67-551. Control and core specimens deformed almost equal amounts before fracturing (52% and 51%). No edge cracks were observed in the sample from the control facility (Fig. 52), but numerous intergranular cracks were evident in the sample from the core (Fig. 53).

Fig. 52. Photomicrographs of a Modified INOR-8 (Heat 67-551) Sample Tested at 25°C After Being Exposed to Static Unenriched Fuel Salt for 7203 hr Above 500°C. (a) Fracture. 100x. (b) Edge. 100x. (c) Typical unstressed microstructure. 500x. Etchant: glyceria regia. Reduced 20.5%.

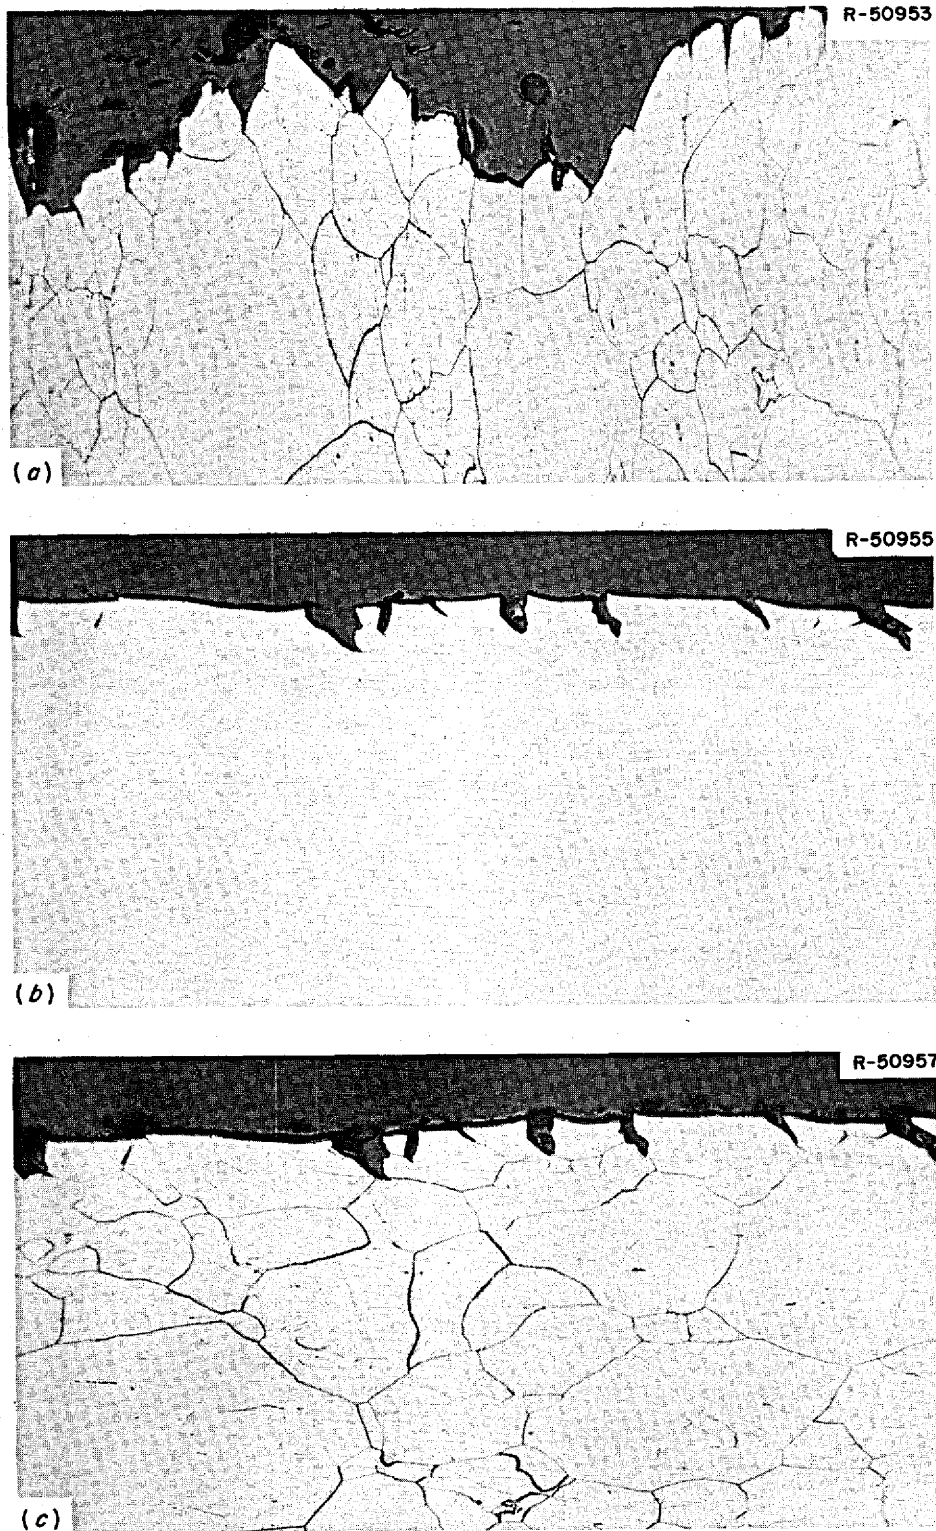
Fig. 53. Photomicrographs of a Modified INOR-8 (Heat 67-551) Sample Tested at 25°C After Being Exposed to the MSRE Core for 7203 hr Above 500°C and Irradiated to a Fluence of 5.1×10^{20} neutrons/cm². (a) Fracture, etched. 100x. (b) Edge, as polished. 100x. (c) Edge, etched. 100x. Etchant: Glyceria regia. Reduced 17%.

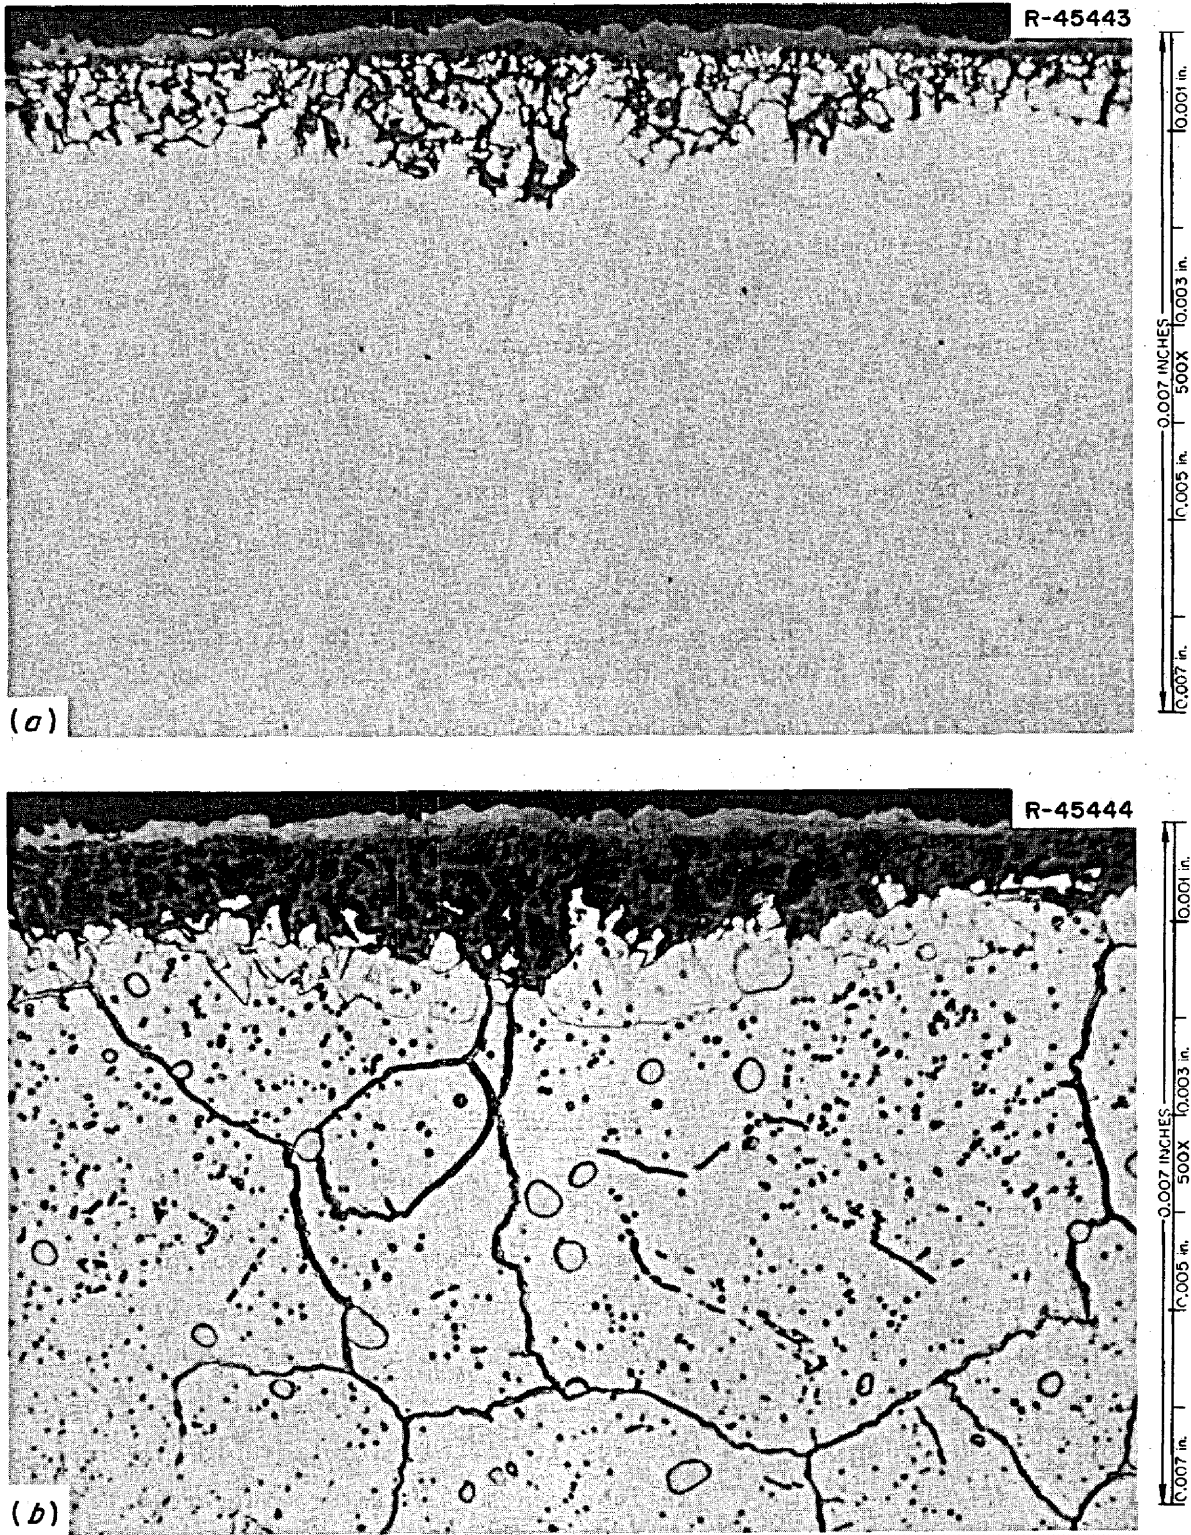
Figure 54 is a photomicrograph of one of the cell specimens exposed the longest (17,483 hr at high temperature). It shows a very thin, uniform layer of oxide on the surface, with internal oxidation extending to a depth of 1 to 2 mils. Also evident is the usual M_6C -type carbide formed during the primary working and the long thermal aging.

Fig. 54. Photomicrographs of Hastelloy N (Heat 5065) Surveillance Specimens Exposed to the Cell Environment of $N_2 + 2$ to 5% O_2 for 20,789 hr at 650°C. 500x. (a) Unetched showing surface oxidation (b) Etched (glyceria regia) showing shallow modification of microstructure due to reaction with cell environment.

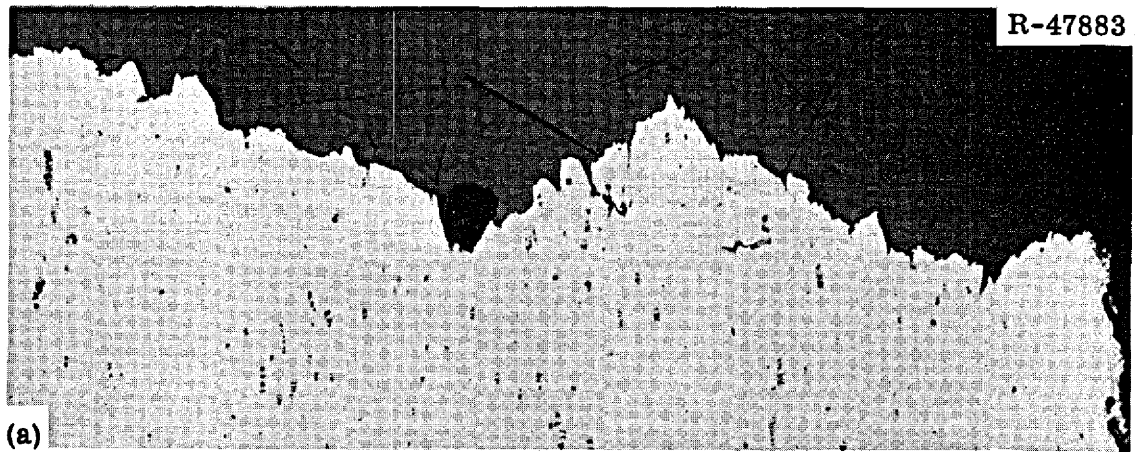
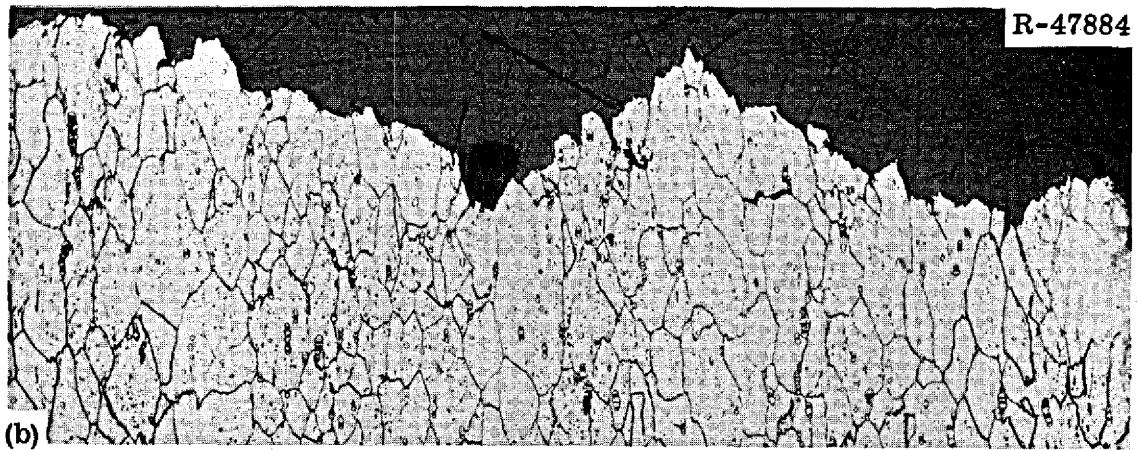
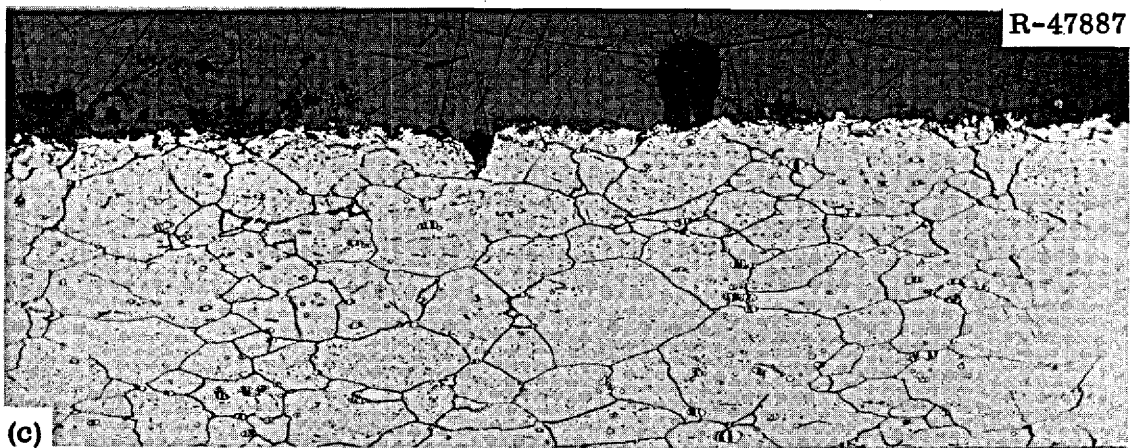
Figure 55 shows a sample of heat 5065 exposed to the cell environment and fractured at 25°C. The elongated grains attest to the large fracture strain (59%), and the fracture is mixed transgranular and intergranular. A heat 5085 specimen exposed the same length of time failed with only 33% fracture strain, in a primarily intergranular mode as shown in Fig. 56. Both specimens showed a few shallow surface cracks, but the oxide layer did not appear to affect the deformation of the specimens.

Fig. 55. Photomicrographs of INOR-8 (Heat 5065) Sample Tested at 25°C at a Strain Rate of 0.05/min. Sample had been irradiated to a thermal fluence of 2.6×10^{19} neutrons/cm² while being exposed to the cell environment above 500°C for 17,483 hr. 100x. (a) Fracture, as polished. (b) Fracture, etched. (c) Edge of stressed portion. Etchant: aqua regia.

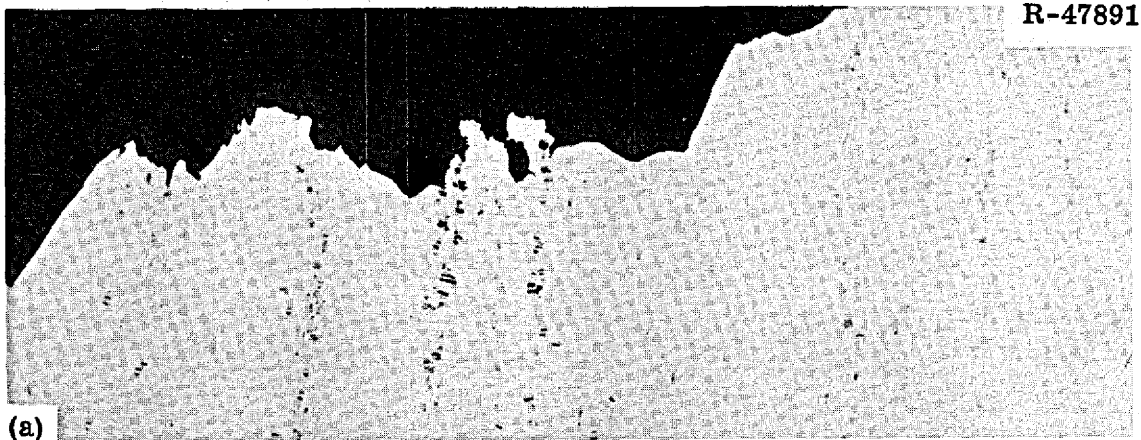
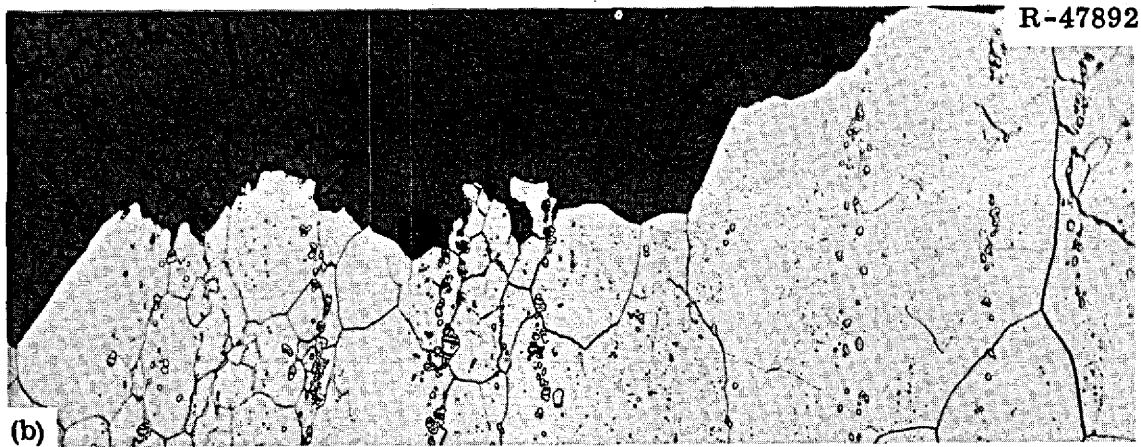
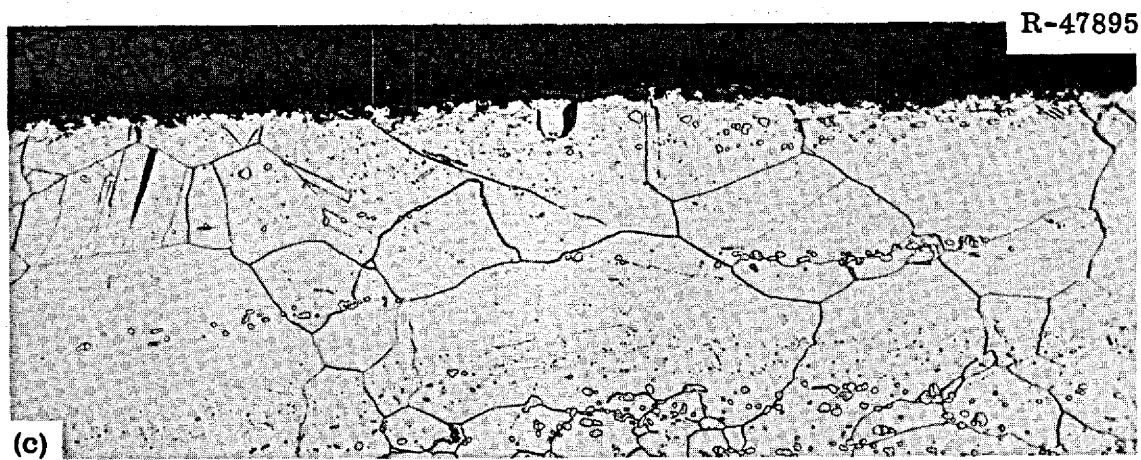
Fig. 56. Photomicrographs of INOR-8 (Heat 5085) Sample Tested at 25°C at Strain Rate of 0.05/min. Sample had been irradiated to a thermal fluence of 2.6×10^{19} neutrons/cm² while being exposed to the cell environment above 500°C for 17,483 hr. 100x. (a) Fracture, as polished. (b) Fracture, etched. (c) Edge of stressed portion. Etchant: aqua regia.

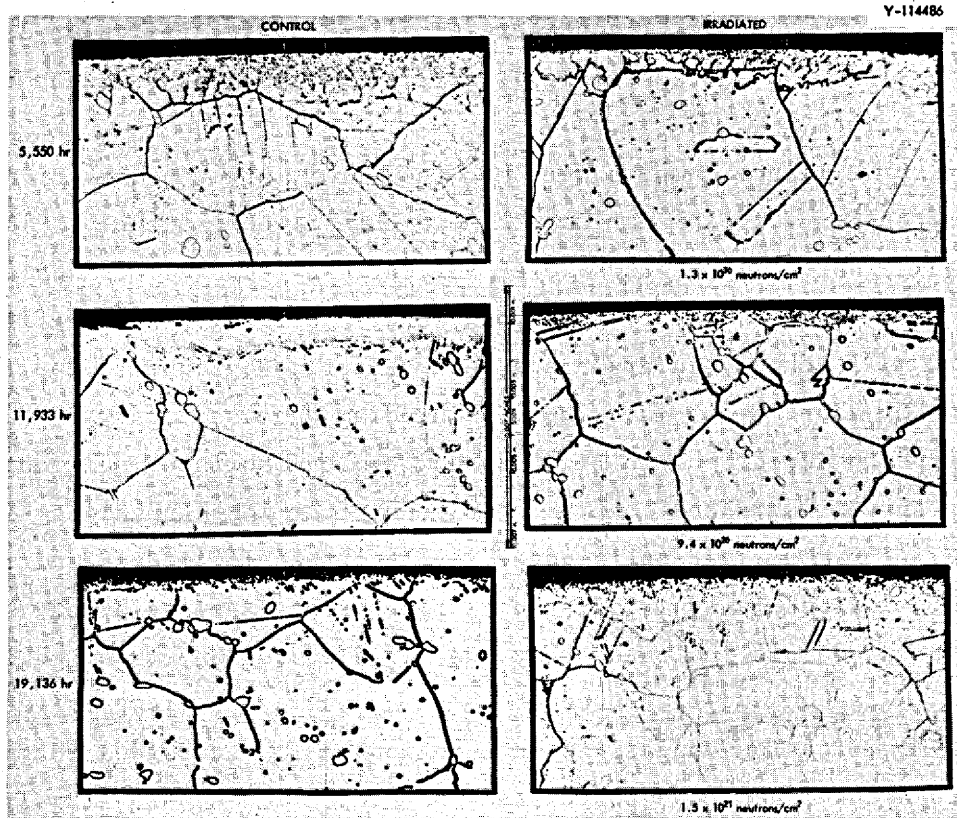
The photomicrographs in Fig. 57 show typical surface modifications noted on surveillance and control specimens after long annealing times at 650°C. The modification is generally less than 1 mil deep and is not detectably influenced by irradiation. Microprobe examination of the first control sample indicated that the modified region was slightly enriched in carbon and that none of the other alloying elements varied. Thus the modification appears to be a region of fine carbides that are dispersed along lines. We postulated that these lines were slip lines that resulted from the surface working during the final stages of fabrication. These slip lines would provide preferred sites for carbide precipitation when the alloy was held at 650°C.

Fig. 57. Photomicrographs of Unstressed INOR-8 (Heat 5085) Control and Irradiated Samples.

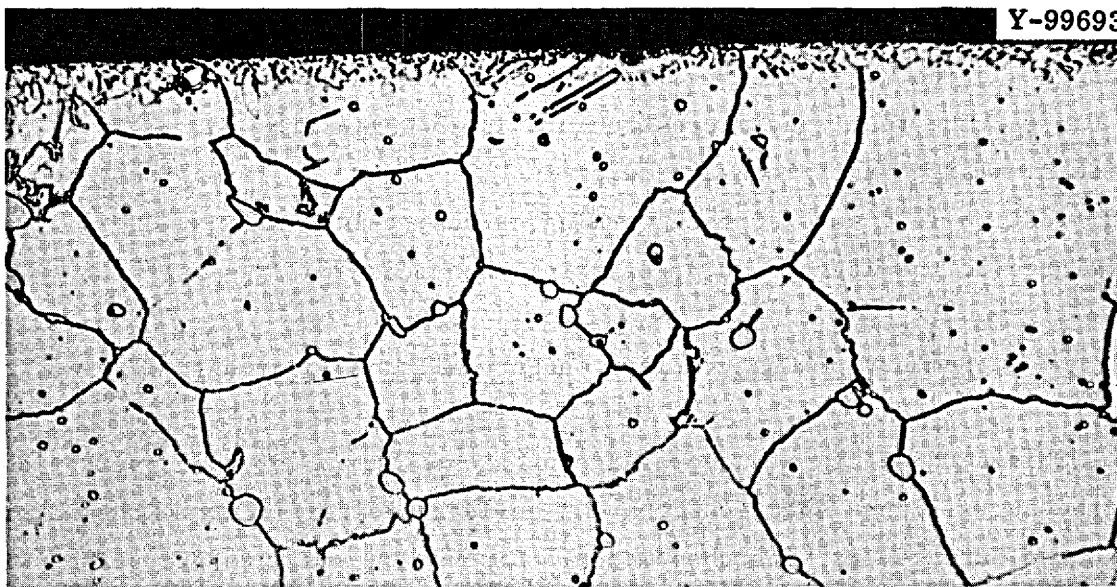
We were able to duplicate the surface modification by solution annealing a rod, centerless grinding, and annealing for a long period at 650°C. The resulting microstructure is shown in Fig. 58. It is quite similar to the microstructures in Fig. 57 and confirms that the modification is due to surface working. Thus, this modification is unrelated to the intergranular cracking phenomenon.

Fig. 58. Photomicrograph of INOR-8 (Heat 5085) Rod that was Annealed 1 hr at 1177°C, Centerless Ground 5.2 mils, and Annealed 4370 hr at 650°C in Argon. 500x. Etchant: glyceria regia.

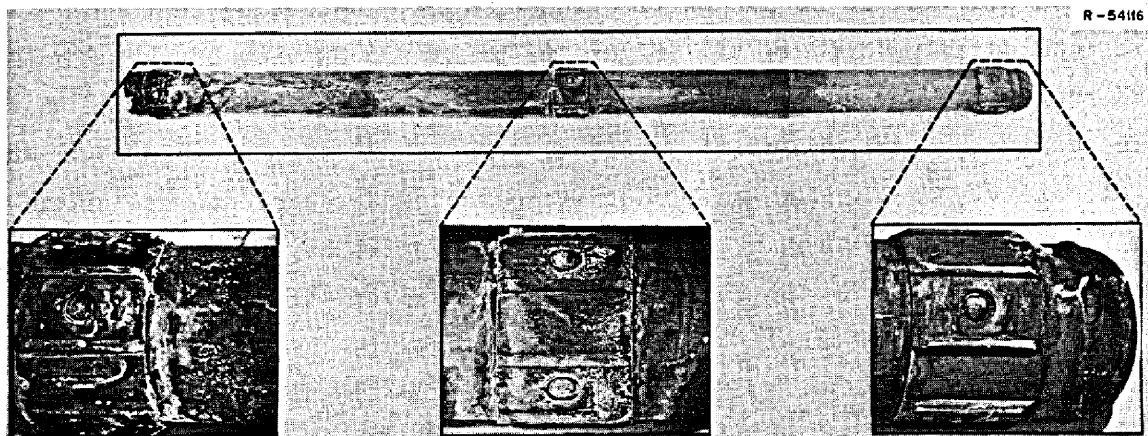
Fig. 60. Portion of Control Rod Thimble that was Examined After Operation of MSRE was Terminated. The thimble is made of 2-in-OD \times 0.065-in.-wall INOR-8 tubing (Heat Y-8487). The electric arc cut on the left was near the center line of the core.

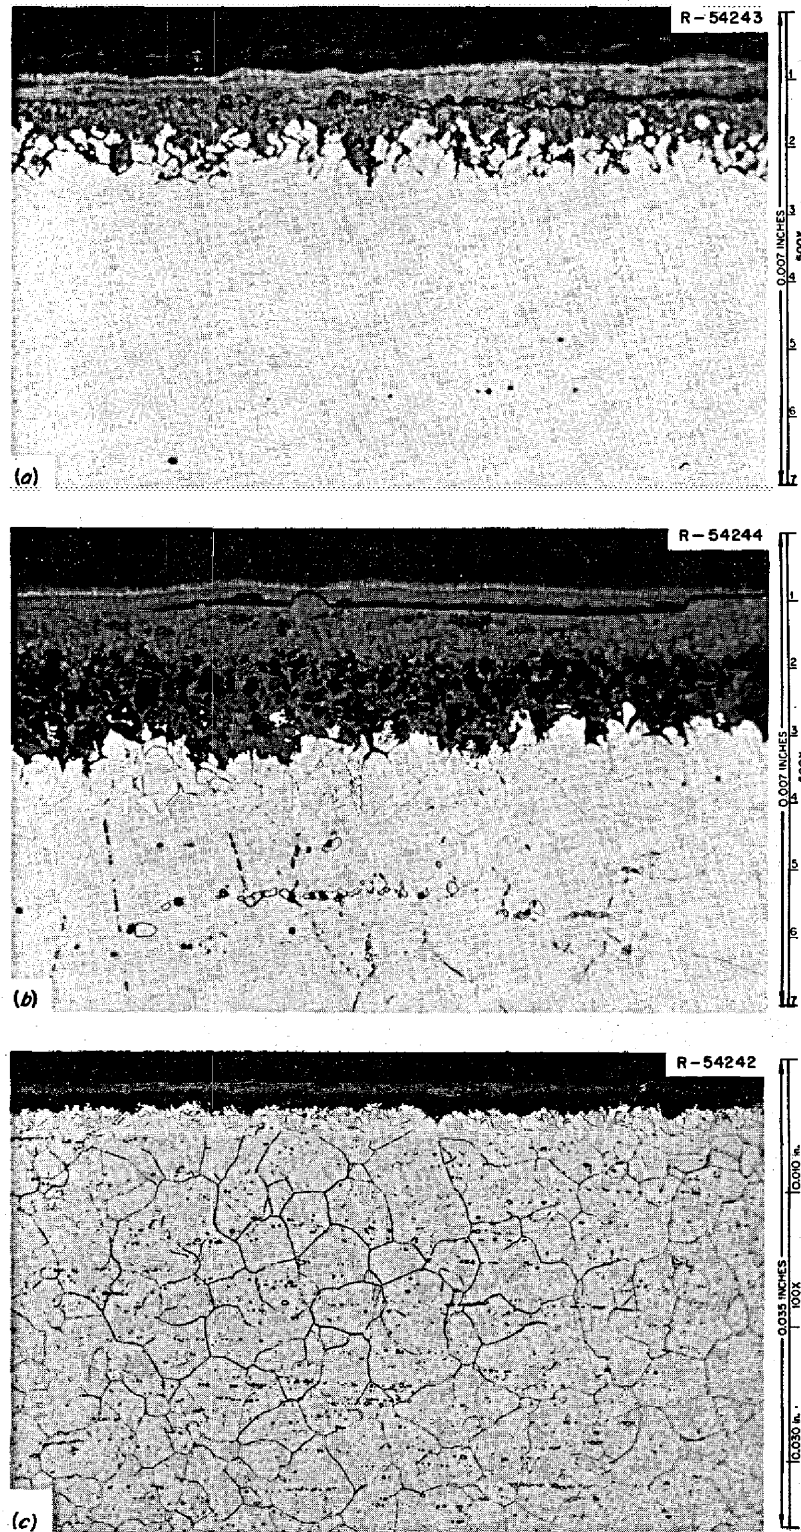
Samples of the control rod thimble and the spacer sleeve were cut and examined to determine their condition at the end of service. Typical photomicrographs of the inside of the thimble tube are shown in Fig. 61. This surface was oxidized to a depth of about 2 mils by the cell environment of nitrogen containing 2 to 5% O_2 . The oxidation process modified the microstructure to a depth of 4 mils, likely due to the selective removal of chromium.

Fig. 61. Photomicrographs of the Inner Surface of the Control Thimble in the As-removed Condition. This surface was exposed to cell environment of N_2 containing 2 to 5% O_2 . (a) As polished. (b) Etched. (c) Etched, typical microstructure. Etchant: Aqua regia. Reduced 30.5%.
