2362
ORNL-4829

INTERGRANULAR CRACKING OF INOR-8 IN THE MSRE

H. E. McCoy
B. McNabb

NOVEMBER 1972

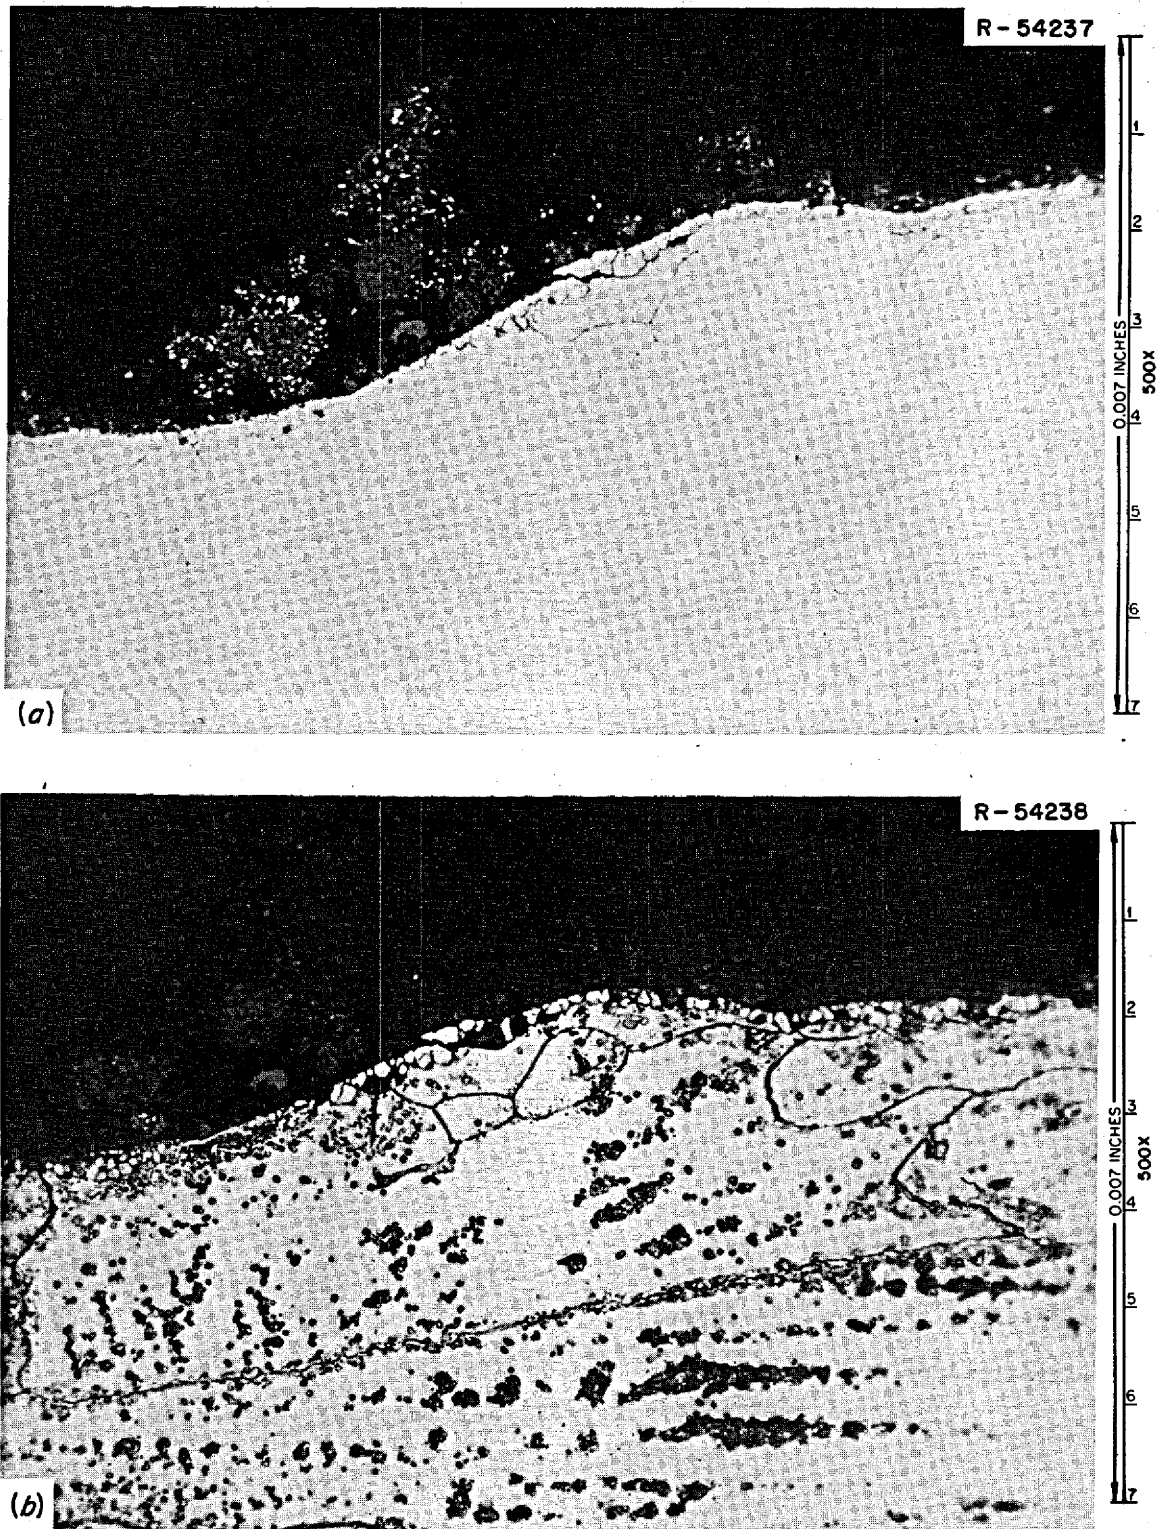
Photomicrographs of one of the weld beads are shown in Fig. 62. All of the surface shown was exposed to flowing fuel salt. Some dislodged grains are near the surface, and grain boundaries are visible in the as-polished condition to a depth of 1 to 1.5 mils.

Fig. 62. Photomicrographs of Outer Surface of Control Rod Thimble Showing the Weld Deposit Made to Hold the Spacer Sleeve. The weld surface was exposed to flowing salt. (a) As polished. (b) Etched: Aqua regia.

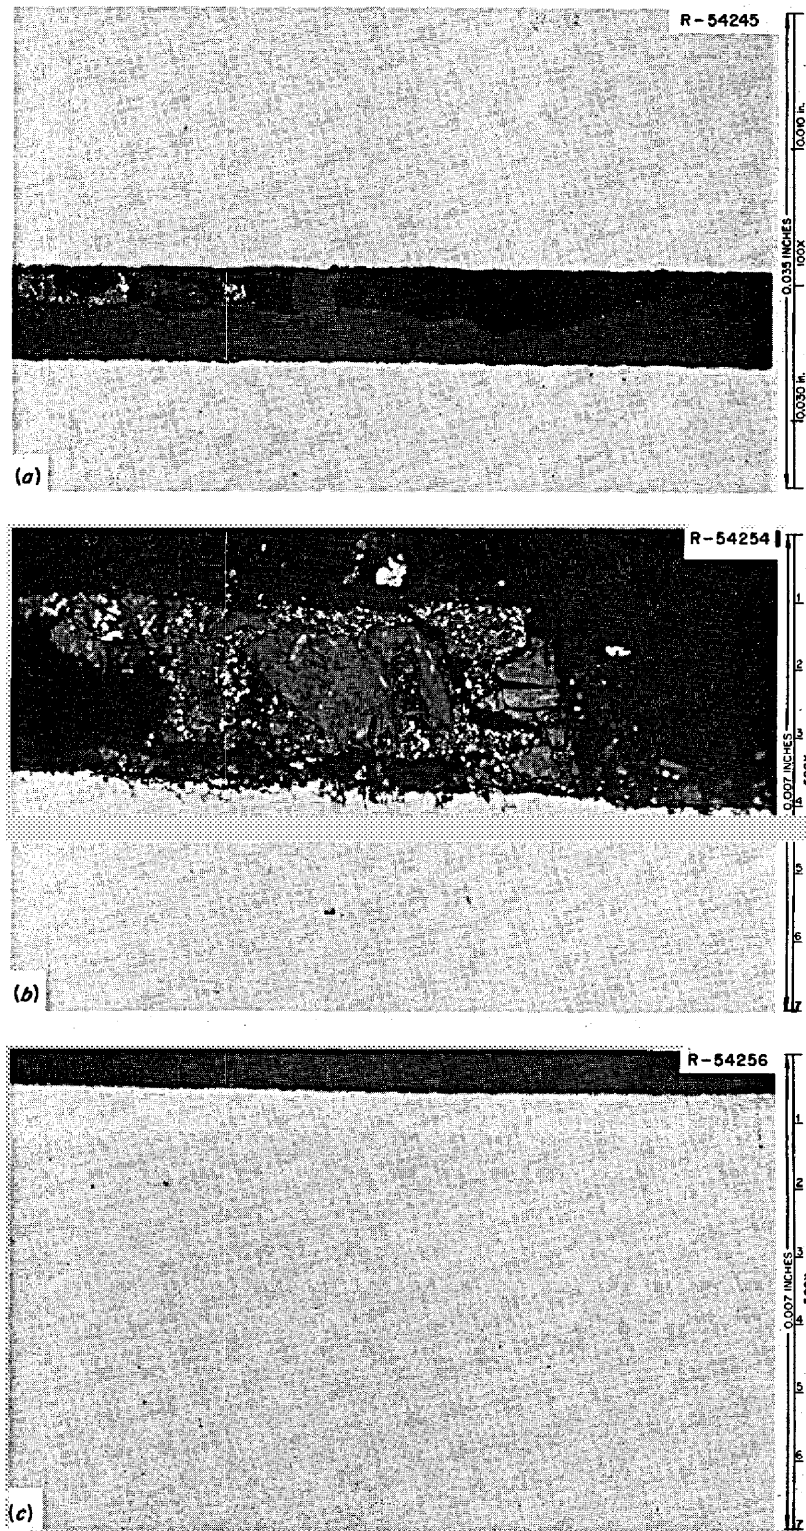
Photomicrographs involving the interface between the thimble and sleeve are shown in Fig. 63. Figure 63(a) shows the annular region with a separation of about 7 mils and some salt present. Few surface irregularities are visible at a magnification of 100x, indicating that they are considerably below 1 mil. Figure 63(b) is a 500x view of the thimble and shows some surface cracks to a depth of 0.3 mil. The outside of the sleeve is shown in Fig. 63(c); a few grain boundaries to a depth of about 1 mil are visible. Additional photomicrographs of the sleeve are shown in Fig. 64. The sleeve material does not appear to have received much working since the carbide is very inhomogeneously distributed. The grain size is larger than usual away from the stringers. The inner and outer surfaces both have modified structures. A higher magnification view of the inner surface [Fig. 64(b)] shows that much of the modification is a high density of primary carbide. The outer surface [Fig. 64(c)] has a shallow layer of small grains, likely due to a working operation.

Fig. 63. Photomicrographs of As-polished Surfaces of Control Rod Thimble and Sleeve. (a) Annulus between thimble and sleeve. Thimble surface is in upper part of picture. (b) Outside surface of control rod thimble, showing presence of some salt and shallow surface cracking. (c) Outside surface of sleeve. Surface exposed to flowing fuel salt.

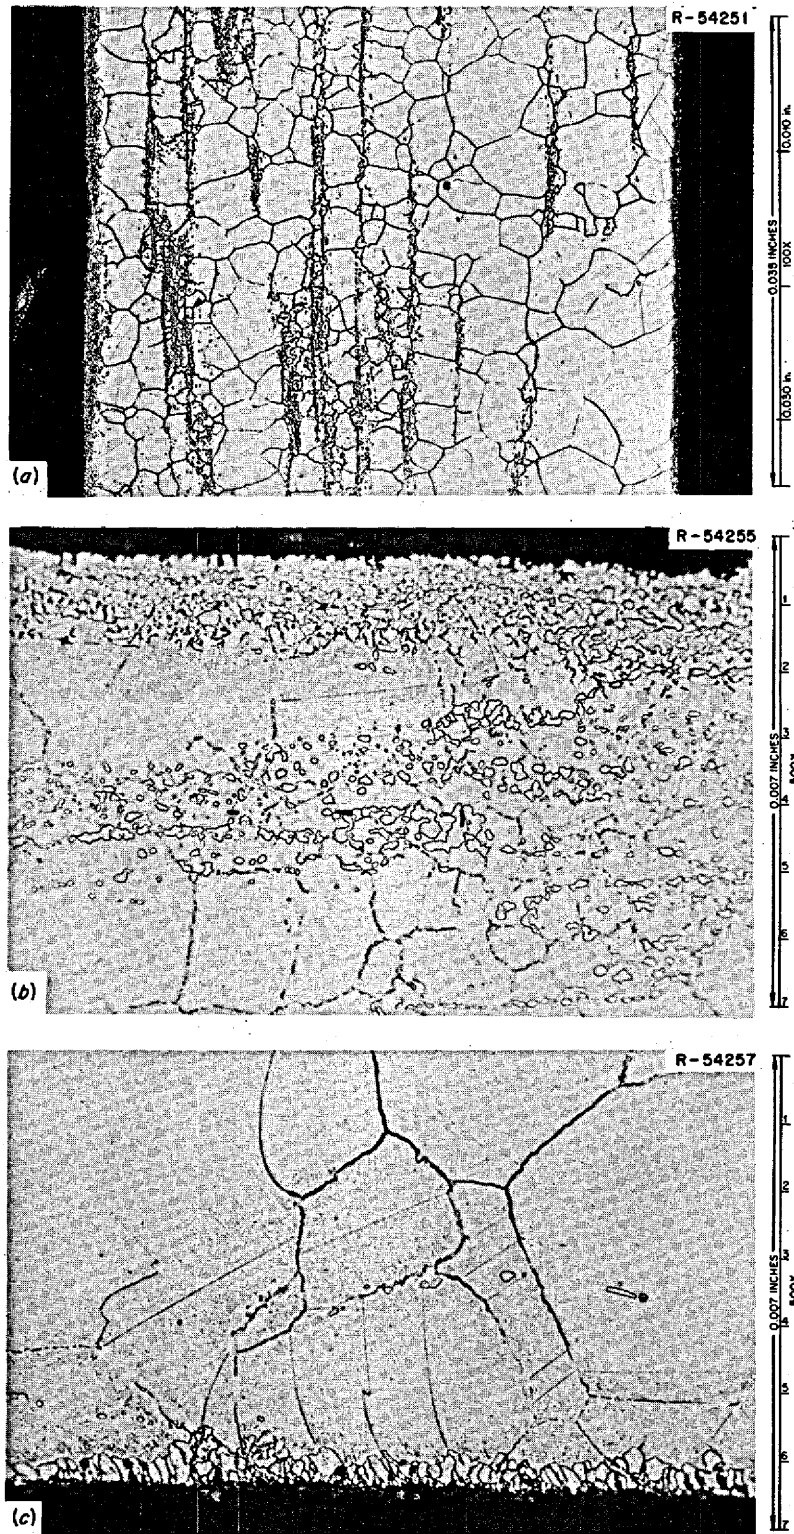
Fig. 64. Photomicrographs of Control Rod Sleeve. (a) Etched view showing general microstructure. Inner surface is on left and outer surface is on right. (b) Inner surface of sleeve. (c) Outer surface of sleeve. Etchant: Aqua regia. Reduced 30.5%

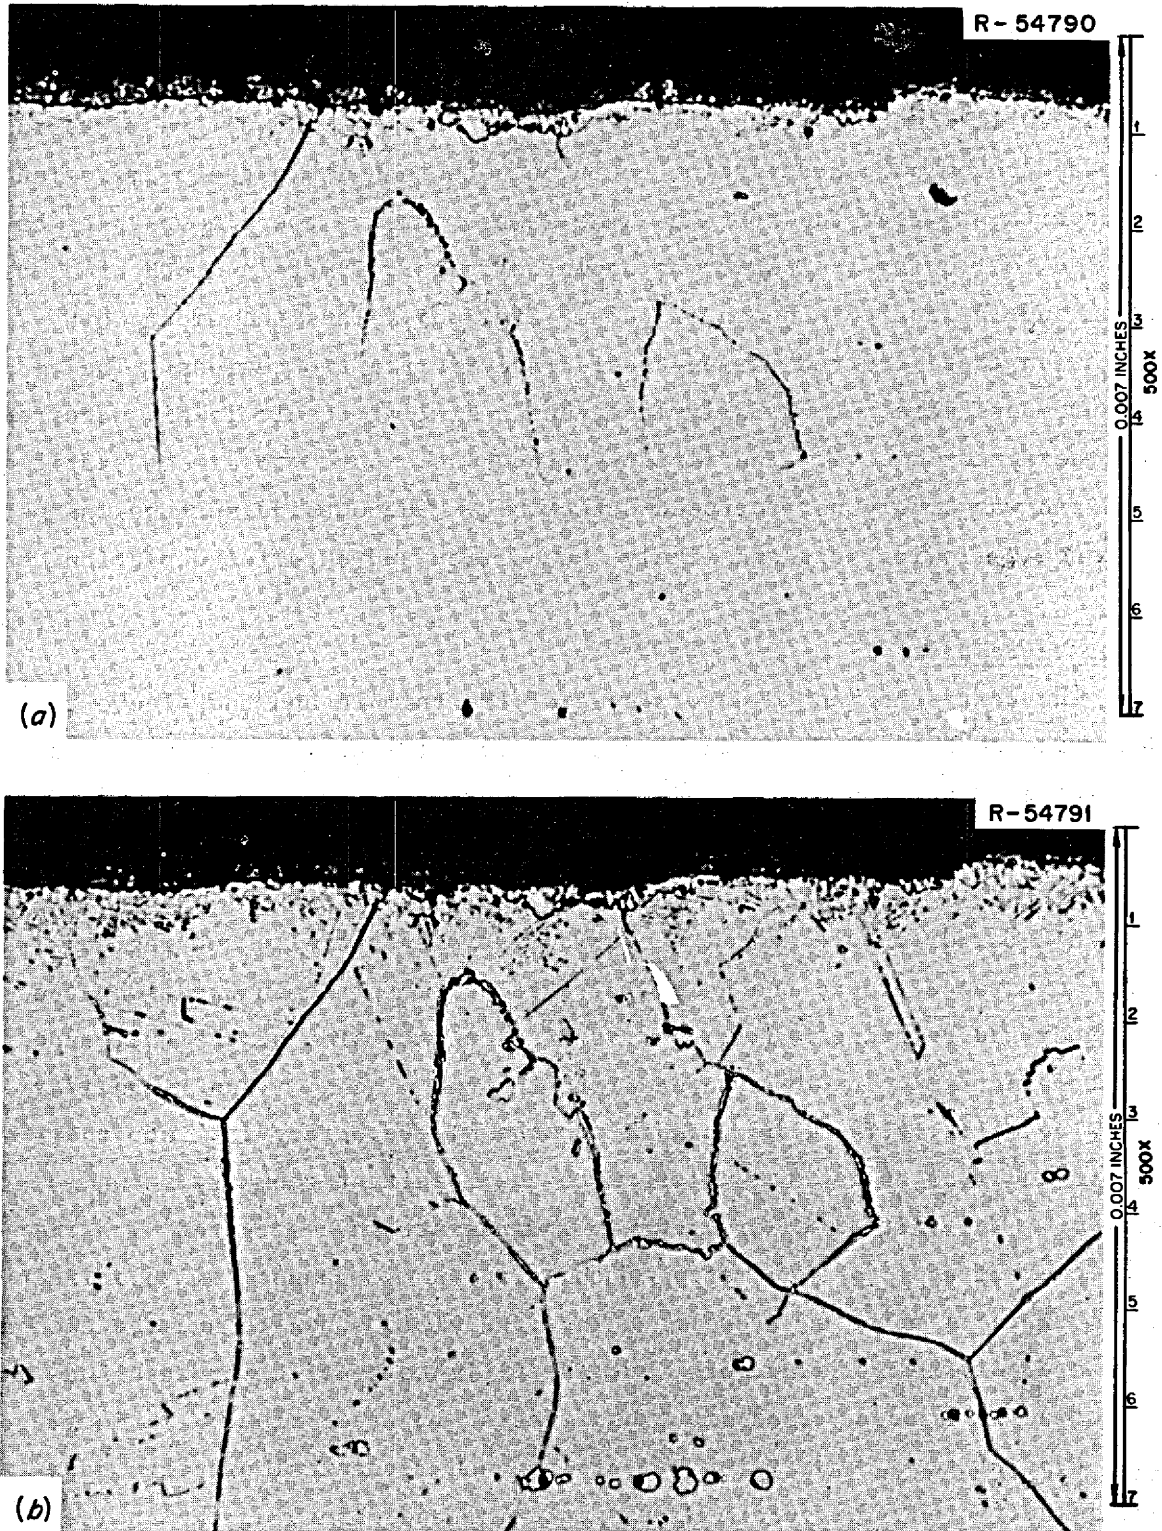
A second cut was made away from the sleeve, and typical photomicrographs are shown in Fig. 65. This part of the thimble was exposed to flowing salt. Some of the grain boundaries are visible in the as-polished condition to a depth of about 4 mils and there is some surface modification [Fig. 65(a)]. Etching [Fig. 65(b)] delineates more of the grain structure and shows the shallow surface modification.

Fig. 65. Photomicrographs of Control Rod Thimble where it was Exposed Directly to Flowing Salt. (a) As polished. (b) Etched: Aqua regia.

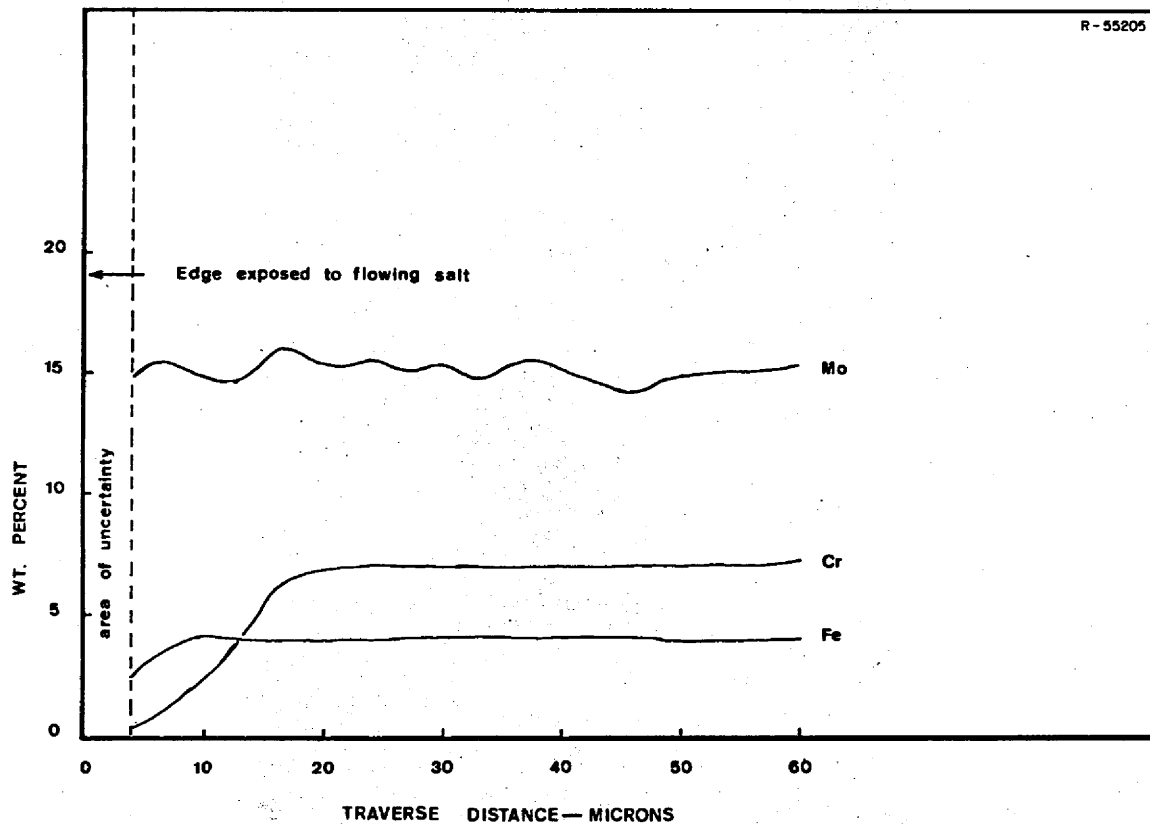
Microprobe scans were run on the thimble samples that were taken from under the sleeve and outside the sleeve. In the first case the thimble wall was exposed to almost static fuel salt, and no gradients in iron and chromium concentration could be detected within the 3- μm region of uncertainty near the surface. The sample outside the sleeve that was exposed to flowing fuel salt was depleted in chromium to a depth of almost 20 μm and in iron to a depth of 10 μm (Fig. 66). Thus the amount of corrosion that occurred varied considerably in the two regions. The measurements were not actually made, but a similar result likely occurred for the spacer sleeve. The inside surface was exposed to almost static salt and was likely not corroded detectably. The outside surface was exposed to flowing salt and likely showed iron and chromium depletion.

Fig. 66. Electron Microprobe Scan of Sample from Control Rod Thimble. The thimble had been exposed to the fuel salt for 21,040 hr and had been above 500°C for 30,807 hr.

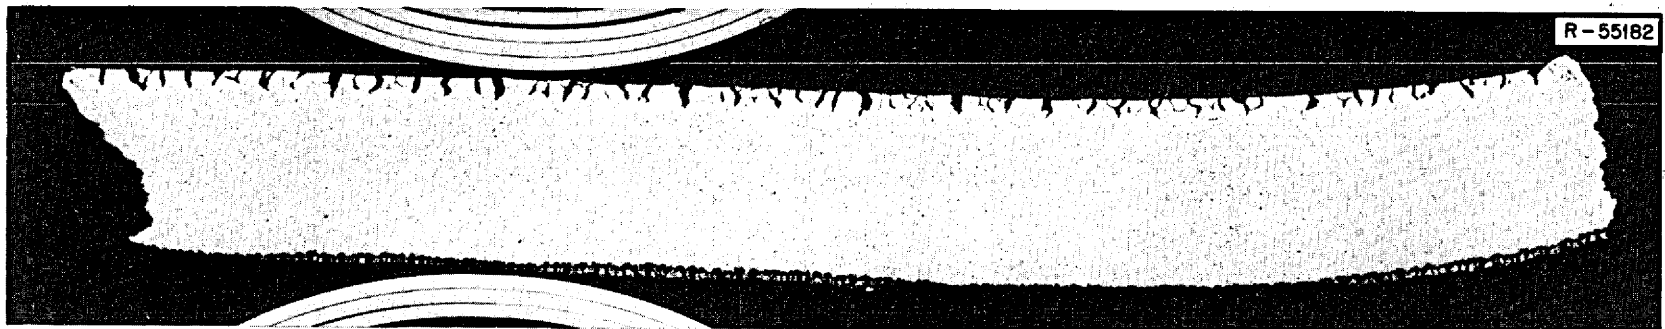
Several of the specimens that had been strained were examined metallographically to determine the extent of cracking during straining. Several photomicrographs of the control rod thimble that was exposed to flowing salt are shown in Fig. 68. The inside surface was oxidized, and the oxide cracked as the specimen was strained. The oxide should be brittle, but it is important that these cracks did not penetrate the metal. The side exposed to the salt exhibited profuse intergranular cracking. Almost every grain boundary cracked, and the cracks generally propagated to a depth of one grain, although there are several instances where the crack depth exceeded a depth of one grain. Several photomicrographs were combined and rephotographed to obtain Fig. 69. This sample had 192 cracks per inch with average and maximum depths of 5.0 and 8.0 mils, respectively. Many of the cracks shown in Fig. 68 and 69 have blunt tips, indicating that they did not propagate into the metal as the specimen was strained.

Fig. 69. Photomicrographs of a Deformed Section of the Control Rod Thimble. The fracture is on the left. The upper surface was in contact with flowing salt and the lower surface was exposed to the cell environment of N_2 plus 2 to 5% O_2 . The sample is about 0.06 in. thick.

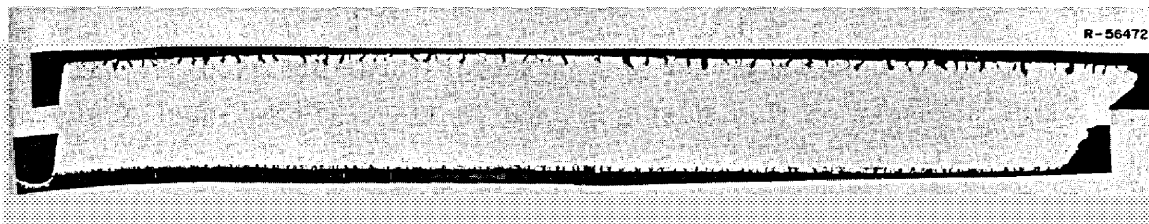
A similar sample was cut from the thimble under the sleeve, where the salt access was restricted. Photomicrographs of a specimen tested at 25°C are shown in Fig. 70. The cracks are quite similar to those in Fig. 68 for a sample that was exposed to flowing salt. The composite photograph in Fig. 71 is quite similar to Fig. 69 of the sample exposed to flowing salt. The sample in Fig. 71 had 257 cracks per inch, with average and maximum depths of 4.0 and 8.0 mils, respectively. The accuracy of our statistics and possible sampling inhomogeneities lead us to conclude that the severity of cracking is equivalent in the samples exposed to flowing and almost static salt. Thus flow rate over the range represented by these two sample locations does not appear to be an important variable.

Fig. 71. Composite Photograph Showing the Density of Cracking Along the Edge of a Portion of the Deformed Control Rod Thimble. 9.5X. The sample is 0.58 in. long. The fracture is on the left, the upper surface was exposed to fuel salt, and the lower surface was exposed to the cell environment of N_2 plus 2 to 5% O_2 .

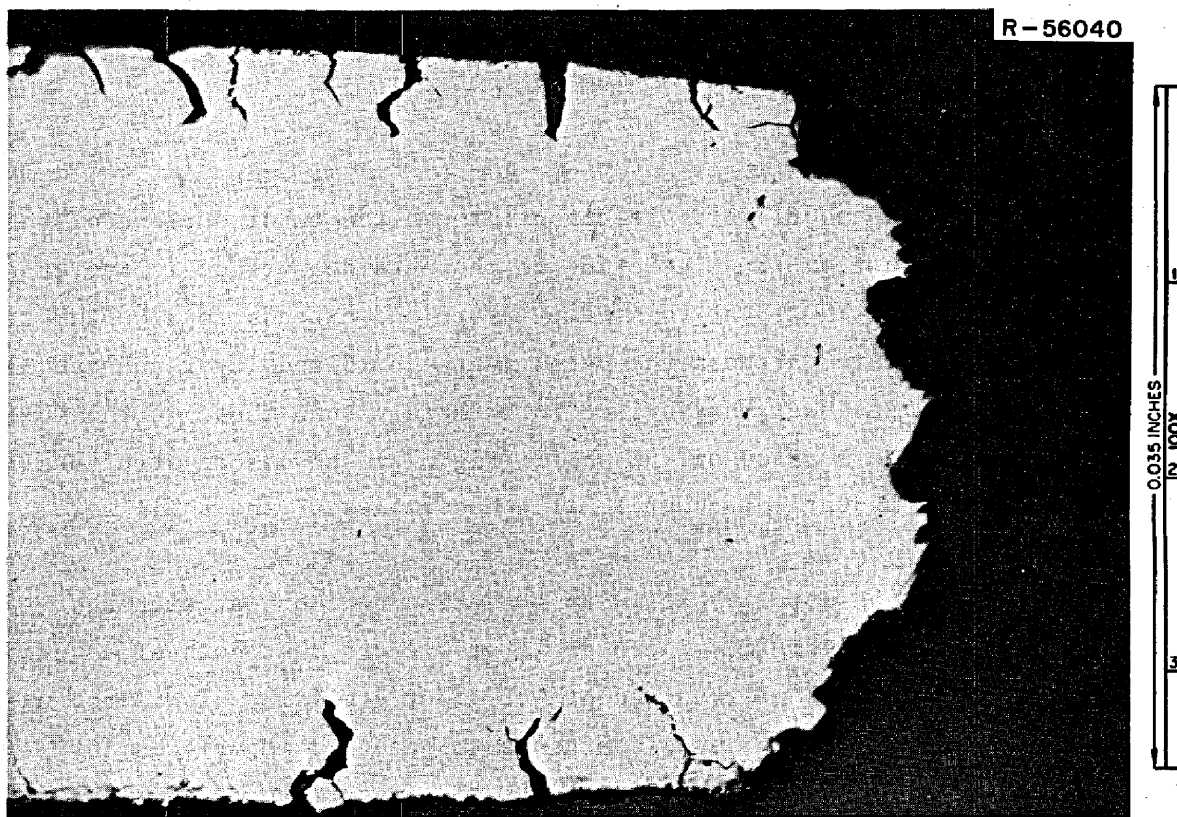
The spacer sleeve gave another opportunity to examine whether a relationship existed between salt velocity and cracking. The photomicrograph in Fig. 72 shows cracks on both sides, with more being present in the field photographed on the side where the salt was rapidly flowing. However, the composite photograph in Fig. 73 shows that the cracking is about equivalent on both sides. Cracking statistics on the side exposed to rapidly flowing salt revealed 178 cracks per inch with a maximum depth of 7.0 mils. The side exposed to restricted salt flow had 202 cracks per inch, with a maximum depth of 5.0 mils. The average depth was 3.0 mils on both sides. These observations again show that salt flow rate is not a significant factor in intergranular cracking.

Fig. 72. Photomicrograph of a Section of Spacer Sleeve Tested at $25^\circ C$. As polished. The upper surface was exposed to almost static fuel salt and the lower surface was exposed to rapidly flowing fuel salt.

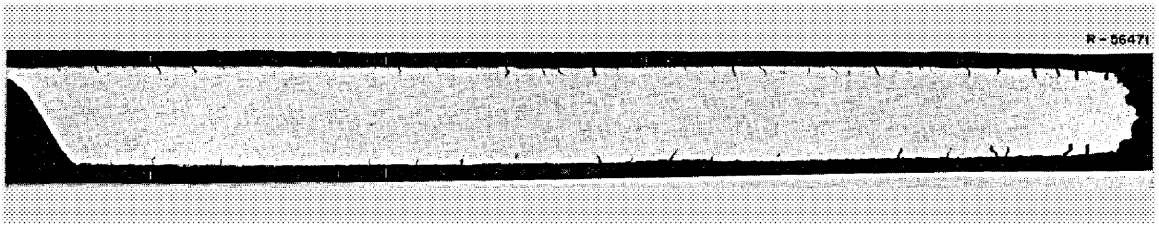
Fig. 73. Composite Photograph Comparing the Density of Cracking of Sides of Spacer Sleeve Exposed to Almost Static Salt (bottom) and to flowing salt (top). 11x. The sample is 0.52 in. long.

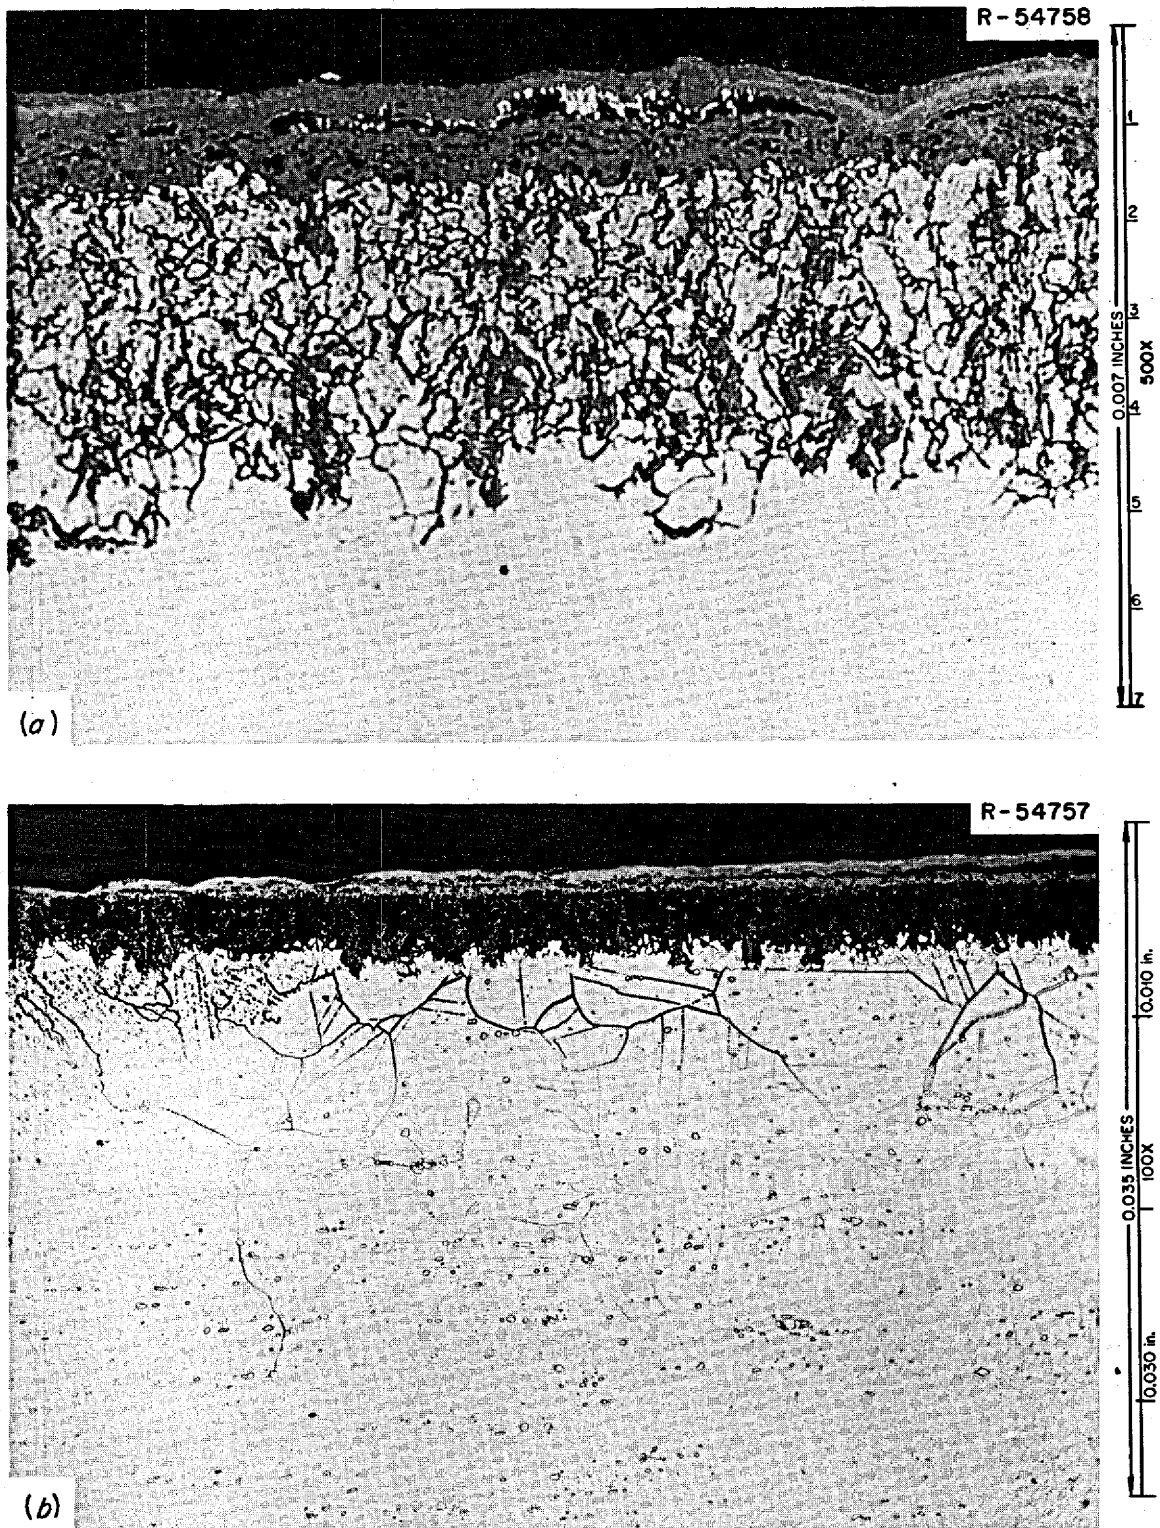
Photomicrographs of a cross section through the outer surface of the shell are shown in Fig. 76. The oxide on the outside surface is typical of that observed on INOR-8 at this temperature and extends to a depth of about 5 mils. Etching attacks the metal in the oxidized layer and etches the grain boundaries near the surface more rapidly than those in the interior. The inside surface of the shell (Fig. 77) shows some structural modifications to a depth of about 1 mil. No samples of the shell were deformed.

Fig. 76. Photomicrographs Showing the Outside Edge of the Primary Heat Exchanger Shell. This surface was exposed to 2 to 5% O_2 in N_2 . (a) As polished, showing the selective oxidation that occurred. (b) Etched view showing that the metal in the oxidized layer was completely removed. Etched with aqua regia.

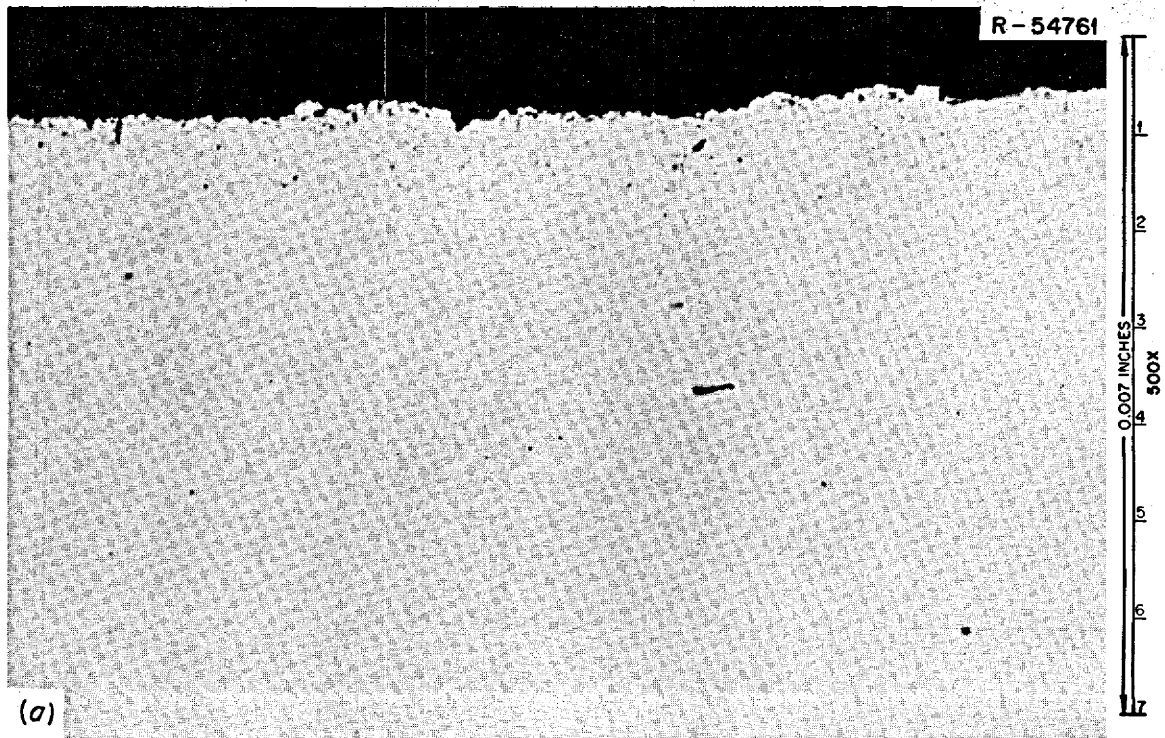
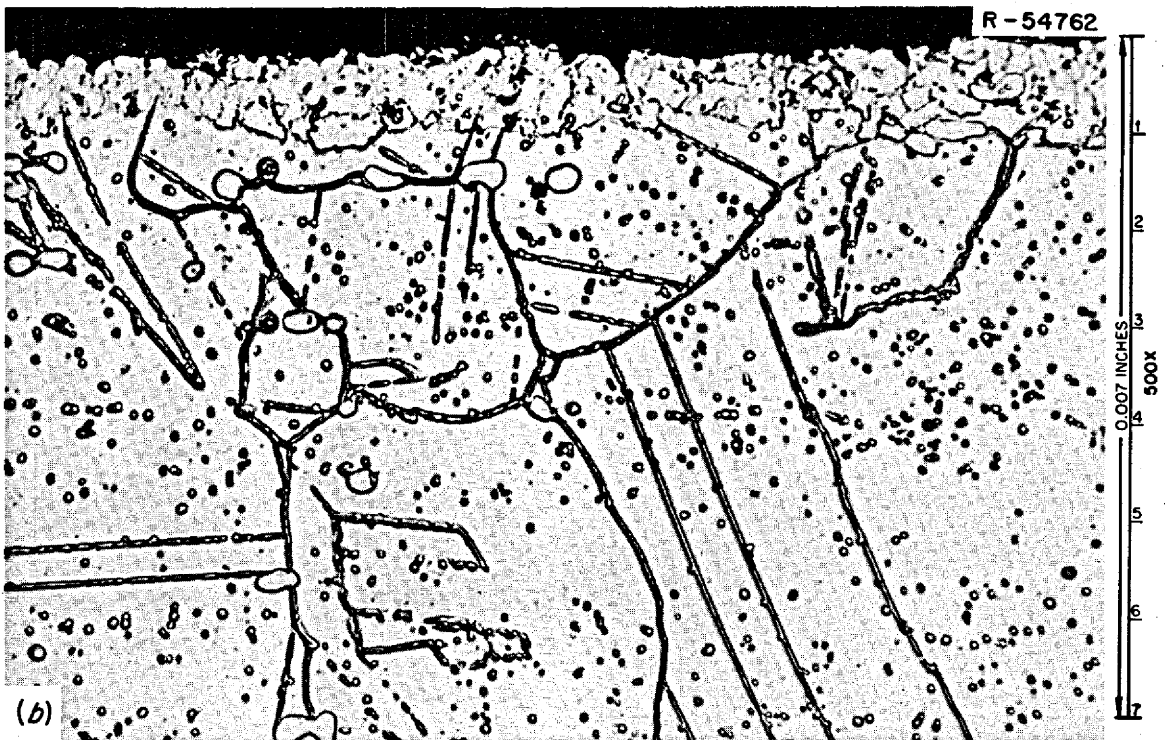
Fig. 77. Photomicrographs of the Inside Surface of the Primary Heat Exchanger Shell. The surface was exposed to fuel salt, and the modified structure to a depth of about 1 mil is apparent. (a) As polished. (b) Etched with aqua regia.

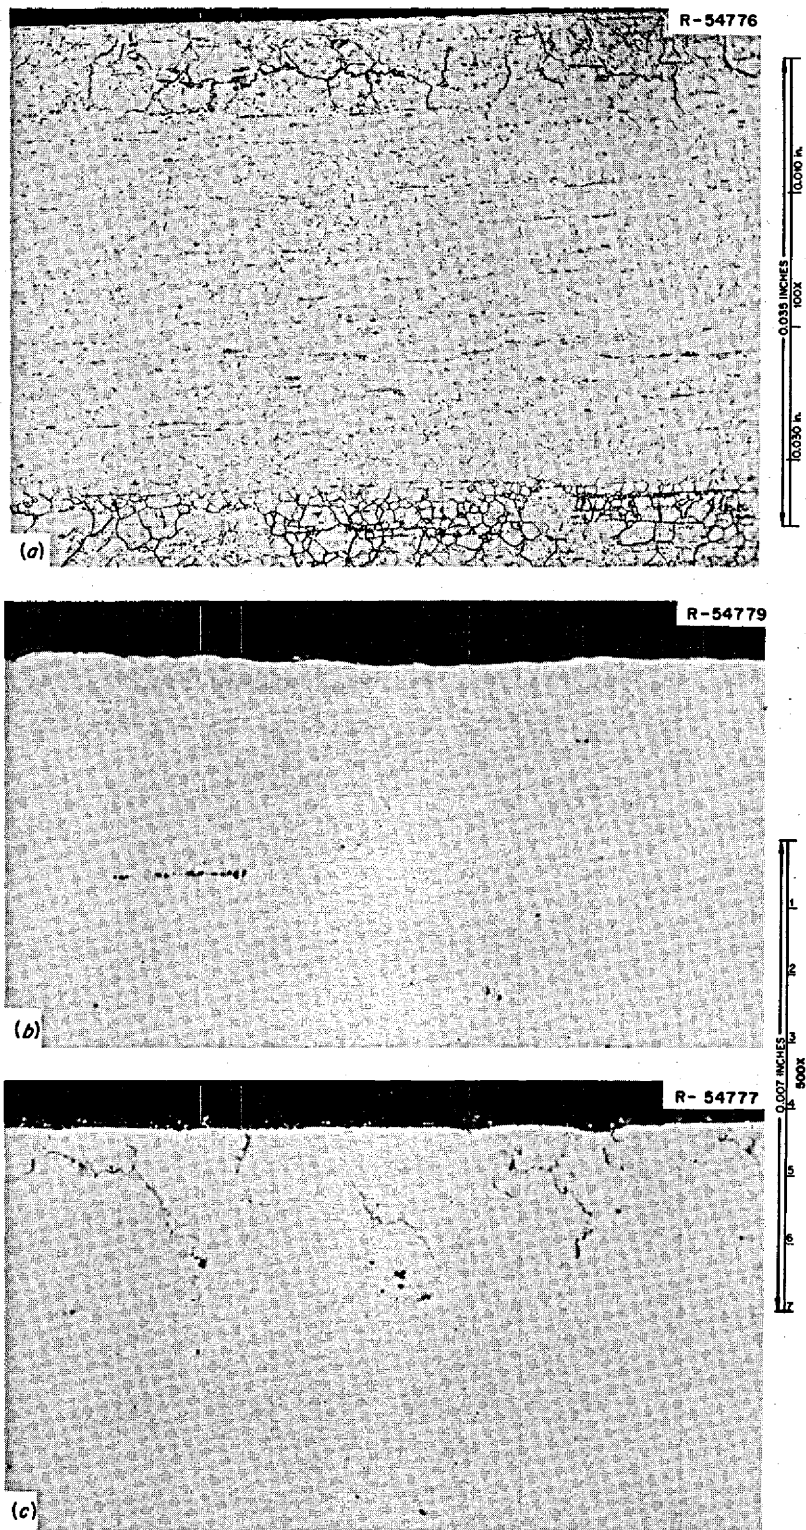
Similar photomicrographs of a longitudinal section of tubing are shown in Fig. 79. The features are quite similar to those discussed for Fig. 78. Both figures show some metallic deposits on the outside surface, which was exposed to fuel salt. These deposits are extremely small and could not be analyzed with much accuracy with the in-cell microprobe. However, they seemed to be predominately iron. Scanning across the tubing detected no concentration gradients of the major alloying elements in INOR-8.

Fig. 79. Photomicrographs of a Longitudinal Section of an INOR-8 Heat Exchanger Tube. (a) Etched with glyceria regia. (b) Inside surface in the as-polished condition after exposure to coolant salt. (c) Outside surface in the as-polished condition after exposure to fuel salt. Reduced 31%.

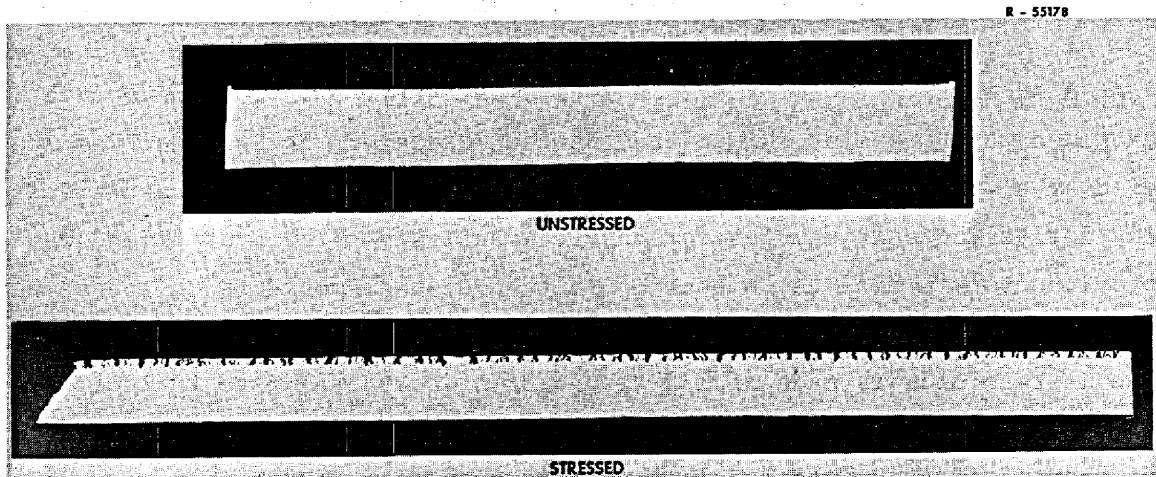
numbers and depths. A composite photograph of the two samples is shown in Fig. 81. The cracks are readily visible in the stressed sample but may not be apparent in the unstressed sample. A higher magnification print used in making the composite is shown in Fig. 82; the cracks can be more easily seen. The stressed sample had 262 cracks per inch with an average depth of 5.0 mils. Two counts were made on the unstressed sample. In the first count only those features that unequivocally were cracks were counted. This gave a crack count of 228 per inch with an average depth of 2.5 mils. In another count, we included some features that were possibly cracks and this gave a crack frequency of 308 per inch. Thus the number of cracks present before straining was about equivalent to that noted after straining. Straining did increase the *visible* depth. Some indirect evidence that the cracks were present initially and only spread open further during the tensile test was obtained from examination of the sample in Fig. 81. The sample length shown deformed 39% (Table 9), and the combined widths of the cracks account for 35% strain. Thus, the cracks widths very closely account for the total strain and indicate that the cracks formed with little or no deformation and spread open as the sample was deformed.

Fig. 81. Composite Photographs of Heat Exchanger Tubing Before and After Stressing. The width of the unstressed sample is 0.042 in.

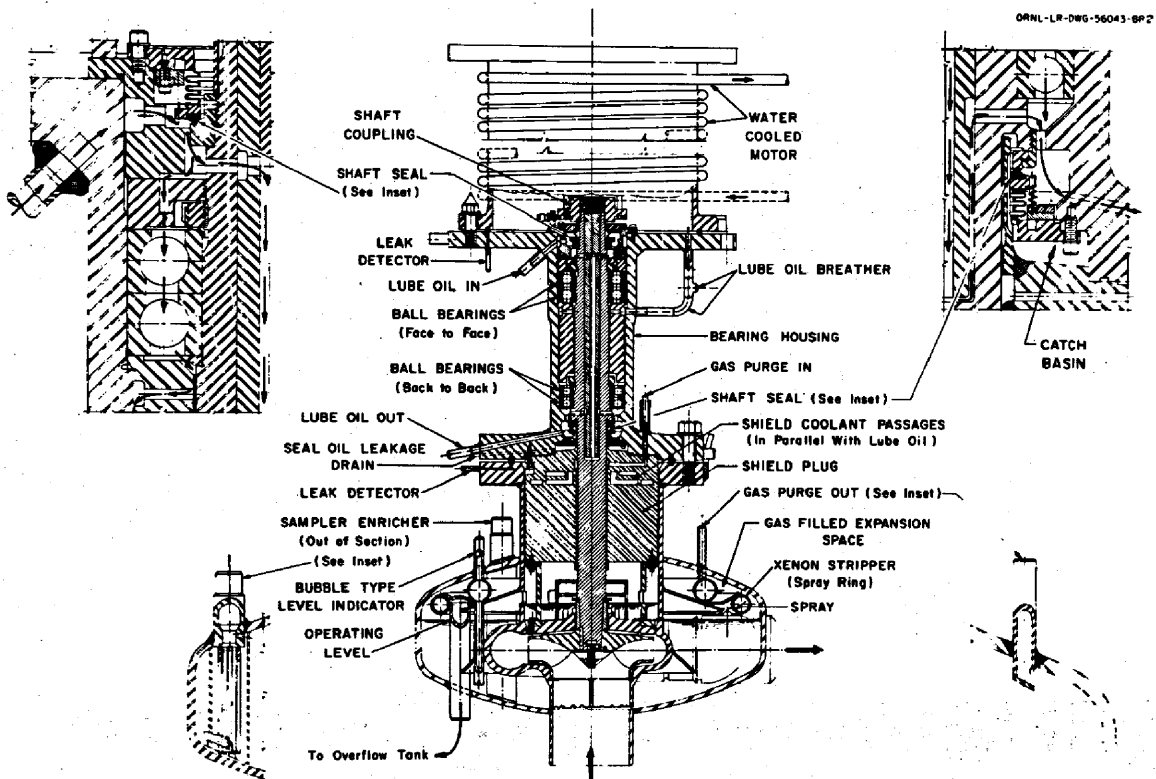
A schematic view of the pump is shown in Fig. 83. The components examined were the mist shield and the sampler cage. The sampler was lowered by a windlass arrangement into the sampler cage and was used primarily for taking salt samples for chemical analysis. The mist shield was provided to minimize the amount of salt spray that would reach the sampler. The vertical sampler cage rods were 1/4 in. diam and made of heat 5059. The mist shield was made of 1/8-in. sheet of heat 5057 (see Table 1 for chemical analysis). The mist shield was a spiral with an inside diameter of about 2 in. and outside diameter of about 3 in. The spiral was about 1 1/4 turns, and the outside was exposed to agitated salt and the inside to salt flowing much slower. The outside was exposed to salt up to the normal liquid level and to salt spray above this level. The inside was exposed to salt up to the normal salt level and primarily to gas above this level.

Fig. 83. Section of MSRE Fuel Pump with Details of Several Areas. The mist shield and the sampler cage that were examined are shown in the lower left insert.

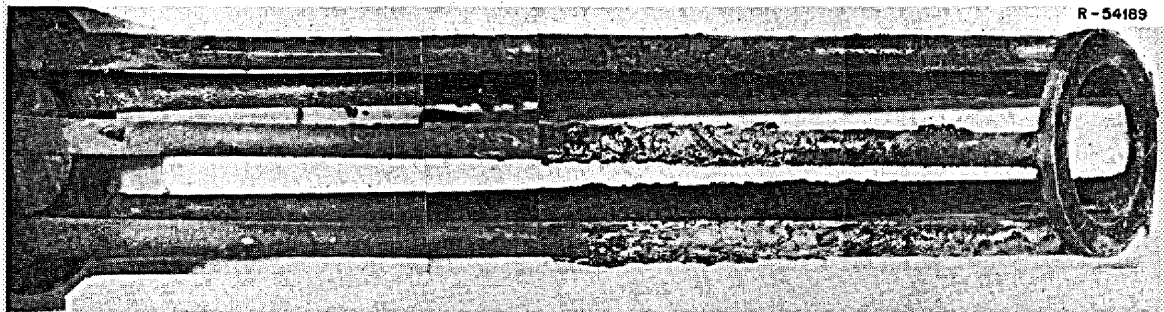
The general appearance of the sampler cage is shown in Fig. 84. The salt normally stayed at a level near the center of the cage, but the level fluctuated slightly. The amount of material deposited on the surface is much higher below the liquid interface than above. A gross gamma scan had a similar profile with a maximum near the liquid interface. A carbonaceous deposit was present at the top of the sampler. The mist shield had some deposits, and these were heavier below the liquid level and on the outer surface of the shield.

Fig. 84. Sampler Cage. The assembly is 8.5 in. high. The salt-vapor interface corresponds with the region of highest material deposition.

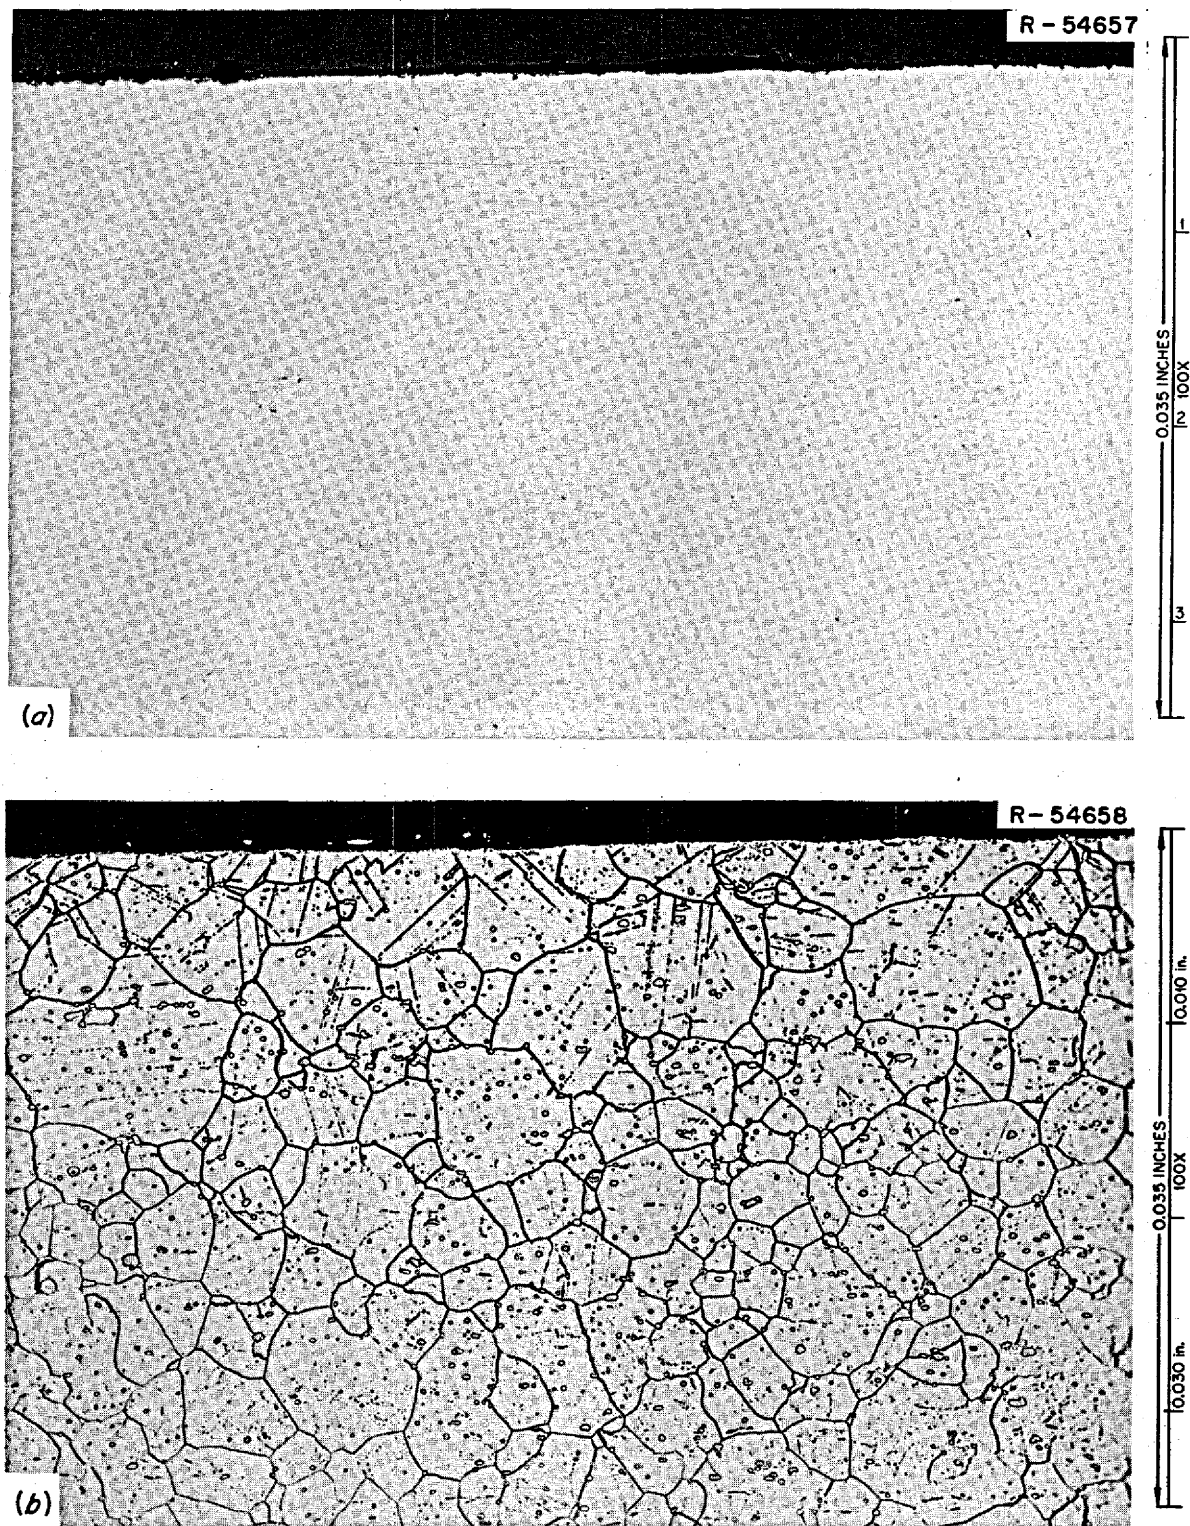
One of the sampler cage rods was examined metallographically. Photomicrographs of samples from the vapor and liquid regions are shown in Fig. 85 and 86, respectively. There is no intergranular penetration visible at this magnification. A heavy surface deposit is on the sample from the liquid region. This deposit was not examined by the electron microprobe analyzer, but a similar deposit on a copper capsule taken from

Fig. 85. Photomicrographs of an INOR-8 Rod from the Sampler Assembly Located Above the Normal Salt Level. (a) As-polished. (b) Etched with aqua regia.

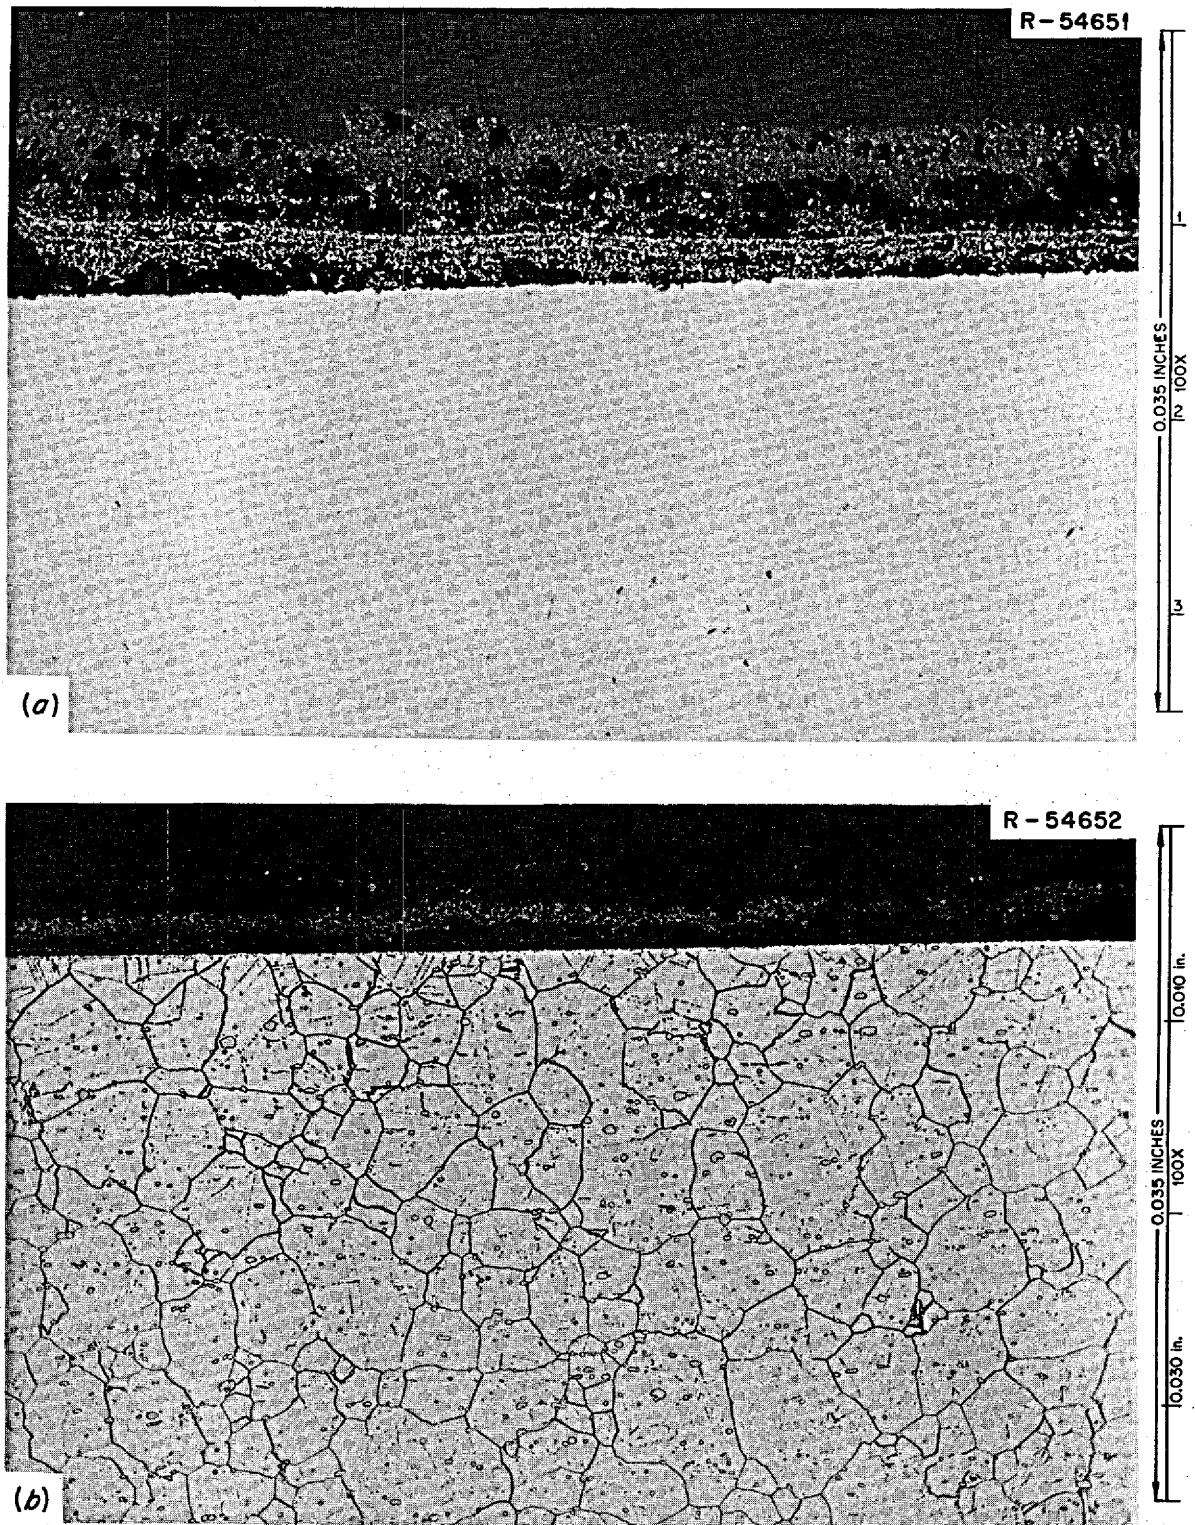
Fig. 86. Photomicrographs of an INOR-8 Rod from the Sampler Assembly. Normally located below the salt level. (a) As polished. (b) Etched with aqua regia.
