2362
ORNL-4829

INTERGRANULAR CRACKING OF INOR-8 IN THE MSRE

H. E. McCoy
B. McNabb

NOVEMBER 1972

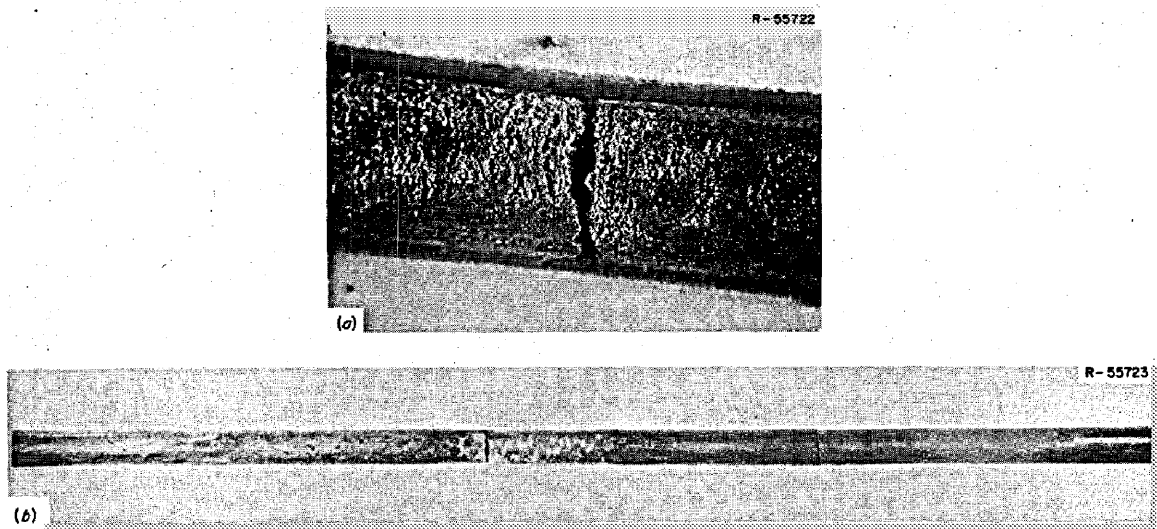
Fig. 87. (a) Tensile-tested Sampler Cage Rod from Pump Bowl. Rupture occurred near the average liquid-vapor interface. (b) Photograph of rupture area showing extensive surface cracking. Rod diameter is 1/4 in.

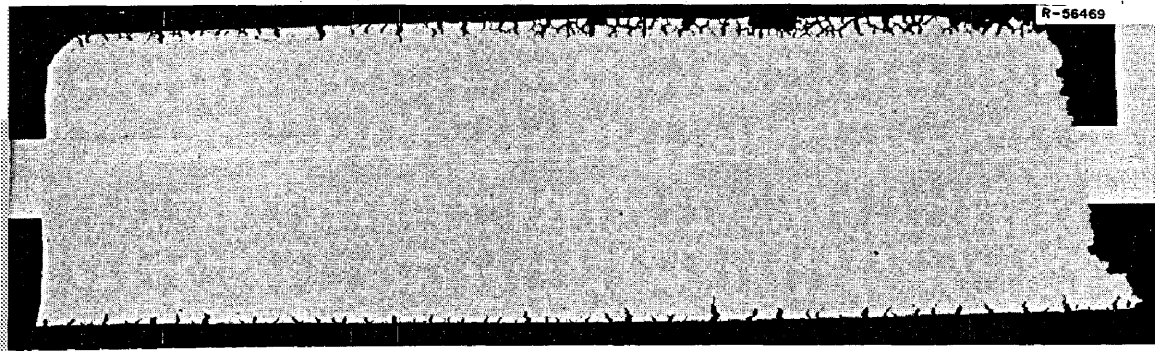
Fig. 88. Section of Sample Cage Rod that was Deformed at 25°C. 9.2x. The fracture (left) occurred at the salt-vapor interface. The rod is immersed further in the liquid from left to right. The length of the sample is 0.63 in.

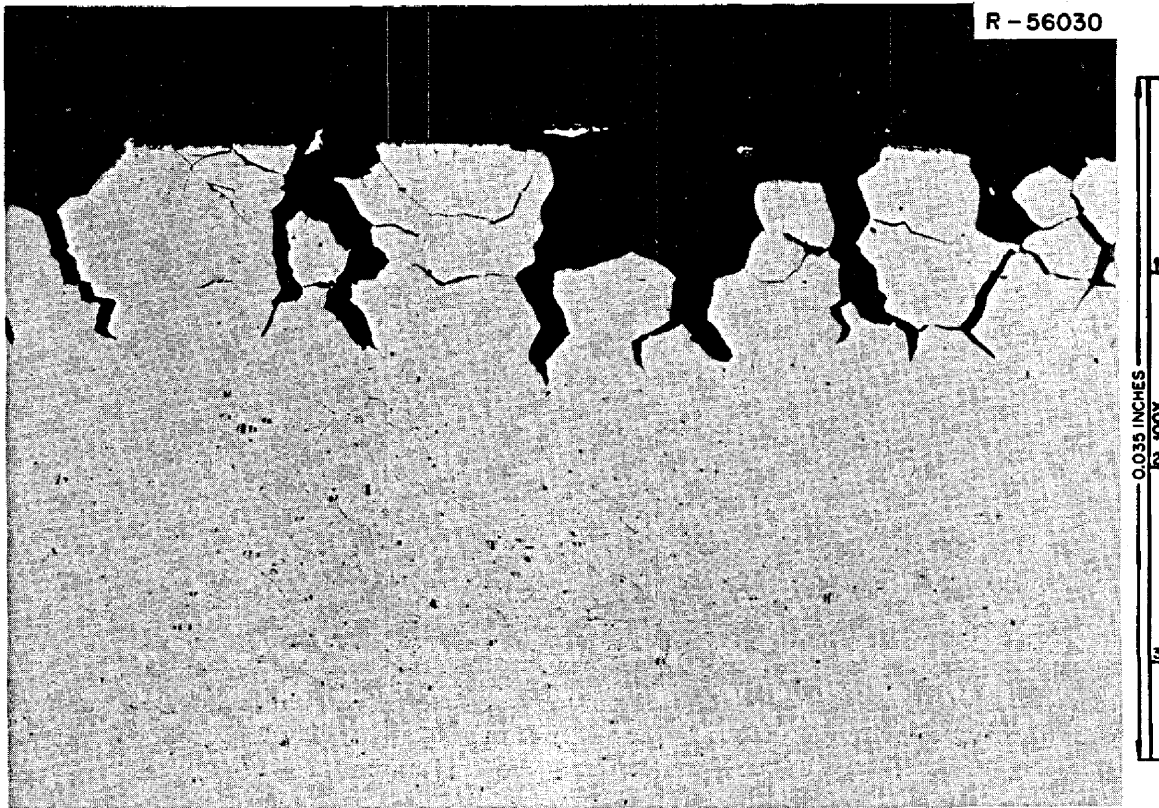
Fig. 89. Photomicrograph of Deformed Sampler Cage Rod Near the Fracture. As-polished.

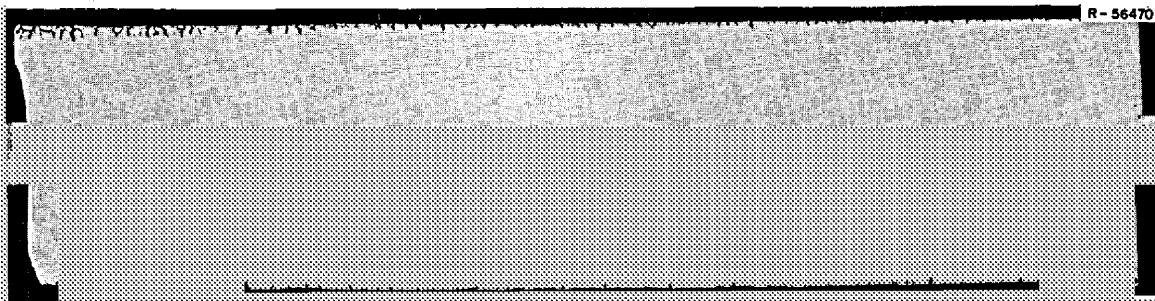
Fig. 90. Composite of Photomicrographs of Sampler Cage Rod that was Strained at 25°C. 8.2x. Left end of sample was 3/4 in. from fracture. The rod progressed further into the vapor region from left to right. The sample length is 0.72 in.

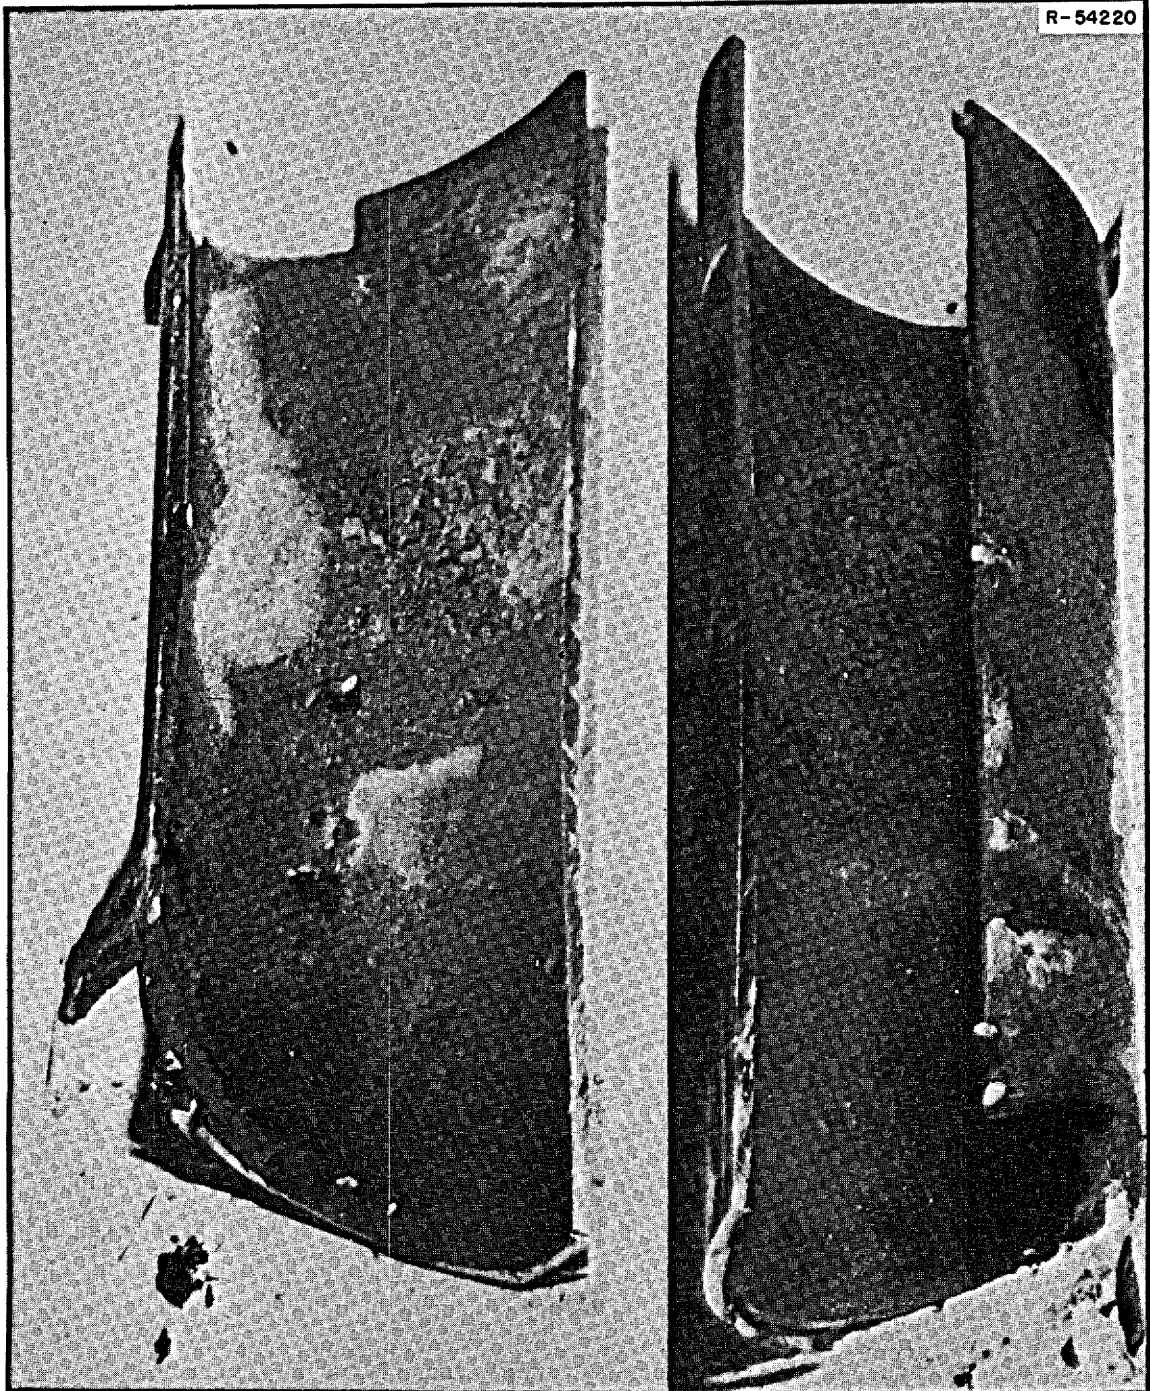
R-54220

Figure 91 shows the mist shield after removal from the MSRE. The shield has been split to reveal the inside surface. Four specimens approximately 1 in. (vertical) × 1/2 in. (circumferential) were cut from the mist shield. Their locations were (1) outside the spiral and immersed in salt, (2) outside the spiral and exposed to salt spray, (3) inside the spiral and immersed in salt, and (4) inside the spiral and exposed primarily to gas. Bend tests were performed on these specimens at 25°C using a three point bend fixture.²² They were bent about a line parallel

Fig. 91. Interior of Mist Shield. Right part of right segment overlapped left part of segment on left.

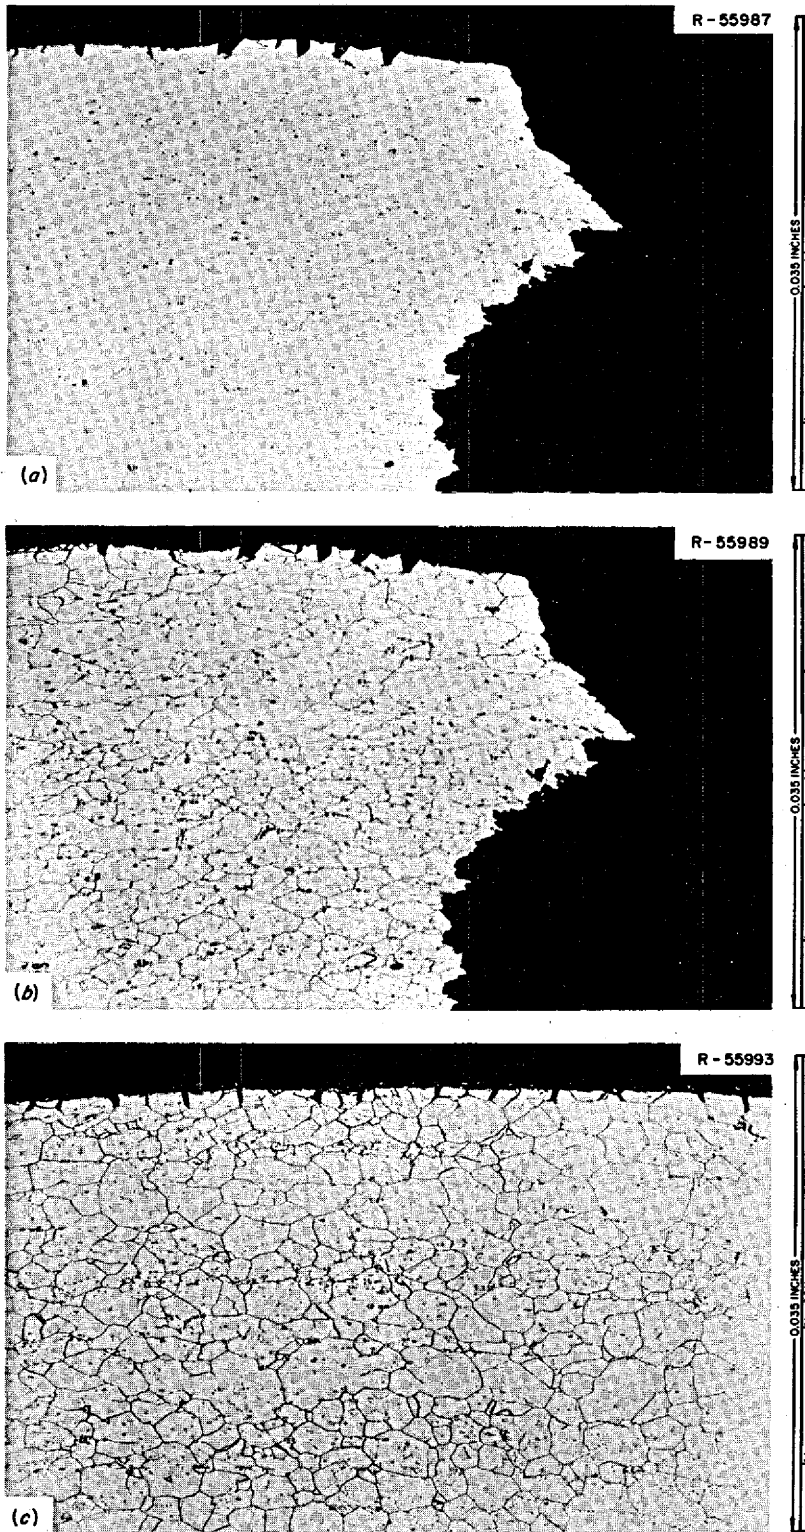
The bend samples of the mist shield were examined metallographically. Photomicrographs of the sample from the inside vapor region are shown in Fig. 92, and a composite of several photomicrographs is shown in Fig. 93. The edge cracks were intergranular and about 1 mil deep. The photomicrographs of the sample from the liquid region (Fig. 94) show that the cracks extended to a depth of about 8 mils in the liquid region. The composite photograph in Fig. 95 also shows the increased frequency and depth of cracking in the liquid region.

Fig. 92. Photomicrographs of Bend Specimen of Mist Shield from Inside Vapor Region. (a) Fracture and tension side, as polished. (b) Fracture and tension side, etched. (c) Tension side, etched. Etchant: Aqua regia. Reduced 31%.

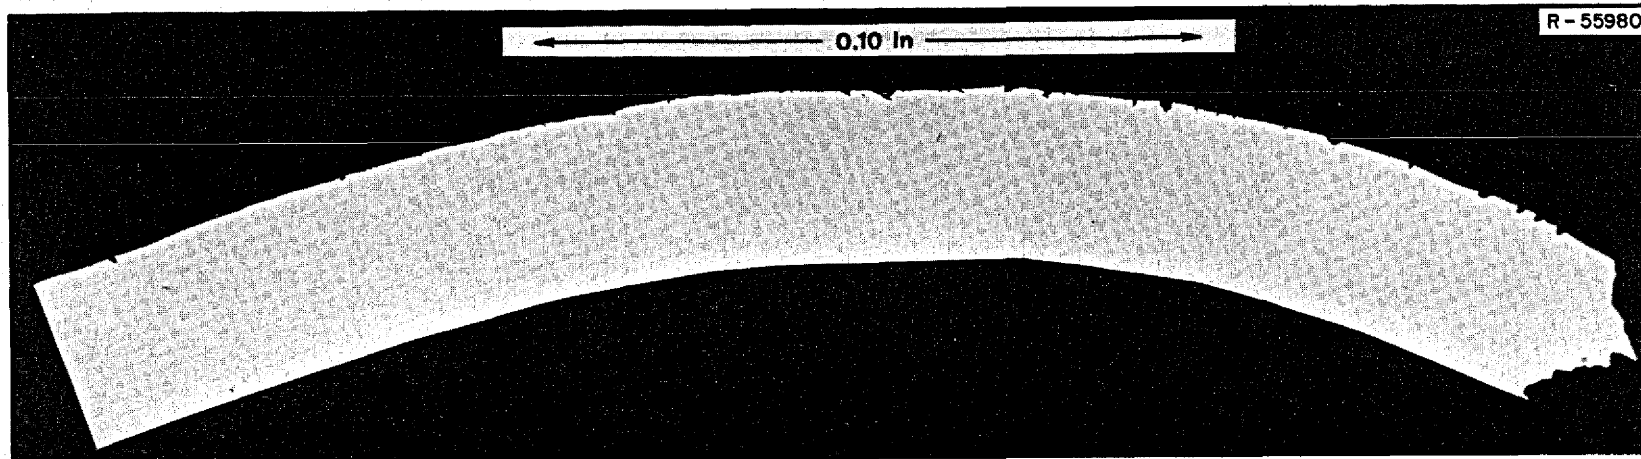
Fig. 93. Composite Photograph of the Tension Side of a Bend Sample from Inside Vapor Region of Mist Shield. Lower edge is not the compression side of the sample.

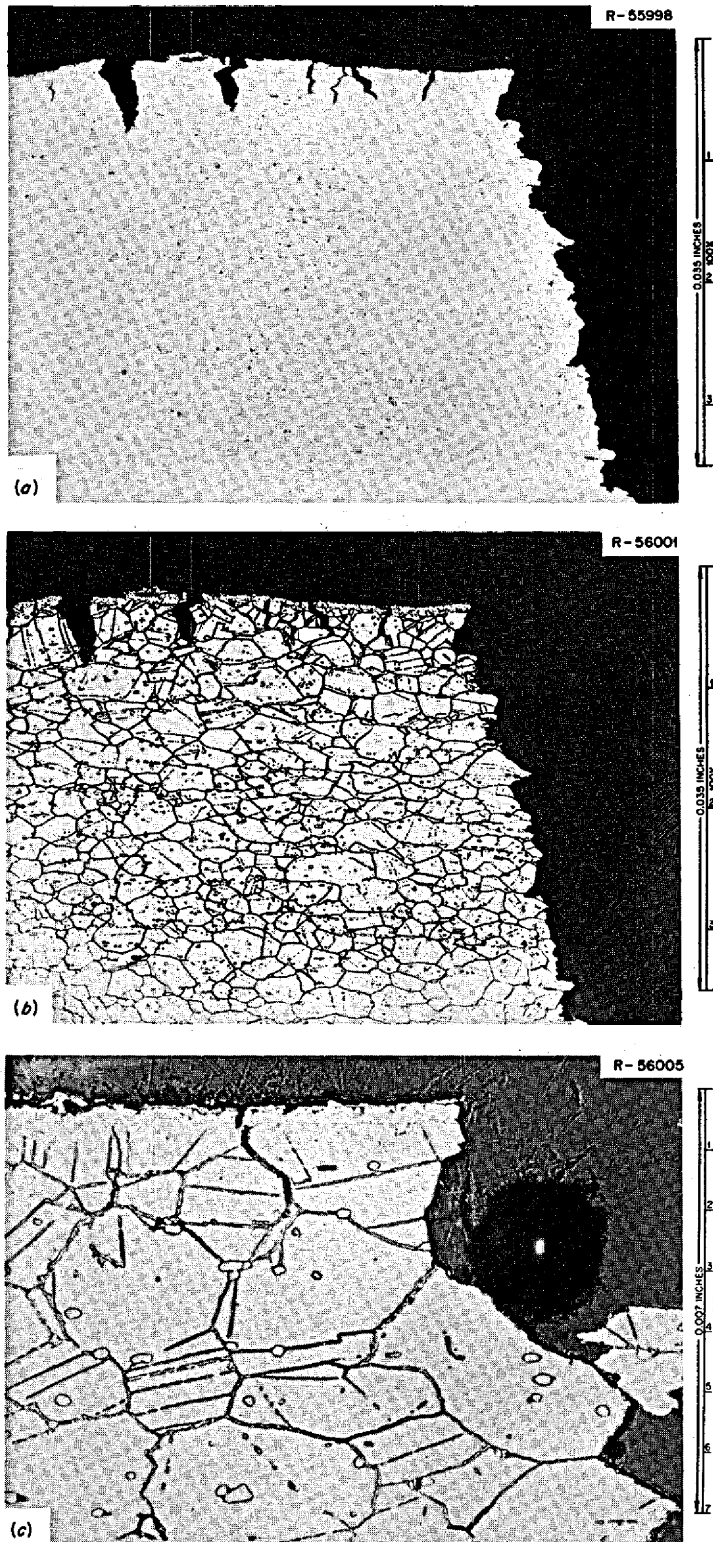
Fig. 94. Photomicrographs of Bend Specimen of Mist Shield from Inside Liquid Region. (a) Fracture and tension side, as polished. (b) Fracture and tension side, etched. (c) Fracture and tension side, etched. Etchant: Aqua Regia.

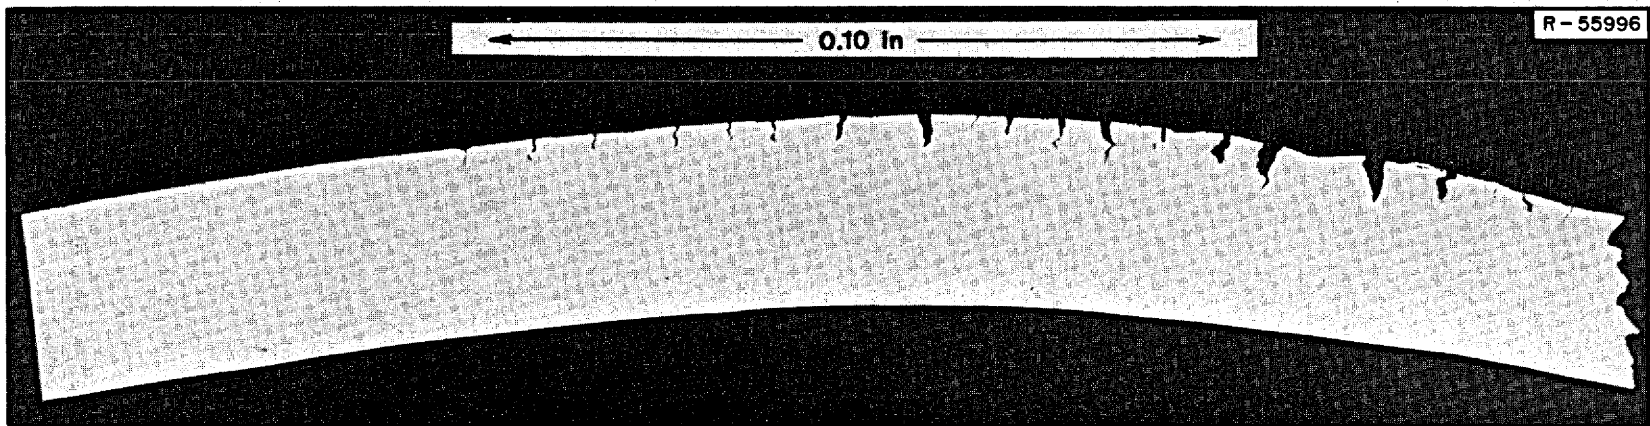
Fig. 95. Composite Photograph of the Tension Side of a Bend Sample from Inside Liquid Region of Mist Shield. Lower Edge is not the compression side of the sample.

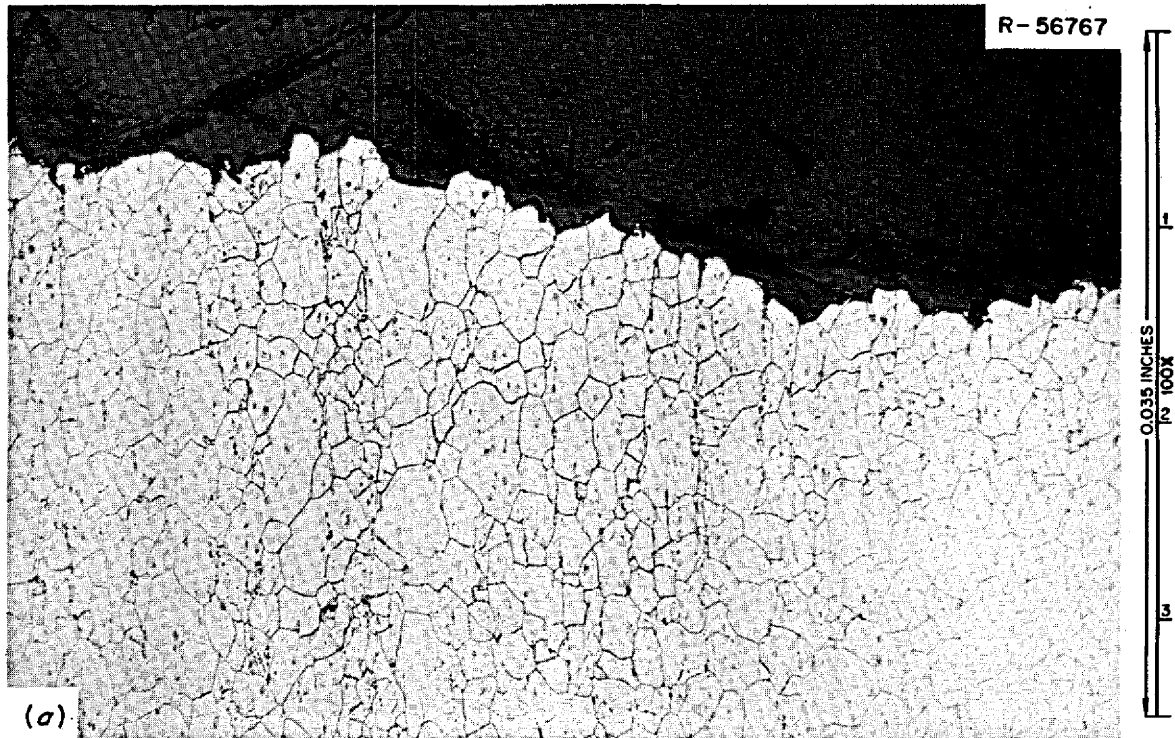
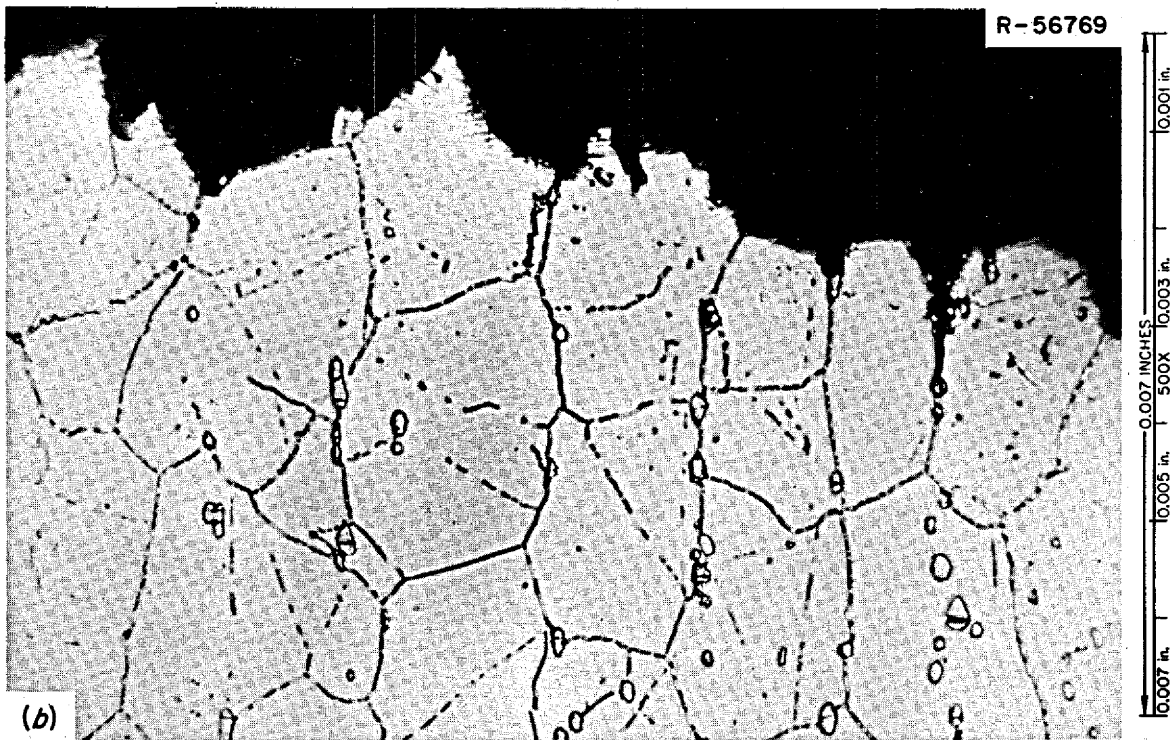
The sample from the outside liquid region was quite similar metallographically to that from the inside liquid region. Photomicrographs of the fracture and a typical region of the tension near the fracture are shown in Figs. 96 and 97, respectively. A composite of several photomicrographs is shown in Fig. 98. Photomicrographs of the outside vapor (salt spray) bend specimen at the fracture and on the tension side near the fracture are shown in Figs. 99 and 100, respectively. The composite of several photomicrographs in Fig. 101 shows that the cracks are not much deeper nor more frequent than in the liquid regions (compare Figs. 95, 98, and 101), but the tendency for grains to fall out is much greater. This is even more significant when one notes that the strain was the least in the sample from the outside vapor region (Table 10).

Fig. 96. Photomicrographs of the Fracture of a Bend Specimen from the Outside Liquid Region of the Mist Shield. (a) 100x. (b) 500x. Etchant: Lactic acid, HNO_3 , HCl .

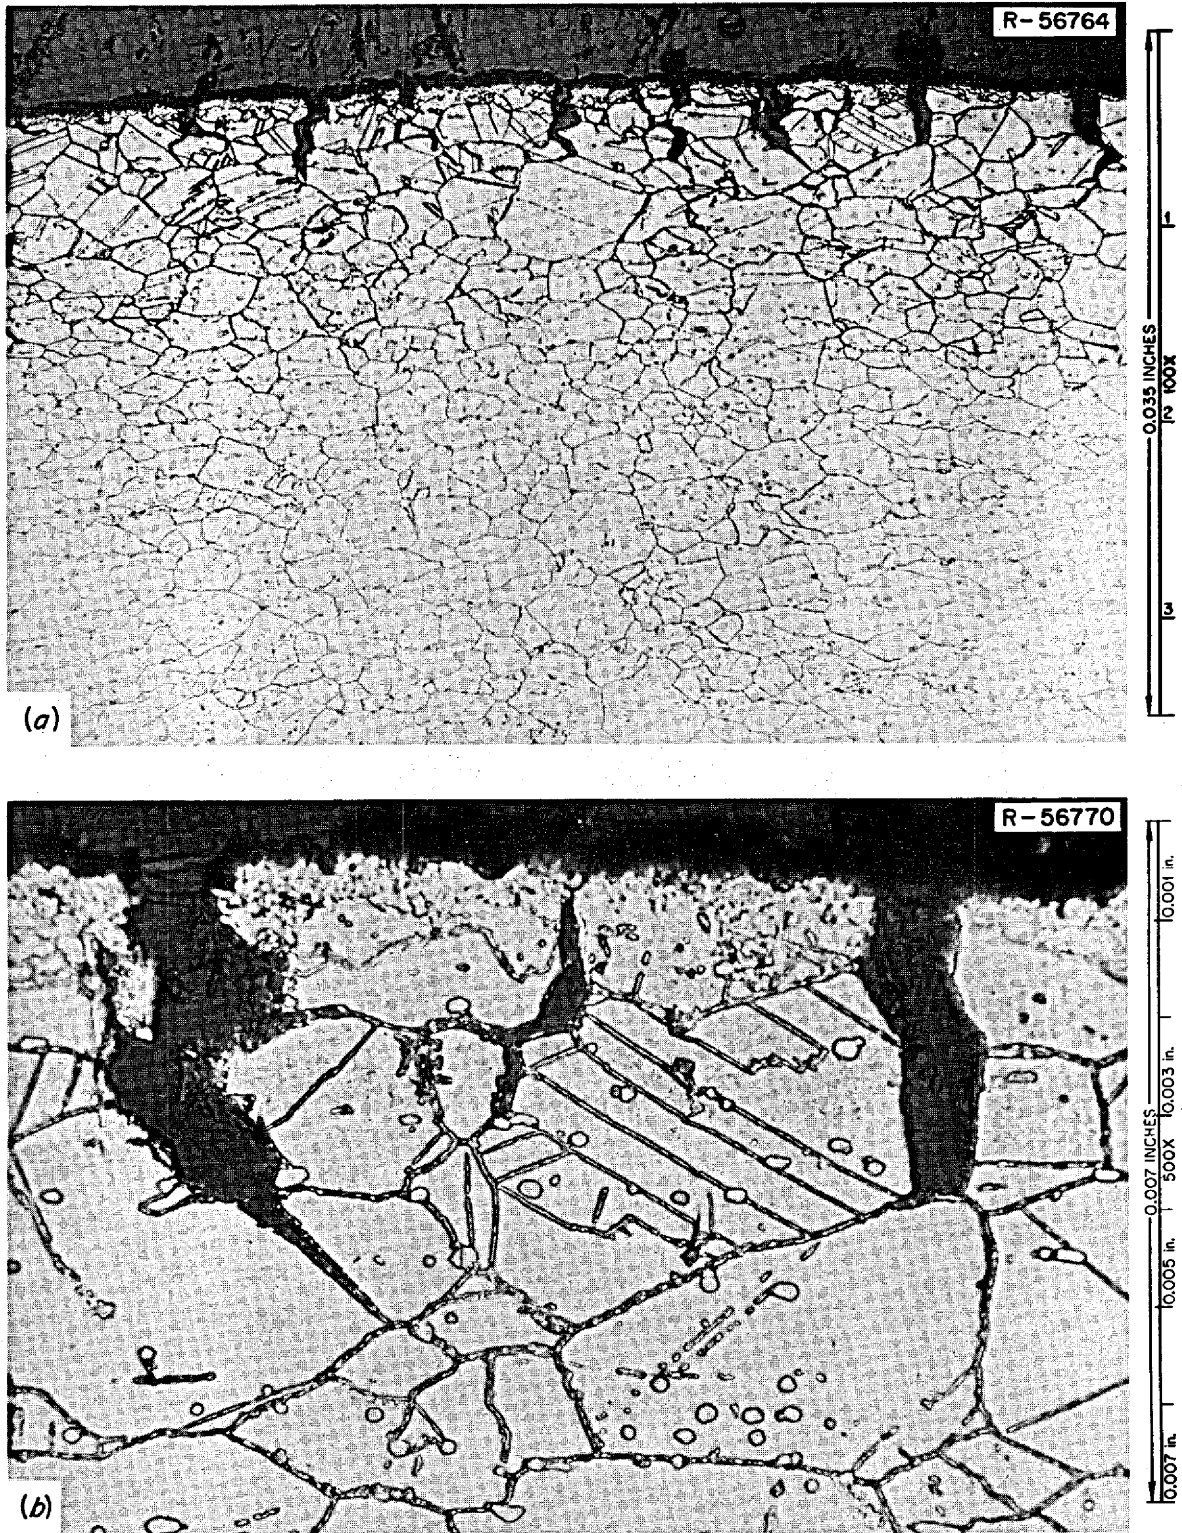
Fig. 97. Photomicrographs of the Tension Side Near the Fracture of a Bend Specimen from the Outside Liquid Region of the Mist Shield. (a) 100 \times . (b) 500 \times . Etchant: lactic acid, HNO_3 , HCl .

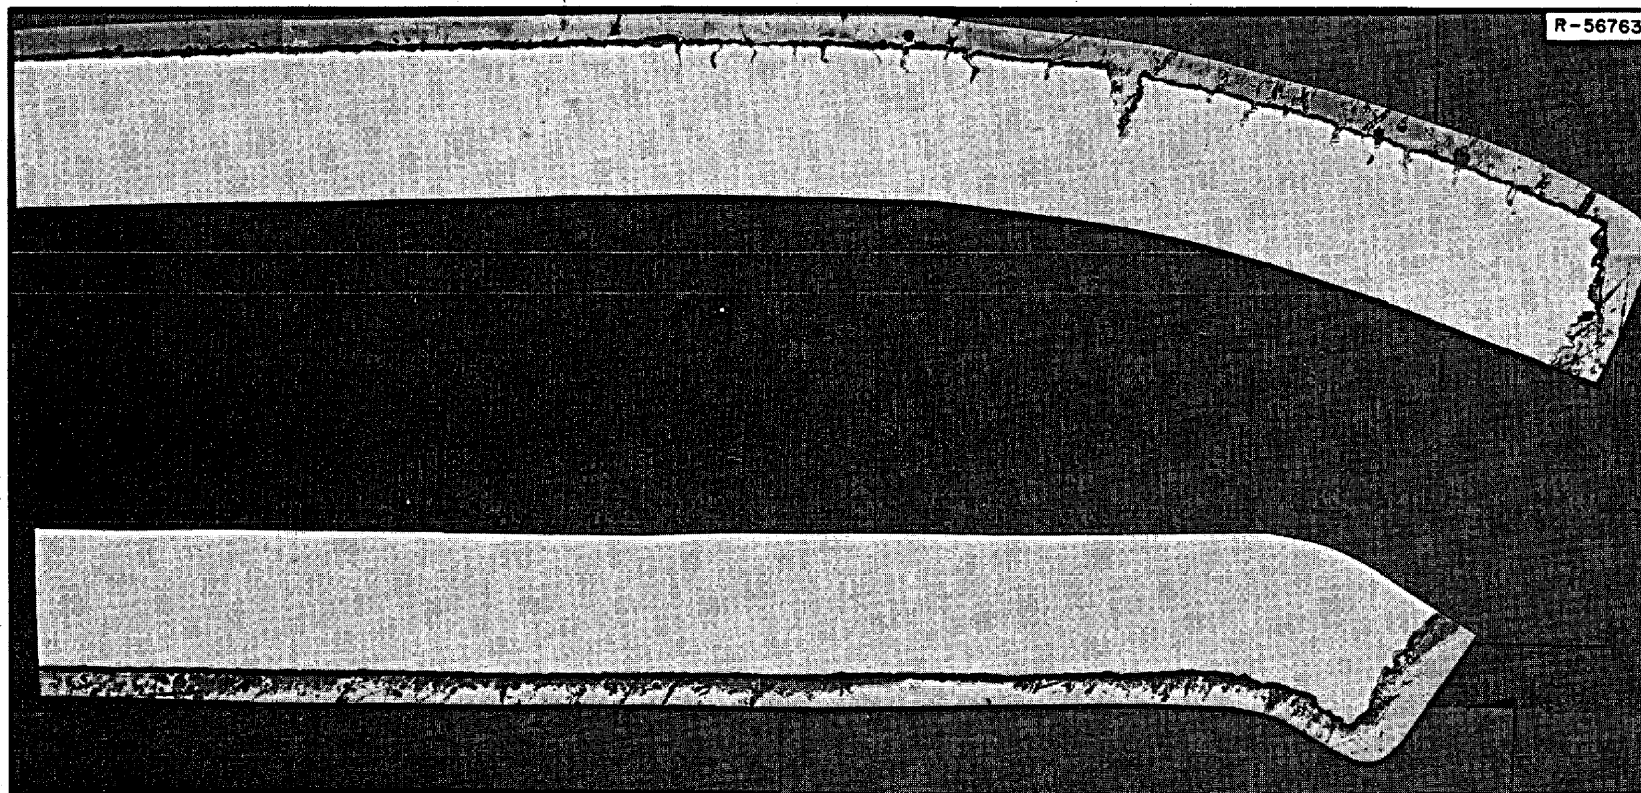
Fig. 98. Composite of Several Photomicrographs of a Bend Specimen from the Outside Liquid Region of the Mist Shield. Top portion shows the tension side and the lower portion shows the compression side. 24x.

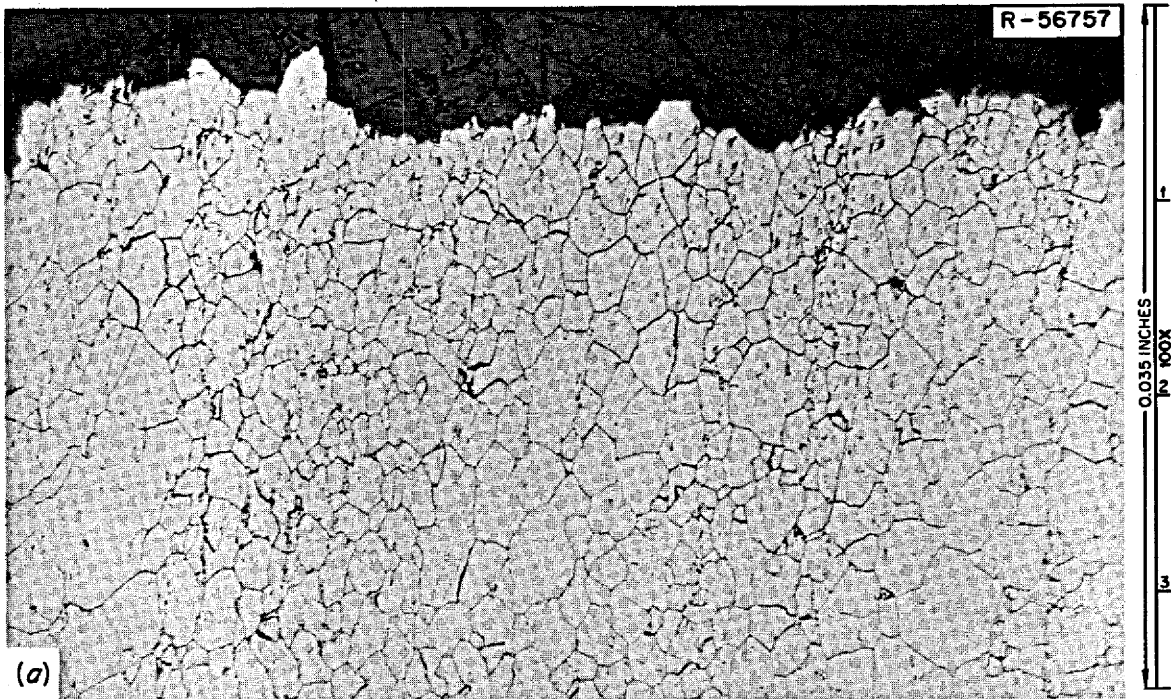
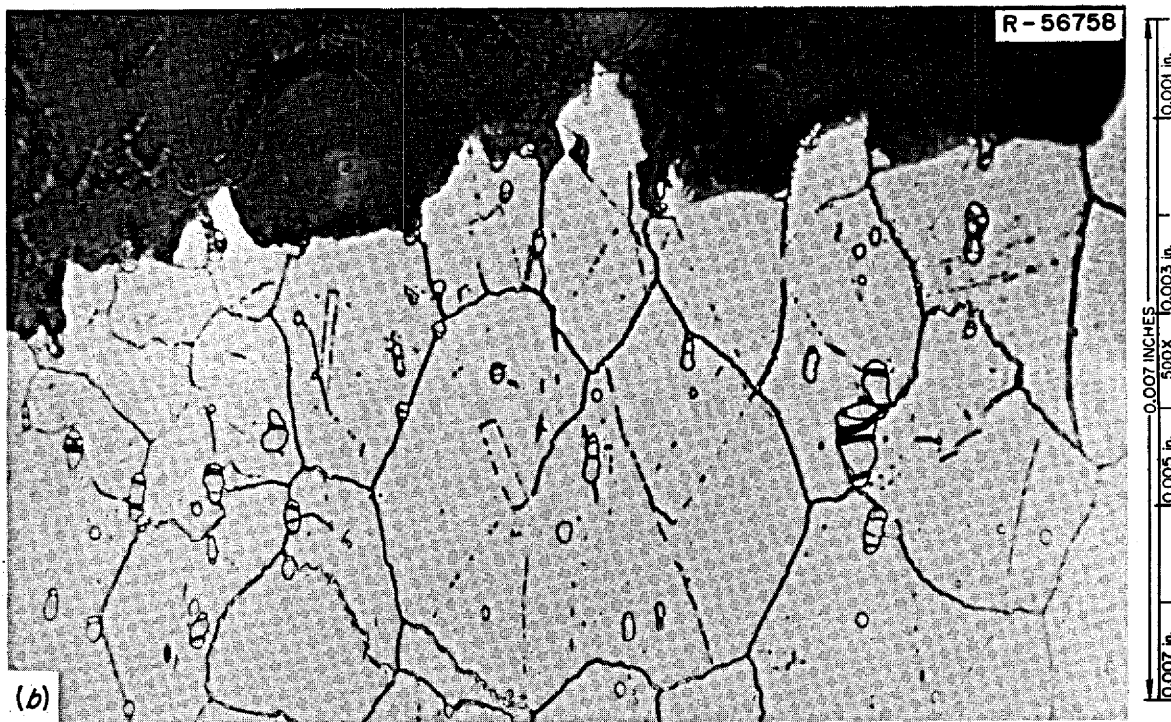
Fig. 99. Photomicrographs of the Fracture of a Bend Specimen from the Outside Vapor Portion of the Mist Shield. (a) 100x. (b) 500x. Etchant: Lactic acid, HNO_3 , HCl .

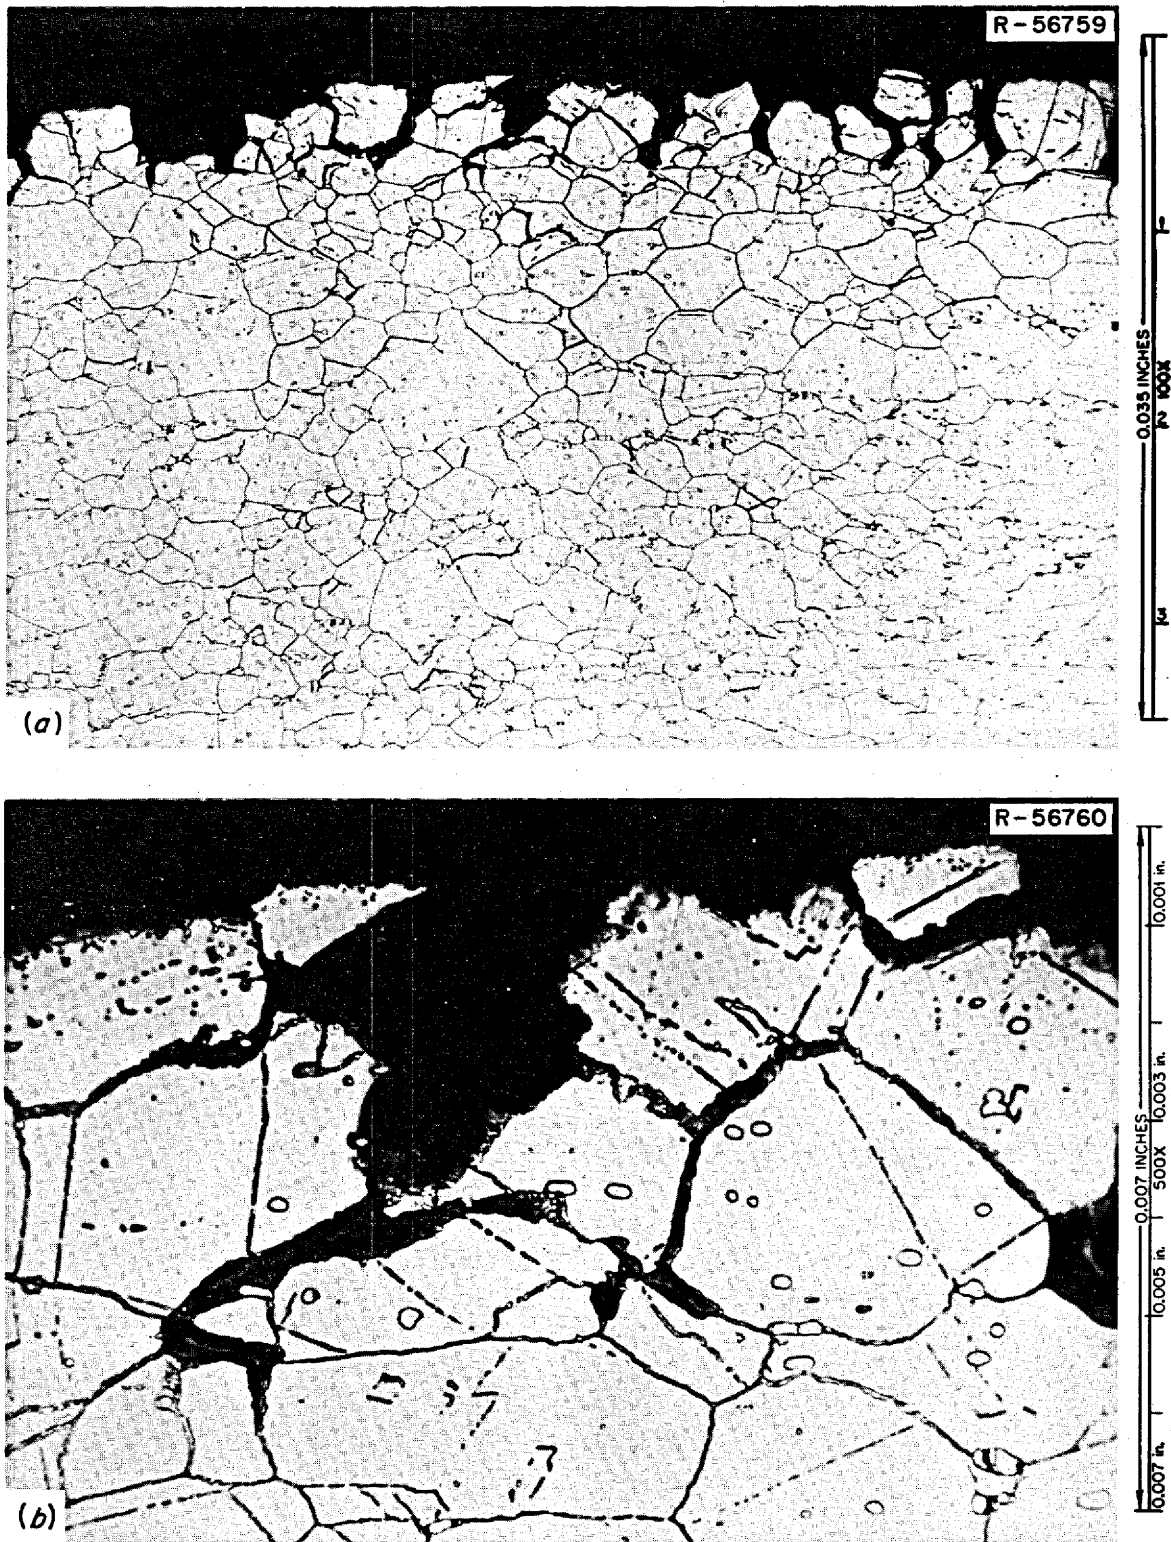
Fig. 100. Photomicrographs of the Edge Near the Fracture of a Bend Specimen from the Outside Vapor Portion of the Mist Shield. (a) 100 \times . (b) 500 \times . Etchant: Lactic acid, HNO_3 , HCl .

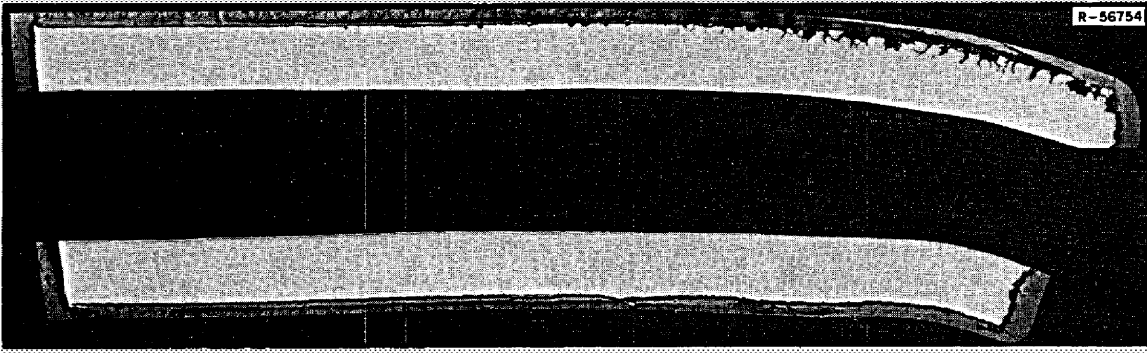
Fig. 101. Composite of Several Photomicrographs of a Bend Specimen From the Outside Vapor Region of the Mist Shield. Top portion is the tension side and the lower part is the compression side. 15x.

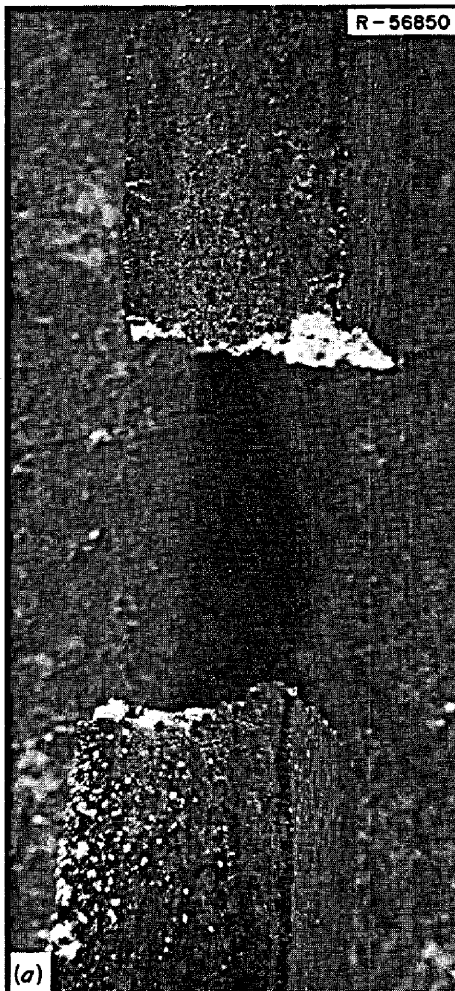
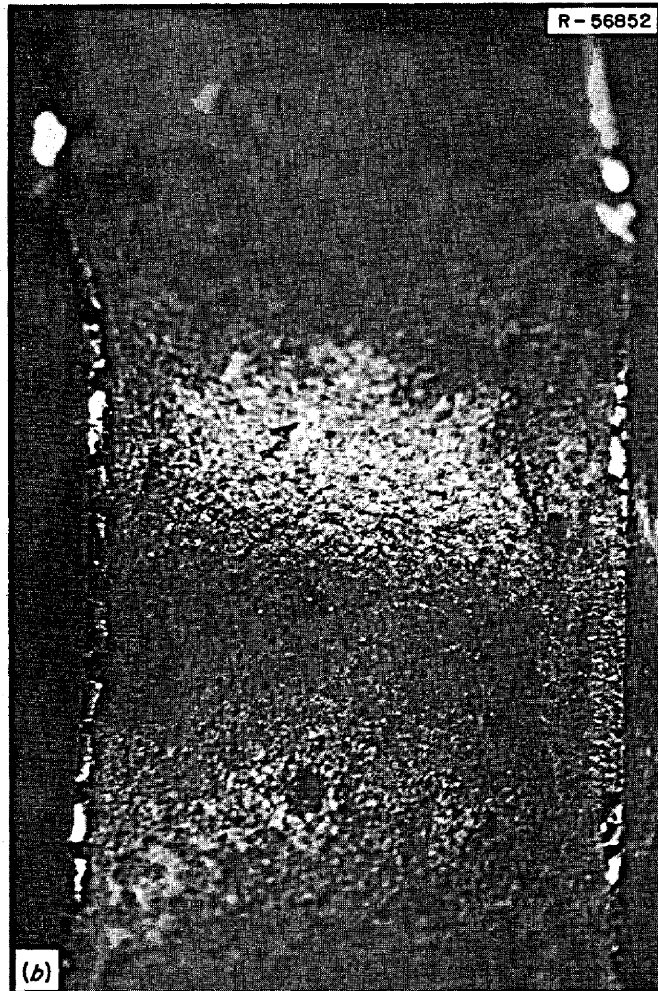
Rings 3/16 in. wide were cut, away from the flattened portion of the pipe. They were subjected to the ring test described previously. A bend specimen and a specimen for chemical analysis were cut from adjacent regions. The results of the mechanical property tests are given in Table 11. As shown in Fig. 102 both the bend specimen and the ring specimens showed some surface cracking when viewed at low magnification.

Fig. 102. The Surfaces Exposed to Salt in Freeze Valve 105 After Deformation at 25°C. (a) Fracture of ring specimen pulled in tension. Note surface cracks near the fracture. 4x (b) Surface of bend specimen. Note some cracks on surface and edge cracks. 7x. Reduced 18.5%.

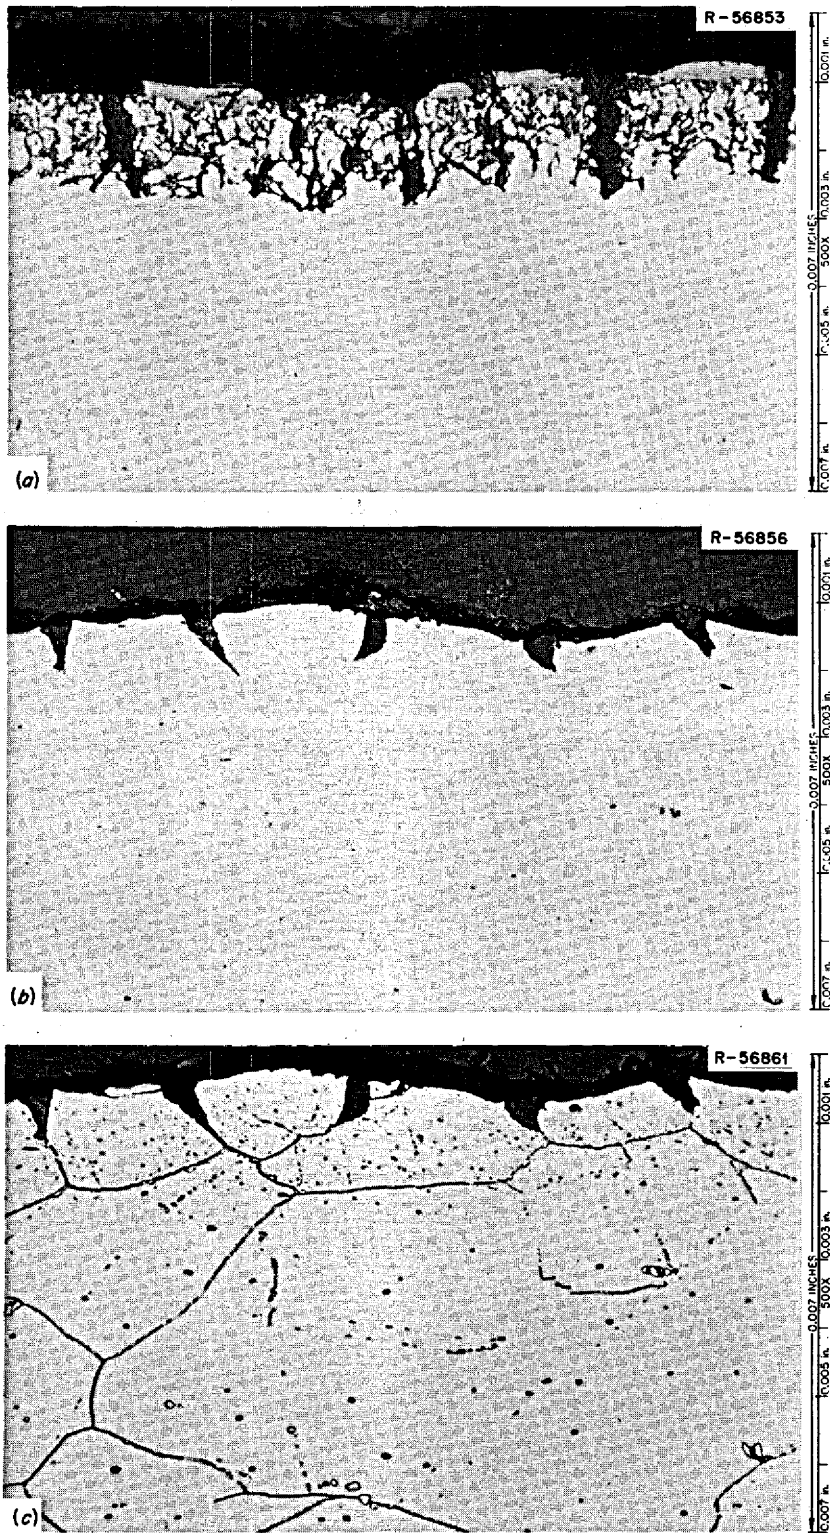
A metallographic section of one of the ring specimens is shown in Figs. 103 and 104. The fracture and both edges are visible in Fig. 103. The oxide is on the outside surface that was exposed to air (top) and shallow cracks formed on the salt side. Typical edges near the fracture are shown in Fig. 104. The cracks on the air side followed the oxide and did not penetrate further. The cracks on the salt side were intergranular and penetrated about 1 mil.

Fig. 104. Photomicrographs Near the Fracture of a Ring Sample from Freeze Valve 105 Deformed at 25°C. (a) Edge exposed to air, as polished. (b) Edge exposed to salt, as polished. (c) Edge exposed to salt, etched with lactic acid, HNO_3 , HCl . Reduced 30%.

product concentration was the one from FV 105. The fission product concentrations were generally less than on the other samples by an order of magnitude (Table 14) and the cracks were very shallow (Fig. 104).

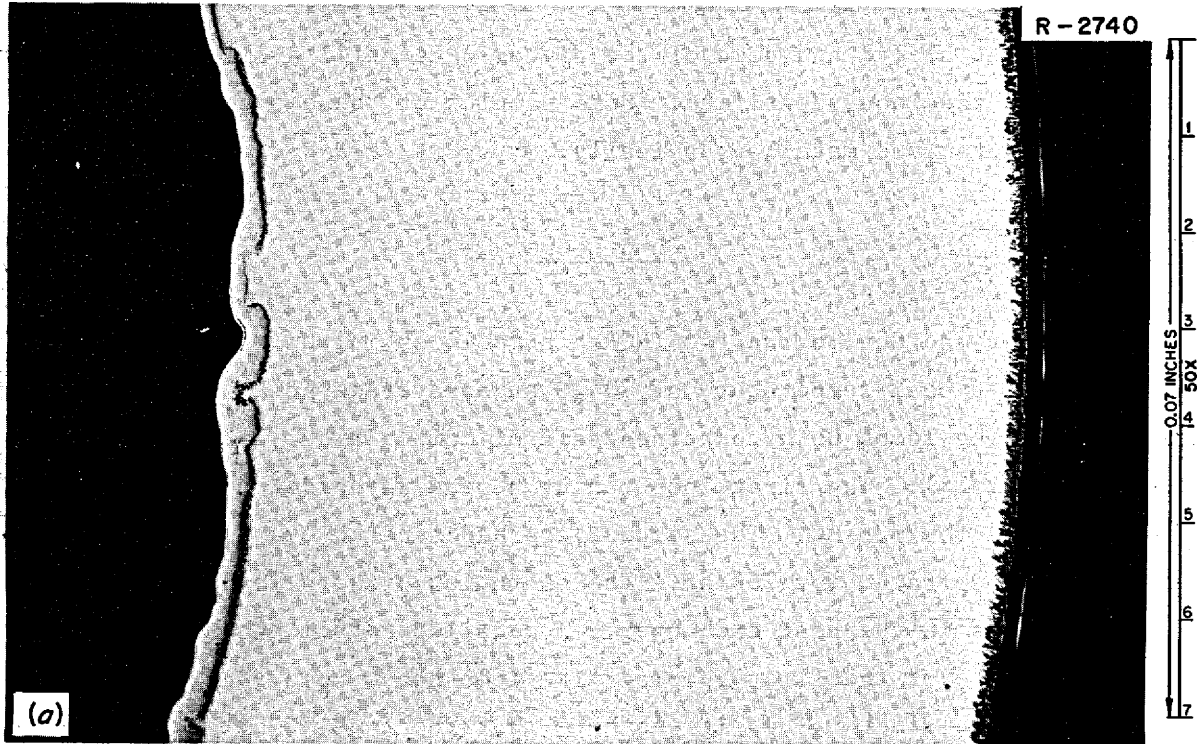
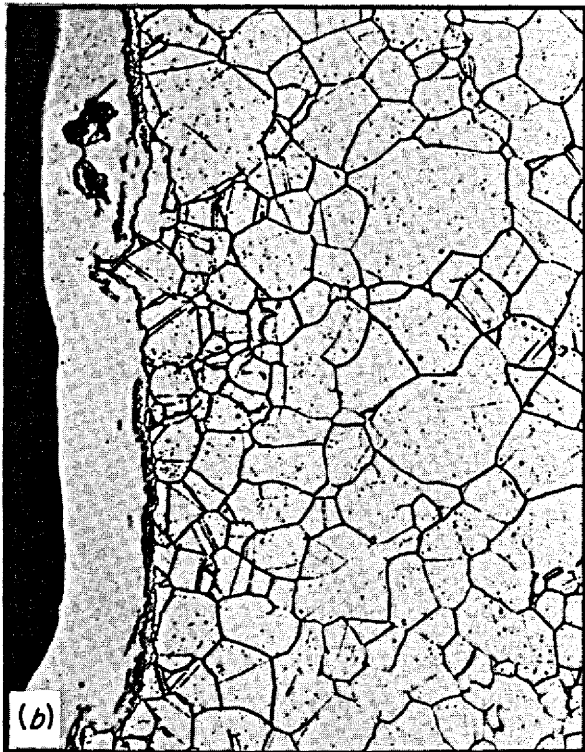
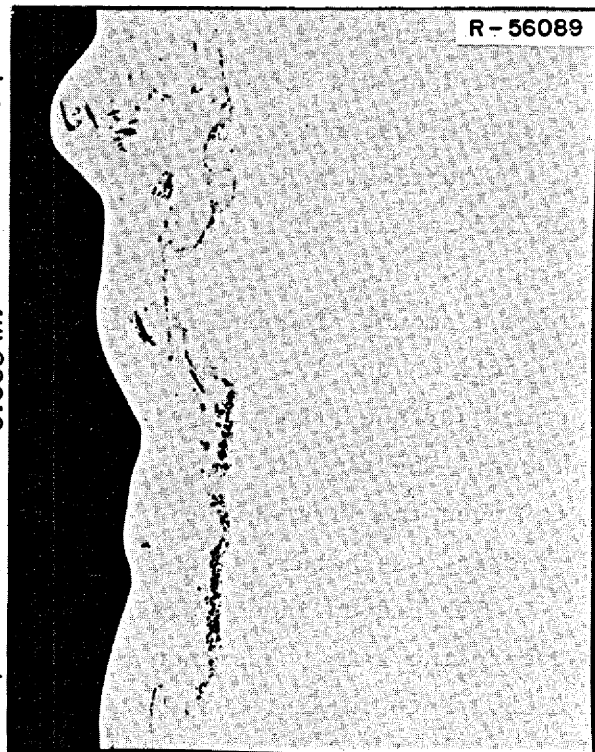
The uneven inner surface of the loop tubing may or may not have been due to the same phenomenon that caused the intergranular cracking in the MSRE. Note in Fig. 105 that the material was removed in increments of single grains. However, there is no evidence of partially cracked grains that had not been completely removed. The explanation of cavitation is also not very acceptable since the peak velocity was only about 1 ft/sec.

Fig. 105. Inside Tube Wall of INOR-8 from In-pile Loop MTR 44-1. The coating is nickel plating used for edge preservation.
