2362
ORNL-4829

INTERGRANULAR CRACKING OF INOR-8 IN THE MSRE

H. E. McCoy
B. McNabb

NOVEMBER 1972

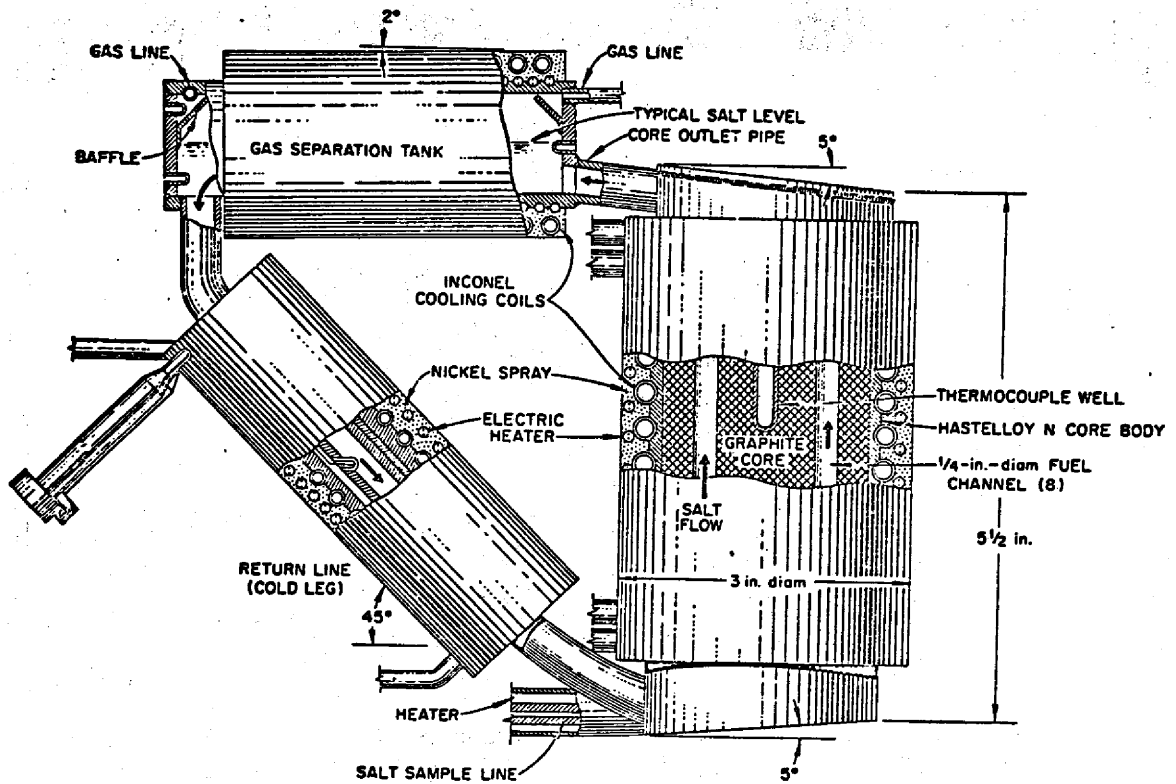
A more recent in-reactor thermal convection loop was run by Compere et al.²⁶ A schematic of the loop is shown in Fig. 106, and the pertinent operating statistics are given in Table 12. The loop was constructed of INOR-8, contained salt of composition ${}^7\text{LiF}-\text{BeF}_2-\text{ZrF}_4-\text{UF}_4$ (65.3-28.2-4.8-1.7 mole %), and had a graphite region where power densities of 150 W/cm^3 of salt were attained. The loop had maximum and minimum operating temperatures of 720 and 545°C , respectively. The loop failed at the hottest portion after 1366 hr of nuclear operation. The failure (Fig. 107) is quite typical of high-temperature failures noted previously in this material after irradiation.⁴⁻⁷ Note that the inside surface is free of cracks except very near the point of failure.

Fig. 106. Diagram of Molten-Salt In-Reactor Loop 2.

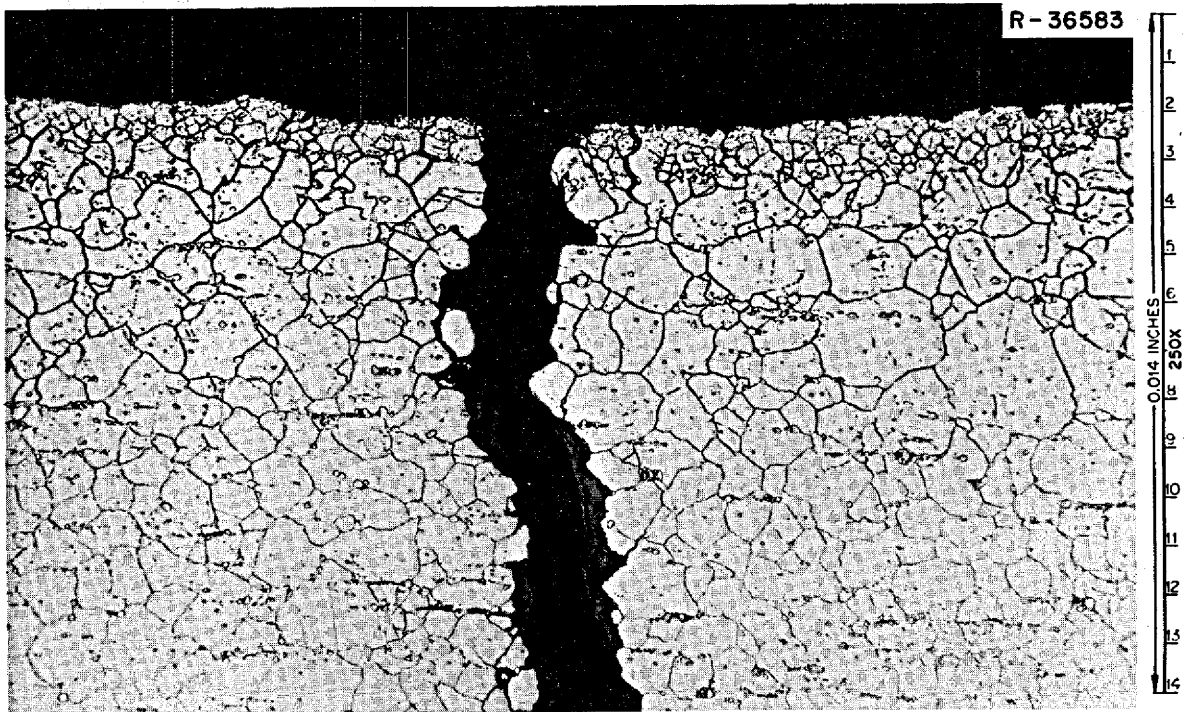
Fig. 107. Photomicrograph of a Cross Section Showing the Inner Surface and Crack in Core Outlet Pipe of In-Reactor Loop 2. Located on top side of tubing. Etchant: Aqua regia.

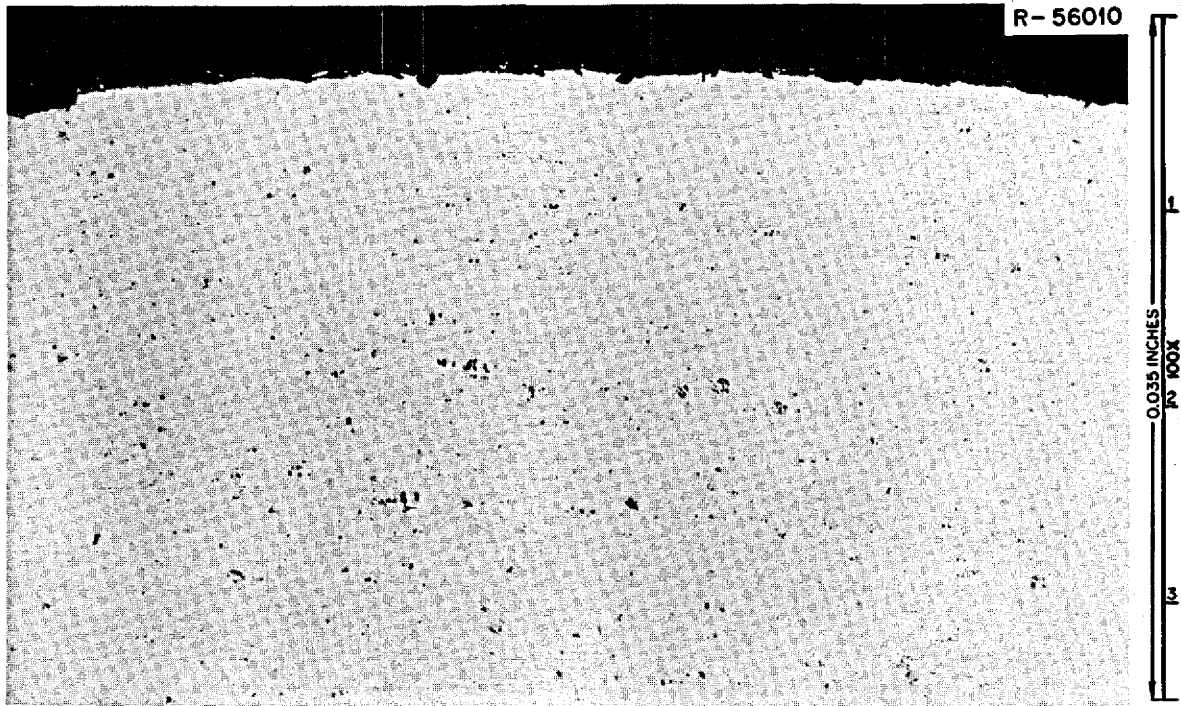
Fig. 108. Bend Specimen from Section of In-Reactor Loop Which Operated at 720°C. The tension side was exposed to the fuel salt.

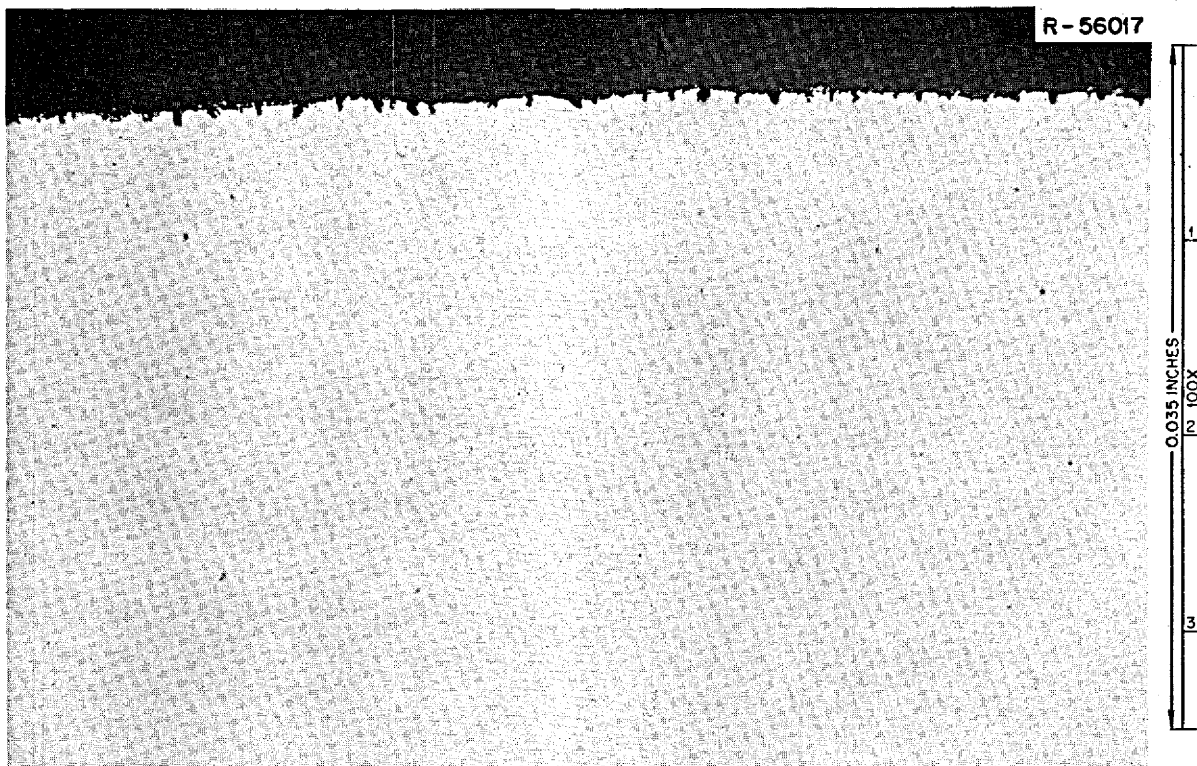
A piece of tubing was available from the coldest section, and it was deformed by crushing in a tensile machine. A typical view of the inside surface is shown in Fig. 109. Cracks occurred along almost every grain boundary, but they only extended to a maximum depth of 1 mil.

Fig. 109. Tension Side of Crushed Tubing from Coldest Part of In-Reactor Loop, Which Operated at 545°C.

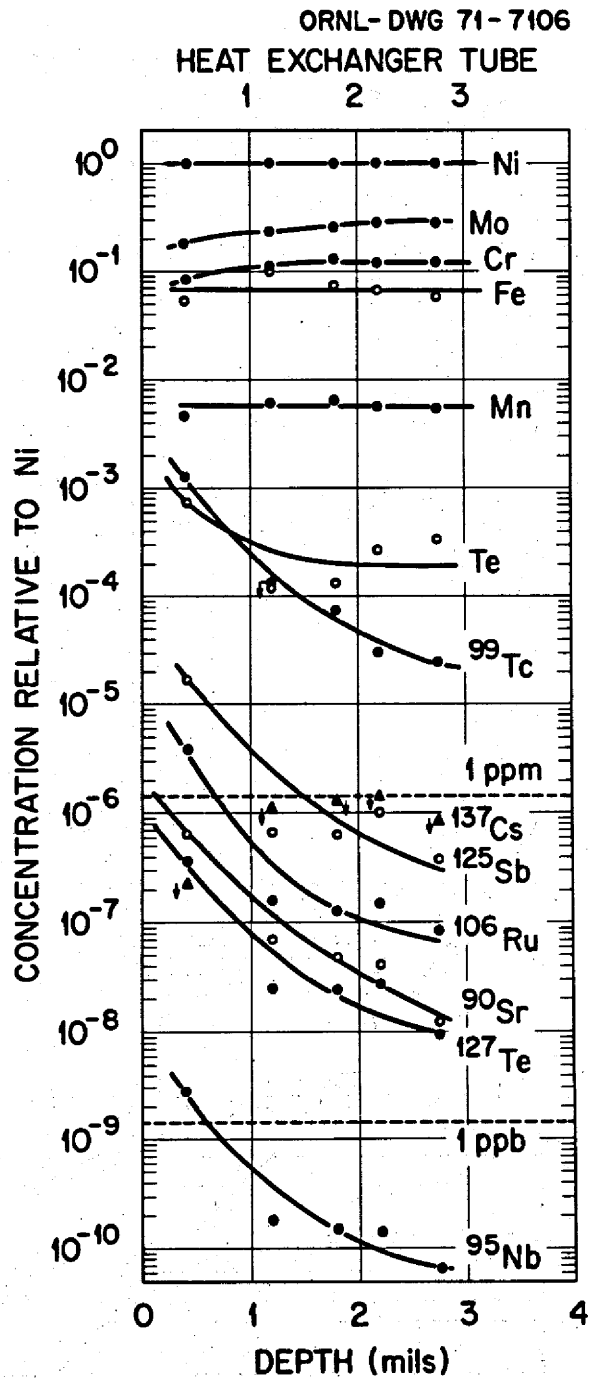
Fig. 110. Concentration Profiles from the Fuel Side of a MSRE Heat Exchanger Tube. Arrows indicate that analytical values were reported as being less than the indicated point.

1. Several of the fission products penetrated the metal to depths of a few mils (Figs. 110 and 111).

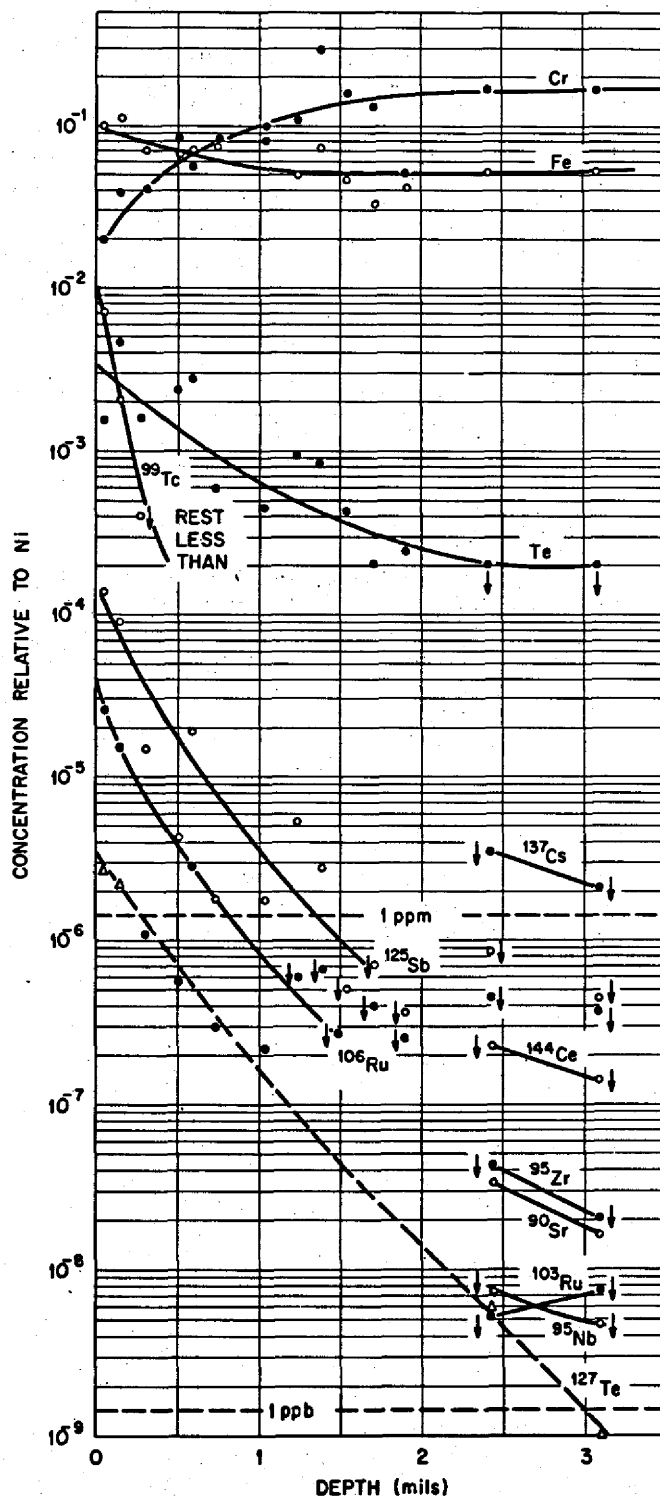
Fig. 111. Concentration Profiles from a Surveillance Sample Exposed in the MSRE for 19,136 hr. Arrows indicate that analytical values were reported as being less than the indicated point.

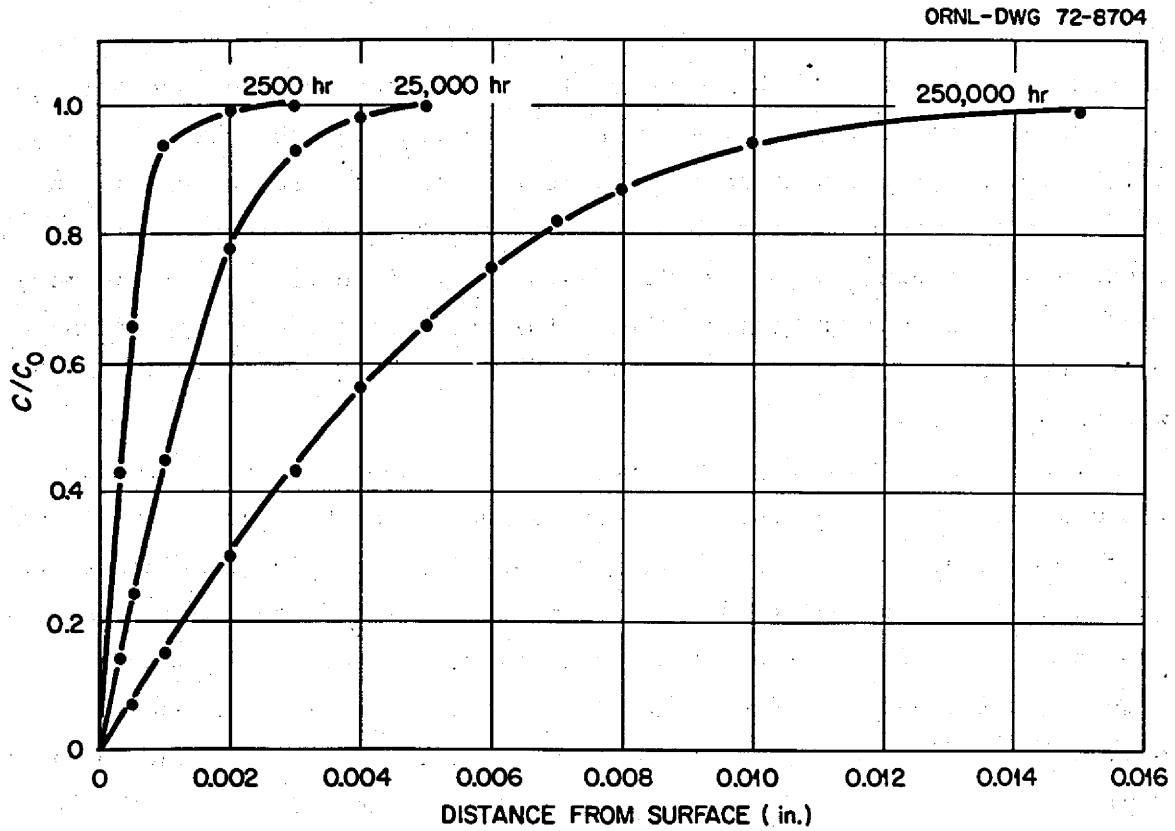
chromium could have been removed. The most extreme case would occur when the chromium concentration at the surface was maintained at zero so that the driving force for chromium diffusion toward the surface would be a maximum. The calculated chromium concentration profiles based on the assumption of zero surface concentration and the measured diffusion coefficient of 1.5×10^{-14} cm²/sec are shown in Fig. 112 for various times. The measured chromium profile for the thimble (Fig. 66) showed depletion to a depth of only 0.8 mil (0.0008 in.) which is somewhat less than the calculated depletion depth shown in Fig. 112. However, the assumption of zero concentration of chromium used in calculating the curves in Fig. 112 is too severe, and it is reasonable that the measured chromium depletion profiles would be less than those calculated. The rate of diffusion along grain boundaries, as we will discuss more in detail later, is more rapid than through the grains. Thus, the depth of chromium depletion along the grain boundaries could be much greater than the 0.8 mil measured within the grains.

Fig. 112. Calculated Chromium Profiles at 650°C in INOR-8 Assuming Zero Surface Concentration of Chromium.

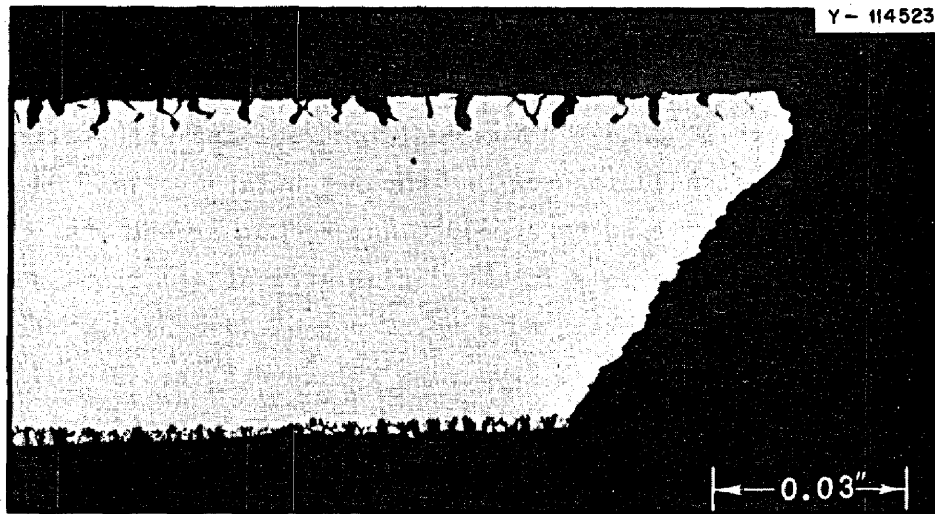
MSRE Thimble - 31,000 hr in Fuel Salt at 650°C
 1.4×10^{17} atoms/cm² of Te

2. The cracks produced in INOR-8 by exposure to tellurium look quite similar to those formed in the material from the MSRE (Fig. 113).

Fig. 113. Samples of INOR-8 Strained to Failure at 25°C. The upper photograph was made of a piece of the MSRE thimble. The upper side was exposed to fuel salt and cracked when strained. The lower side was exposed to the cell environment and the oxide that formed cracked during straining.

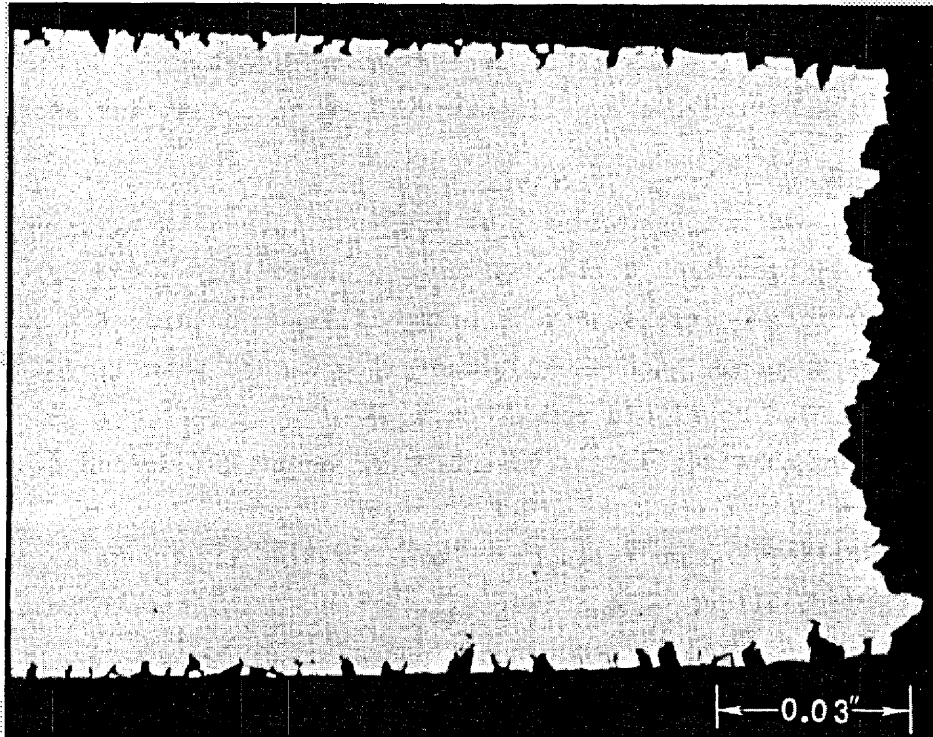
Vapor Plated with 5.4×10^{18} atoms/cm² of Te
 Annealed 1000 hr at 650°C

The lower specimen was exposed to tellurium vapor on both sides and deformed. The cracks are similar to those formed on the surface of the upper sample that had been exposed to fuel salt.
