ORNL-TM-3039

MSRE SYSTEMS AND COMPONENTS PERFORMANCE

Molten-Salt Reactor Experiment Staff

JUNE 1973

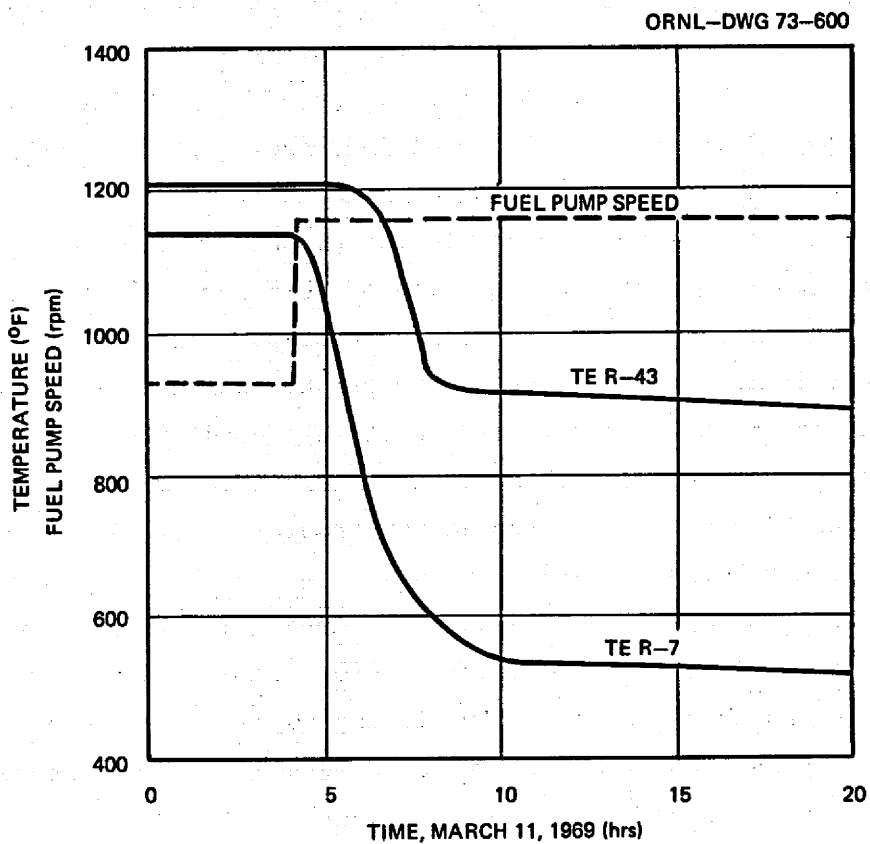
Fig. 5.13 Effect of Fuel Pump Speed (i.e. circulating bubbles) on Reactor-Access Nozzle Salt Level (as indicated by wall temperatures)

The effect of a direct change in the amount of circulating bubbles can be seen in Fig. 5-13. At the beginning of this period the fuel-pump speed was lower than normal and it can be seen that the RAN salt level was very high. Other indications such as the reactivity balance led to the conclusion there were no bubbles circulating at this condition. When the fuel-pump speed was increased, with no other change in operating temperature or pressure, the RAN salt level dropped very rapidly. (Note the abscissa in Fig. 5-13 is now hours instead of days.)

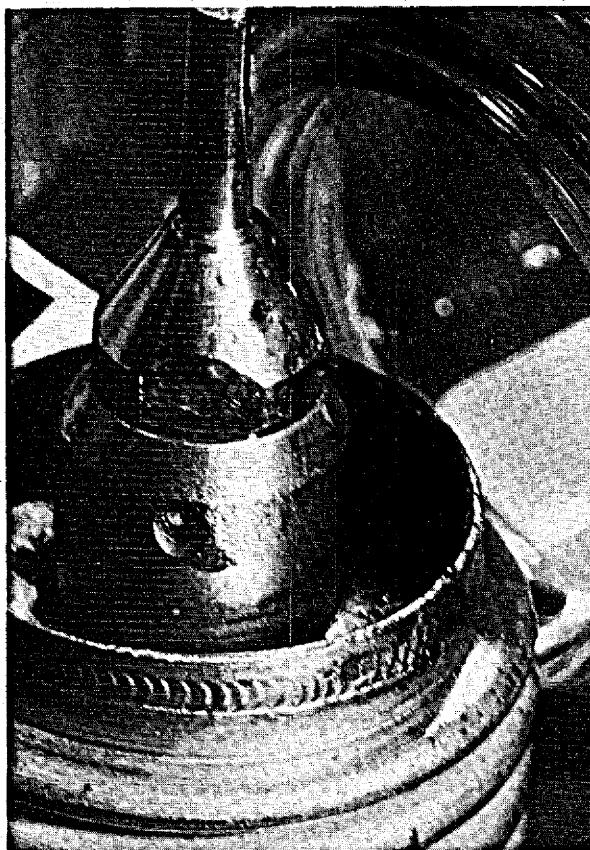
PHOTO R27812

Examination of PCV-522 — The stem of the control valve shown in Fig. 8.6A, was covered with an amber oil-like coating and there was an accumulation of oil in the recess formed by the bellows-to-stem adapter. The tapered flat (flow area) on the stem had small accumulations of solids; the body was coated with a similar material and had a semisolid mass of material on the surface near the seat port as shown in Fig. 8.6B. A gamma scan⁶ of this material indicated the presence of ⁸⁹Sr, ¹⁴⁰Ba, and ¹⁴⁰La.

Fig. 8.6A PCV-522 Valve Stem

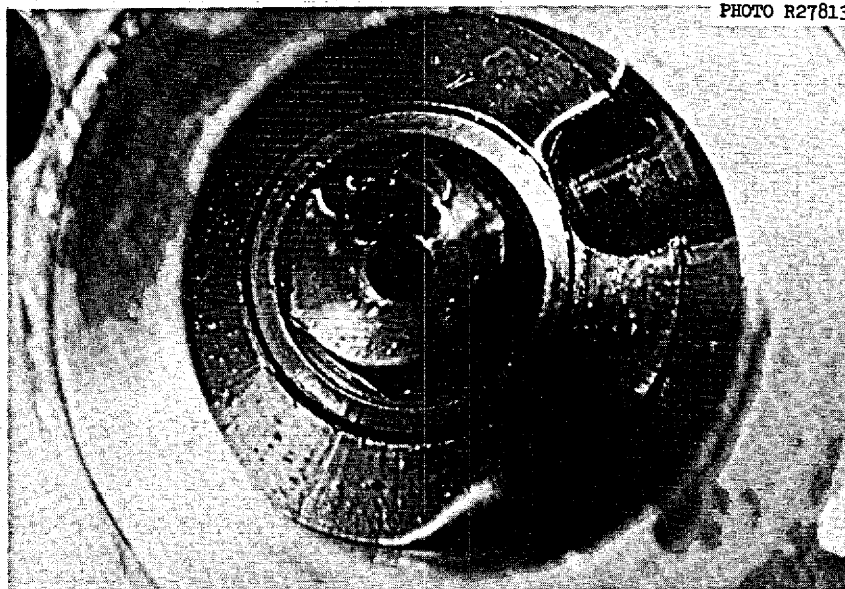
PHOTO R27813

Fig. 8.6B PCV-522 Valve Body

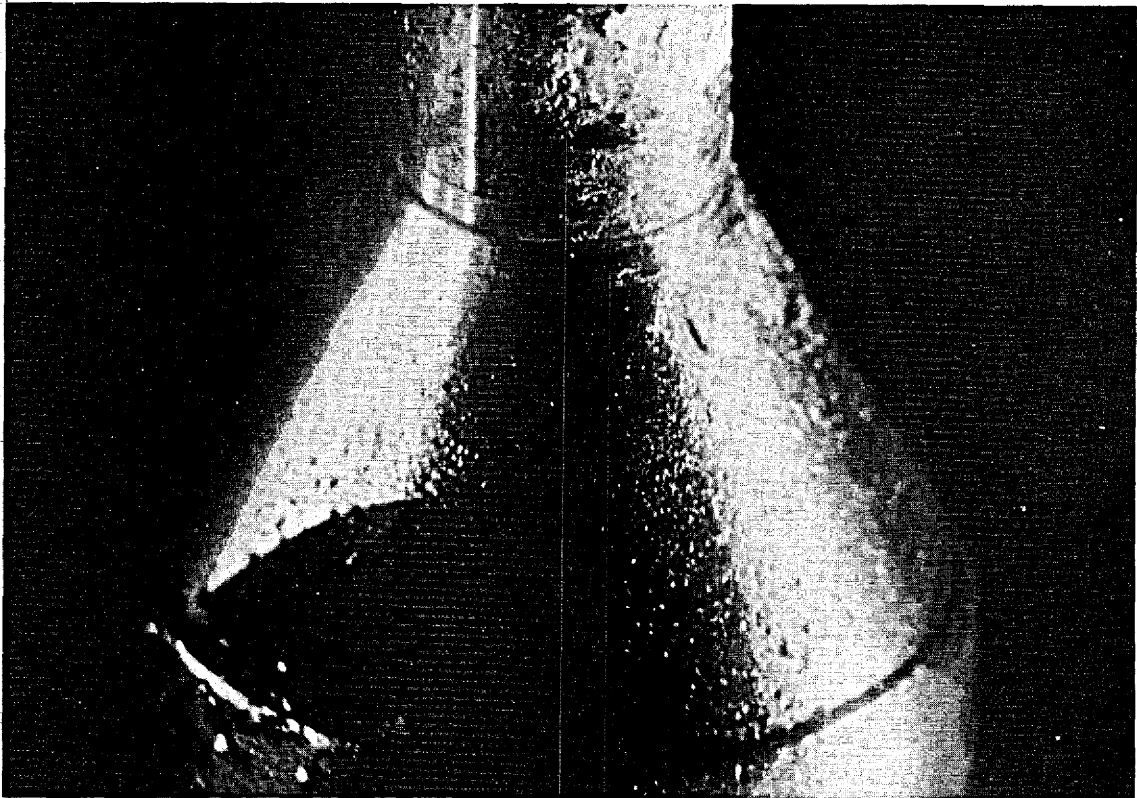
PHOTO R28500

Fig. 8.7 Charcoal Bed Inlet Valve Stem HV-621

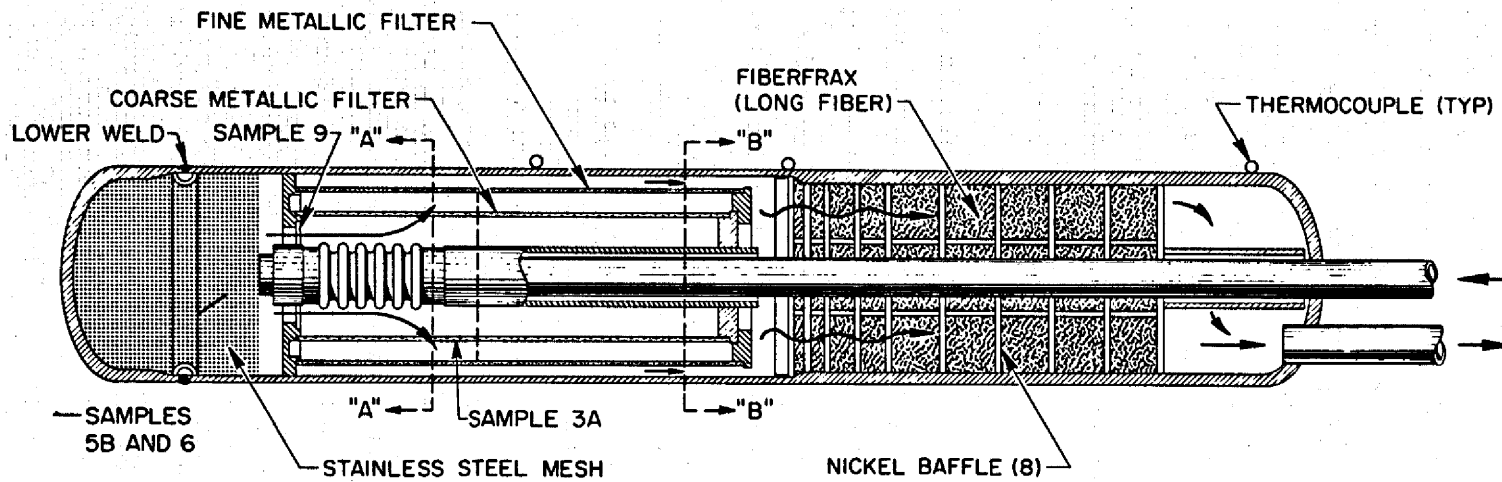
Fig. 8.8 Line 522 Particle Trap (Mark I) and Location of Sampling Points During Subsequent Examination

The perforated plate of the coarse filter section and the lower flange of the filter assembly were covered with a stratified scale (view A-A, Fig. 8.8). The colors varied from a very light yellow to orange. One stratum in the lower flange area appeared gray, almost black. A sample (No. 9) was taken of the light-colored material, including some of the black material. The perforated plate of the fine filter section was covered with a thin, dark-brown coating, which seemed to be evenly distributed over the surface of the plate. The inner surface of the outer wall of the trap was covered with a light-amber coating, which was also evenly distributed.

Analytical Results.⁸ A total of four samples from three different locations (Fig. 8.8) were subjected to a variety of analytical tests. The samples were identified as follows:

<u>Sample No.</u>	<u>Taken from</u>
3A	Coarse section of porous metal filter
9	Scale on lower flange of porous metal section
5B	Mat at inlet to Yorkmesh section
6	Mat at inlet to Yorkmesh section

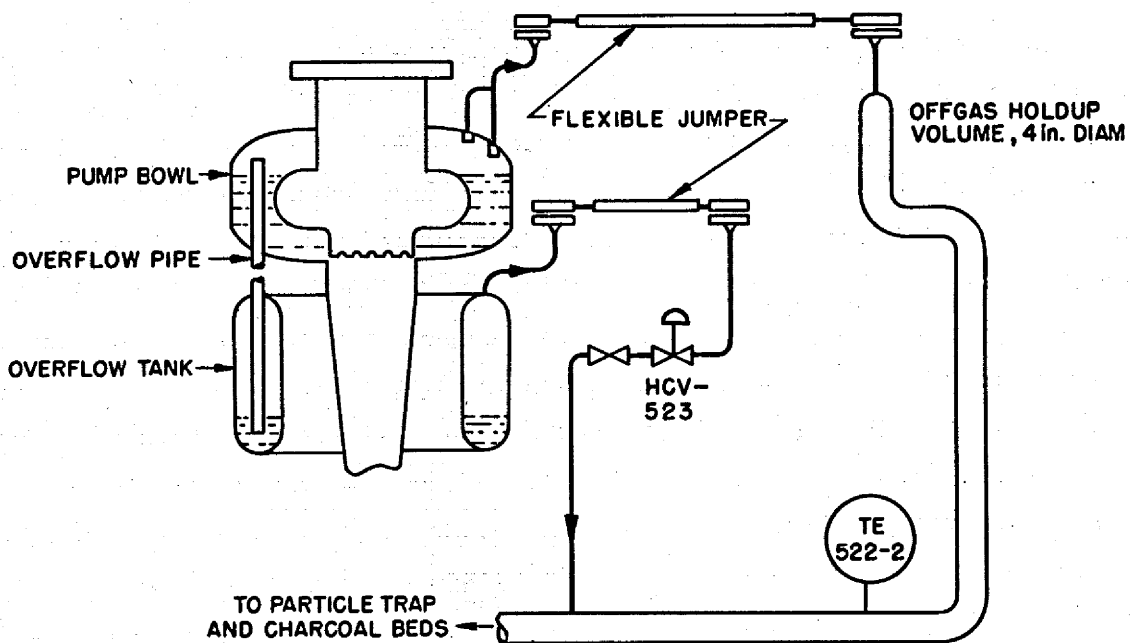
ORNL-DWG 67-4764

Fig. 8.9 Off-Gas Piping Near Fuel Pump and Overflow Tank

fuel salt at low power. Then, two days after power operation was resumed at 5.8 MW, a plug developed in line 522 somewhere between the pump bowl and the junction of the overflow tank vent with the 4-in. holdup line. The first indication was a decrease over a few hours from 107°C to 71°C at TE-522-2, as the plug caused the off-gas to bypass through the overflow tank (OFT). The presence of the plug was confirmed when HCV-523 was closed to build up pressure in the OFT to return salt from the tank to the pump bowl; pressure in the pump bowl also built up. Efforts to remove the restriction by applying a 10-psi differential either forward or backward were unsuccessful.

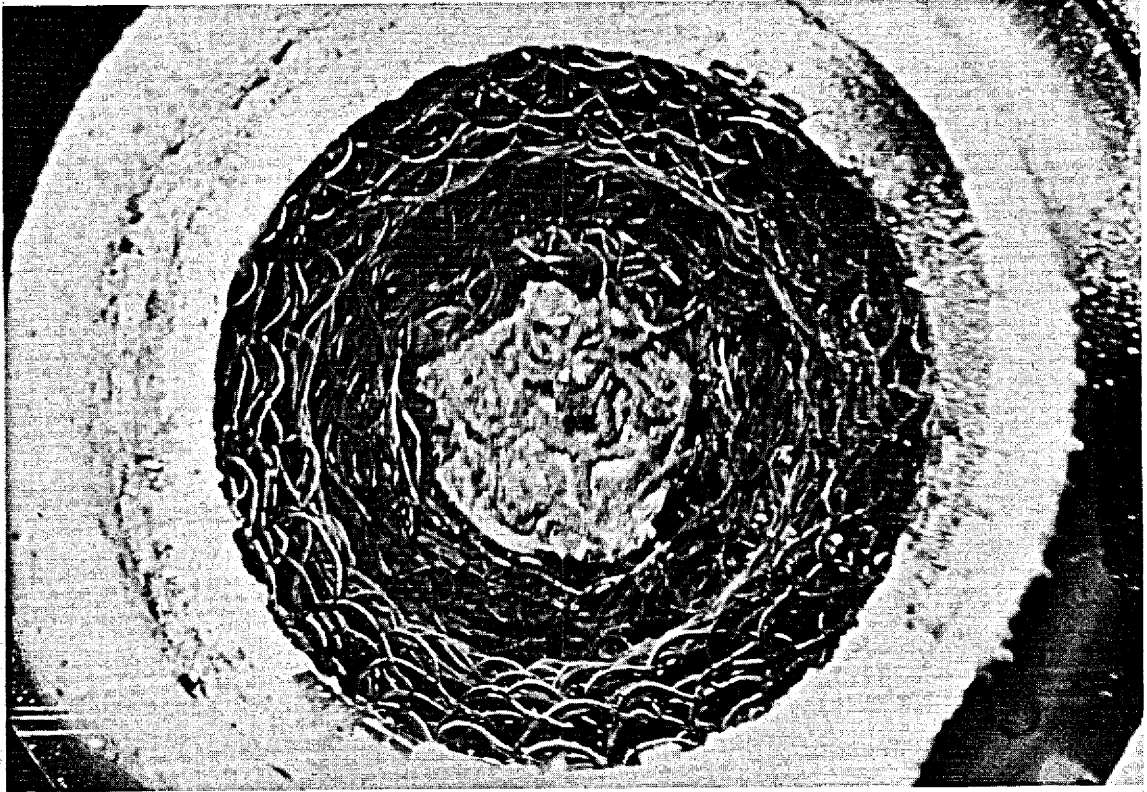
PHOTO R32824

The area of the Yorkmesh which had been immediately below the inlet pipe was covered with a blue-gray to black mat which had completely filled the space between the wires of the mesh (Fig. 8.10). The shape of the mat corresponded to the bottom of the inlet pipe, and it is likely that this material was the major restriction to gas flow while in service.

Since the inlet pipe temperature probably increased several hundred degrees during power operation of the reactor, it is believed that this restriction behaved similar to a thermal valve. This could account for the unexpected increase in pressure drop while at power and the decrease in pressure drop when the power was reduced or when the off-gas was delayed via the drain tank.

Fig. 8.10 Inlet to Yorkmesh Section MSRE Particle Trap Mark I

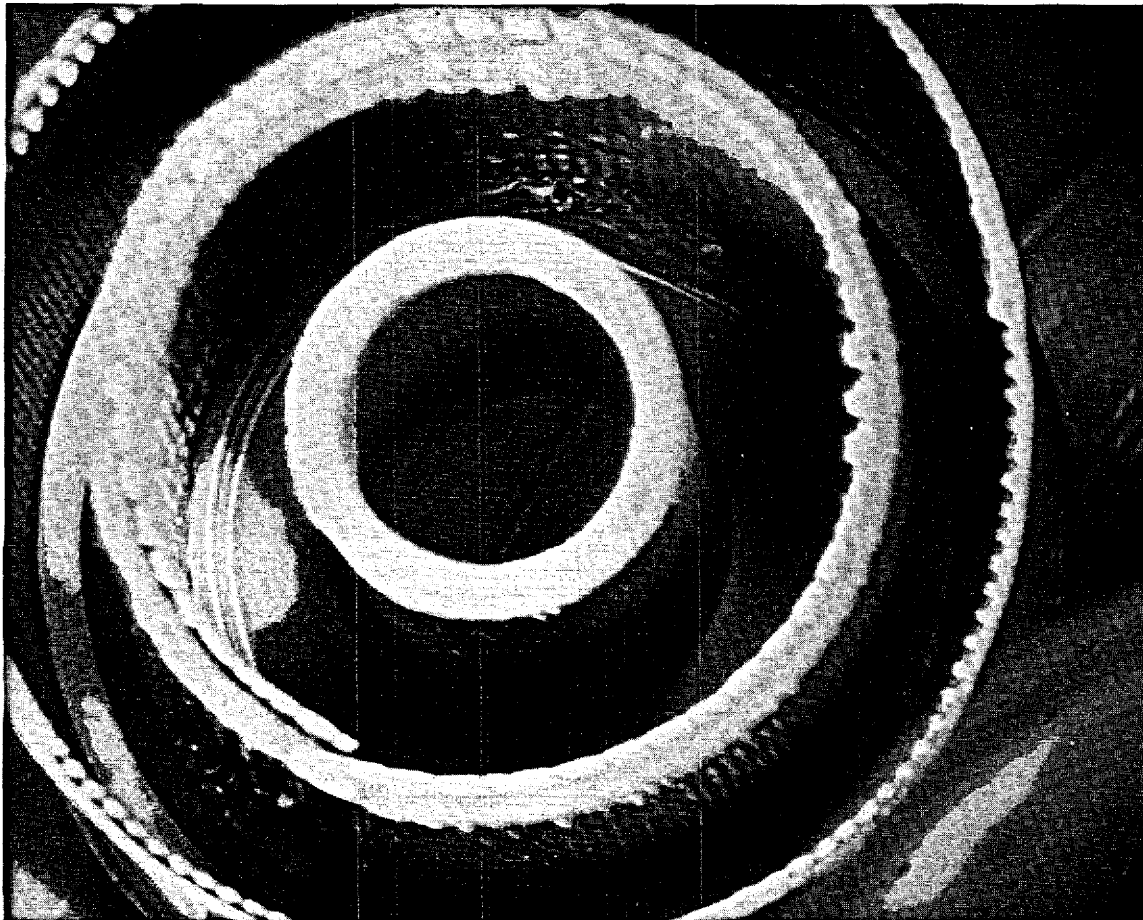
Fig. 8.11 Upper End of Porous Metal Section — MSRE Particle Trap Mark I

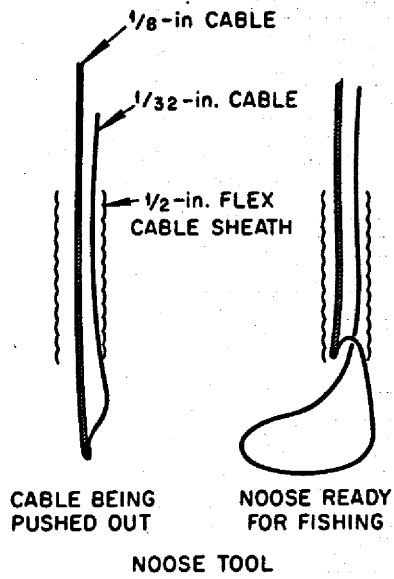
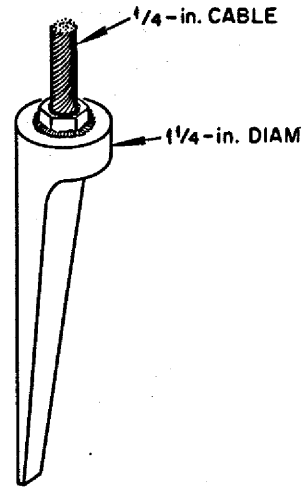
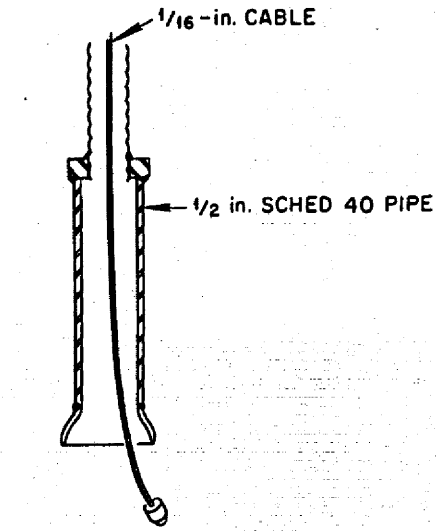
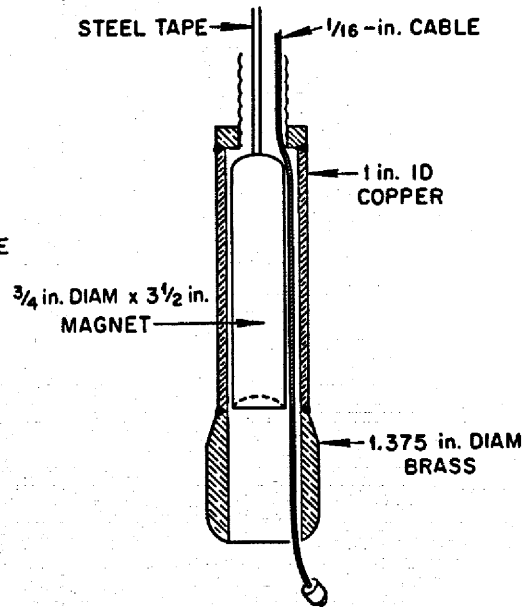
Fig. 18.3 Tools Developed for Retrieval of Latch and Capsule from Sampler-Enricher

a hot cell revealed that the cable was not tangled in the gears as had been assumed; the failure to withdraw or insert was due to a sharp kink in the cable which became lodged in the 17/32-in. diameter channel of the latch positioner.

While retrieval efforts were in progress, a replacement 1-C assembly which was on hand, was equipped with a latch made of 430 stainless steel and with a sleeve to prevent future tangling of the cable in the gears of the drive unit. However, subsequent examination of the old drive unit in

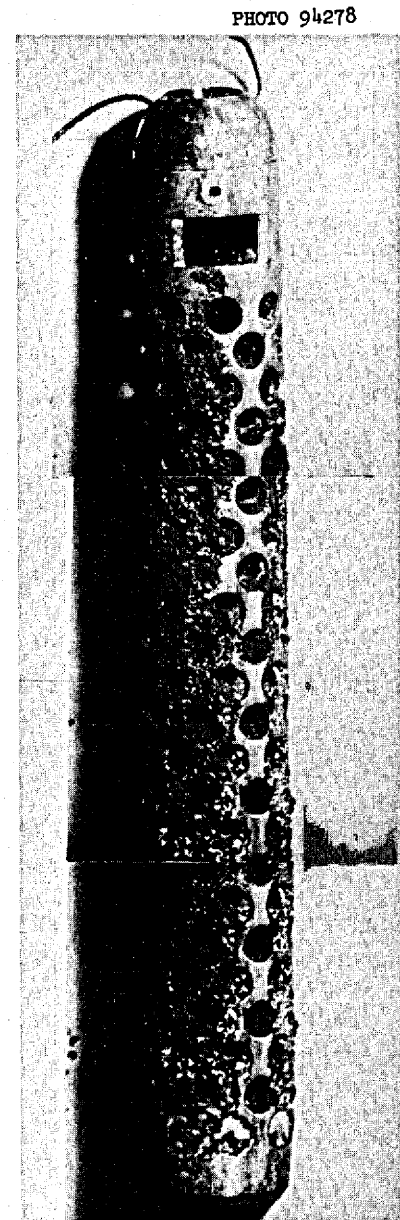
Fig. 8.5b Nickel Cage Beryllium Rod Assembly after Exposure to MSRE Fuel Salt for 10.5 hr

When the beryllium addition capsules were withdrawn, they were encrusted with solids as shown in Figure 18.5b. As a result, the capsules were difficult to load into the bottom part of the transport tubes even though the plastic liner was removed. Also the enriching capsules were sometimes difficult to load because of their length (6-1/4 in.). The cables of these long capsules were occasionally caught in the threads of the mating parts of the transport container and were difficult to unload at the hot cell.

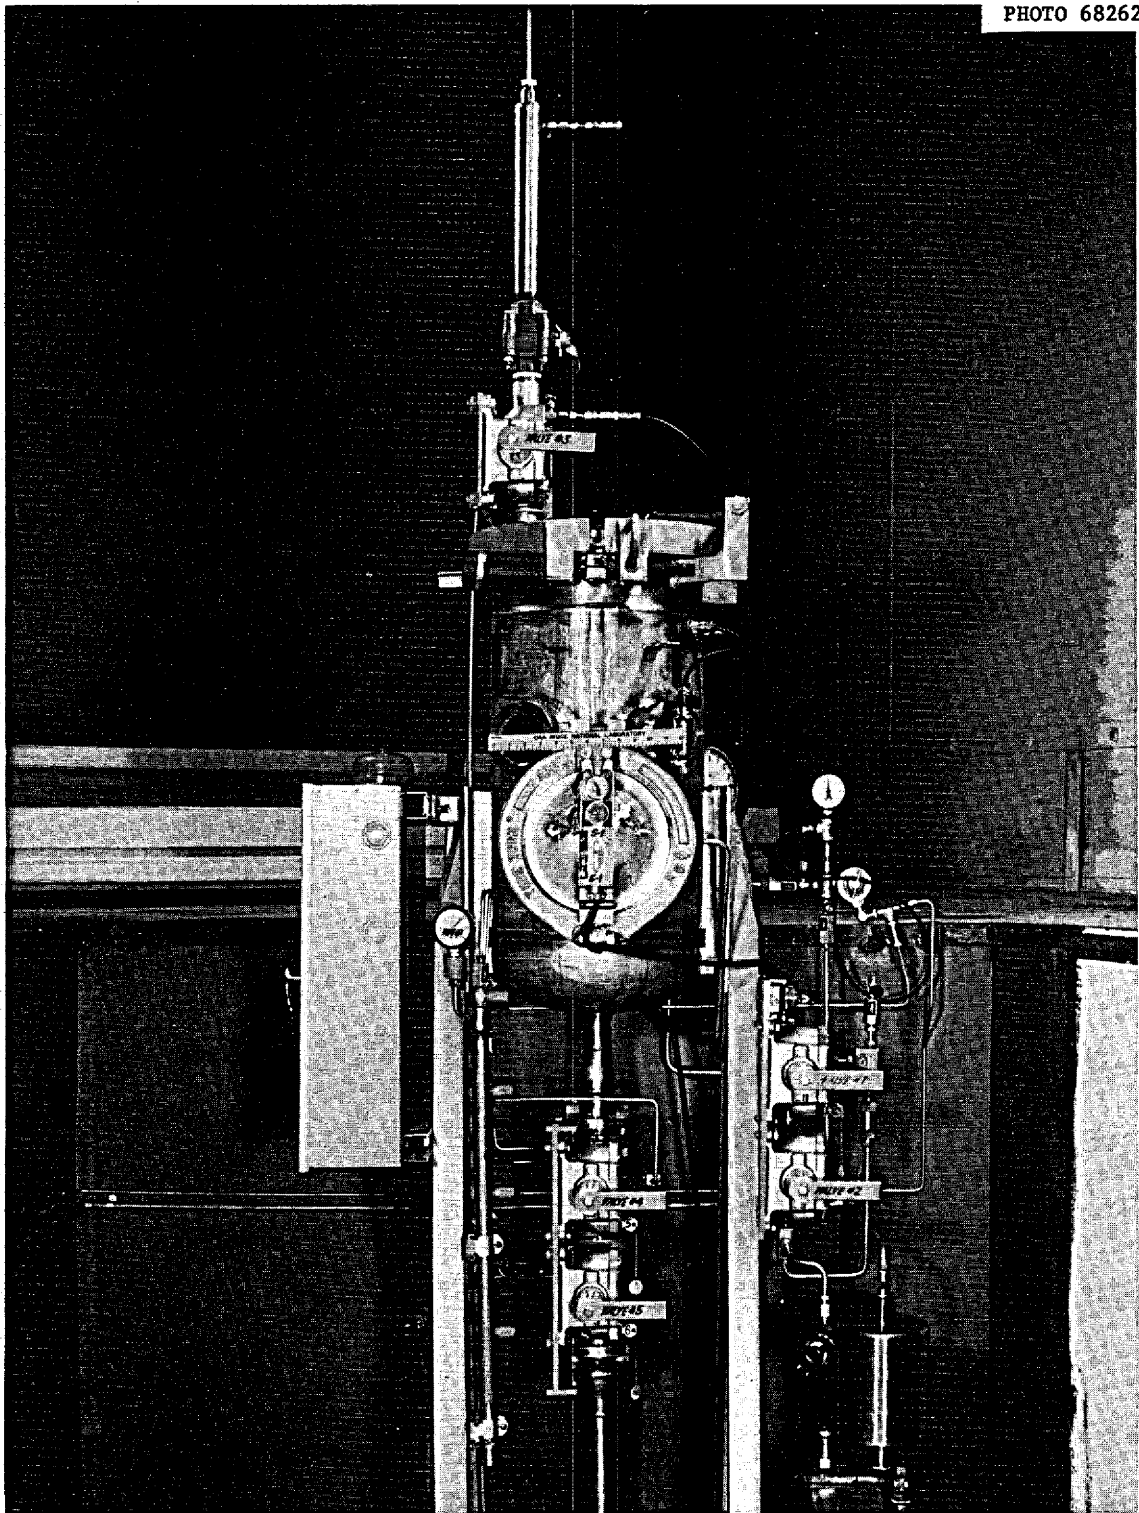
Fig. 18.6 Coolant Salt System Sampler

Early in 1966 during one sampling operation, the latch failed to slide freely through the transfer tube. No reason for the difficulty could be found. However, the outside diameter of the latch was reduced and no similar trouble was reported.

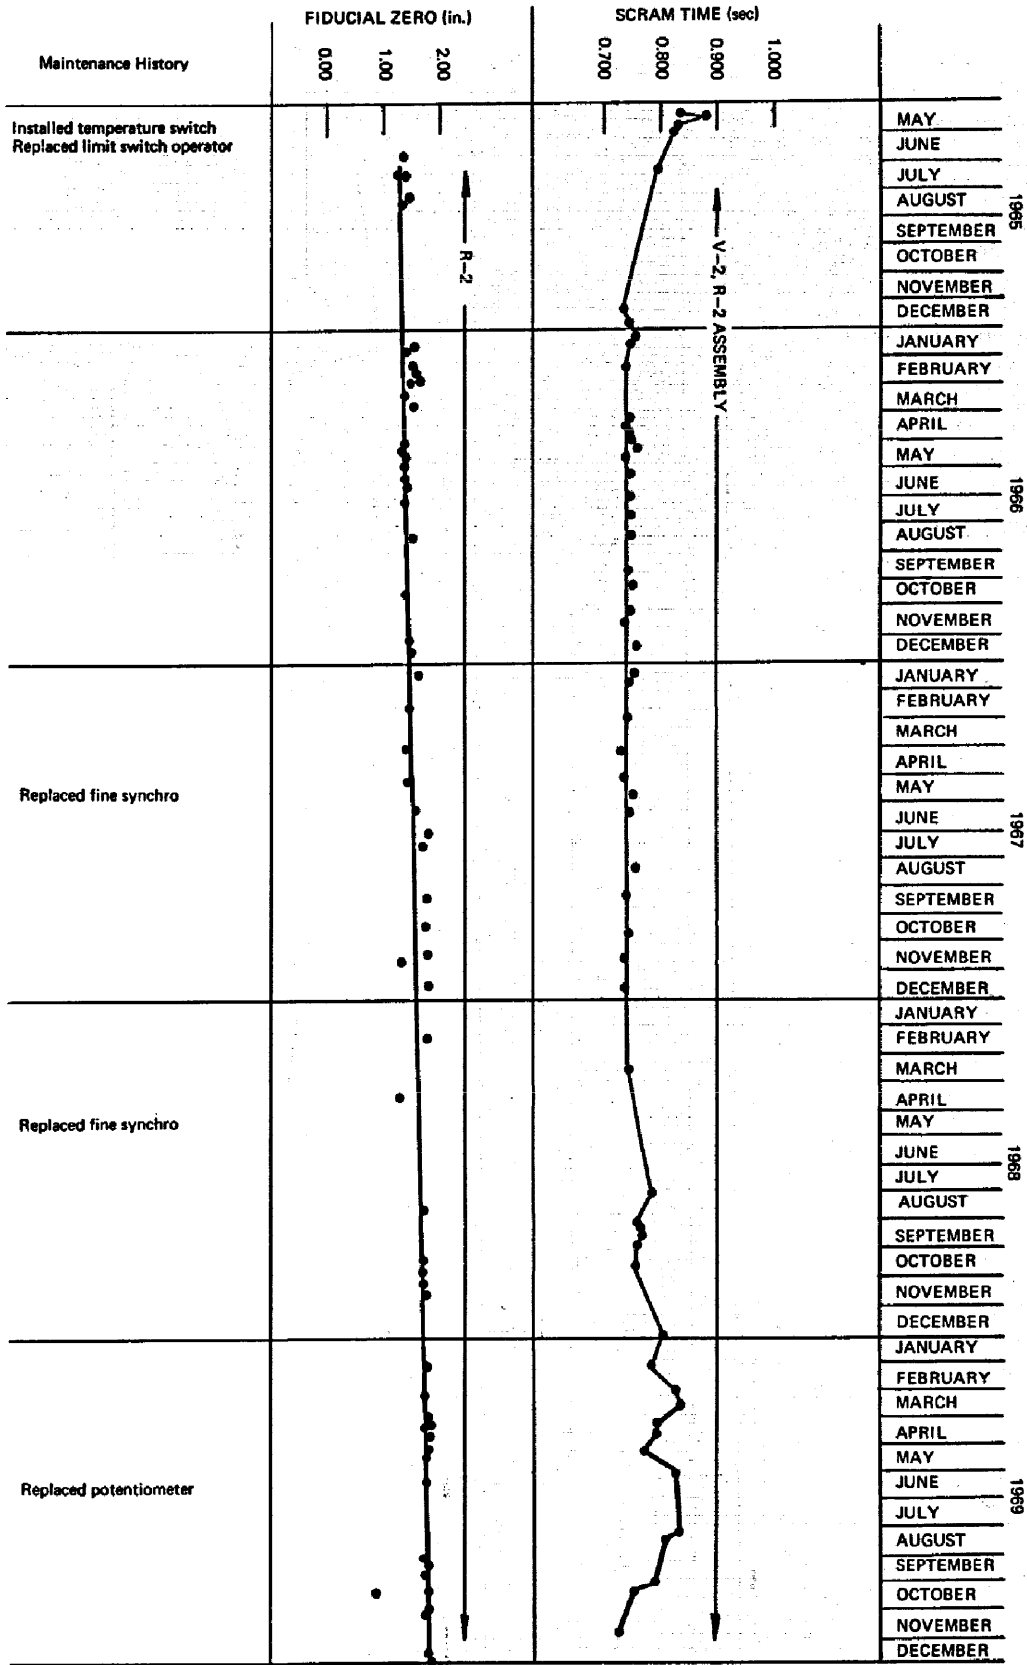
Fig. 19.3 Service History of Rod Assemblies in Thimble T-3

This assembly was made up of V-1 drive and R-3 rod at the time of installation as shown in Fig. 19.3. As indicated by the scram history shown in the figure, this assembly was the most troublesome of the three MSRE control rods. The drive units were removed during the precritical maintenance period in the summer of 1965 to install the modified limit switches described elsewhere. The No. 3 control rod was inspected at this time and found to have a torn section in the upper hose, 28 in. below the flange. The damage to the rod was the result of the failure of the upper roller

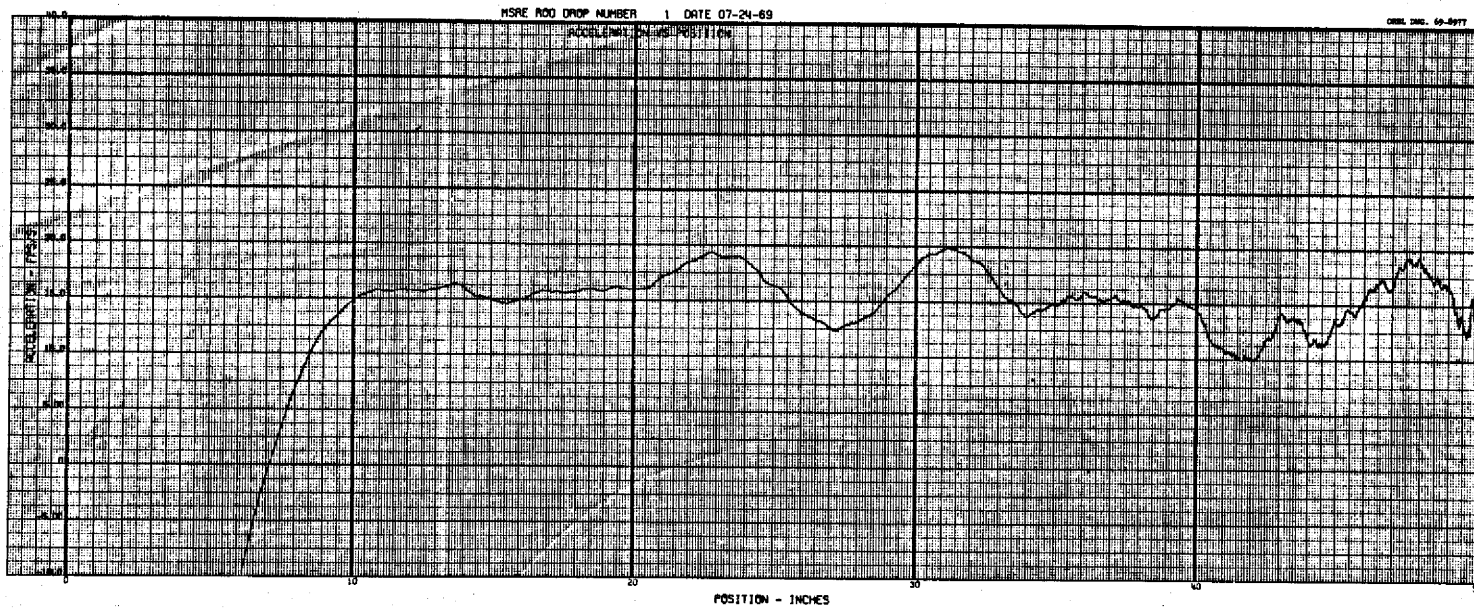
Fig. 19.5 Rod Acceleration Curve

It was obvious from the No. 3 rod failure to scram that the method of testing each rod by a single 50-in. scram was inadequate. The method failed to expose any local areas of high drag. The incremental method of testing, scram time vs starting position, as shown in Fig. 19.4, showed no region of excessive drag for any of the rods. In an effort to provide a quick testing procedure that would not require numerous rod drops, yet would reveal regions of abnormal drag, a procedure developed for the EGCR was renovated. The output from the 1000-ohm position potentiometer was amplified and transmitted by wire to the main ORNL area, where it was passed through a filter with a 5-Hz time constant to remove transmission noise, digitized at 2000 samples/sec, and stored on magnetic tape. The data was then sent to the IBM-360 computer for smoothing and analysis by a program especially developed for this purpose. This procedure when activated during a rod drop from 50 in. gave about 1800 data points during the drop. From this velocity and acceleration curves were generated. Data taken before repair of the sticking rod assembly (R-4 and V-1 in T-3) showed a region of near zero acceleration between 26 and 40 in., in good agreement with the incremental results shown in Fig. 19.4. After reinstallation, all three assemblies were tested by both incremental drops and the single drop computer analyzed method. Both methods showed reasonably constant accelerations of 10 ft/sec² or more. A typical plot of acceleration vs position is shown in Fig. 19.5.⁵⁹

The signal filtering and data smoothing that are required because of the noise that is inherent in the position signal generator and transmission system made it impossible to detect with certainty a zero acceleration zone less than about six inches long if it is more than about six inches below the scram starting point.

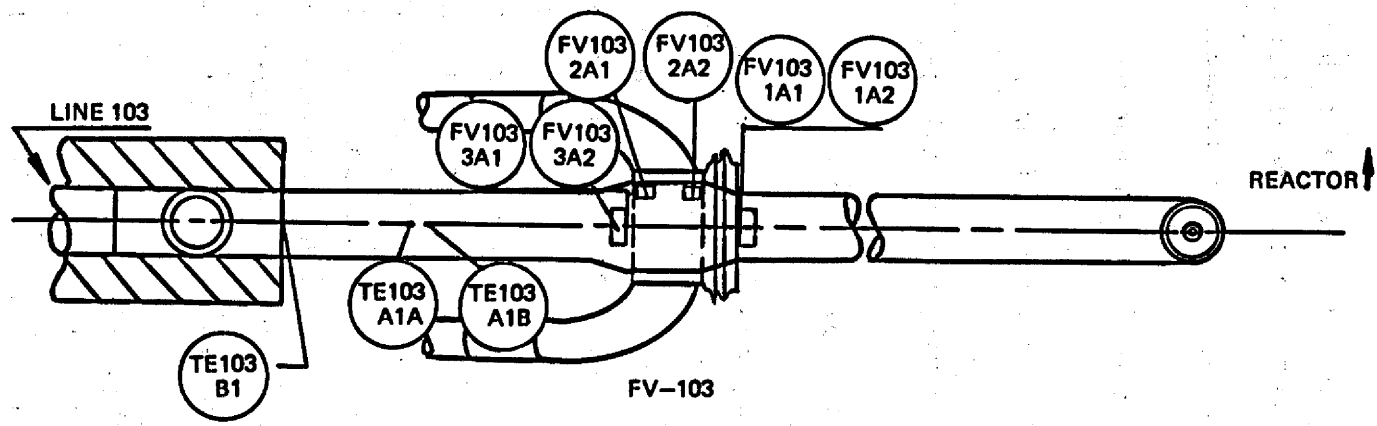
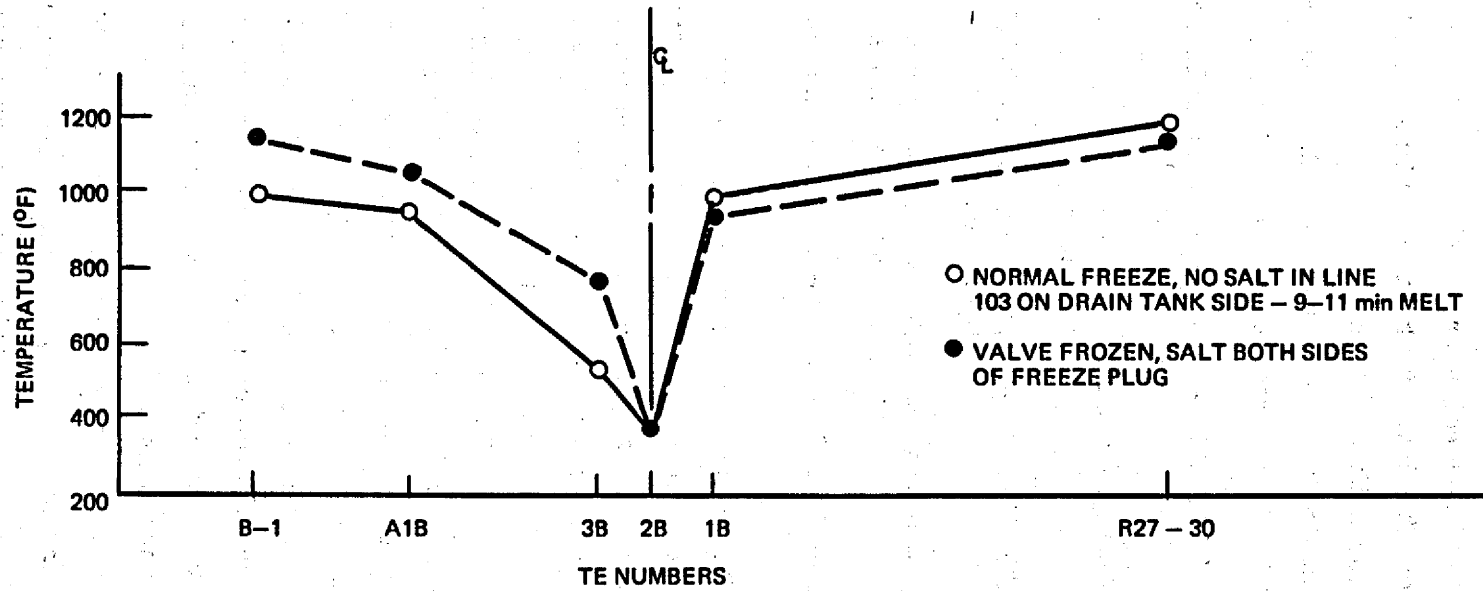
Fig. 20.3 Temperature Distribution at FV-103

Once the valve conditions were established, FV-103 operated well except for one unscheduled drain which occurred on April 15, 1969. This was caused by an upward 50°F drift of the setpoint of the FV-103-3A1 module from 750°F to 810°F plus an administrative change of the FV-103-1A1 setpoint from 1010°F to 1050°F.

The upward drift had occurred prior to the previous freezing operation and a short plug (<2 in.) of salt was formed in the valve. The controls and freeze test indicated a good freeze. At the time of the incident, the salt temperature was not at 1210°F for which the controls were originally adjusted, but at 1110°F with the cooling gas flow controlling the valve center temperature at 420°F.

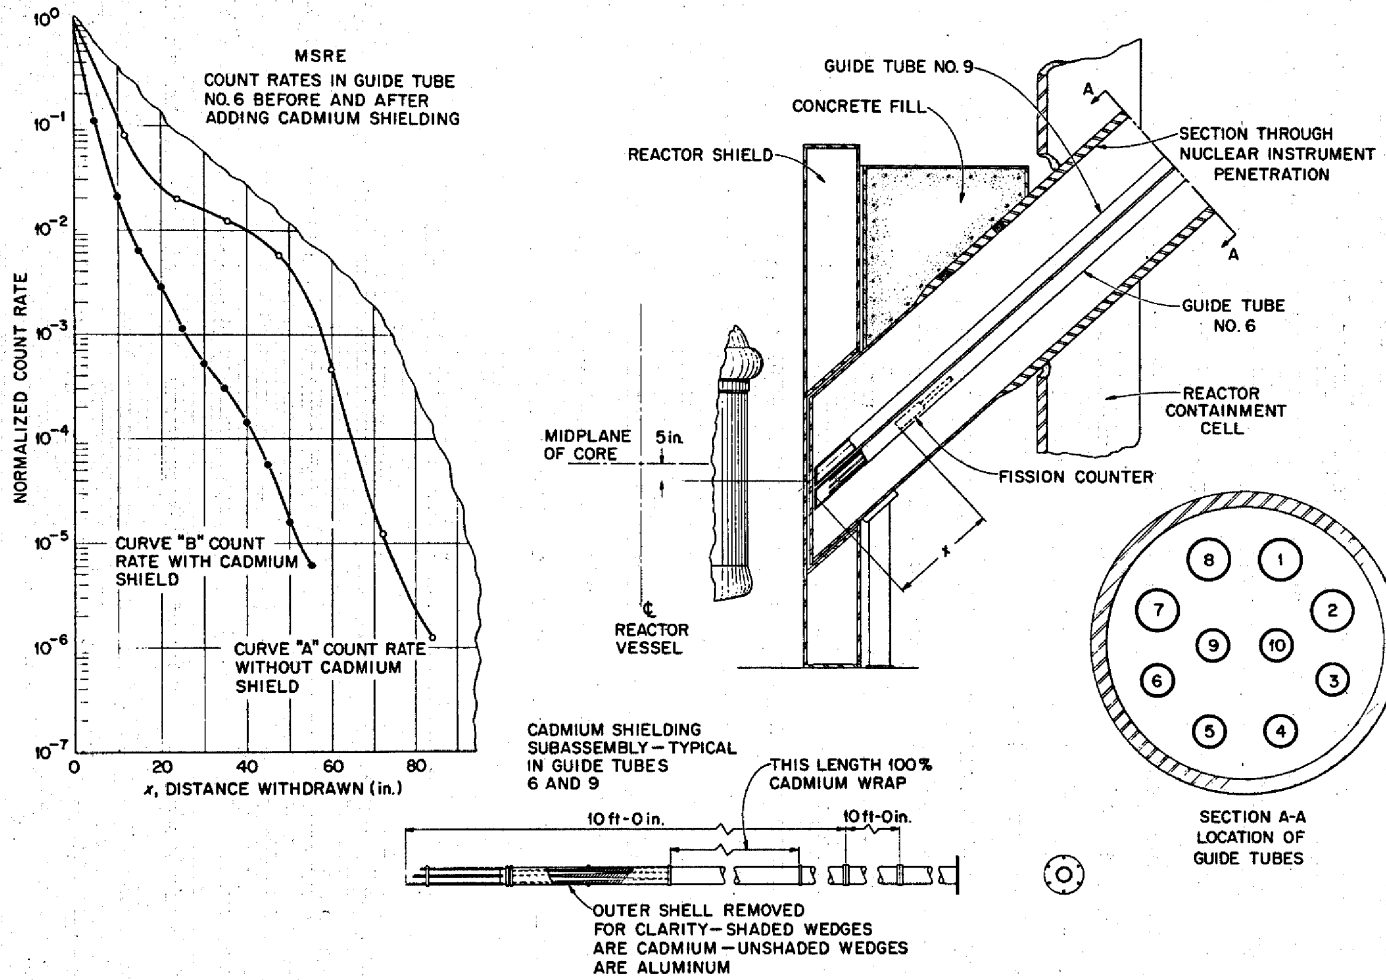
Fig. 24.2 Guide Tube Shield in the MSRE Instrument Penetration

Initial criticality tests disclosed that the neutron flux attenuation in the instrument penetration did not follow an ideal exponential curve. The deviation was too large to be adequately compensated for by the vernistats in the wide-range counting channels. This is illustrated by curve A of Fig. 24.2 which shows fission counter response (normalized count rate) vs withdrawal from the lower end of the penetration in guide tube 6. It was reasonable to conclude from this, and from similar curves, that the excess neutrons responsible for the distorted part of the curve were entering the penetration along its length. The count rates in other guide tubes nearer the upper half of the penetration were even more distorted than curve A. Since a flux field with attenuation per Curve A precluded successful operation of the wide-range counting instrumentation, shields of sheet cadmium were inserted in guide tubes 6 and 9 to shield the fission chambers from stray neutrons. Curve B of Fig. 24.2, normalized count rate vs distance, shows the improvement for guide tube 6.

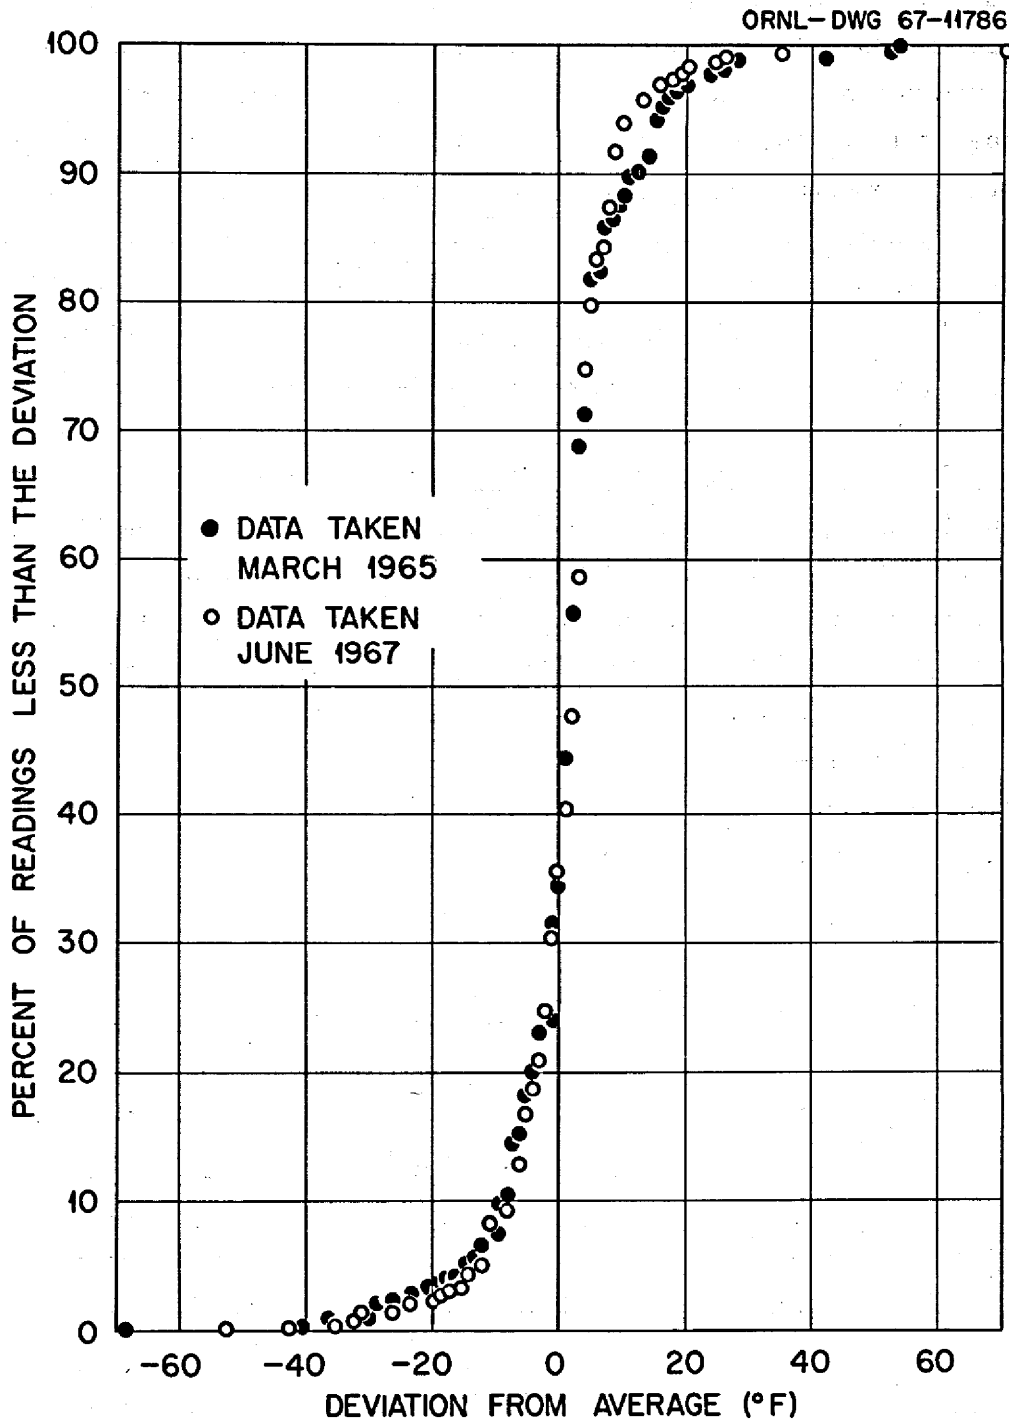
Fig. 24.3 Comparison of MSRE Thermocouple Data from March 1965 and June 1967

Only three thermocouple wells were provided in the circulating salt systems, one each in the coolant radiator inlet and outlet pipes and one in the reactor neck. The remaining thermocouples were attached to the pipe or vessel walls. The thermocouples on the radiator tubes were insulated to protect them from the effects of the high-velocity air that flows over them during power operation; the others were not insulated and thus were subject to error because of exposure to heater shine and to thermal convection flow of the cell atmosphere within the heater insulation. In March 1965, with the fuel and coolant systems circulating salt at isothermal conditions, a complete set of readings was taken from all the thermocouples that should read the temperature of the circulating salt. A similar set of data was taken in June 1967 at the start of Run 12. The results of the two sets of measurements are shown in Table 24.5. Comparison of the standard deviations for the radiator thermocouples with those for the other thermocouples shows the effect of insulation on reducing the scatter. Comparison of the sets of data taken over two years apart shows very little change, certainly no greater scatter. Figure 24.3 shows that the statistical distribution of the deviations on individual thermocouples from the mean also changed little in the two years.

The scatter in the various thermocouple readings was reduced to an acceptable level by using biases to correct each reading to the overall average measured while both fuel and coolant systems were circulating salt at isothermal conditions. These biases were entered into the computer and were automatically applied to the thermocouple readings. The biases were revised at the beginning of each run and were checked when isothermal conditions existed during the runs. Generally the biased thermocouple readings were reliable. However in a few cases, there were shifts which caused calculational errors.
