ORNL-TM- 3524

**OPERATION OF THE SAMPLER-ENRICHER
IN THE
MOLTEN SALT REACTOR EXPERIMENT**

R. B. Gallaher

OCTOBER 1971

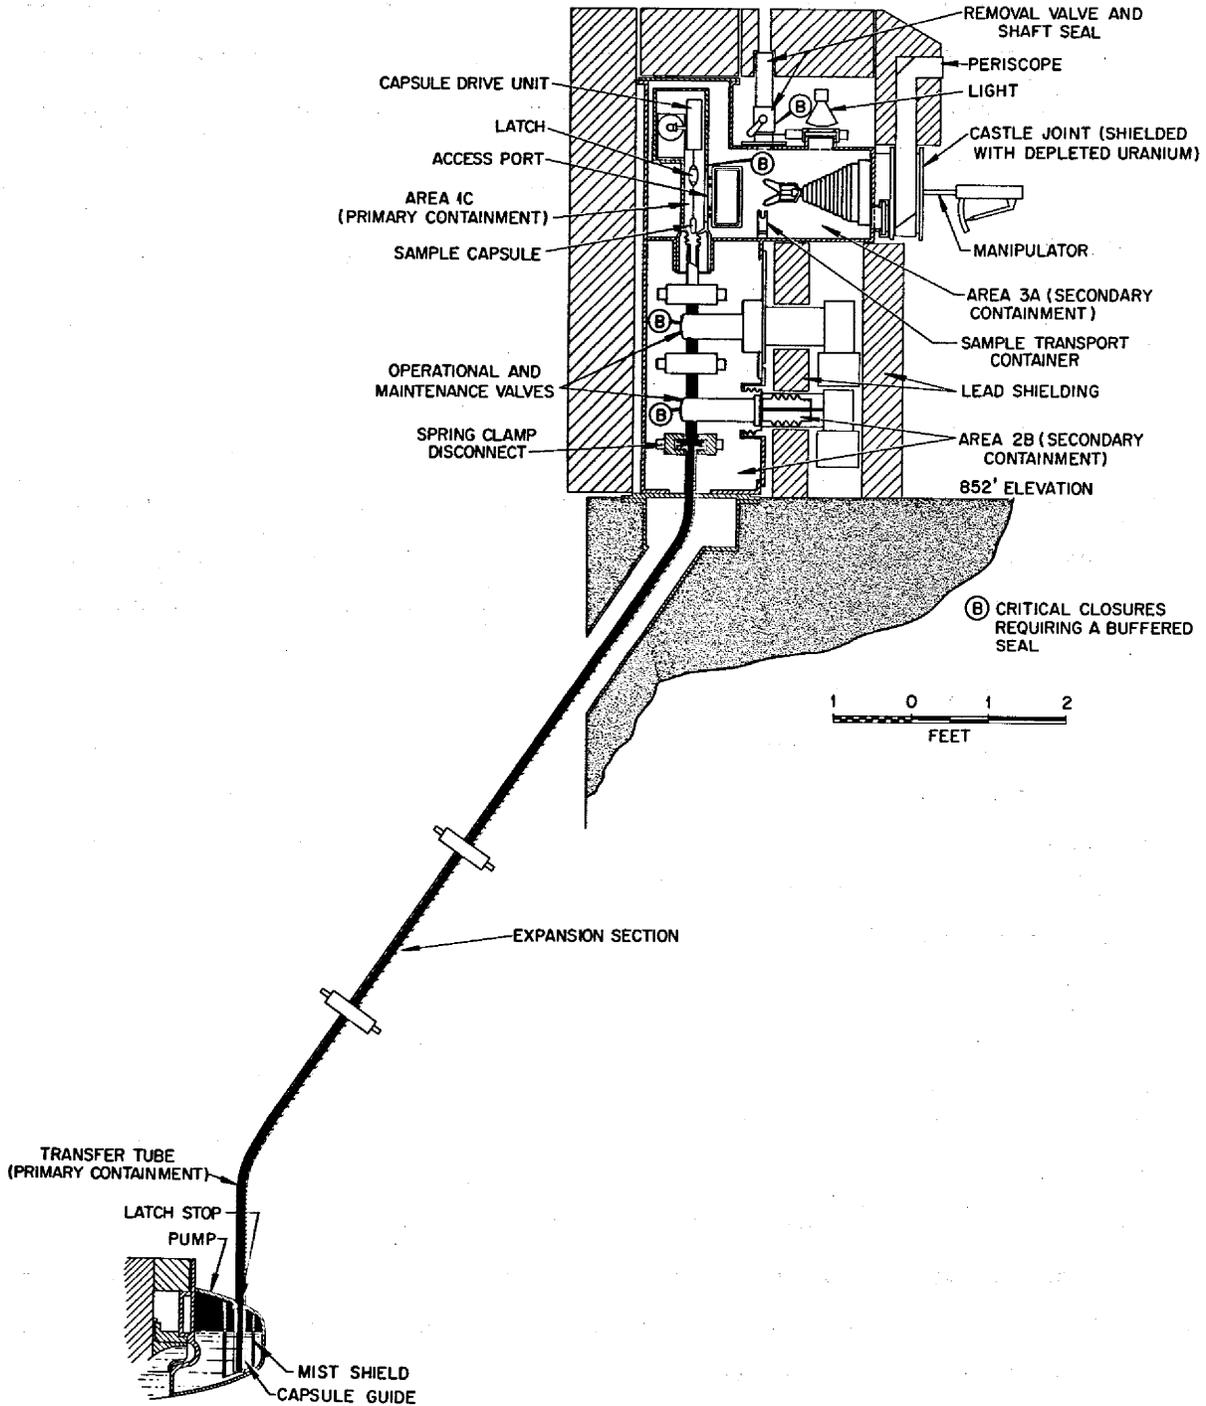
Fig. 1. Sampler-Enricher Schematic.

Figure 1 is a schematic diagram of the sampler-enricher. Note that both primary and secondary containment barriers of the reactor had to be penetrated to reach into the fuel salt from the operating area. In order to assure that there were always at least two barriers between the fuel system and atmosphere and between the sample and atmosphere, the equipment was compartmentalized. Adjacent compartments or areas were separated by buffered, double-sealed barriers. The pressure of the buffer gas was used to define when a barrier was closed.

The system consisted of a transfer tube which connected the two-compartment dry box (see Fig. 1) to the gas space of the pump bowl. The capsule, which was connected to the drive unit cable by a special latch, was lowered through the transfer tube into a guide cage beneath the salt surface in the pump bowl. It was then pulled up through the tube and two

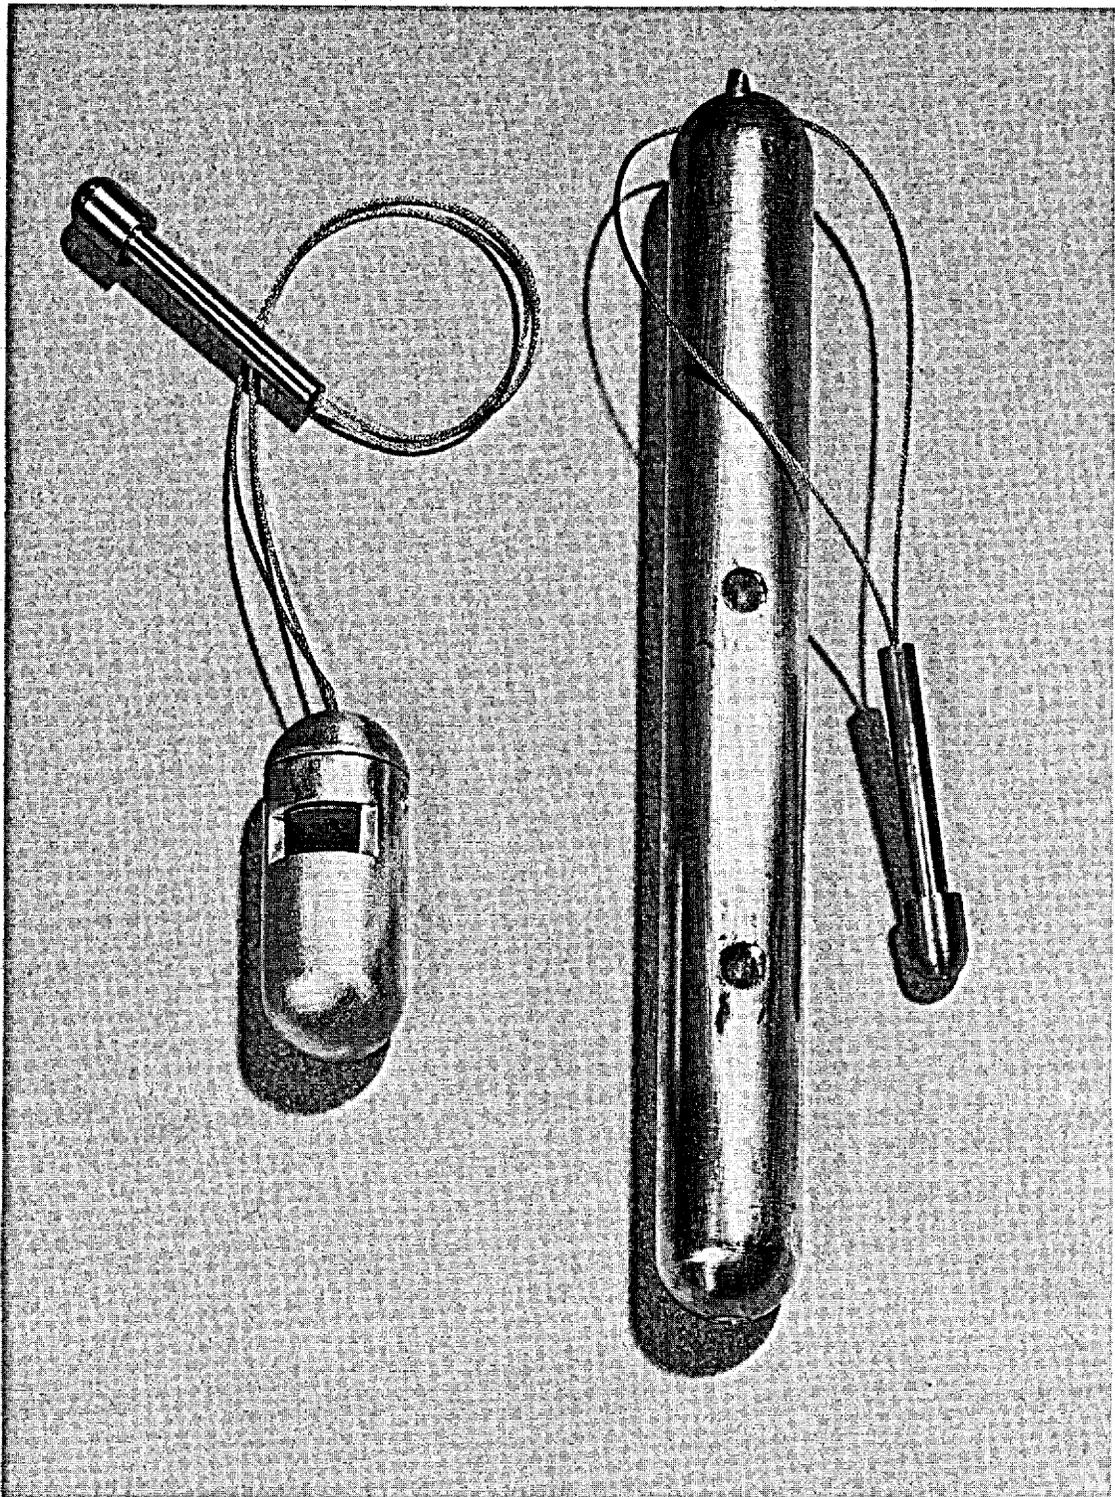
Fig. 2. Ten-gram Sample Capsule (left) Enriching Capsule (right).

Ten-Gram Sample Capsule — About 10 grams of salt was required for routine chemical analysis. A copper capsule used to isolate this size of sample is shown in Fig. 2. The capsule was 3/4 in. in diameter by 1.6 in. long with hemispherical top and bottom. Salt entered through two windows whose location determined the quantity that was trapped. The solid metal top provided sufficient weight to assure that the capsule would be submerged in the salt. A key was attached to the top of the capsule by a loop of 1/32-in.-diam stranded-steel rope, which provided the flexibility necessary for the sample assembly to pass through the two 15-in.-radius bends in the transfer tube. The key locked the assembly to the latch on the drive unit cable.

Enriching Capsules — Figure 2 also shows an enriching capsule assembly. The capsule was fabricated from 3/4-in. by 0.035-in.-wall nickel tubing. The bottom was spun shut on a 3/8-in. radius. A solid top was welded in place. The capsule was 6-3/8 in. long and contained about 120 g of enriching salt (90 g of ^{235}U). The holes, shown in the photograph, were drilled after the capsule was filled and just prior to use. Only the interior of the capsules was cleaned by hydrogen firing before the salt was loaded. The exterior was cleaned of dirt and grease just before use.

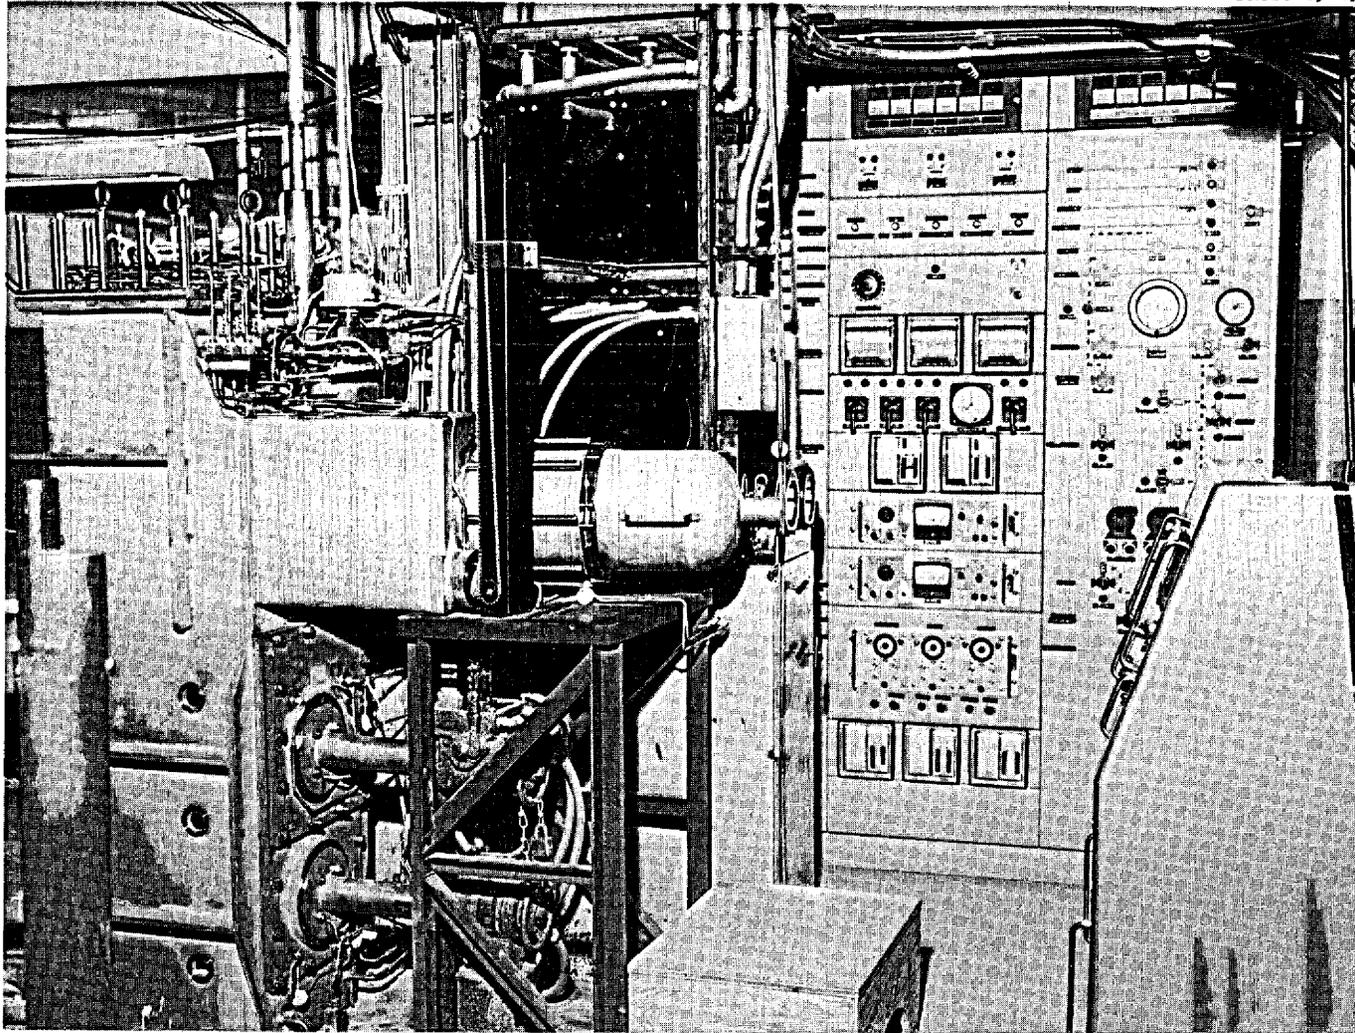
Fig. 3. Sampler-Enricher Before Installation of Shielding.

Figure 3 shows part of the instrument cabinet and the dry box prior to the installation of the shielding.

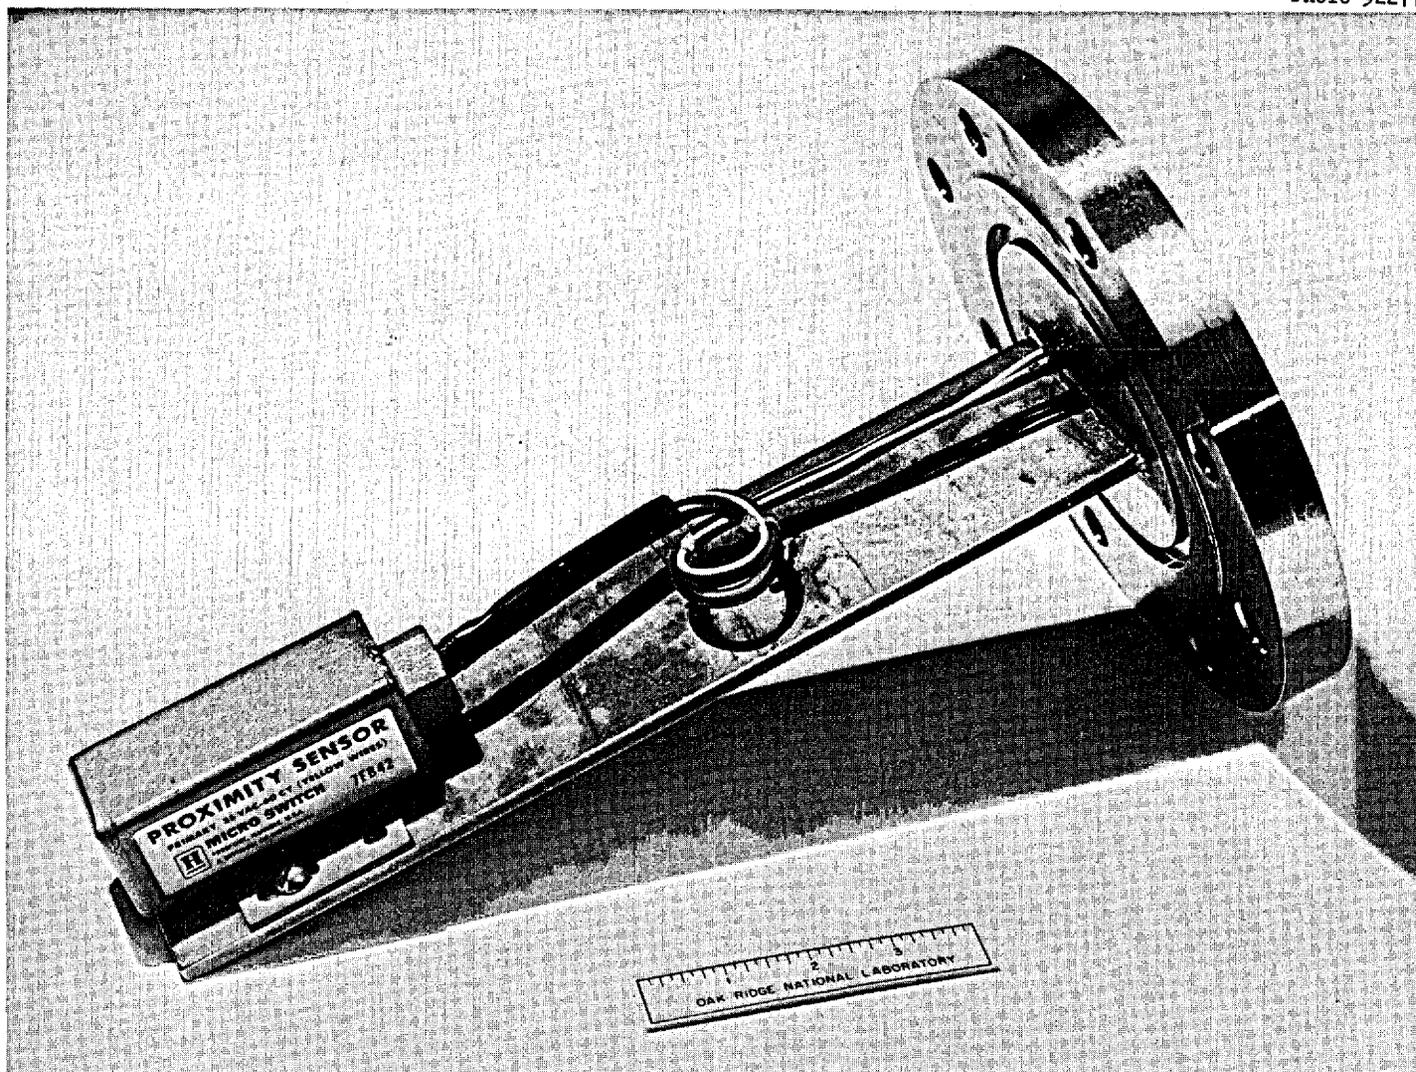
Fig. 8. Proximity Switch Assembly.

While the reactor was drained a proximity switch, shown in Fig. 8, was mounted on the transfer tube between the maintenance valve and the floor of the containment box. This unit could detect the movement of the magnetic latch past this point, thus indicating that the capsule and latch had indeed entered the transfer tube. This switch was obtained immediately after the fourth hangup occurred and was awaiting a reactor shutdown for installation when the fifth hangup occurred. Several malfunctions were detected by the switch and were corrected before difficulties occurred.

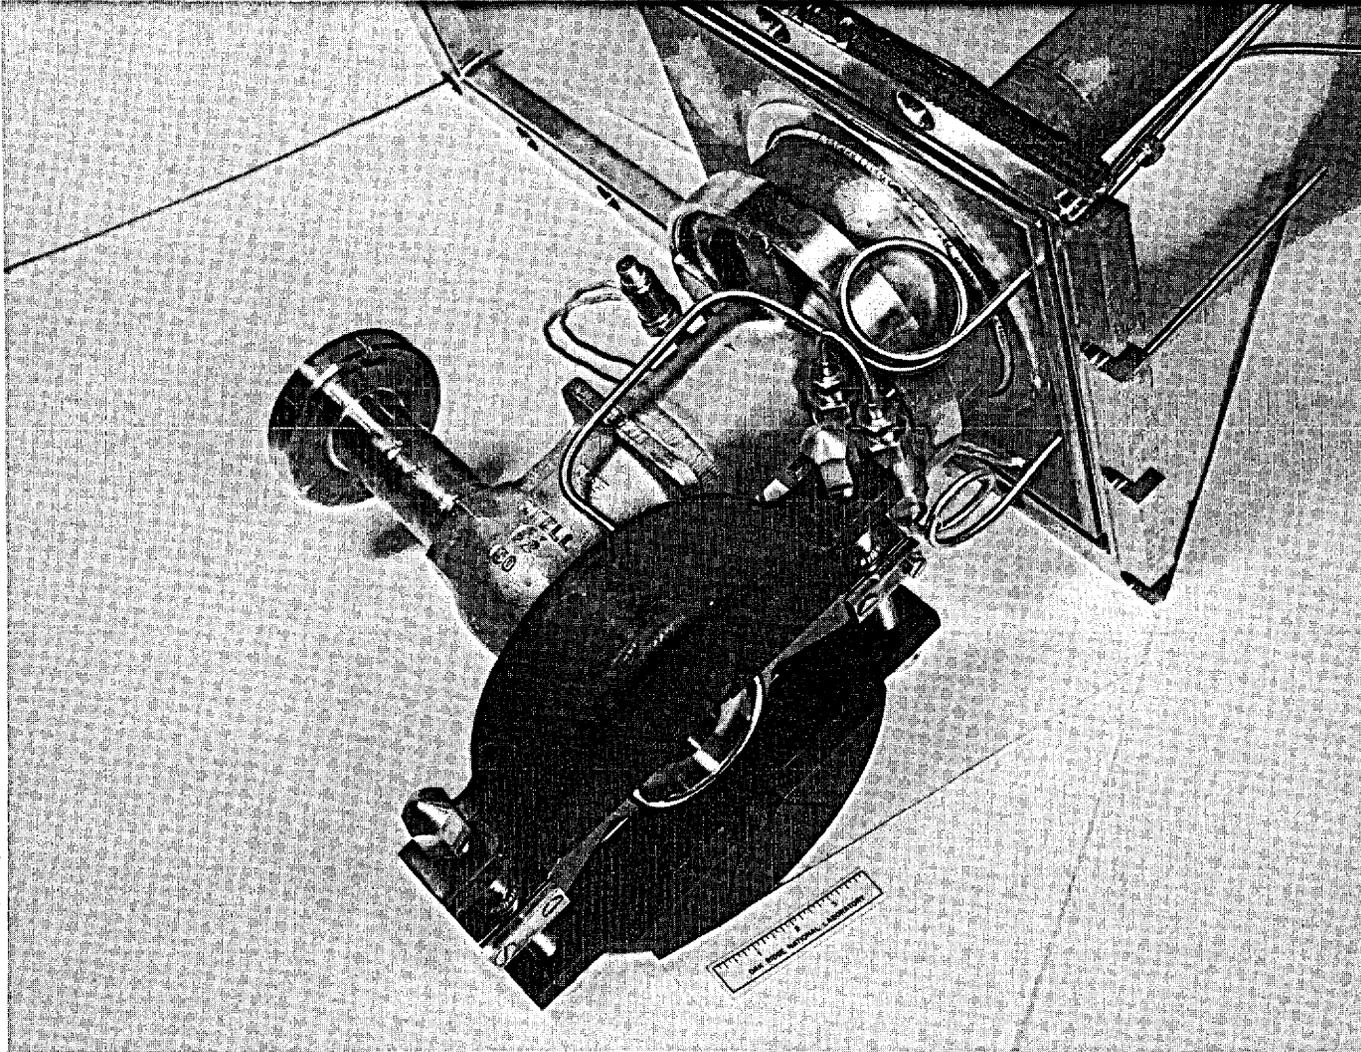
Fig. 11. Operational Valve Assembly.

Special ring-joint spring-clamp disconnects¹⁴ developed at ORNL for remote maintenance usage were chosen for the valves. Figure 11 shows the operational valve with the flanges and a pair of spring clamps. For this application each flange half was fabricated individually using a set of master gages as guides instead of the previously used method of machining two halves to match each other. The change was necessary to permit replacement of components. When the new IC assembly was installed, a new flange half was mated with a used one for the first time. A leaktight ($<10^{-4}$ cc He/sec) joint was obtained.
