ORNL-TM-4174

# POSTIRRADIATION EXAMINATION OF MATERIALS FROM THE MSRE

**POSTIRRADIATION EXAMINATION OF MATERIALS FROM THE MSRE**

**DECEMBER 1972**

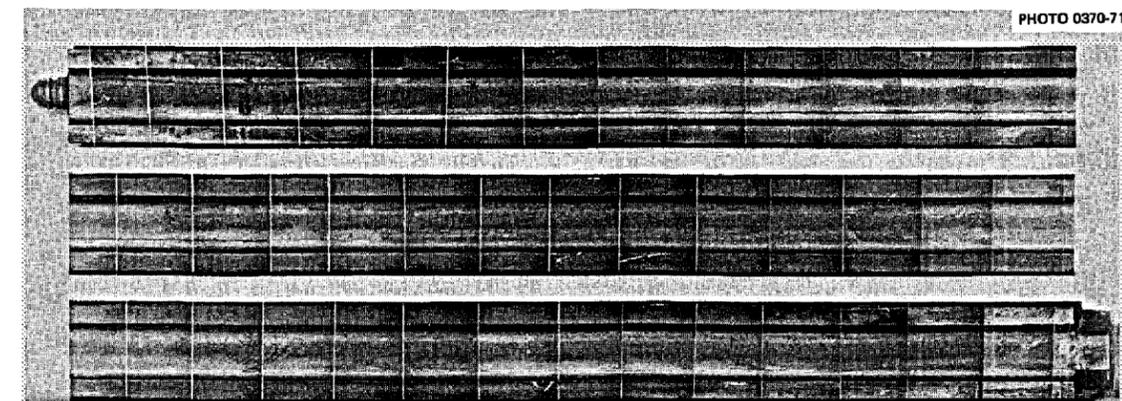
One of the five removable graphite core moderator elements (1184) was examined in the High-Radiation-Level Examination Laboratory (HRLEL) after completion of the operation of the MSRE. Visual examination revealed machining marks still plainly visible in the fuel channels and on surfaces not exposed directly to flowing fuel salt, indicating little if any change during operation. Figure 6 is a photograph of the fuel channel facing the center of the reactor, and it shows the excellent condition of the core block. The small thumbnail flaw in the fuel channel about 39 in. from the top is likely a small crack that was in the bar during fabrication, since tool marks are on the top of the flaw and skip over an area at the end of the flaw. The few scratches on the surface are not very deep and were likely caused by handling.

Fig. 6. One of the removable graphite moderator elements after operation in the MSRE, showing the fuel channel facing the center of the reactor. Machining marks are plainly visible in the fuel channel, showing excellent condition of the core block.

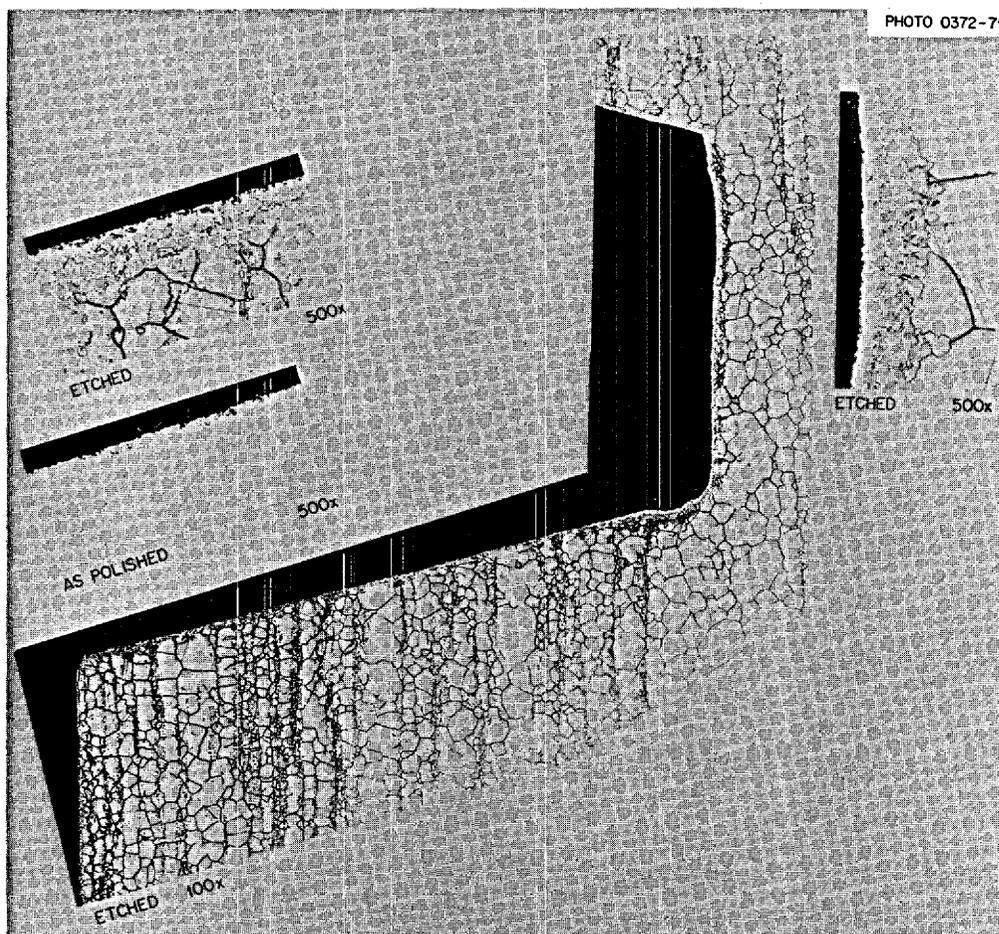
A cross section of the INOR-8 lifting stud in contact with the graphite is shown in Fig. 9. There appears to be little if any reaction with the graphite. There is a surface modified layer about 1 or 2 mils deep similar to that observed on surveillance samples and attributed to cold working of the surface and subsequent heat treatment during service. There appears to be very little difference in the side of the thread in contact with the graphite and the root of the thread, which probably was not in intimate contact.

Fig. 9. INOR-8 thread that was in contact with graphite for about three years at  $650^{\circ}\text{C}$ . The modified layer is likely due to working effects from machining the thread. Reduced 35%.

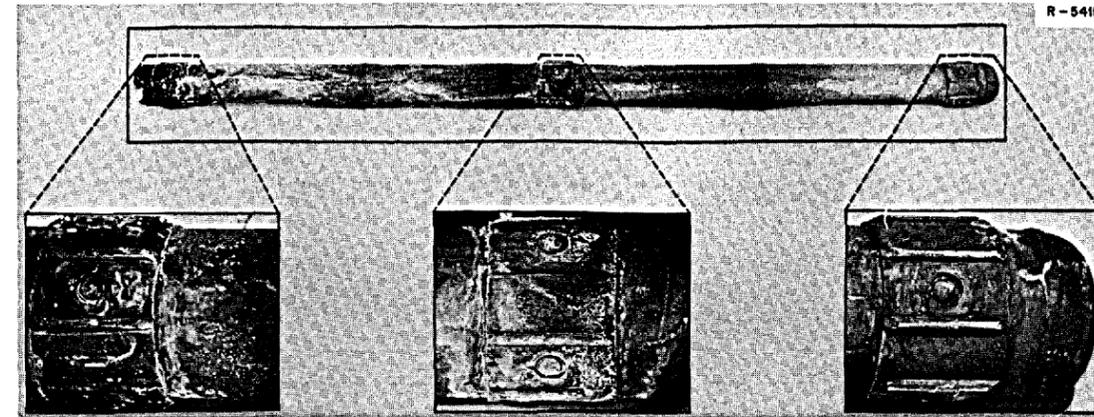
The exterior of the thimble was exposed to fuel salt and the interior to the cell environment of  $\text{N}_2 + \text{O}_2$ . The tubing was above 500°C for 30,807 hr and received a peak thermal fluence of  $1.9 \times 10^{21}$  neutrons/cm<sup>2</sup>. The lower portion of the control rod thimble was severed by electric arc cutting and moved to the hot cells for examination. Figure 12 shows the electric arc cut at the left (about at the midplane of the core), the spacer sleeves, and the end closure (located at the bottom of the core). The fuel salt appears to have wet the INOR-8 near the center of the core, where the temperature and flux were highest (as shown around the left and center spacer sleeves), but not at the bottom (as shown on the right sleeve). Some of

Fig. 12. Portion of control rod thimble examined after operation of MSRE was terminated. The thimble is made of 2-in.-OD  $\times$  0.065-in.-wall INOR-8 tubing (heat Y-8487). The electric arc cut on the left was near the center line of the core.

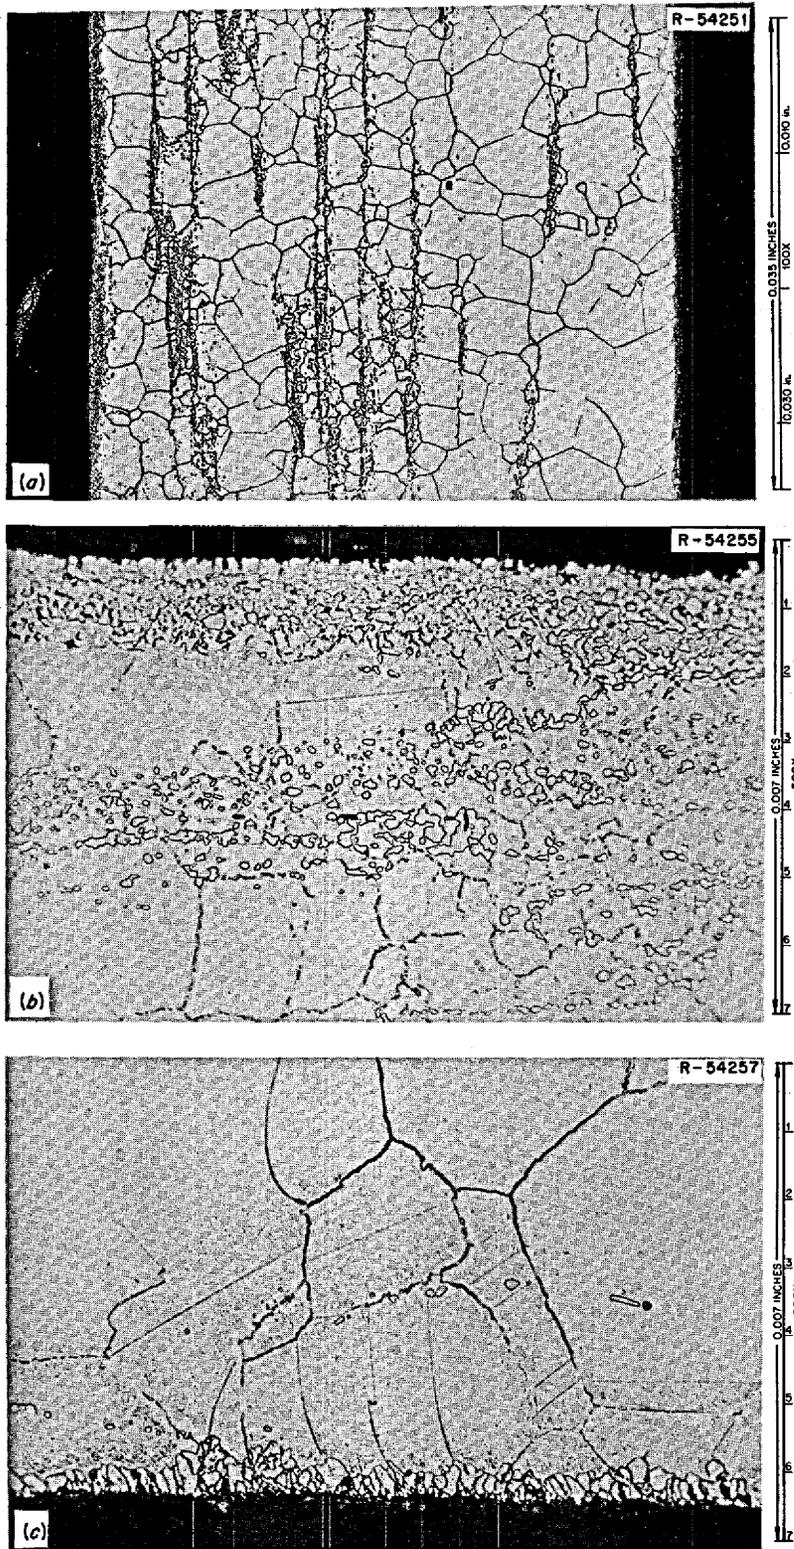
Photomicrographs involving the interface between the thimble and sleeve are shown in Fig. 15. Figure 15(a) shows the annular region with a separation of about 7 mils and some salt present. Few surface irregularities are visible at a magnification of 100x, indicating that they are considerably below 1 mil. Figure 15(b) is a 500x view of the thimble and shows some surface cracks to a depth of 0.3 mil. The outside of the sleeve is shown in Fig. 15(c); a few grain boundaries to a depth of about 1 mil are visible. Additional photomicrographs of the sleeve are shown in Fig. 16. The sleeve material does not appear to have received much work, since the carbide is very inhomogeneously distributed. Grain size is larger than usual away from the stringers. The inner and outer surfaces both have modified structures. A higher magnification view of the inner surface [Fig. 16(b)] shows that much of the modification is a high density of primary carbide. The outer surface [Fig. 16(c)] has a shallow layer of small grains, likely due to a working operation.

Fig. 16. INOR-8 control rod sleeve. Etched with aqua regia. (a) General microstructure; inner surface is on left and outer surface is on right. (b) Inner surface of sleeve. (c) Outer surface of sleeve. Reduced 30.5%.

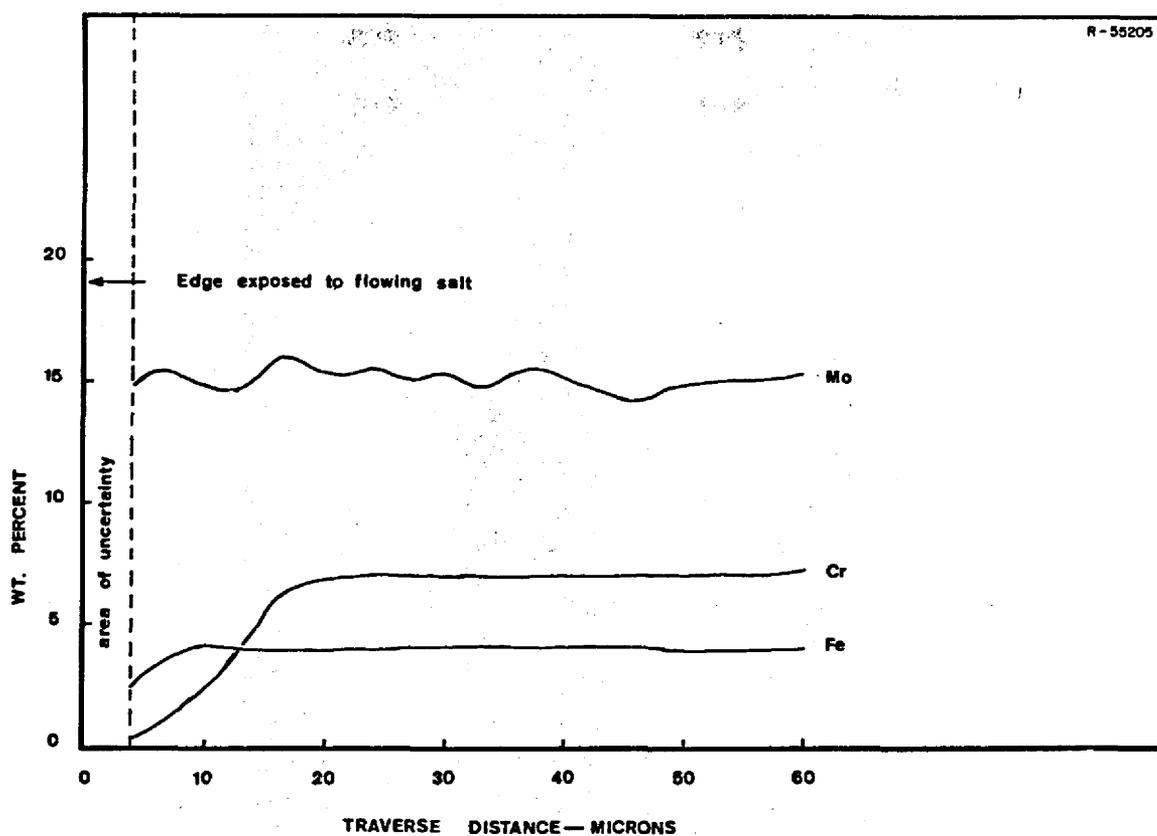
Microprobe scans were run on the thimble samples that were taken from under the sleeve and outside the sleeve. In the first case the thimble wall was exposed to almost static fuel salt, and no gradients in iron and chromium concentration could be detected within the 3- $\mu\text{m}$  region of uncertainty near the surface. The sample outside the sleeve, which was exposed to flowing fuel salt, was depleted in chromium to a depth of almost 20  $\mu\text{m}$  and in iron to a depth of 10  $\mu\text{m}$  (Fig. 18). Thus the amount of corrosion that occurred varied considerably in the two regions. Measurements were not actually made, but we would expect similar results for the spacer sleeve. The inside surface was exposed to almost static salt and was likely not corroded detectably. The outside surface was exposed to flowing salt and probably was depleted in iron and chromium.

Fig. 18. Electron microprobe scan of INOR-8 sample from control rod thimble. Thimble had been exposed to fuel salt for 21,040 hr and had been above 500°C for 30,807 hr.

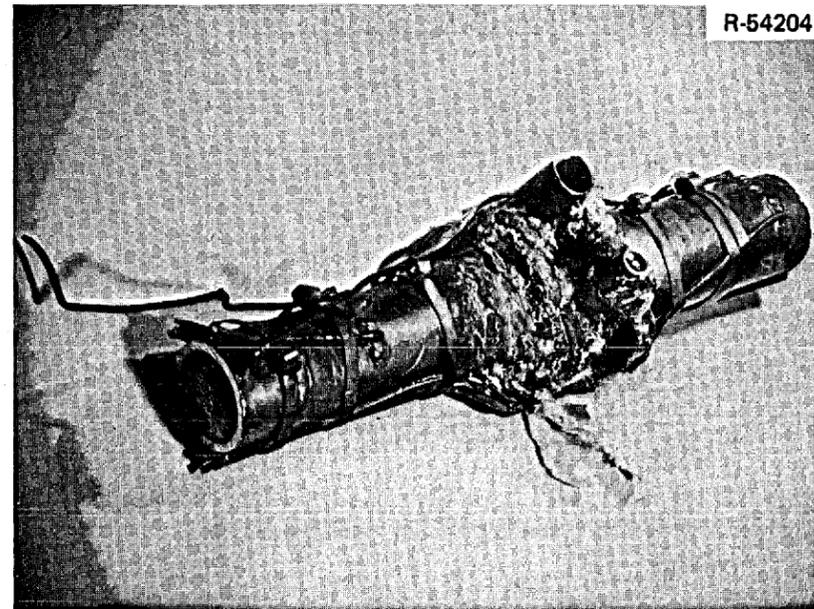
Fig. 30. Bottom portion of freeze valve 105.

Parts of three tubes are visible in Figs. 30 and 31. The large tube in relatively good condition is the type 304 stainless steel air inlet tube, the center tube is the original INOR-8 air outlet tube with two thermocouples visible, and the hole is the remains of the type 304 stainless steel outlet tube. The original INOR-8 air inlet line was capped off and is hidden by the salt. Attack of the type 304 stainless steel by salt when air was present is as expected. The relative nobility of INOR-8 in this environment is a strong argument for the use of INOR-8 where salt may be present.

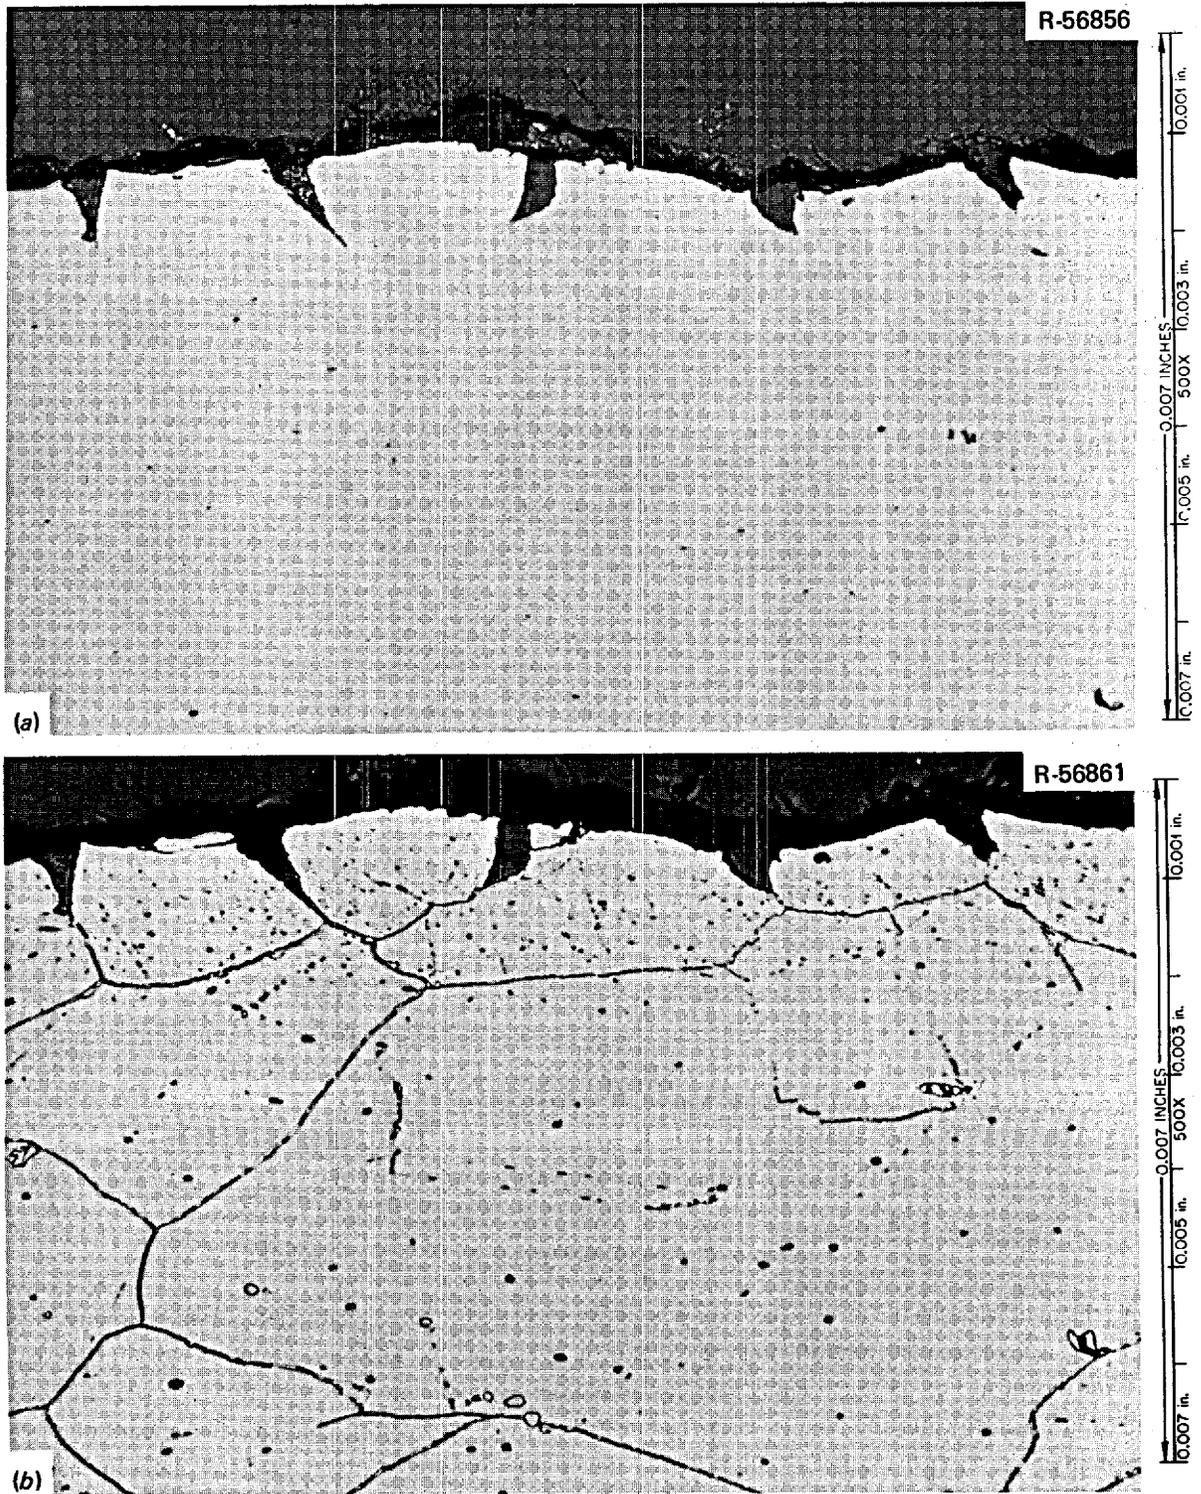
One of the three tensile-tested rings was examined metallographically. Figure 36 is a composite of photomicrographs of a section through the specimen showing the inside surface, which was exposed to fuel salt (top), and the outside, which was exposed to the cell environment of 2 to 5% O<sub>2</sub> in nitrogen. The reason for the unevenness of the oxide on the outside is not known. Possibly it was due to corrosion after the leak, although the rings were cut approximately 4 in. away from the nearest visible residue from the salt leak. Figure 37 shows at 500x the oxide in one of the worst areas. The crack ends tend to be blunted and did not penetrate the metal beyond the oxidized surface. Figure 38 shows at 500x the inside of the pipe exposed to fuel salt. About 1 crack per grain or 240 cracks per inch show, but the cracks are shallow and blunt, having an average depth of 0.75 mil and a maximum depth of 1.5 mils. Figure 39 shows that a large amount of strain occurred before fracture.

Fig. 38. Salt side of an INOR-8 tensile specimen from freeze valve 105. (a) As polished; (b) etched with lactic acid,  $\text{HNO}_3$ ,  $\text{HCl}$ .

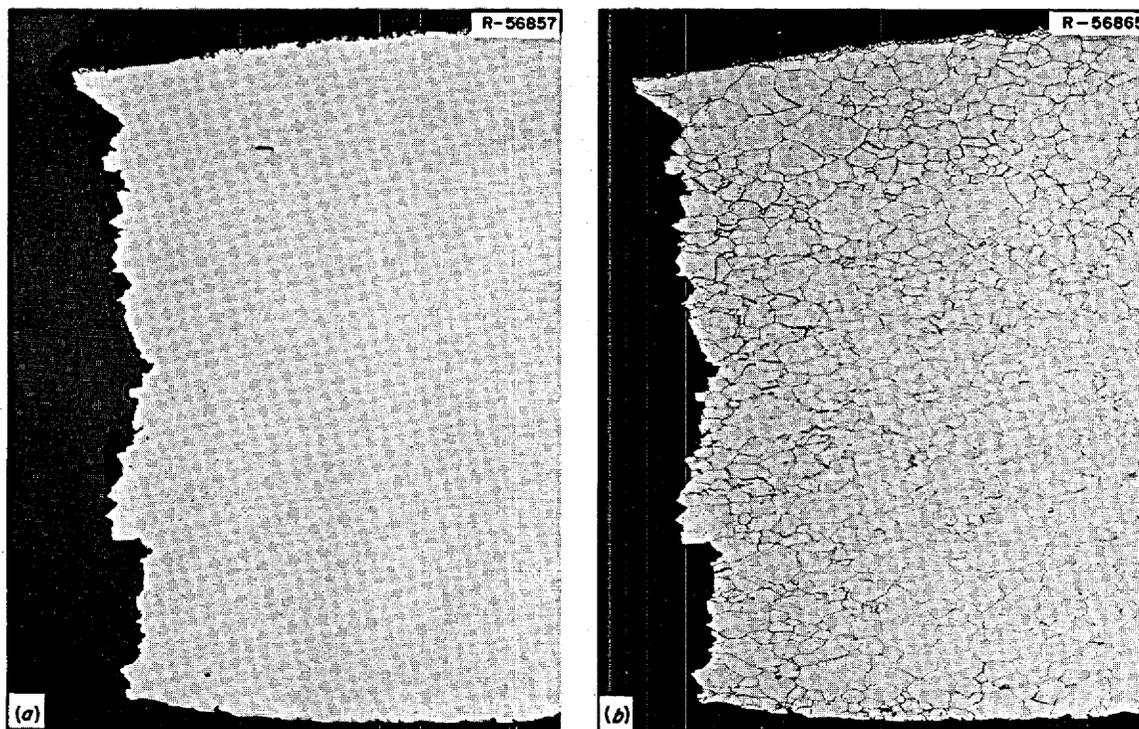
Fig. 39. Fracture of an INOR-8 ring specimen from freeze valve 105 that was deformed at 25°C. (a) As polished; (b) etched with lactic acid, HNO<sub>3</sub>, HCl. 40X. Reduced 29.5%.

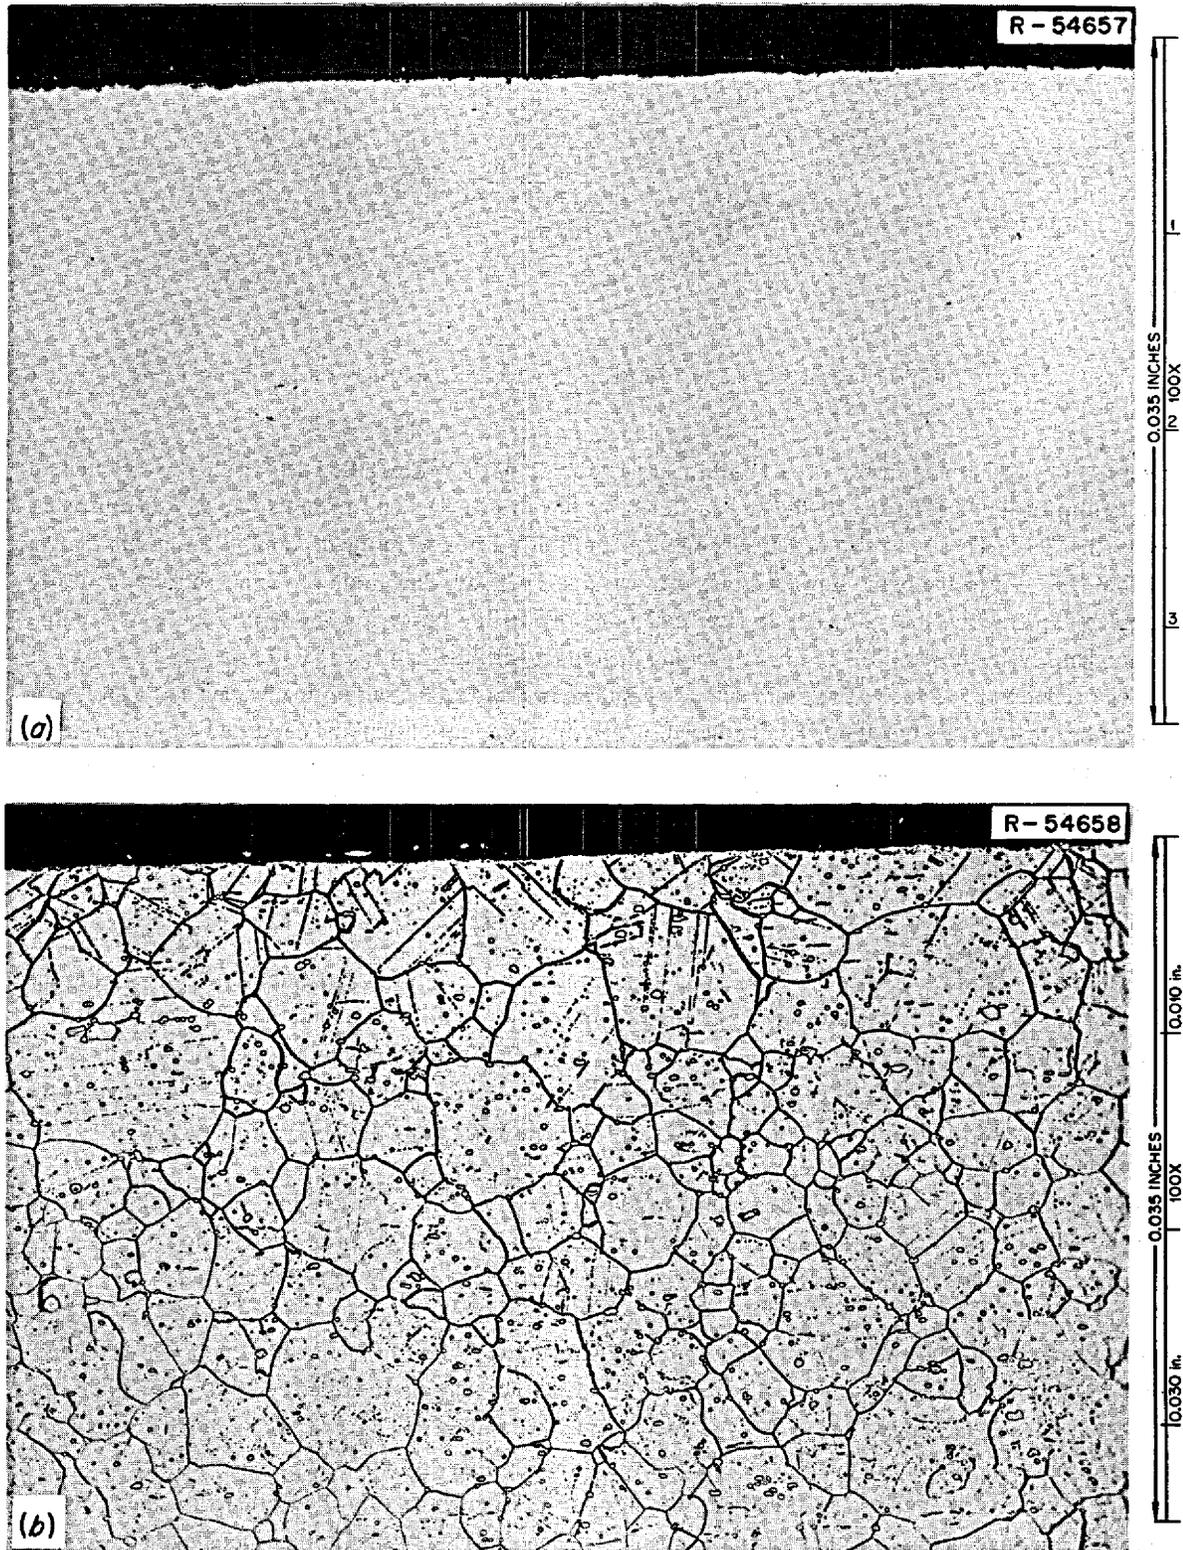
One of the sampler cage rods was examined metallographically. Photomicrographs of samples from the vapor and liquid regions are shown in Figs. 43 and 44 respectively. No intergranular penetration is visible at this magnification. A heavy surface deposit was on the sample from the liquid region. This deposit was examined by the electron microprobe analyzer. It contained some salt but had regions that were high in the elements of INOR-8: Ni, Cr, Fe, and Mo. This is illustrated by the x-ray displays in Figs. 45 and 46, which also show that the deposits were very inhomogeneous.

Fig. 43. INOR-8 rod from sampler assembly located above normal salt level. (a) As polished; (b) etched with aqua regia.

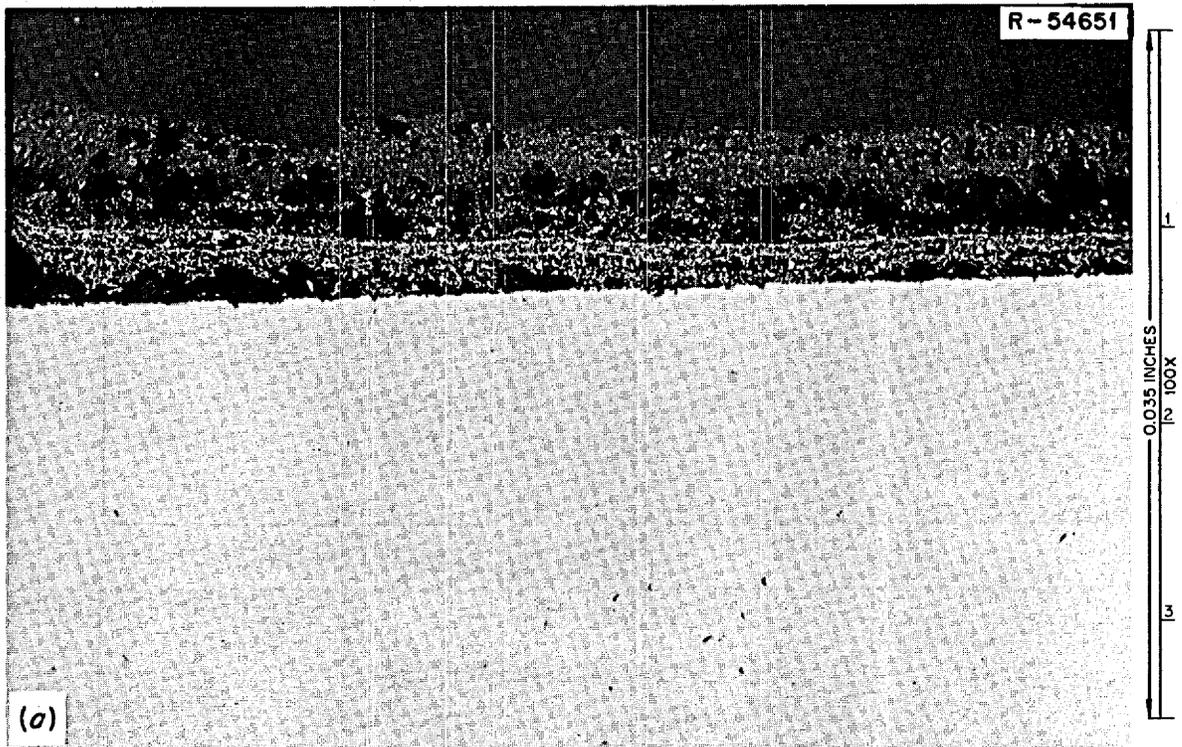
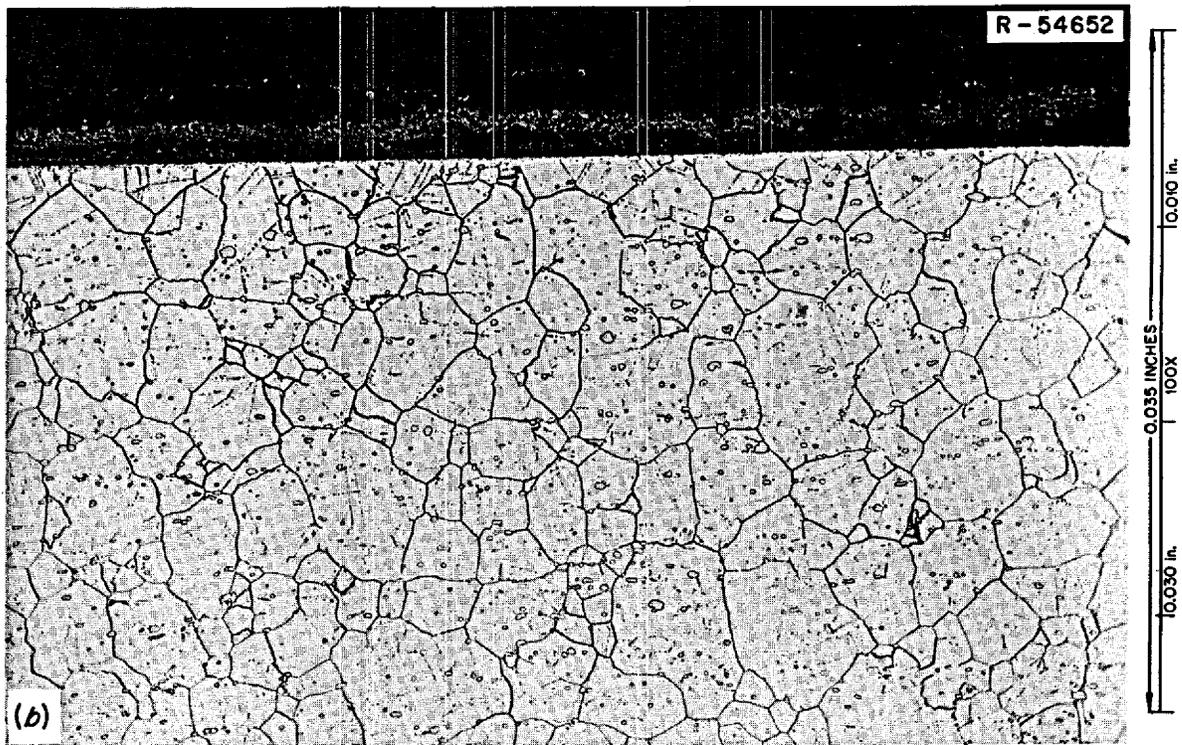
Fig. 44. INOR-8 rod from the sampler assembly. Normally located below the salt level. (a) As polished; (b) etched with aqua regia.

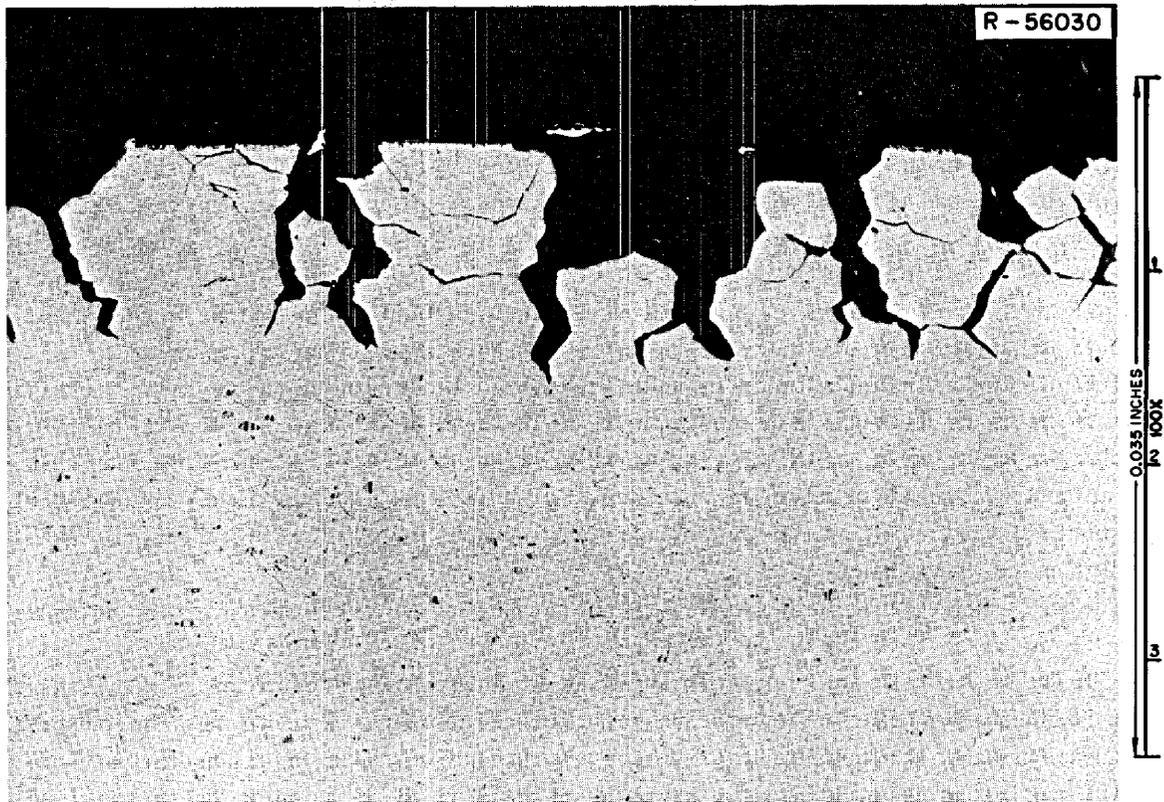
Fig. 49. Deformed INOR-8 sampler cage rod near the fracture. As polished.

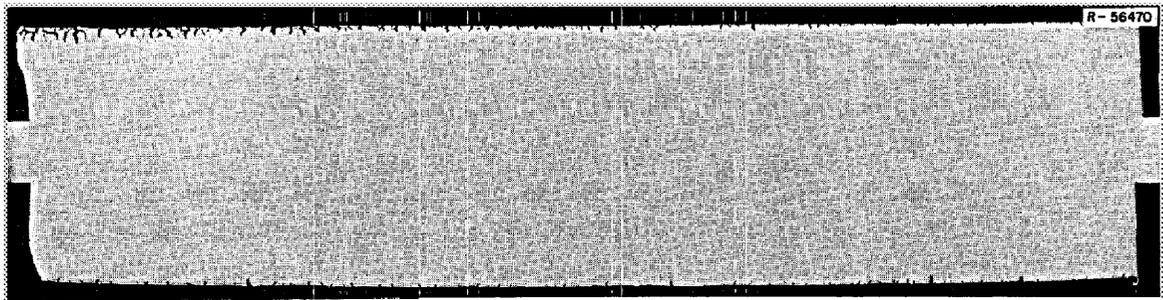
Fig. 50. Composite of photomicrographs of INOR-8 sampler cage rod strained at 25°C. 8.2X. Left end of sample was  $\frac{3}{4}$  in. from fracture. The rod progressed further into the vapor region from left to right. Sample length is 0.72 in.

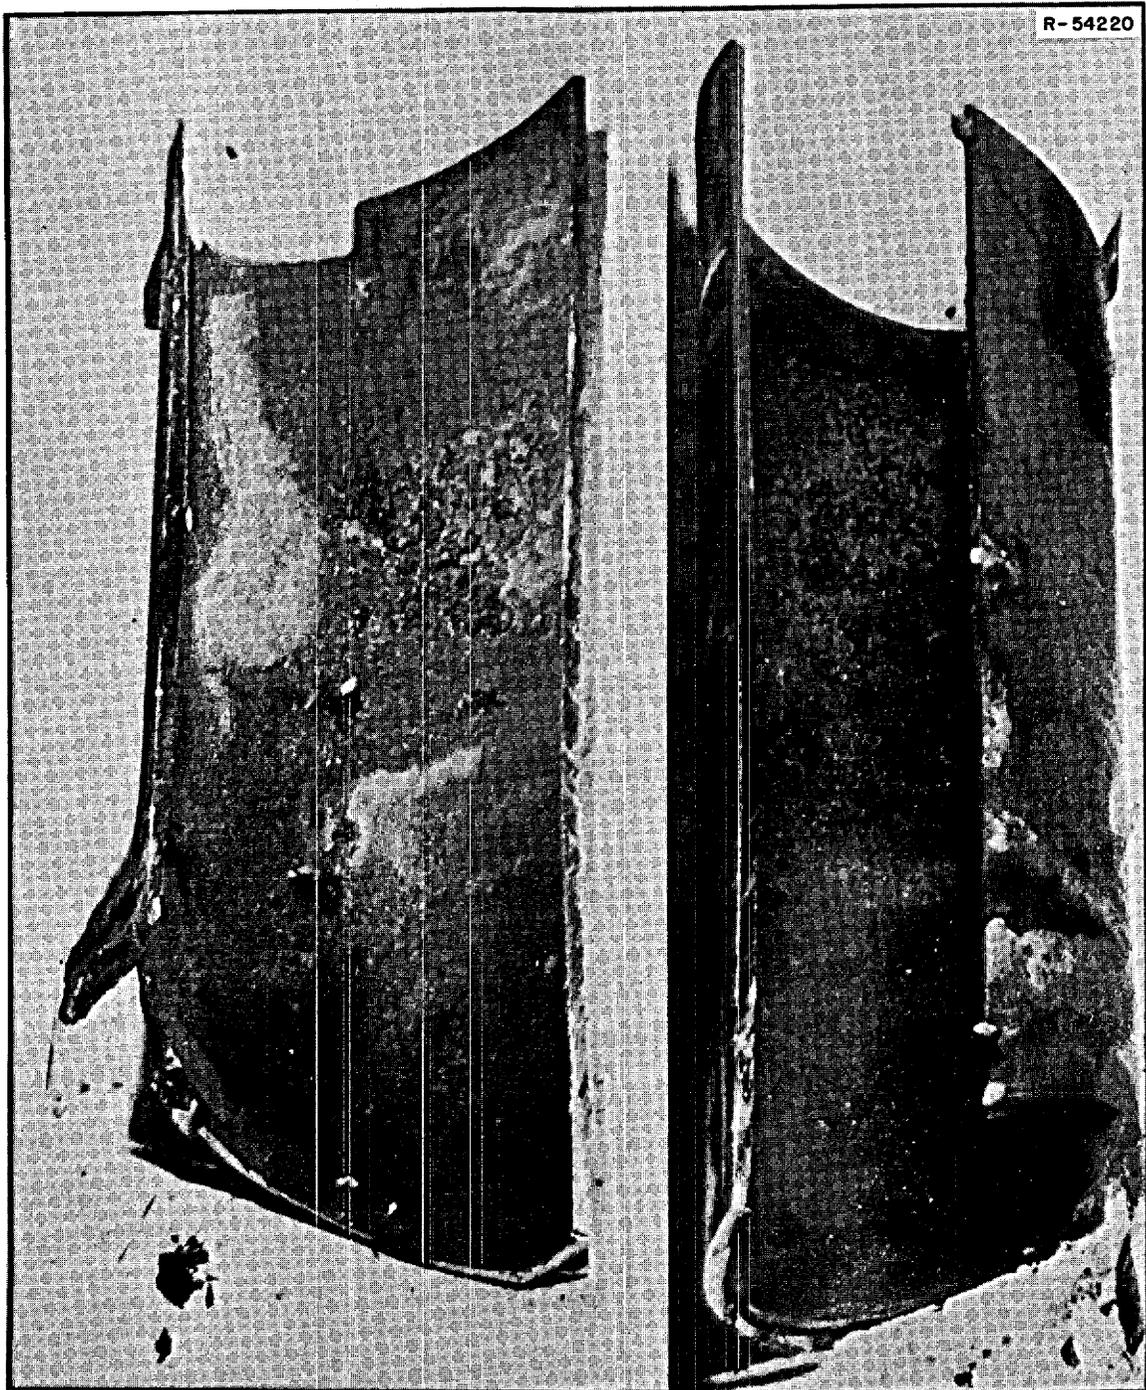
Figure 51 shows the mist shield after removal from the MSRE. The shield has been split to reveal the inside surface. Four specimens approximately 1 in. (vertical)  $\times$   $\frac{1}{2}$  in. (circumferential) were cut from the mist shield. Their locations were (1) outside the spiral and immersed in salt, (2) outside the spiral and exposed to salt spray, (3) inside the spiral and immersed in salt, and (4) inside the spiral and exposed primarily to gas. Bend tests were performed on these specimens at 25°C using a three-point bend fixture.<sup>30</sup> They were bent about a line parallel to the  $\frac{1}{2}$ -in. dimension so that the outer surface was in tension. The information obtained from such a test is a load deflection curve. The equations normally used to convert this to a stress-strain curve do not take into account the plastic deformation of the part, and the stresses obtained by this method become progressively in error (too high) as the deformation progresses.

Fig. 51. Interior of INOR-8 mist shield. Right part of right segment overlapped left part of segment on left.

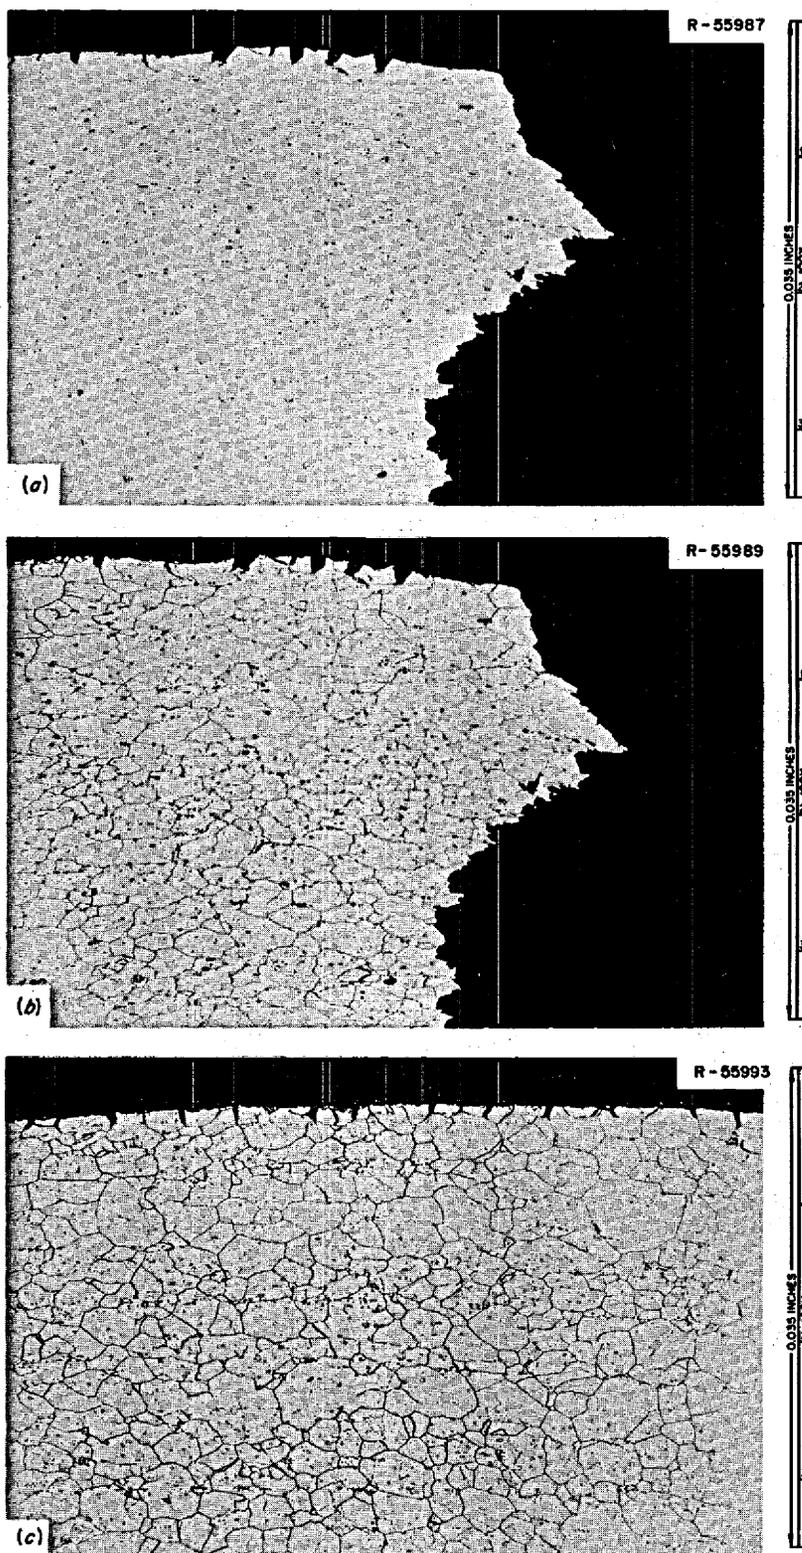
The bend samples of the mist shield were examined metallographically. Photomicrographs of the sample from the inside vapor region are shown in Fig. 52, and a composite of several photomicrographs is shown in Fig. 53. The edge cracks were intergranular and about 1 mil deep. The photomicrographs of the sample from the liquid region (Fig. 54) show that the cracks extended to a depth of about 8 mils. The composite photograph in Fig. 55 also shows the increased frequency and depth of cracking in the liquid region.

Fig. 52. Bend specimen of INOR-8 mist shield from inside vapor region. (a) Fracture and tension side, as polished. (b) Fracture and tension side, etched. (c) Tension side, etched. Etchant: aqua regia. Reduced 31%.

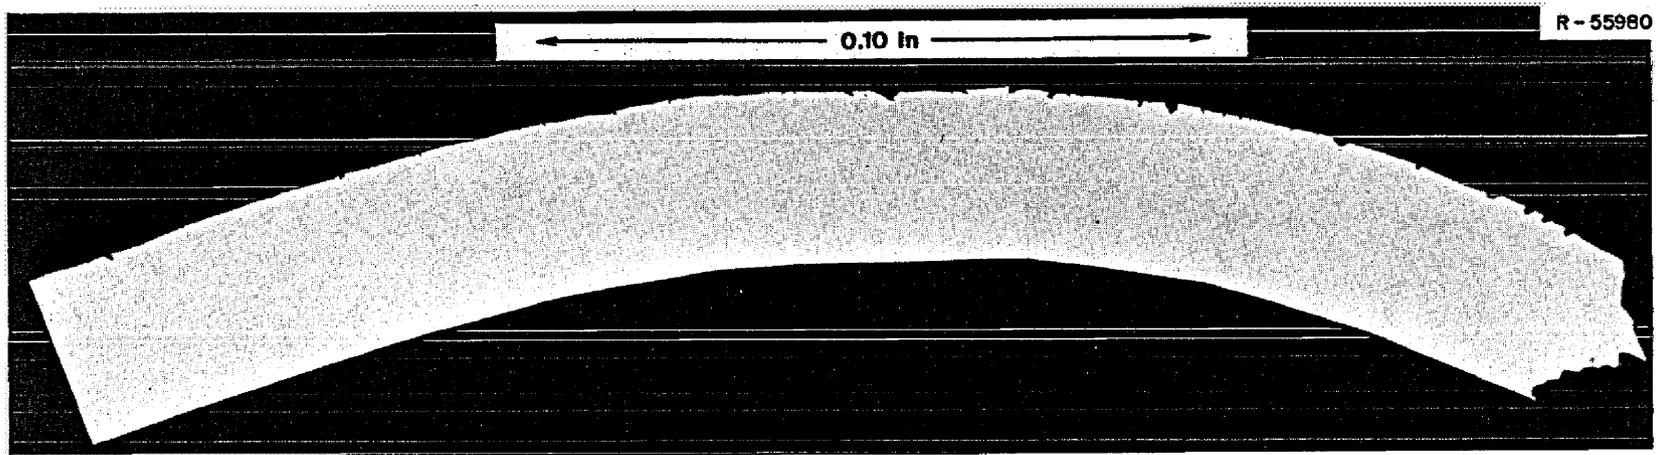
Fig. 53. Composite photograph of tension side of bend sample from inside vapor region of INOR-8 metal shield. Lower edge is not the compression side of the sample.

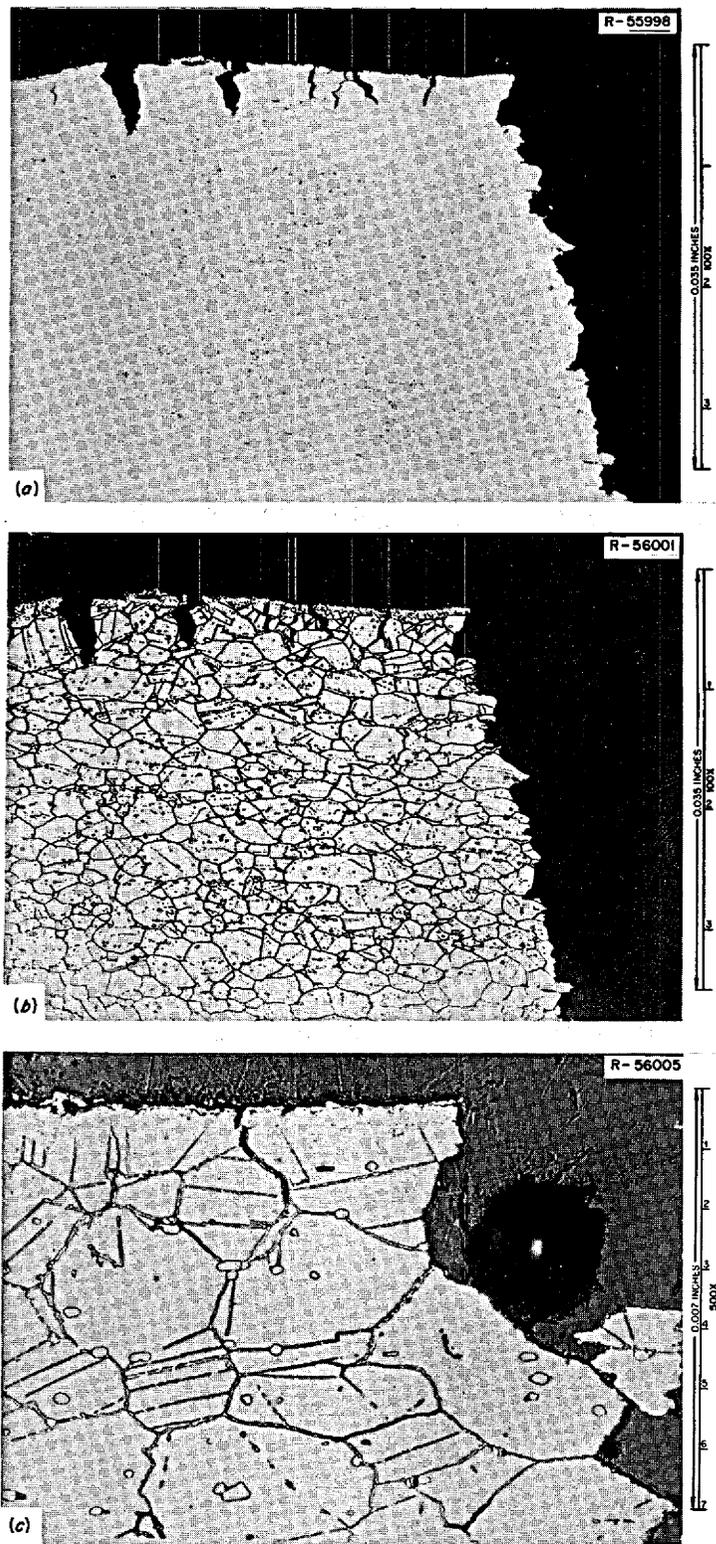
Fig. 54. Bend specimen of INOR-8 mist shield from inside liquid region. Fracture and tension side (a) as polished, (b) and (c) etched with aqua regia.

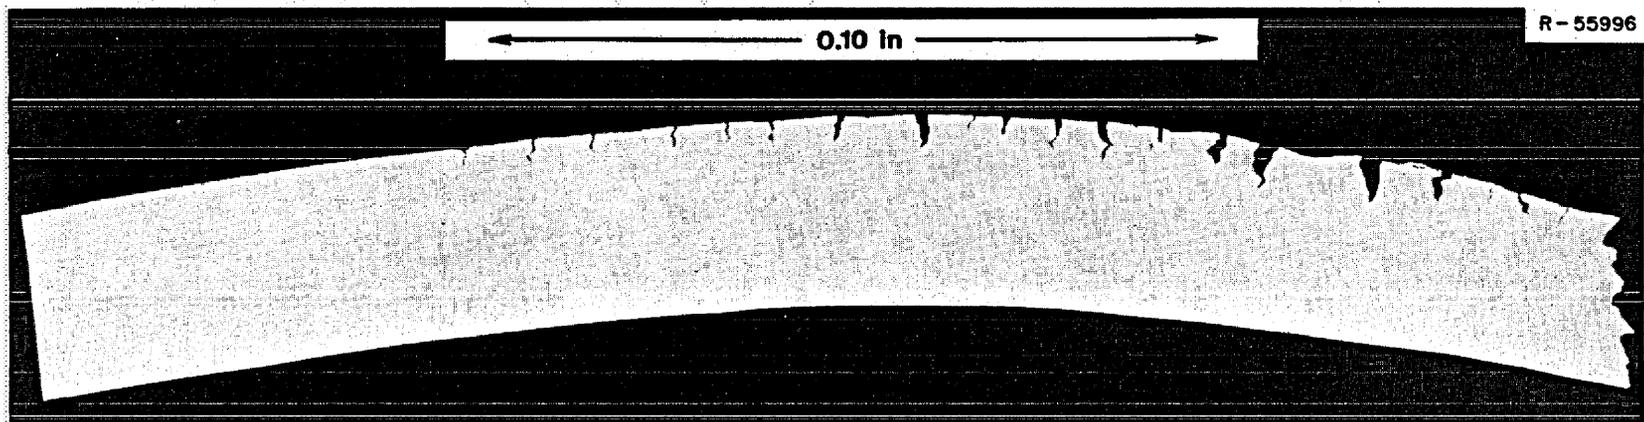
Fig. 55. Composite photograph of tension side of bend sample from inside liquid region of INOR-8 mist shield. Lower edge is not the compression side of sample.

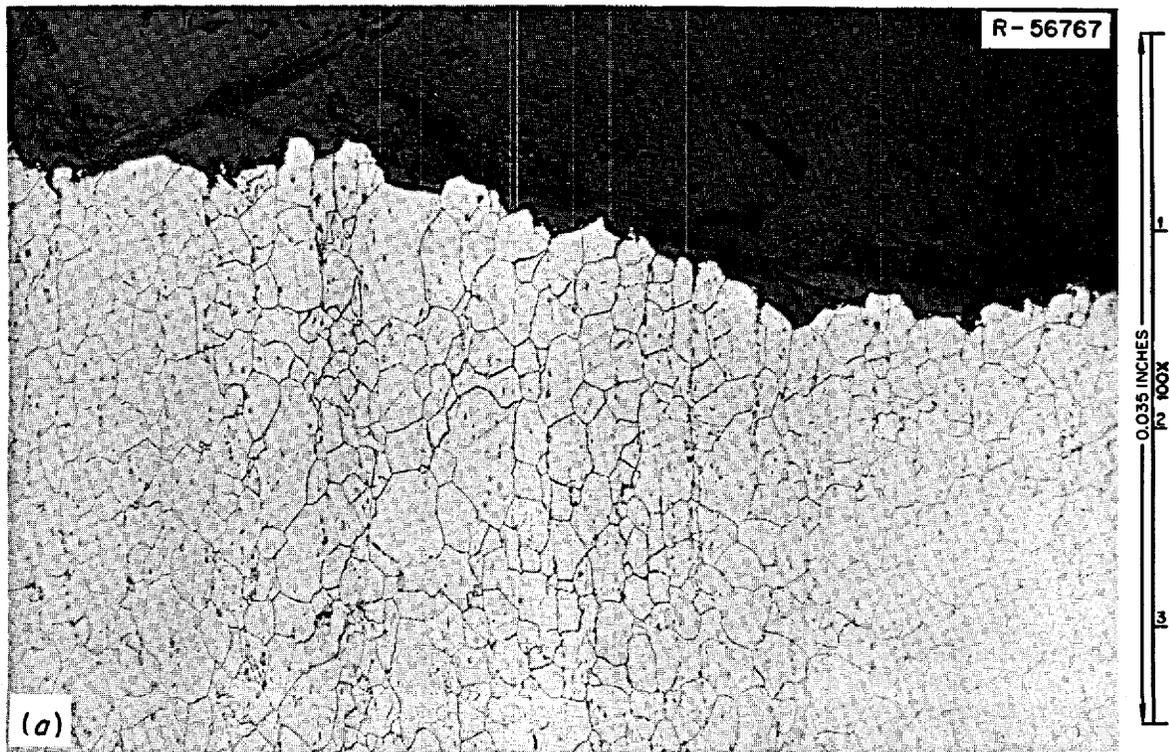
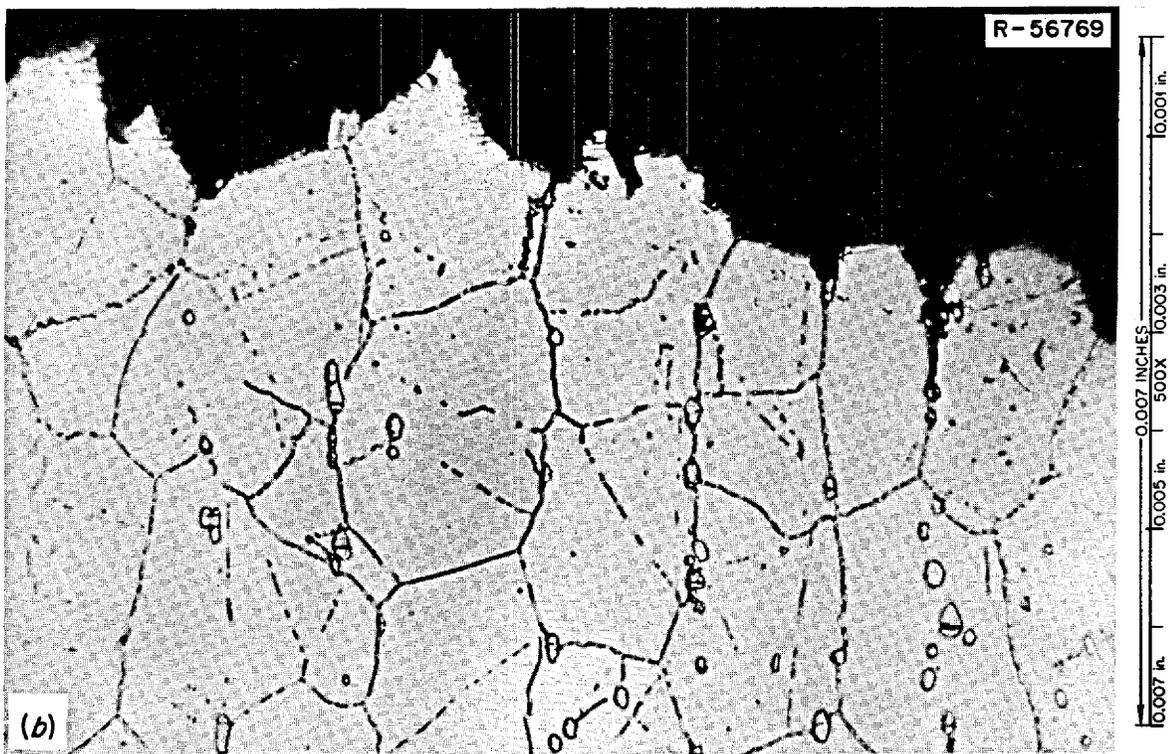
The sample from the outside liquid region was quite similar metallographically to that from the inside liquid region. Photomicrographs of the fracture and a typical region of the tension side near the fracture are shown in Figs. 56 and 57 respectively. A composite of several photomicrographs is shown in Fig. 58.

Fig. 56. Fracture of bend specimen from outside liquid region of INOR-8 mist shield. (a) 100X; (b) 500X. Etchant: lactic acid,  $\text{HNO}_3$ ,  $\text{HCl}$ .
