ORNL-TM-4174

# POSTIRRADIATION EXAMINATION OF MATERIALS FROM THE MSRE

**POSTIRRADIATION EXAMINATION OF MATERIALS FROM THE MSRE**

**DECEMBER 1972**

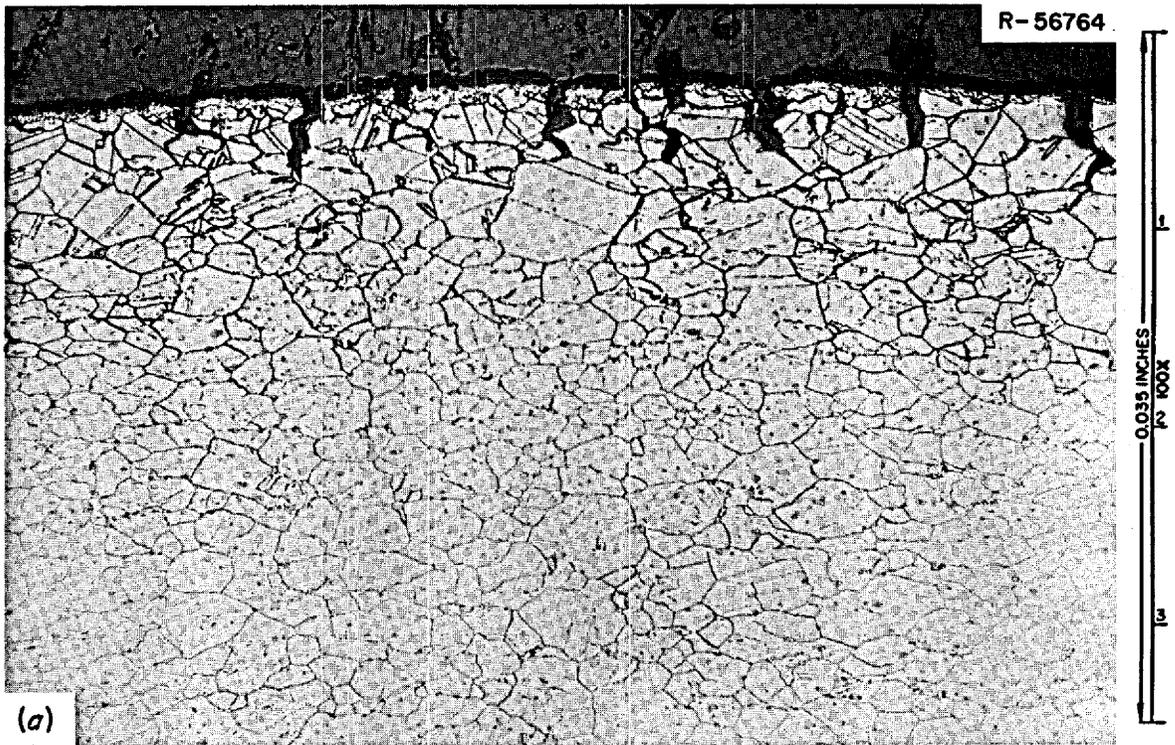
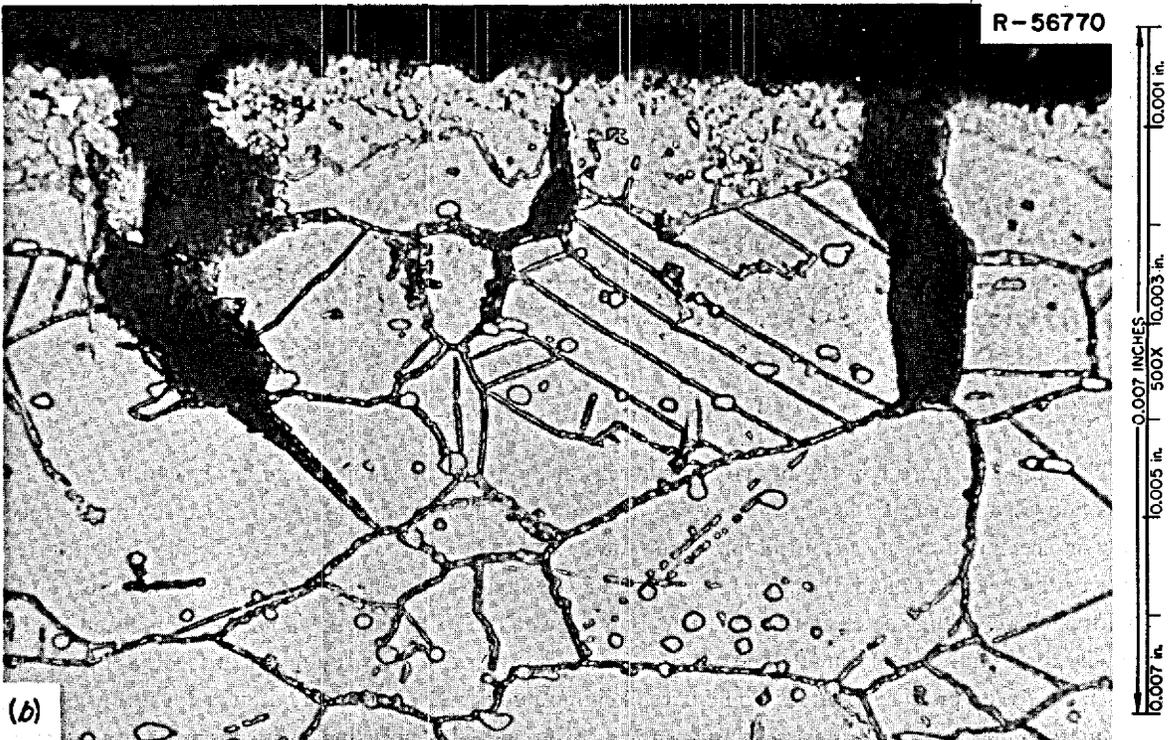
The sample from the outside liquid region was quite similar metallographically to that from the inside liquid region. Photomicrographs of the fracture and a typical region of the tension side near the fracture are shown in Figs. 56 and 57 respectively. A composite of several photomicrographs is shown in Fig. 58.

Fig. 57. Tension side near fracture of bend specimen from outside liquid region of INOR-8 mist shield. (a) 100X; (b) 500X. Etchant: lactic acid,  $\text{HNO}_3$ ,  $\text{HCl}$ .

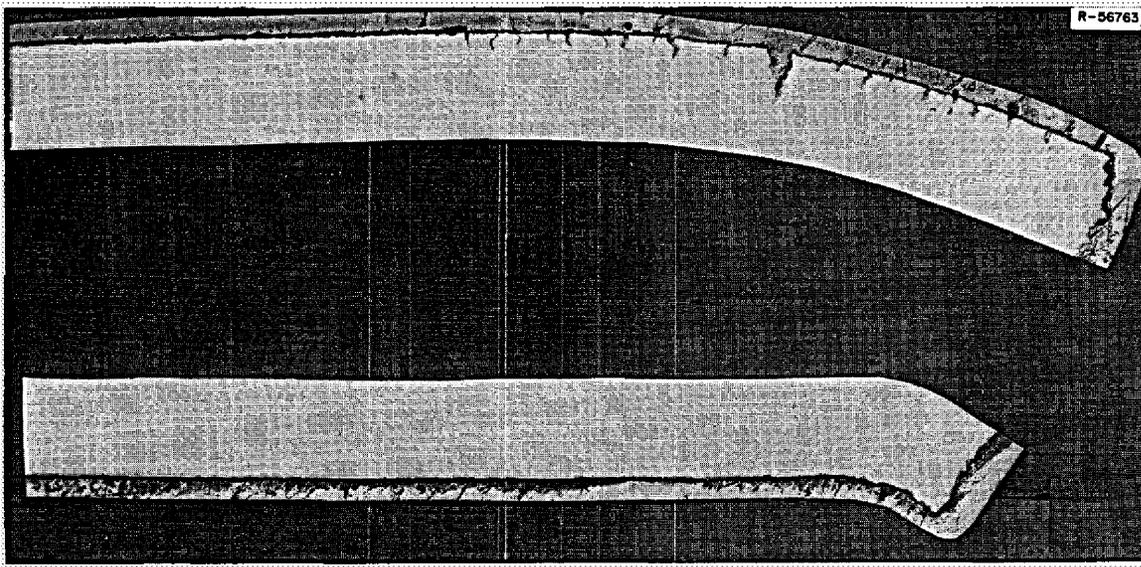
Fig. 58. Composite of several photomicrographs of bend specimen from outside liquid region of INOR-8 mist shield. Top portion shows the tension side, and the lower portion shows the compression side. 24X. Reduced 44%.

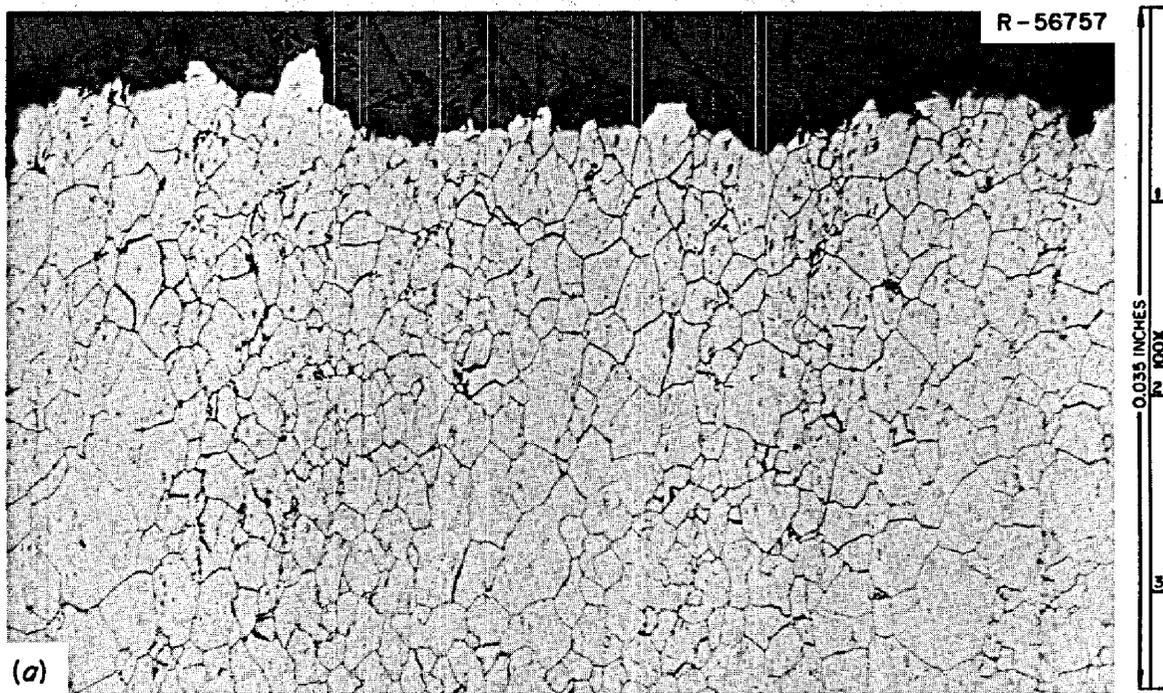
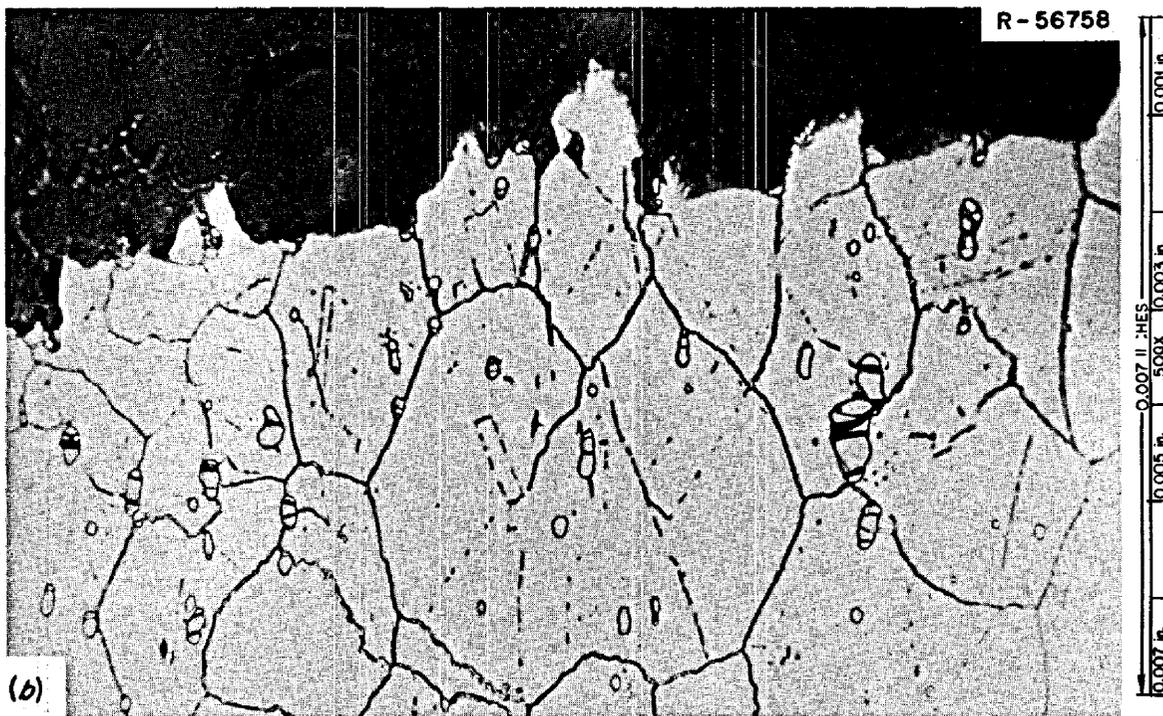
Photomicrographs of the outside vapor (salt spray) bend specimen at the fracture and on the tension side near the fracture are shown in Figs. 59 and 60 respectively. The composite of several photomicrographs in Fig. 61 shows that the cracks are not much deeper nor more frequent than in the liquid regions (compare Figs. 55, 58, and 61), but the tendency for grains to fall out is much greater. This is even more significant when one notes that the strain was the least in the sample from the outside vapor region (Table 7).

Fig. 59. Fracture of a bend specimen from outside vapor portion of INOR-8 mist shield. (a) 100X; (b) 500X. Etchant: lactic acid,  $\text{HNO}_3$ ,  $\text{HCl}$ .

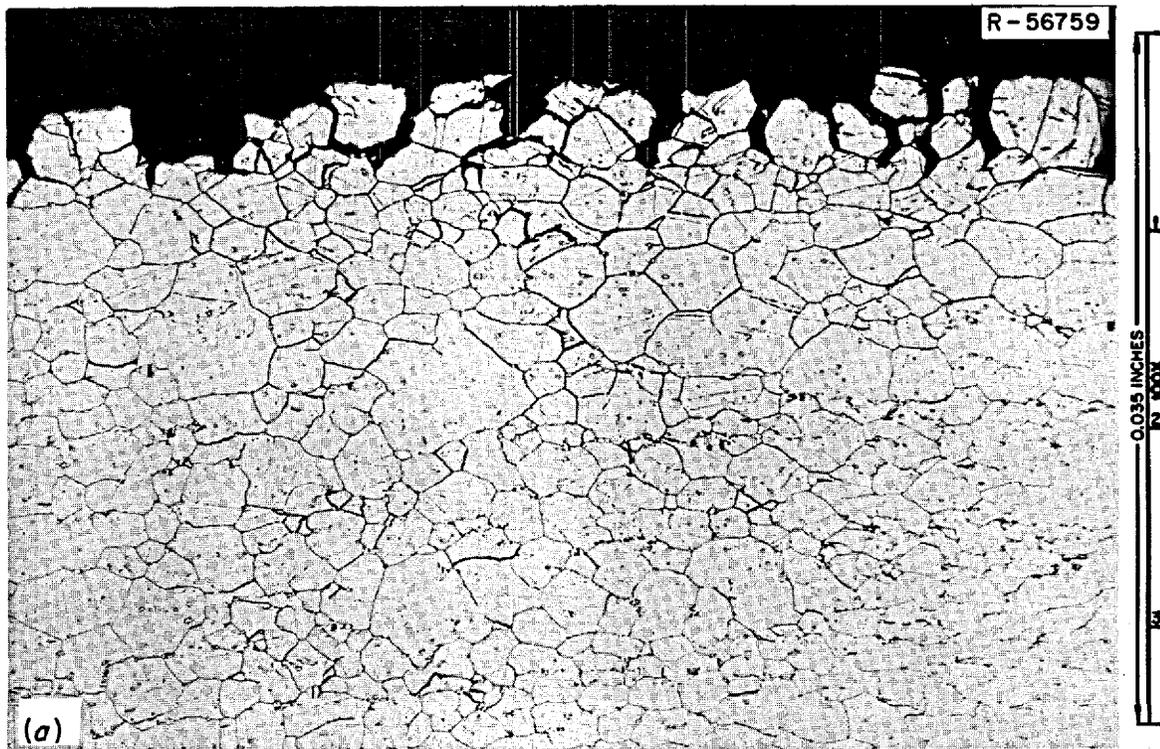
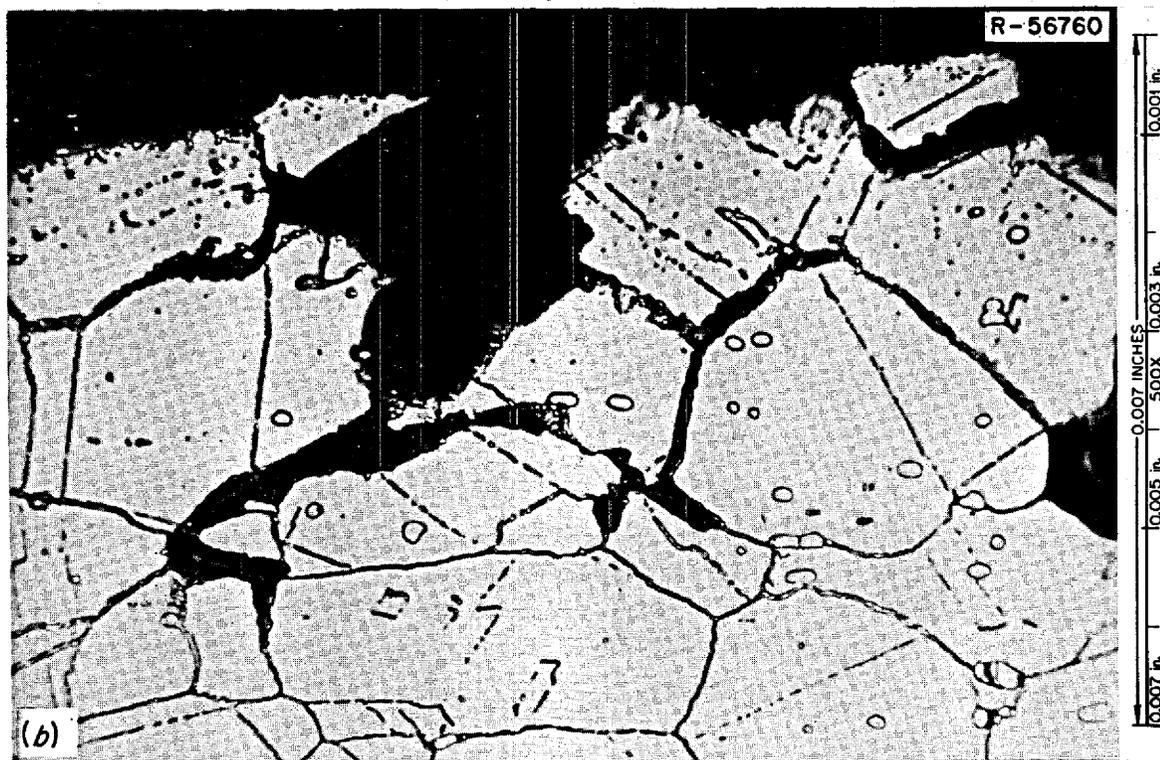
Fig. 60. Edge near fracture of bend specimen from outside vapor portion of INOR-8 mist shield. (a) 100x; (b) 500x. Etchant: lactic acid,  $\text{HNO}_3$ ,  $\text{HCl}$ .

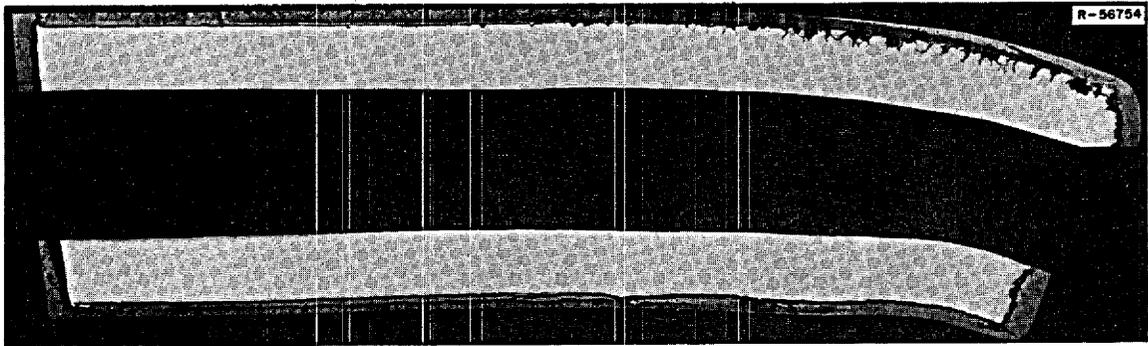
The reduced ductility of these samples remains unexplained. The maximum crack depth in the liquid region was only 8 mils, and it is quite unlikely that an 8-mil reduction in a sample thickness of 125 mils would cause much embrittlement. The embrittlement may have been partially due to the extensive carbide precipitation shown in Figs. 53, 55, 56, 58, and 59. However, the outside and inside of the shield received identical thermal treatments, but the samples from the outside had lower ductilities. Thus, attributing the embrittlement solely to carbide formation does not seem appropriate.

Fig. 61. Composite of several photomicrographs of bend specimen from outside vapor region of INOR-8 mist shield. Top portion is tension side, and lower part is compression side. 15X. Reduced 44%.

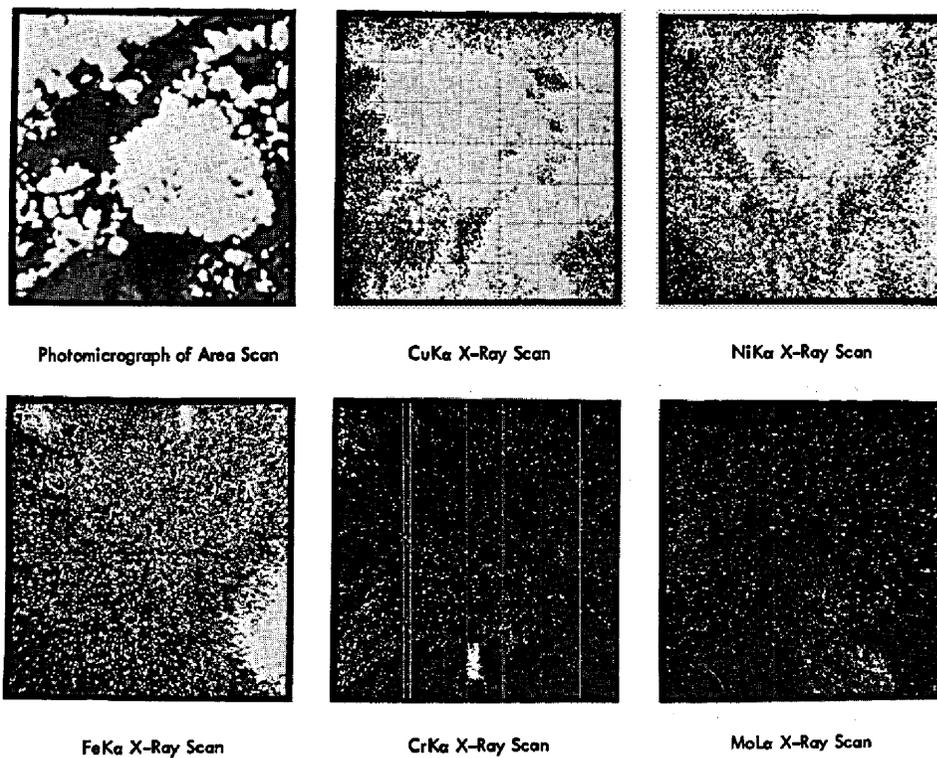
Fig. 66. Views of the surface of the copper sampler in the electron-probe microanalyzer. The upper left picture is an optical photomicrograph showing deposited metal crystals. The other pictures show the intensity of x-ray fluorescence for various elements. These displays are a mirror image of the first optical picture. Note that certain areas are enriched in Ni, Fe, Cr, and Mo. Some copper from the capsule is present in the deposited material. Approx 200X.

An electron-probe microanalysis of the material in the grain boundaries and x-ray scans for the distribution of Ni, Fe, Cr, and Cu in the surface layer in the area around the large metallic particle on the outer surface were made. Figure 66 shows the distribution of these elements, and it appears that the surface layers were made up mostly of copper and nickel, with some areas containing high concentrations of chromium and molybdenum. The inner and outer surfaces of the capsule appear similar. The grain-boundary precipitate was only 28% Cu, and no other element could be detected. This observation indicates that the remainder is a light element, perhaps beryllium or lithium, that could not be detected by the instrument.

Although copper is generally accepted as being compatible with fuel salt, this capsule was severely embrittled in its 13,000-hr exposure to MSRE fuel salt. Heavy deposits quite similar to those noted on the sample cage and shield were present on the surfaces of the copper capsule. Some of the constituents of these deposits may have caused the embrittlement, but we were unable to identify the responsible element.

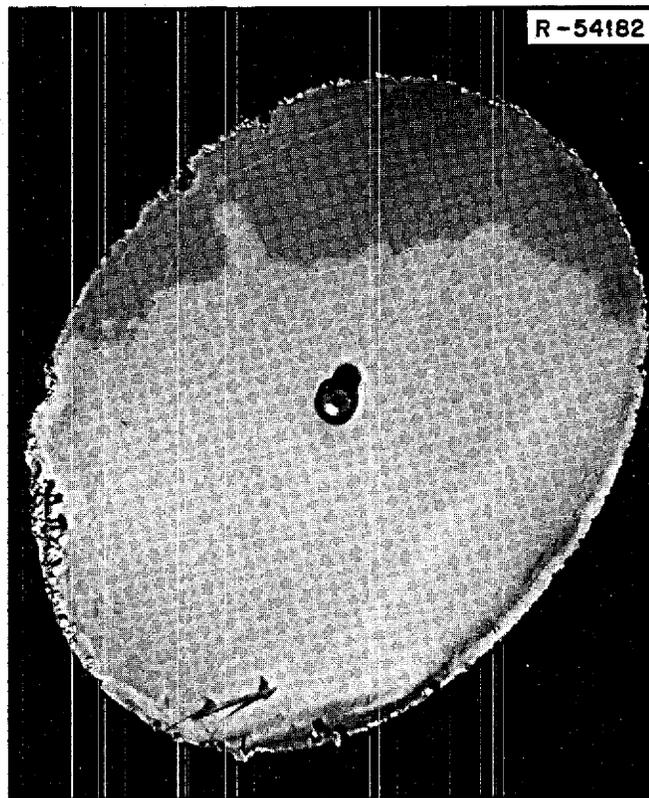
The heat exchanger was above 500°C for 30,807 hr and was exposed to fuel salt for 21,040 hr. An oval piece of the shell 10 × 13 in. was cut by plasma torch near the outlet end of the heat exchanger. This same cut severed a piece of one tube, and pieces of five others were cut by an abrasive wheel. These parts are shown in Figs. 68 and 69. The outside of the shell had a dark adherent oxide; the inside surfaces were discolored slightly and had a thin bluish-gray coating, probably caused by the plasma cutting operation. Some of this powder was brushed off and found by gamma scanning to contain  $^{106}\text{Ru}$  and  $^{125}\text{Sb}$ .

Fig. 68. Section 10 x 13 in. cut from the primary heat exchanger shell. The piece was cut with a plasma torch, and the center stud was used for guiding the torch.

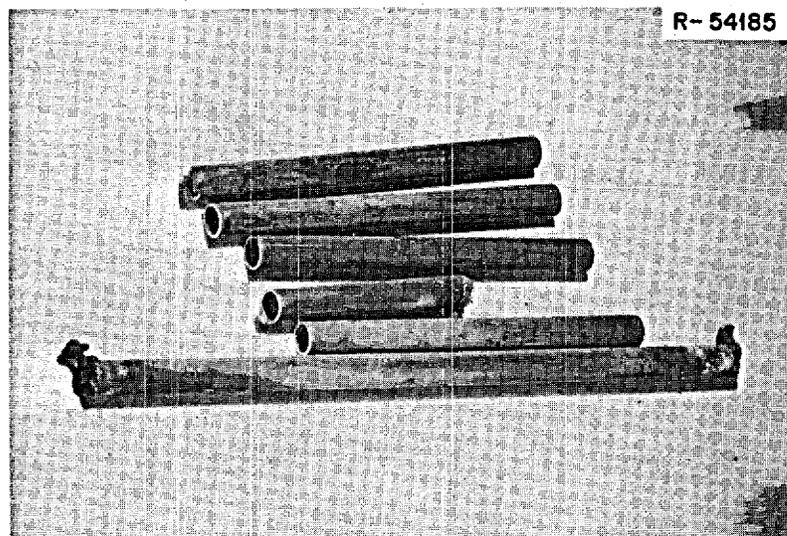
Fig. 69. The  $\frac{1}{2}$ -in.-OD INOR-8 tubes from the primary heat exchanger. The different shades arise from a dark film thought to have been deposited when the shell was being cut. The film was deposited on the side of the tubes facing the shell.

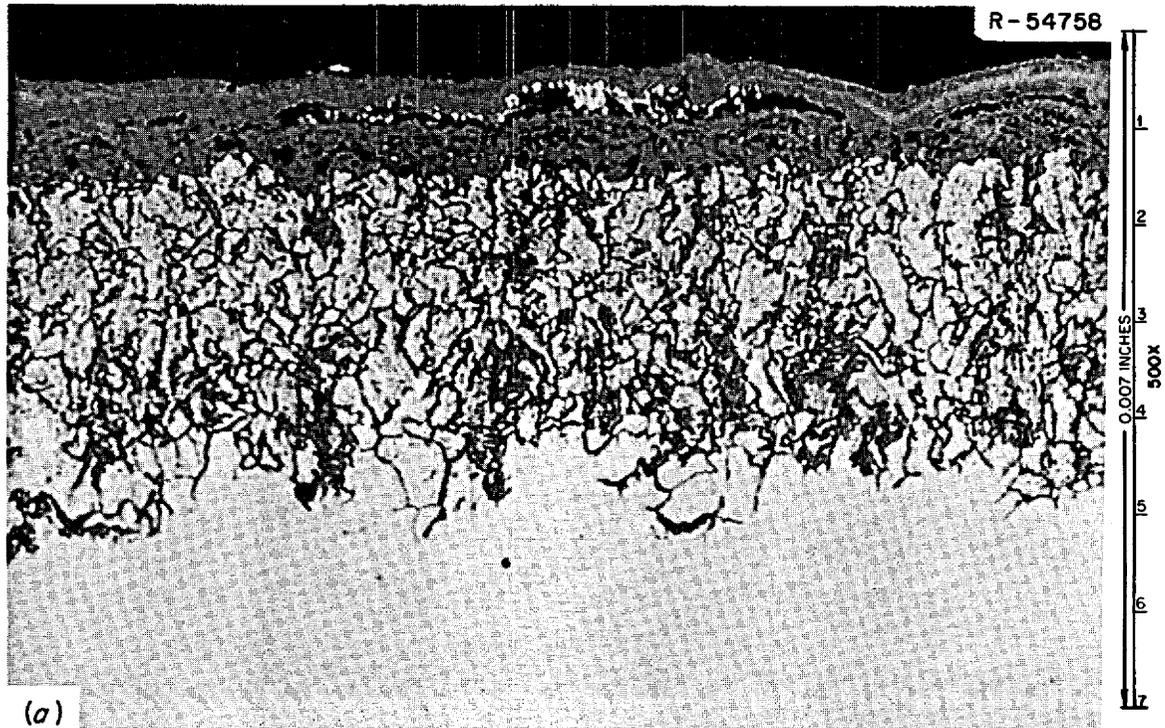
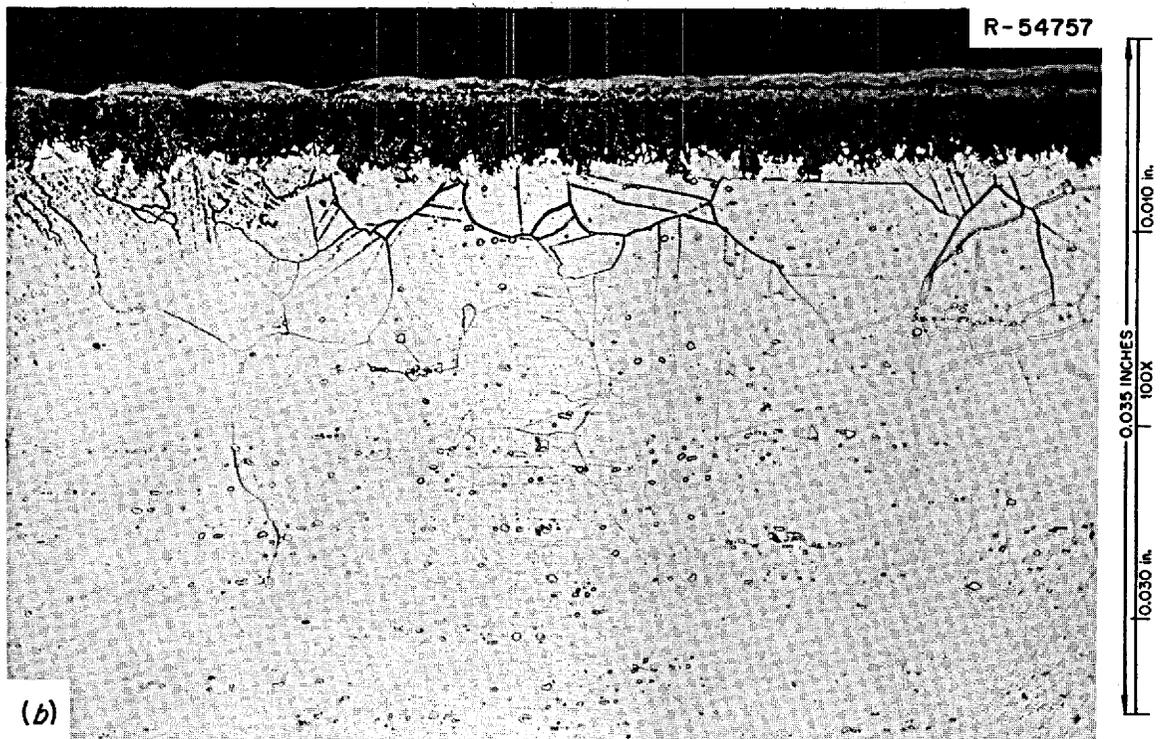
Photomicrographs of a cross section through the outer surface of the shell are shown in Fig. 70. The oxide on the outside surface is typical of that observed on INOR-8 at this temperature and extends to a depth of about 5 mils. Etching attacks the metal in the oxidized layer and etches the grain boundaries near the surface more rapidly than those in the interior. The inside surface of the shell (Fig. 71) shows some structural modifications to a depth of about 1 mil. No samples of the shell were deformed.

Fig. 70. Outside edge of INOR-8 primary heat exchanger shell. This surface was exposed to 2 to 5%  $O_2$  in nitrogen. (a) As polished, showing selective oxidation. (b) Etched view showing that metal in oxidized layer was completely removed. Etchant: aqua regia.

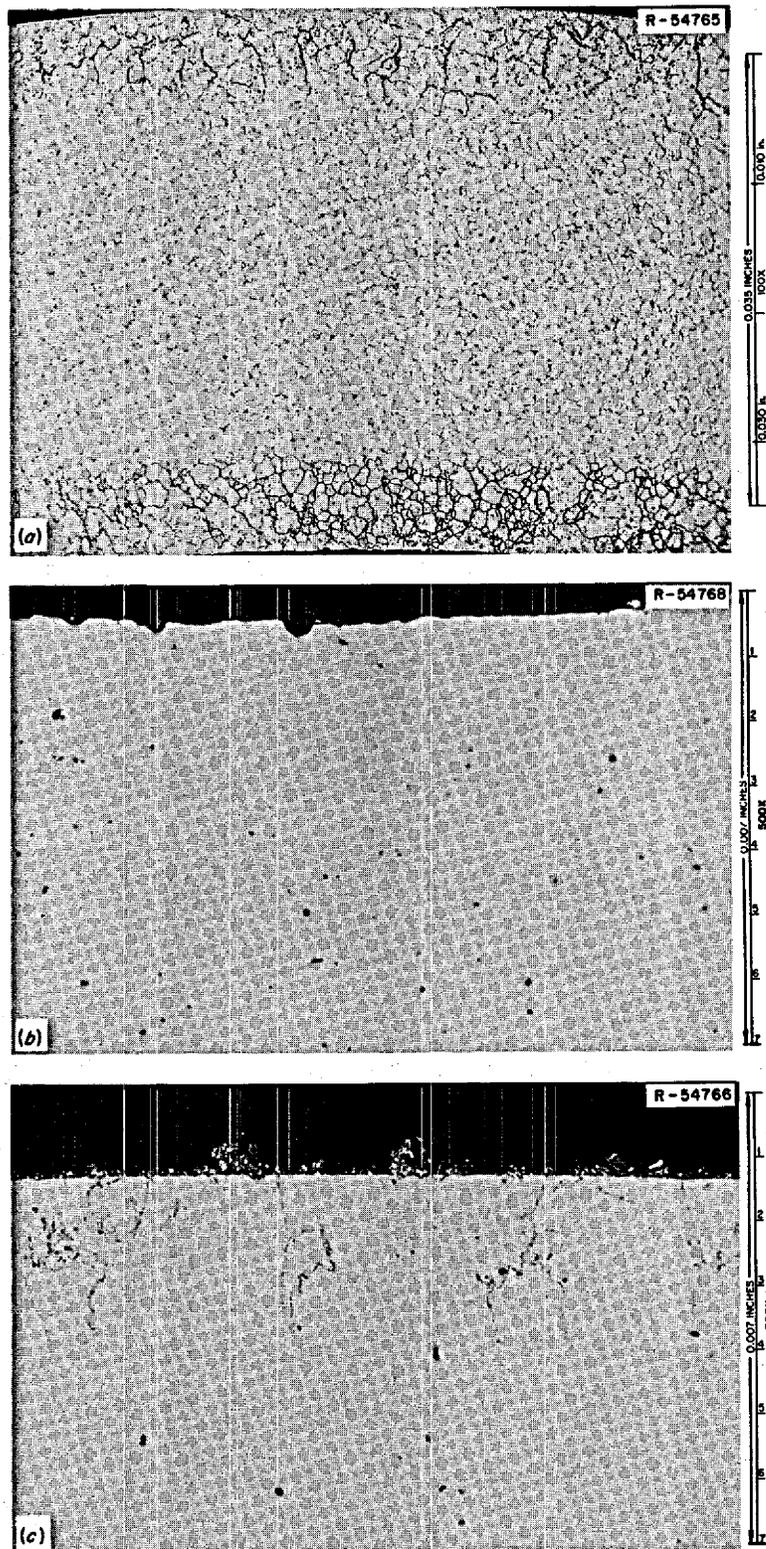
Photomicrographs of a typical cross section of the heat exchanger tubing are shown in Fig. 72. The overall view shows that both sides etch more rapidly than the center to a depth of about 7 mils. This is not unusual for a tubular product and is often attributed to impurities (primarily lubricants) that are worked into the metal surface during repeated steps of deformation and annealing. The higher magnification views in the as-polished condition show that grain boundary attack (or cracking) occurred on the surface exposed to fuel salt (outer) but not on the coolant side (inner). The temperatures under normal operating conditions were such that the fuel salt side would have been in compression.

Fig. 72. Cross section of INOR-8 heat exchanger tube. (a) Etched with glyceria regia. (b) Inside surface in the as-polished condition after exposure to coolant salt. (c) Outside surface in the as-polished condition after exposure to fuel salt. Reduced 34%.

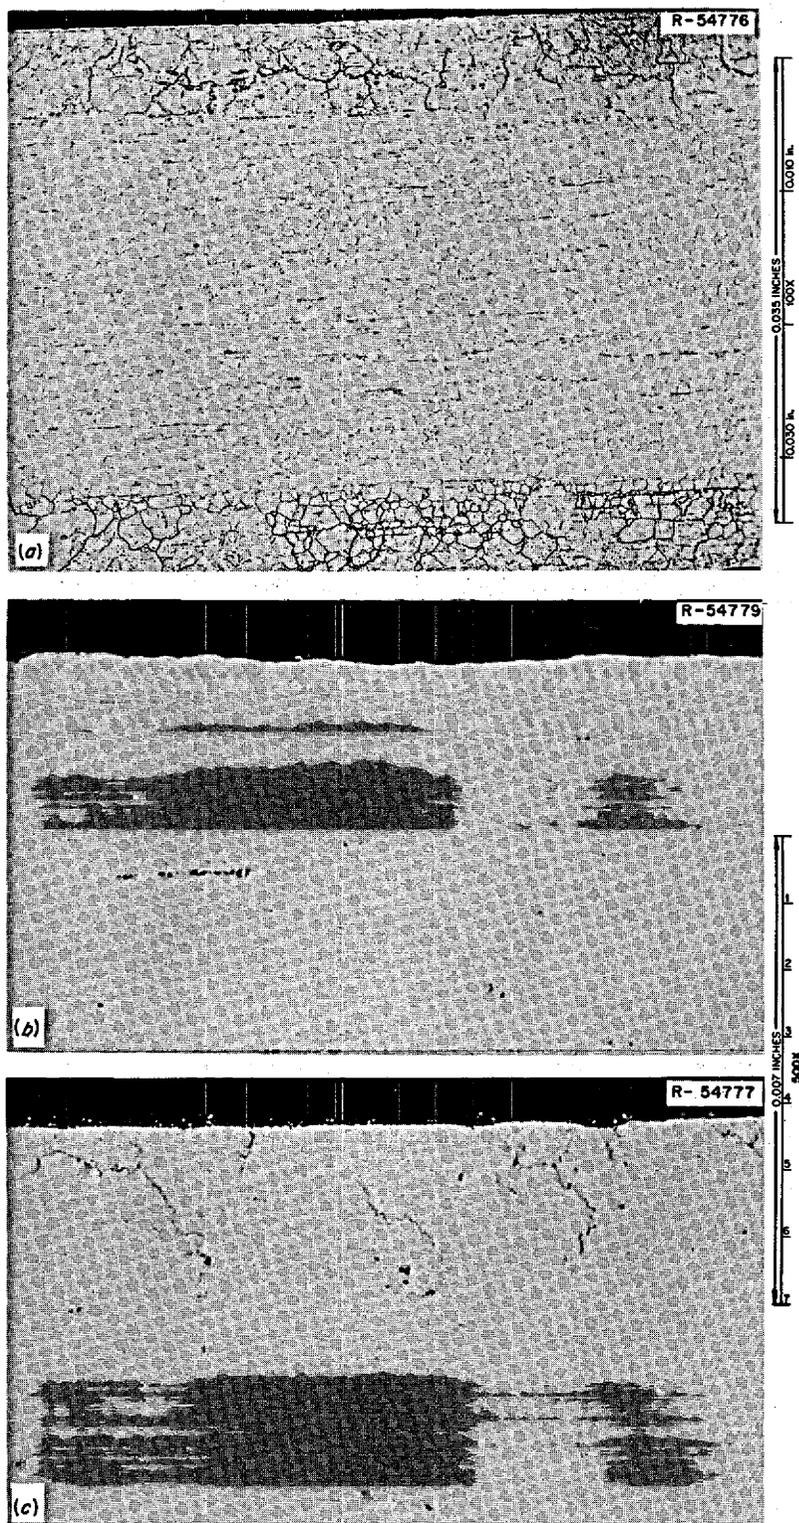
Similar photomicrographs of a longitudinal section of tubing are shown in Fig. 73. The features are quite similar to those discussed for Fig. 72. Both figures show some metallic deposits on the outside surface, which was exposed to fuel salt. These deposits are extremely small and could not be analyzed with much accuracy with the in-cell microprobe. However, they seemed to be predominately iron. Scanning across the tubing detected no concentration gradients of the major alloying elements in INOR-8.

Fig. 73. Longitudinal section of INOR-8 heat exchanger tube. (a) Etched with glyceric acid. (b) Inside surface in the as-polished condition after exposure to coolant salt. (c) Outside surface in the as-polished condition after exposure to fuel salt. Reduced 31%.

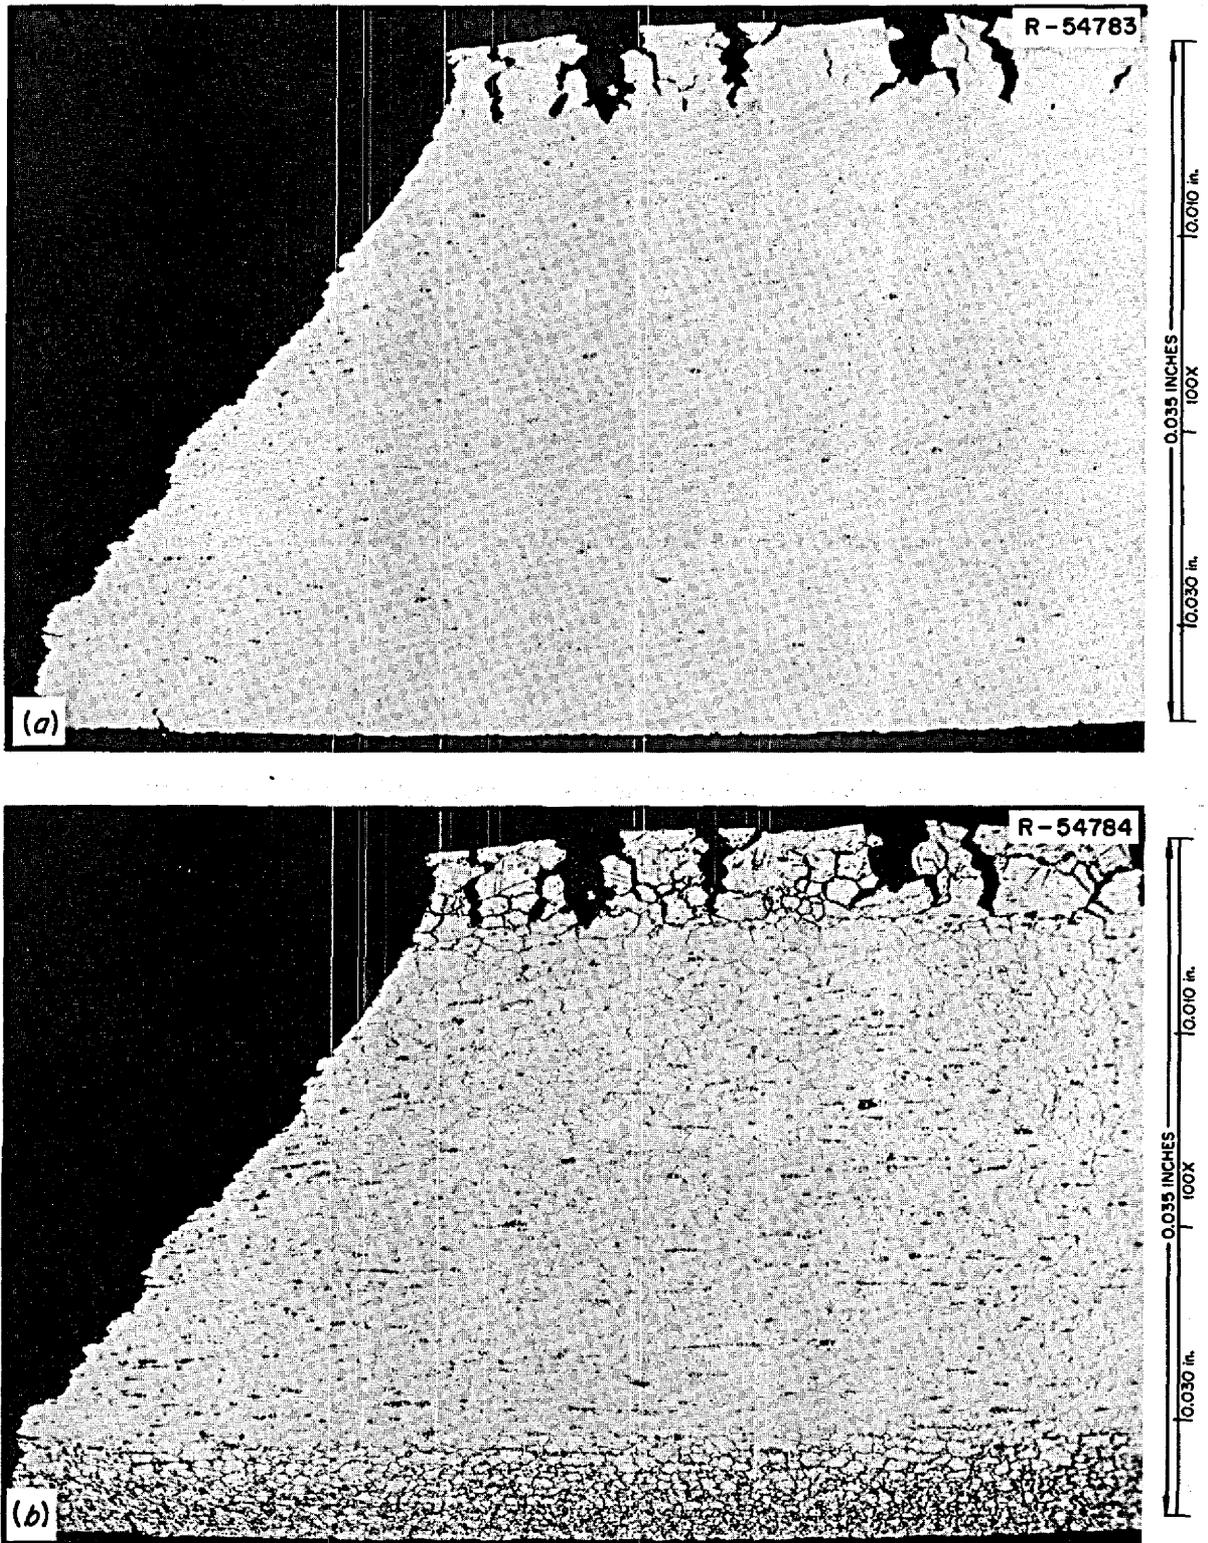
Photomicrographs of one of the tubes deformed at 25°C are shown in Fig. 74. Profuse intergranular cracks were formed to a depth of about 5 mils on the side exposed to fuel salt, but none were formed on the coolant salt side. Etching again revealed the abnormal etching characteristics near the surface, but whatever caused this abnormality did not result in grain-boundary embrittlement.

Fig. 74. INOR-8 heat exchanger tube deformed to fracture at 25°C. (a) As polished; (b) etched with aqua regia.

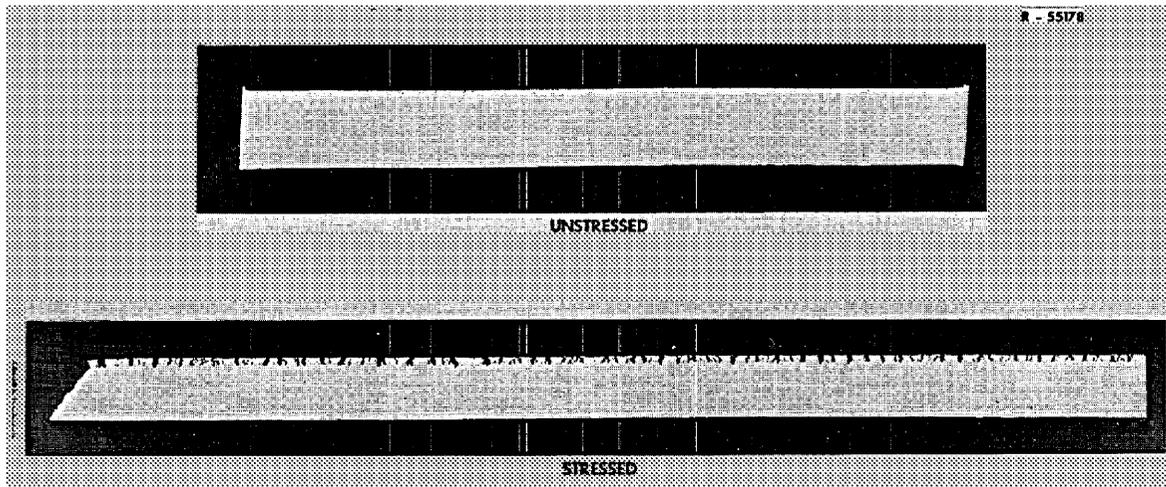
Unstressed and stressed sections of tubing were photographed over relatively large distances to get more accurate statistics on crack numbers and depths. Composite photographs of the two samples are shown in Fig. 75. The cracks are readily visible in the stressed sample but may not be apparent in

Fig. 75. Composite photographs of INOR-8 heat exchanger tubing before and after stressing. Width of unstressed sample is 0.042 in.

the unstressed sample. A higher magnification print used in making the composite is shown in Fig. 76; the cracks can be more easily seen. The stressed sample had 262 cracks per inch with an average depth of 5.0 mils. Two counts were made on the unstressed sample. In the first count only those features that unequivocally were cracks were counted. This gave a crack count of 228 per inch with an average depth of 2.5 mils. In another count, we included some features that were possibly cracks, and this gave a crack frequency of 308 per inch. Thus the number of cracks present before straining was about equivalent to that noted after straining. Straining did increase the *visible* depth. Some indirect evidence that the cracks were present initially and only spread open further during the tensile test was obtained from examination of the sample in Fig. 75. The sample length shown deformed 39% (Table 9), and the combined widths of the cracks account for 35% strain. Thus, the crack widths very closely account for the total strain and indicate that the cracks formed with little or no deformation and spread open as the sample was deformed.

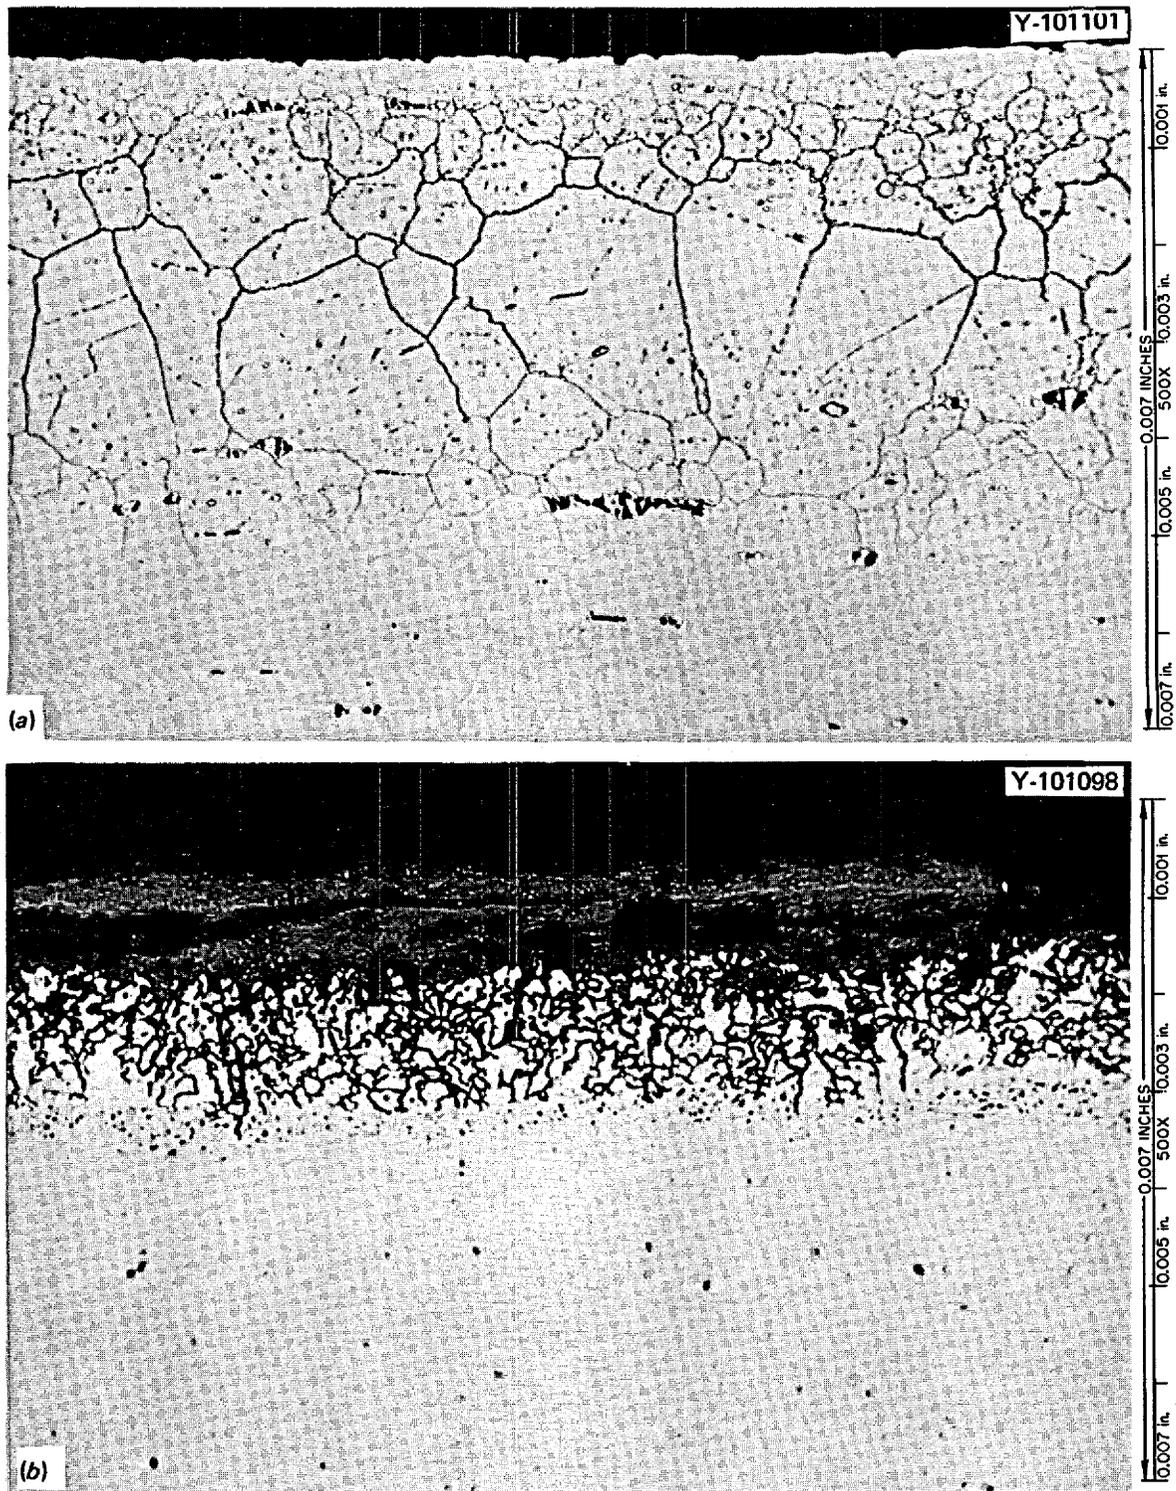
The microstructure of the tubing was altered two ways during service. The outside of the tubing was oxidized, and the inside of the tubing etched more rapidly to a depth of about 5 mils. These changes are shown in Fig. 80 for tubing at the inlet end and in Fig. 81 for the outlet end. The oxidation is not excessive, and the penetration of the oxide front is typical for nickel alloys with chromium content as low as that in INOR-8.

Fig. 80. Microstructures of a longitudinal section of INOR-8 tubing from the inlet end of the MSRE radiator. (a) Inside of pipe wall, etched with glyceric acid; (b) outside of pipe wall, as polished.

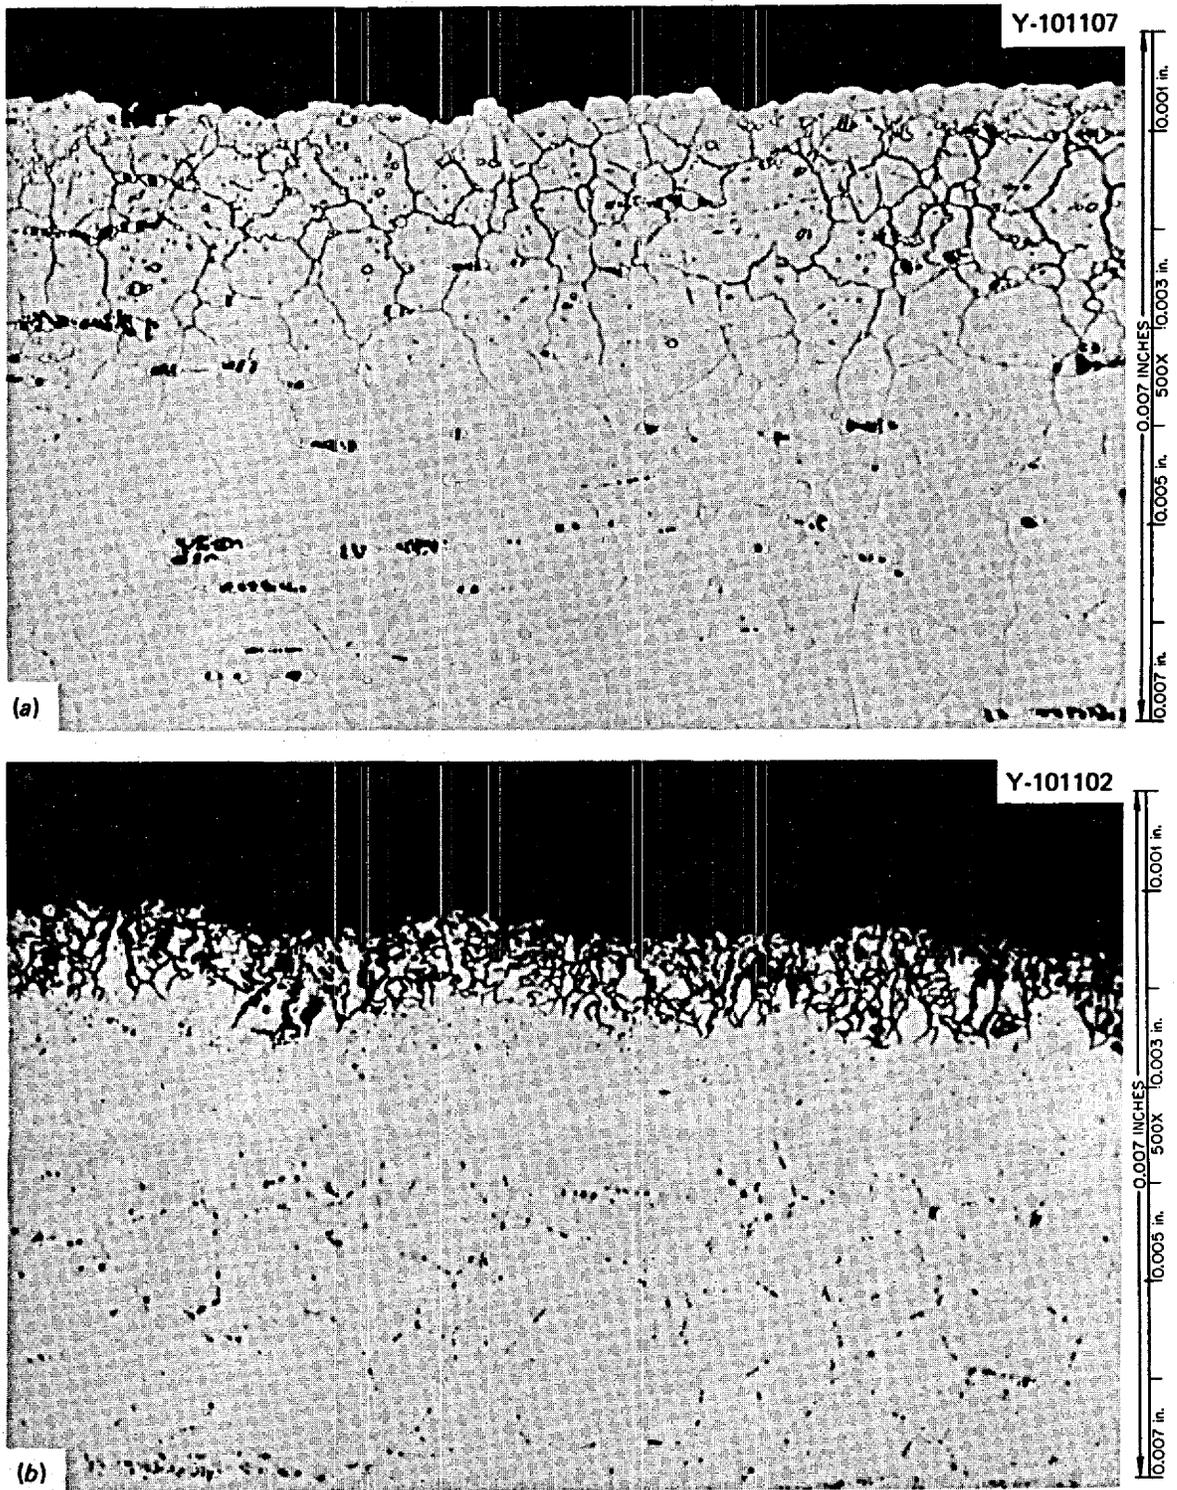
Fig. 81. Microstructures of a longitudinal section of INOR-8 tubing from the outlet end of the MSRE radiator. (a) Inside of pipe wall, etched with glyceric regia; (b) outside of pipe wall, as polished.

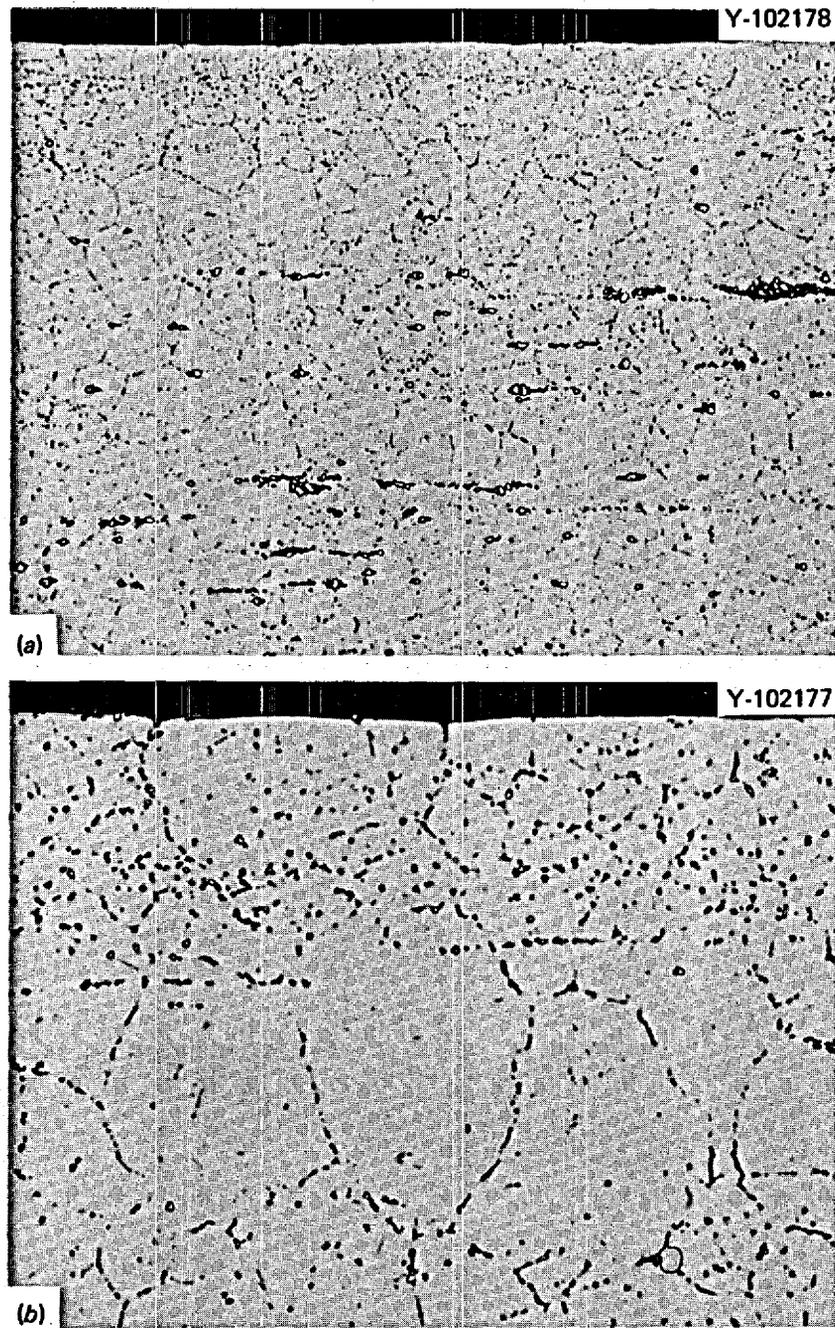
Fig. 83. Tubing from the inlet end of the MSRE INOR-8 radiator. Etched electrolytically in an aqueous solution of 5% sodium citrate, 5% sodium acetate, 1% citric acid, 1% potassium thiocyanate. 700 mV for 10 sec, started at 8 mA and dropped to 4 mA. (a) 250X; (b) 1000X.

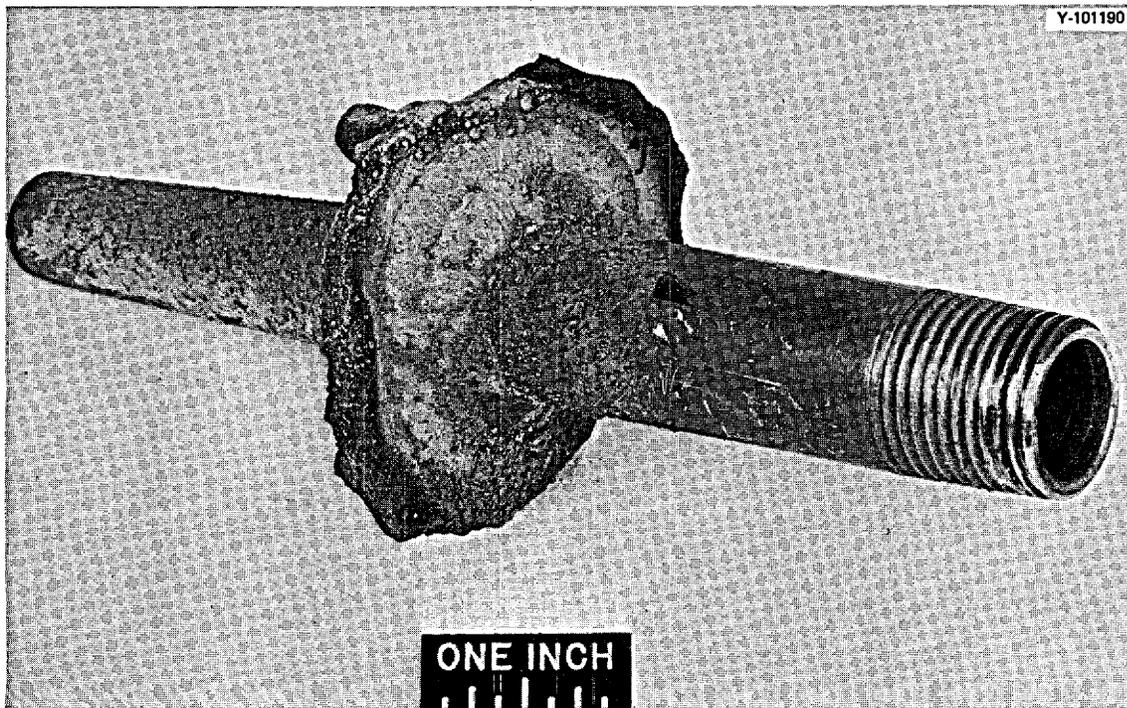
The inlet thermocouple well after it was cut off with a coated welding electrode is shown in Fig. 84. The oxidized appearance and the metal fragments on the part arose from the cutting operation. The circular piece of material is part of the 5-in. pipe wall. The thermocouple well was machined from bar stock and extended about 3 in. into the flowing salt stream. The cross-sectional view of part of the inlet well in Fig. 85 makes the geometry more evident. The pipe wall, the welds, and the thermocouple well are evident.

Fig. 84. INOR-8 thermocouple well removed from the inlet line to the radiator of the MSRE. Much of the discoloration and the fragments of metal resulted from cutting the part out with a coated welding electrode.
