ORNL-TM-4174

# POSTIRRADIATION EXAMINATION OF MATERIALS FROM THE MSRE

**POSTIRRADIATION EXAMINATION OF MATERIALS FROM THE MSRE**

**DECEMBER 1972**

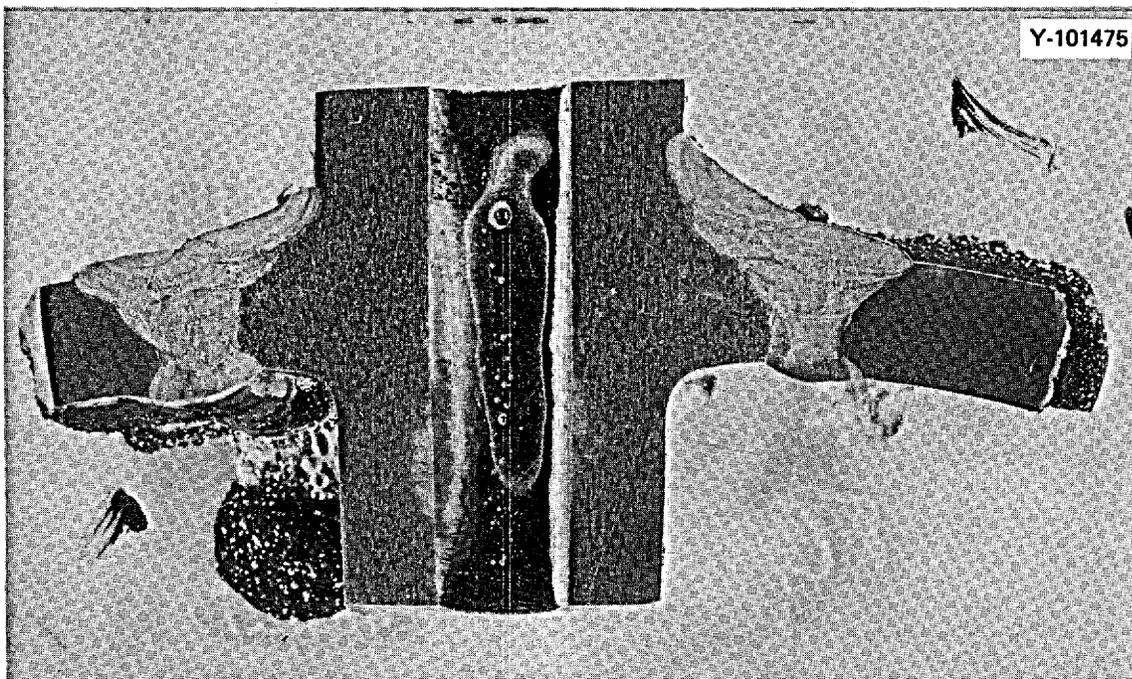
Fig. 85. Cross section of INOR-8 thermocouple well from the inlet line to the MSRE radiator. From left to right the components are the 5-in. coolant line, the weld, and the thermocouple well. The side having the most weld metal was exposed to air, and the other side was exposed to coolant salt.

Metallographic examination of the mounted cross section shown in Fig. 85 revealed that the weld had cracked on the salt side of the pipe. The cracks on both of the polished surfaces in Fig. 85 are shown in Fig. 86. In the worst case the cracks penetrated to a depth of about 3 mils. The remaining half of the well was cleaned by acid etching to remove the metal left from the cutting operation, and the weld was checked with dye penetrant. A photograph of the weld with dye still present is shown in Fig. 87. Note that the crack, as indicated by the dark color, extends almost completely around the weld. There is also an area where penetration of the root pass was incomplete. We propose that the cracks formed as the weld was made, because of the poor fit-up of the parts to be welded. The welds were not stress relieved, and the fact that the cracks did not penetrate further attests to the lack of stress and crevice corrosion by lithium-beryllium fluoride salts.

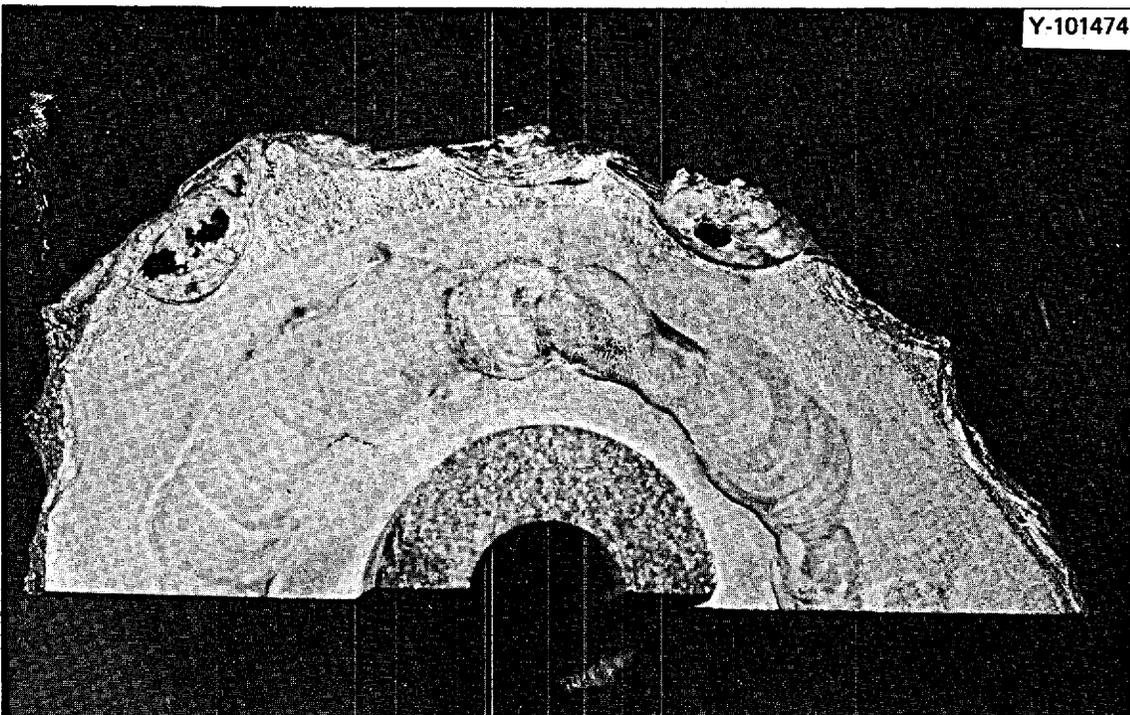
Fig. 87. Underside (salt side) of half of the INOR-8 thermocouple well from the inlet line to the MSRE radiator. The part was acid etched and coated with dye penetrant. Note the indication of a crack around most of the weld and an incomplete root pass region.

The cracked weld where the inlet thermocouple well was attached to the 5-in. pipe header likely resulted from poor fit of the parts during welding. The crack probably formed when the weld was being made, and it is encouraging that it did not propagate further during service.

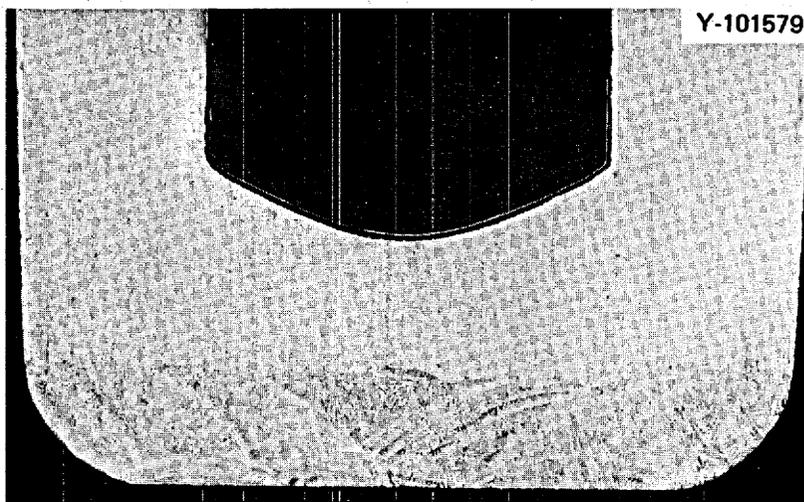
A cross section from the bottom of the well was examined. A macroscopic view of this section is shown in Fig. 89. The inside of the well was prepared by drilling, and the pointed shape of the drill is still apparent at the bottom. The weld metal deposit on the bottom was made to ensure that salt did not leak along the carbide stringers. The amount of oxidation was greater at the bottom of the well than further up. The transition to the thinner oxide about  $\frac{1}{8}$  in. from the bottom is apparent in Fig. 89. Figure 90(a) shows the oxide layer of about 5 mils at the bottom of the well, and Fig. 90(b) shows the abrupt transition about  $\frac{1}{8}$  in. from the bottom. Since lubricant would have been used during drilling, we suggest that this difference may have been due to the bottom of the well not being as clean as the sides.

Fig. 89. Cross section of the inlet INOR-8 thermocouple well. The outside was exposed to coolant salt, and the inside contained the thermocouple in air. 8X; as polished.

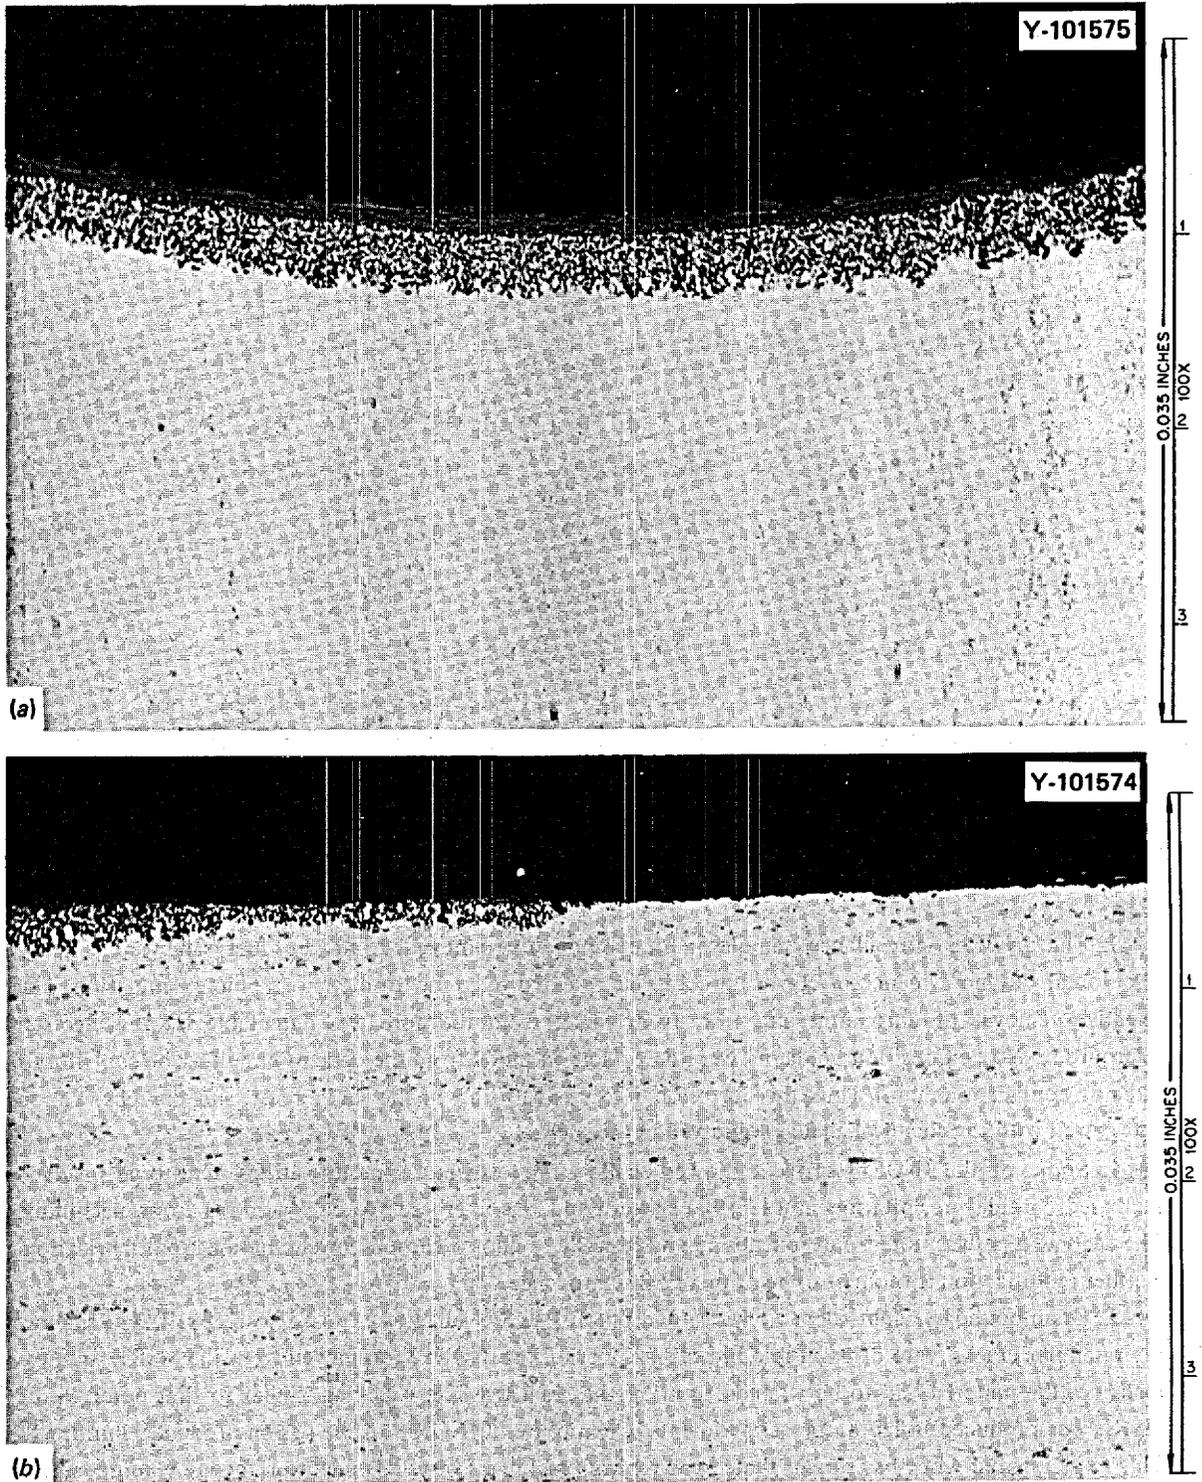
Fig. 90. Oxide inside the inlet INOR-8 thermocouple well. As polished, (a) At the bottom; (b) transition in depth about  $\frac{1}{8}$  in. from bottom of well.

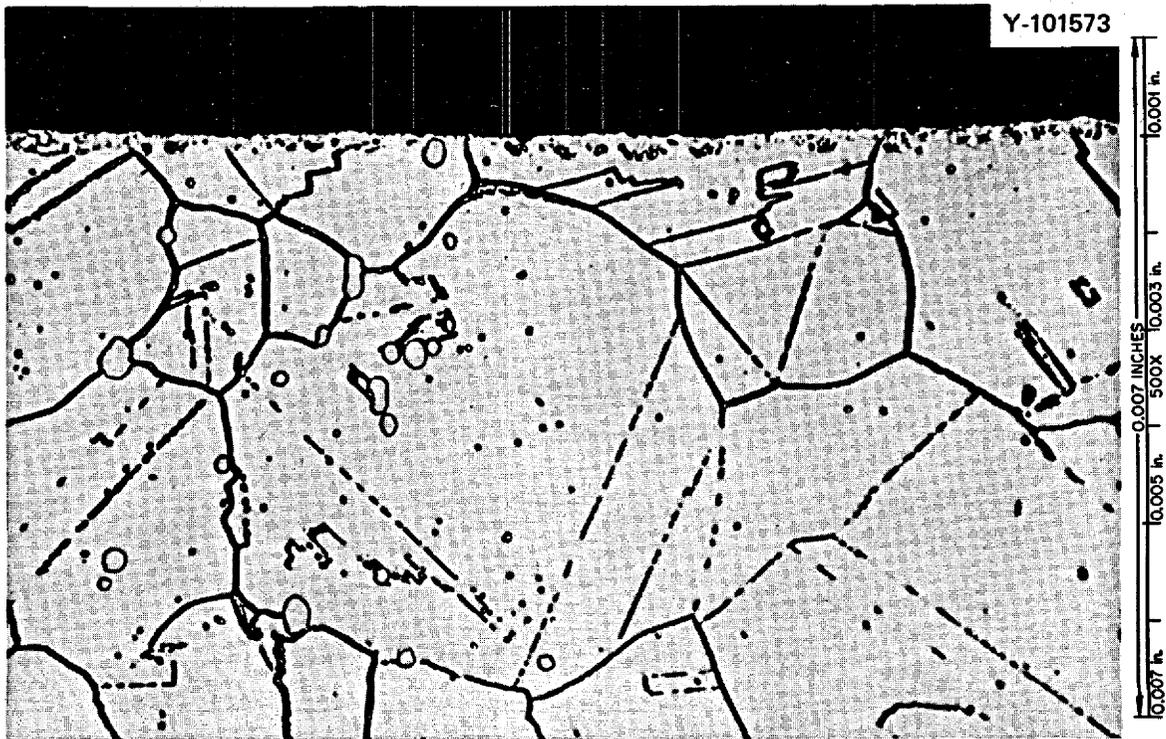
A further significant observation was that the surfaces of the well exposed to the salt looked quite similar to those of surveillance samples removed from the MSRE (Fig. 91). We have previously attributed this modified surface structure to cold working from machining and have shown that it can be produced in the absence of salt. The structure likely results from carbide forming on the slip bands produced by machining. Thus there is no evidence of corrosion of this part.

Fig. 91. The outside of the inlet INOR-8 thermocouple well that was exposed to coolant salt. Note the modified layer near the outer surface. Etchant: glyceria regia.
