ORNL-1965 *cy 118-A*
C-84 - Reactors-Special Features of Aircraft Reactors

A FLUORIDE FUEL IN-PILE LOOP EXPERIMENT

O. Sisman, W. E. Brundage, and W. W. Parkinson

ORNL-1965

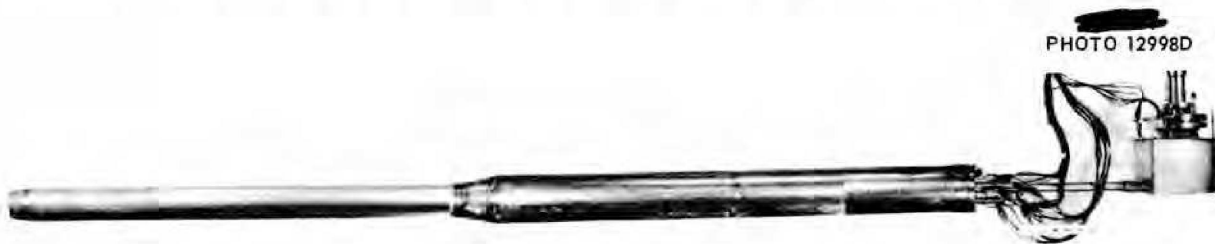
Fig. 12. Assembled Fuel Loop in Water Jacket.

When completely assembled, the "in-pile" portion of the loop was enclosed in a stainless steel jacket, as shown in Fig. 12. The flange

The jacket, which provided water cooling and an inert atmosphere for the loop, was fabricated from $\frac{1}{8}$ -in.-thick stainless steel (see Fig. 12). Two baffles, running the full length of the annular region between the double walls of the jacket, directed the water flow so that the cooling water went in along the bottom half of the jacket, across the end, and returned along the upper half. The flange, which is part of the loop assembly, was bolted onto the jacket during final assembly. A hermetic seal was made with a copper gasket. Electrical and gas-line connections to the in-pile region of the loop were made through the flange, using Kovar-glass seals for the electrical and

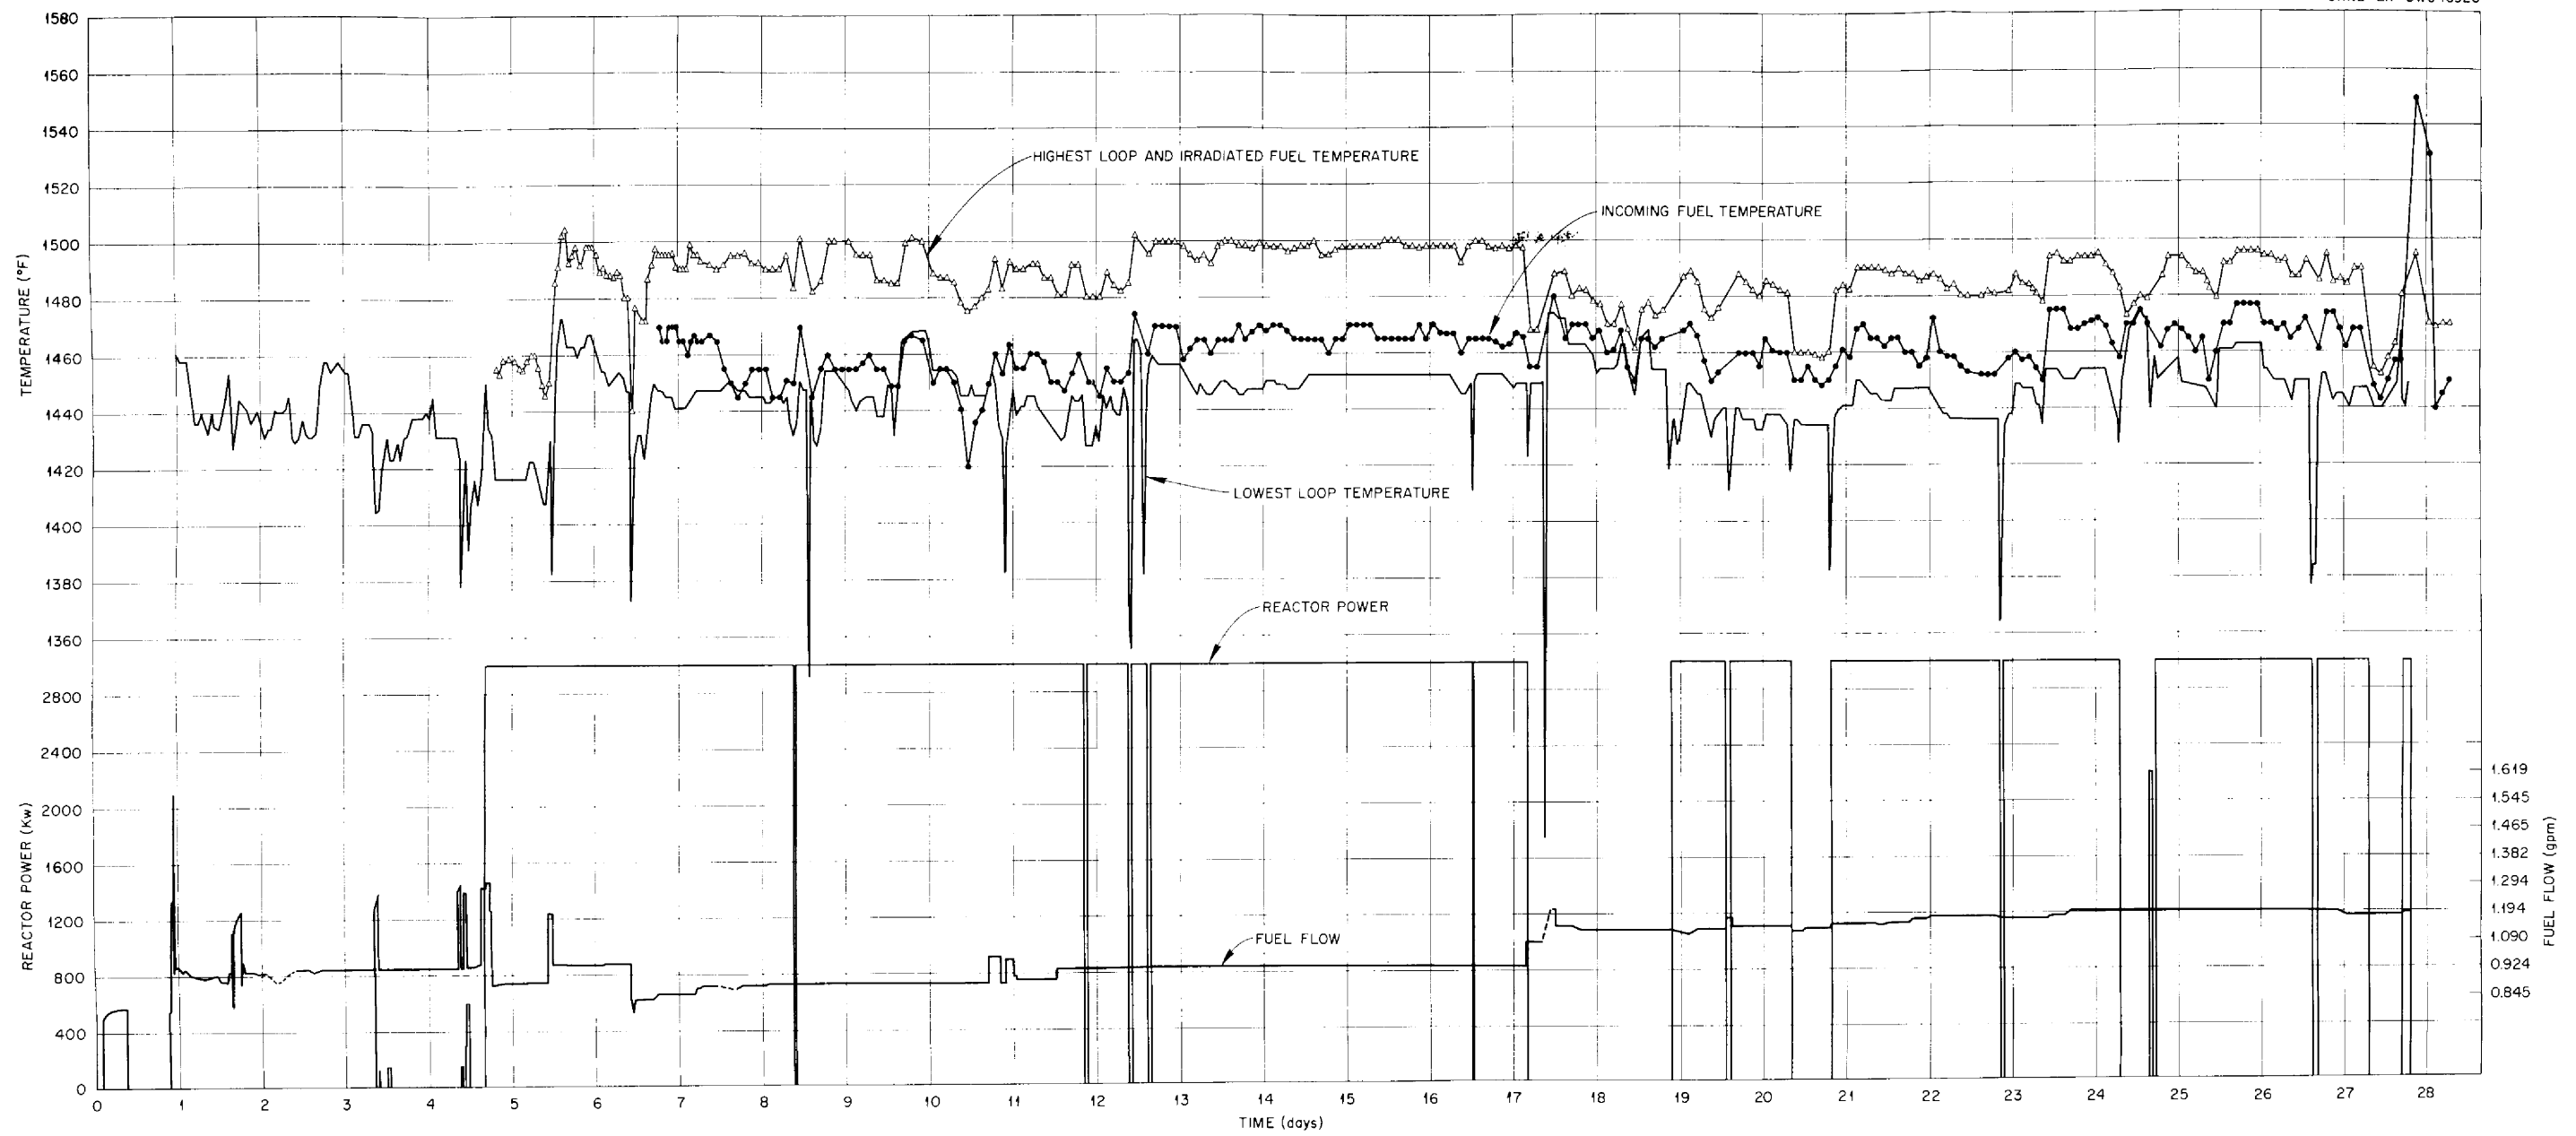
Fig. 24. Conditions of Operation of Fuel Loop During In-Pile Period.

The discharge side of the nosepiece, as expected, registered the highest temperatures, which averaged 1485°F. The well at the inlet of the nosepiece averaged 1475°F, and the surface of the venturi ran about 1440°F. Fuel temperature should have been lowest at the venturi, since all the out-of-pile heaters and those of the heat exchanger were off or were at reduced power. (It was necessary to supply some heat in this region, so this was done at the pump, the component of the loop with the most heating capability.) The temperature of the tubing adjacent to the venturi was

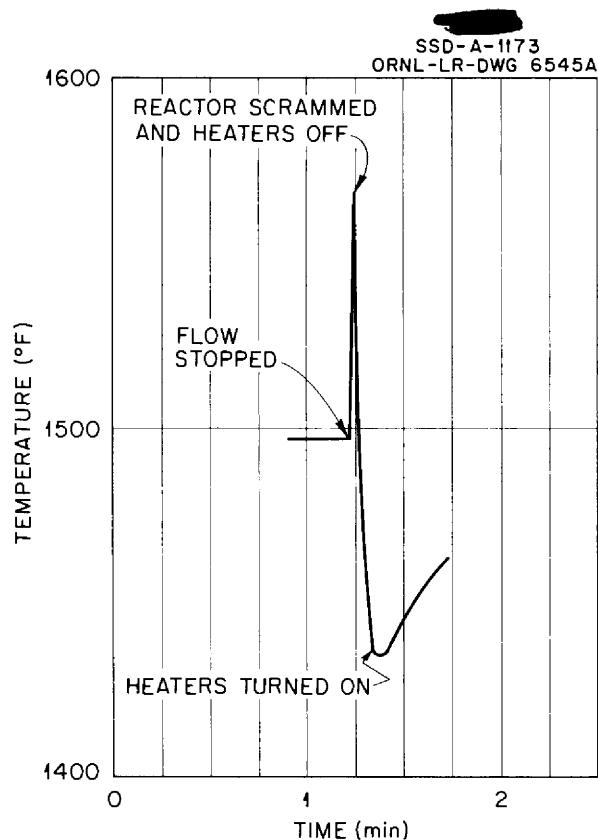
Fig. 25. Temperature Excursion upon Flow Stoppage in the Loop.

The experiment ran very smoothly throughout the month that it was in the reactor. An early plugging in one of the off-gas lines was easily corrected, and the only adjustments required were heater power regulation for reactor shutdown and startup. Temperatures, fuel flow rate, and reactor power are plotted in Fig. 24 for the entire period of operation; the conditions of operation are summarized in Table 1. Termination of the experiment was caused by flow stoppage due to failure of the pump drive belt. The flow stoppage caused an overshoot in temperature which scrambled the reactor by means of the safety circuit built into the equipment. The temperature overshoot was 70°F and lasted for about 1 sec, after which time the reactor was shut down (see Fig. 25).

rapid as the response rate of the recorder, but the total rise was not more than 80°F before the reactor was cut off. The record of the potentiometer which gave the emergency signal and which was connected to the thermocouple on the hottest point of the nose piece is shown in Fig. 25. The high-temperature period is seen to have been of very short duration.

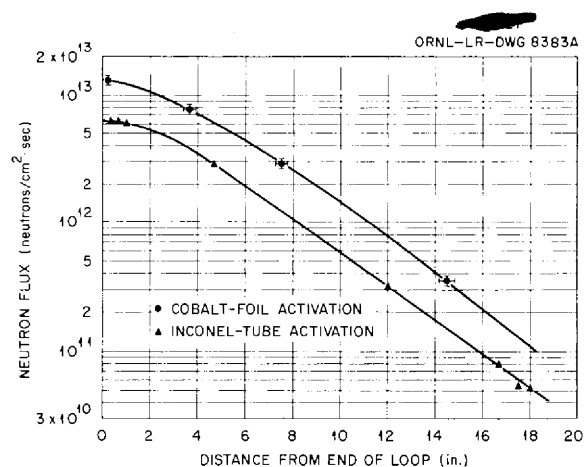
Fig. 26. Thermal-Neutron Flux, as a Function of Distance, Determined by Activation.
