# INFLUENCE OF AGING ON THE IMPACT PROPERTIES OF HASTELLOY N, HAYNES ALLOY NO. 25, AND HAYNES ALLOY NO. 188

ORNL-TM-4380

METALS AND CERAMICS DIVISION

DECEMBER 1973

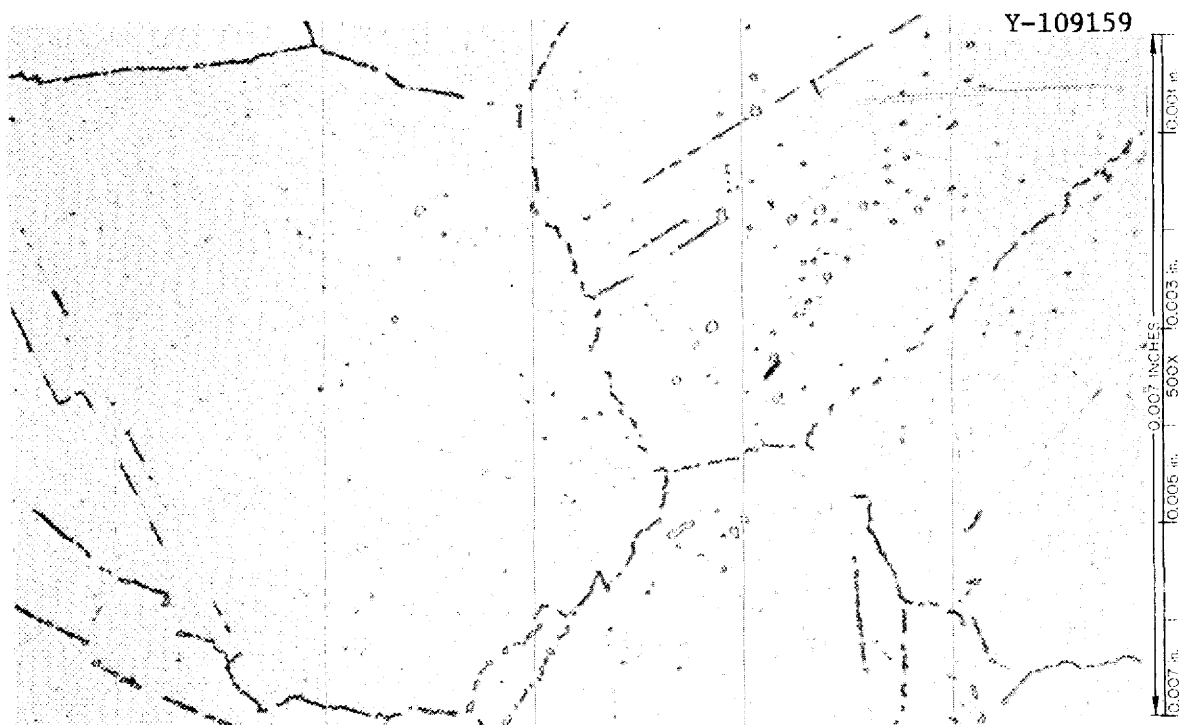
Fig. 13. Typical Photomicrograph of Hastelloy N Annealed 1 hr at 1150°C and Aged 4000 hr at 800°C. Impact energy was 40 ft-lb. Etchant: glyceria regia.

boundaries. Aging at 700°C caused carbide precipitation similar to that noted at 650°C. Aging at 800°C initially caused grain boundary carbide precipitation and some general precipitation (Fig. 12). After prolonged aging at 800°C, the grain boundary carbide agglomerated, and the amount of precipitate within the grain increased (Fig. 13). However, the impact energy continued to decrease with further aging at 800°C (Fig. 1, p. 4) even though the grain boundary carbide appeared to become discontinuous. At 900°C the carbide formed preferentially along the grain boundaries (Fig. 14). It was initially quite fine and became coarser and agglomerated with further aging time. The impact energy decreased with increasing carbide formation and seemed to reach a plateau of about 30 ft-lb after the carbide became quite coarse (Fig. 1, p. 4).

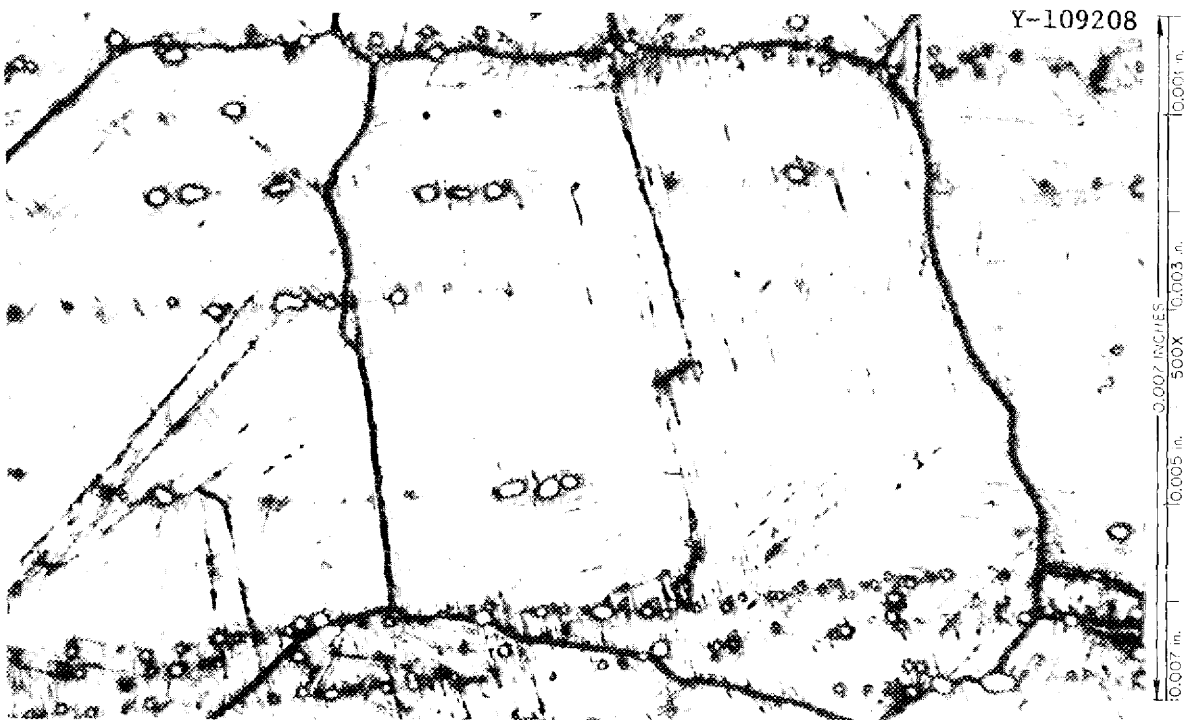
Fig. 17. Typical Photomicrograph of Haynes Alloy No. 25 Annealed 1 hr at 1150°C and Aged 4843 hr at 700°C. Impact energy at 25°C was 5 ft-lb. Etchant: glyceria regia.

The microstructure of solution-annealed Haynes alloy No. 25 is shown in Fig. 15; it contains a primary carbide, likely  $M_6C$ . Even though aging at 650°C caused a steady decrease in the impact energy from 60 to 2 ft-lb (Fig. 4, p. 5), the microstructure changed only slightly. After aging for 4843 hr at 650°C (Fig. 16) the grain boundaries etched very quickly (likely because of the presence of carbide or Laves precipitate), and some precipitate was visible in the grains. Aging at 700°C produced a steady decrease in the impact energy (Fig. 4, p. 5), and large amounts of precipitate (likely Laves phase) were visible in the microstructure (Fig. 17). Aging at 800°C resulted in coarser precipitate than noted at 700°C, and the grain boundaries etched very readily (Fig. 18). Aging at 850°C for 50 hr caused the impact energy to decrease from 50 to 6 ft-lb (Fig. 4, p. 5), but the microstructure showed little change from the solution-annealed condition (compare Figs. 15 and 19). The main difference is the more rapid etching characteristics of the grain boundaries after aging. Aging 4843 hr at 850°C caused the impact energy to decrease only slightly from that noted after aging 50 hr; however, the amount of precipitate increased dramatically (Fig. 20). These observations lead to the speculation that the impact property changes in Haynes alloy No. 25 result primarily from the grain boundary precipitate structure and to a lesser extent on the precipitate within the grains.
